## 308468: Tybalds Estate - Phase 1 - Ground Remediation

Harley Haddow (HH) have been recently asked by DWD to provide a cover letter to describe the proposed ground remediation measures associated with the proposed Phase 1 Works at Tybalds Estate in Camden, which we understand relates to planning condition 12. Please refer to the summary of the proposed remediation measures below.

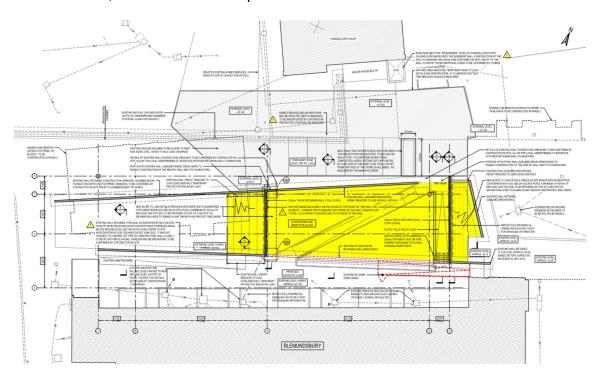
Figure 1 – Extract from HH drawing 308468-HAH-BL-00-DR-S-0050 (Blemundsbury ramps enabling works)

Areas, which are proposed to be excavated, should be confirmed by the Design Team. The area of proposed structural and civil works which will require ground remediation works is limited to the construction of a new ramp in front of the Blemundsbury building (see highlighted in Figure 1). Harley Haddow drawing 308468-HAH-BL-00-DR-S-0050 can be found in Appendix A. For other works, such as the extent of excavations to the new temporary access road, and landscaping works in front of Falcon and Richbell, refer to the Landscape Architect's information.
