# Brooks & Brooks

Heritage Statement - 28 Great Queen Street, London, WC2B 5BB - 22/02/2023

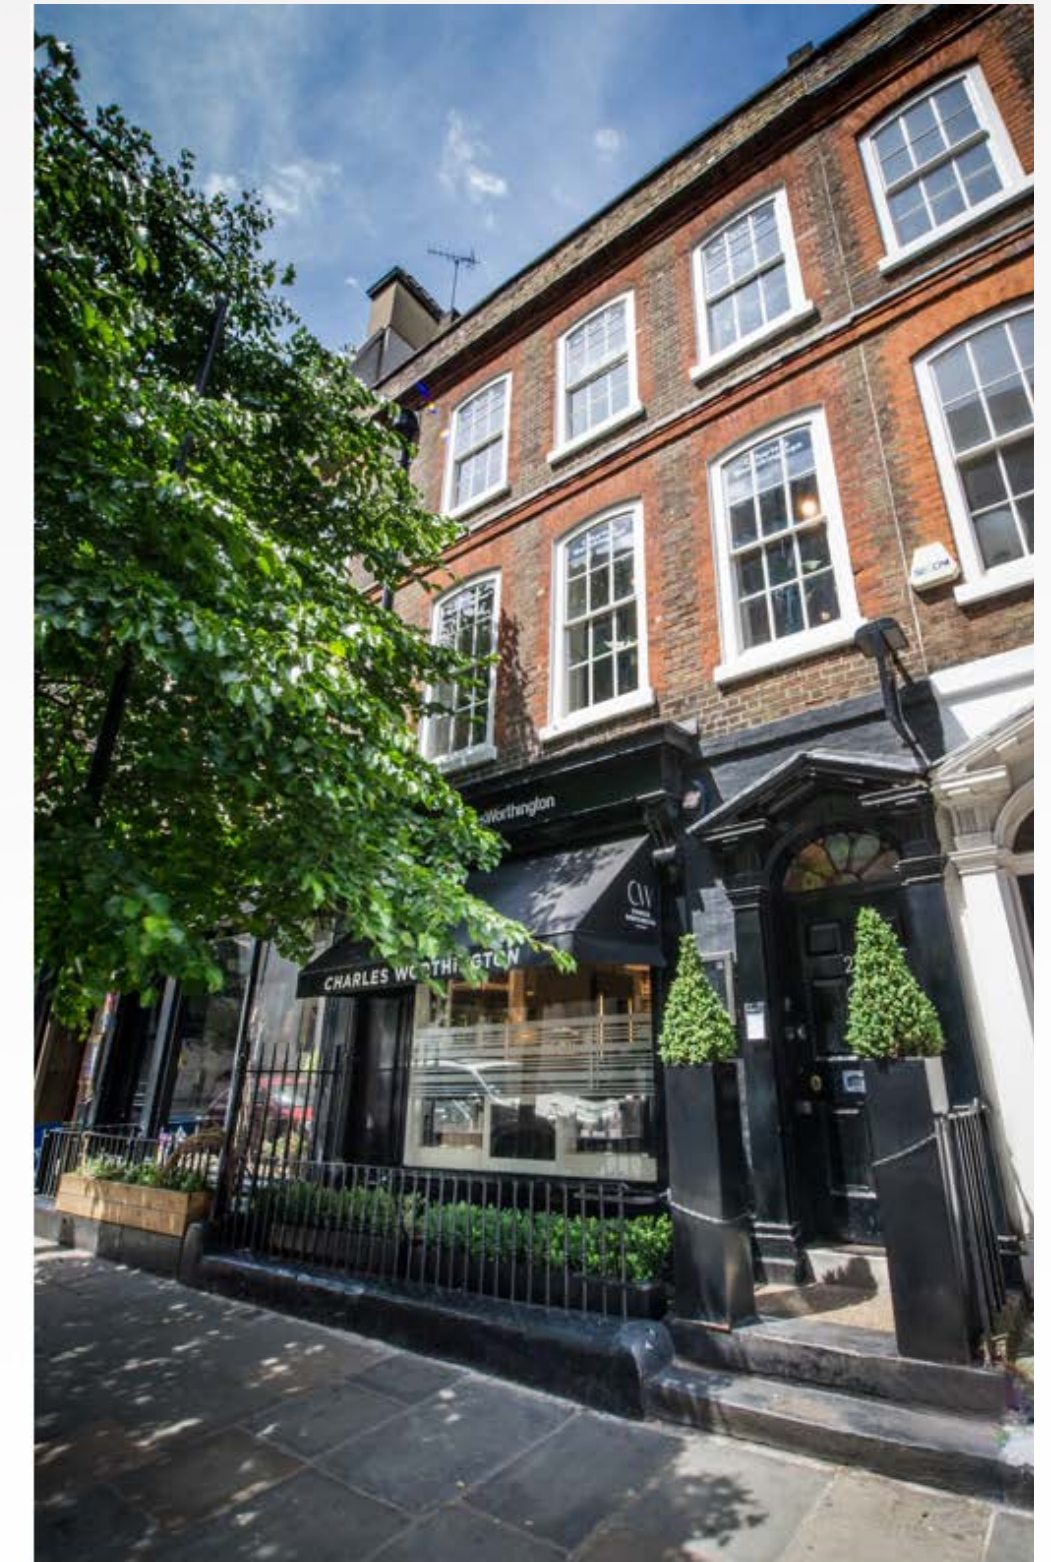
The existing signage is made up of fret cut lettering applied on studs to the shopfront signage fascia, an illuminate projecting sign and a branded canopy.

Existing External

We would like to add halo effect lighting to the fret cut letters on the shopfront signage fascia.

This will be achieved by fitting controlled LED strip behind each letter set to a warm colour temperature. The power will be surface run from the supply to the existing project signage.

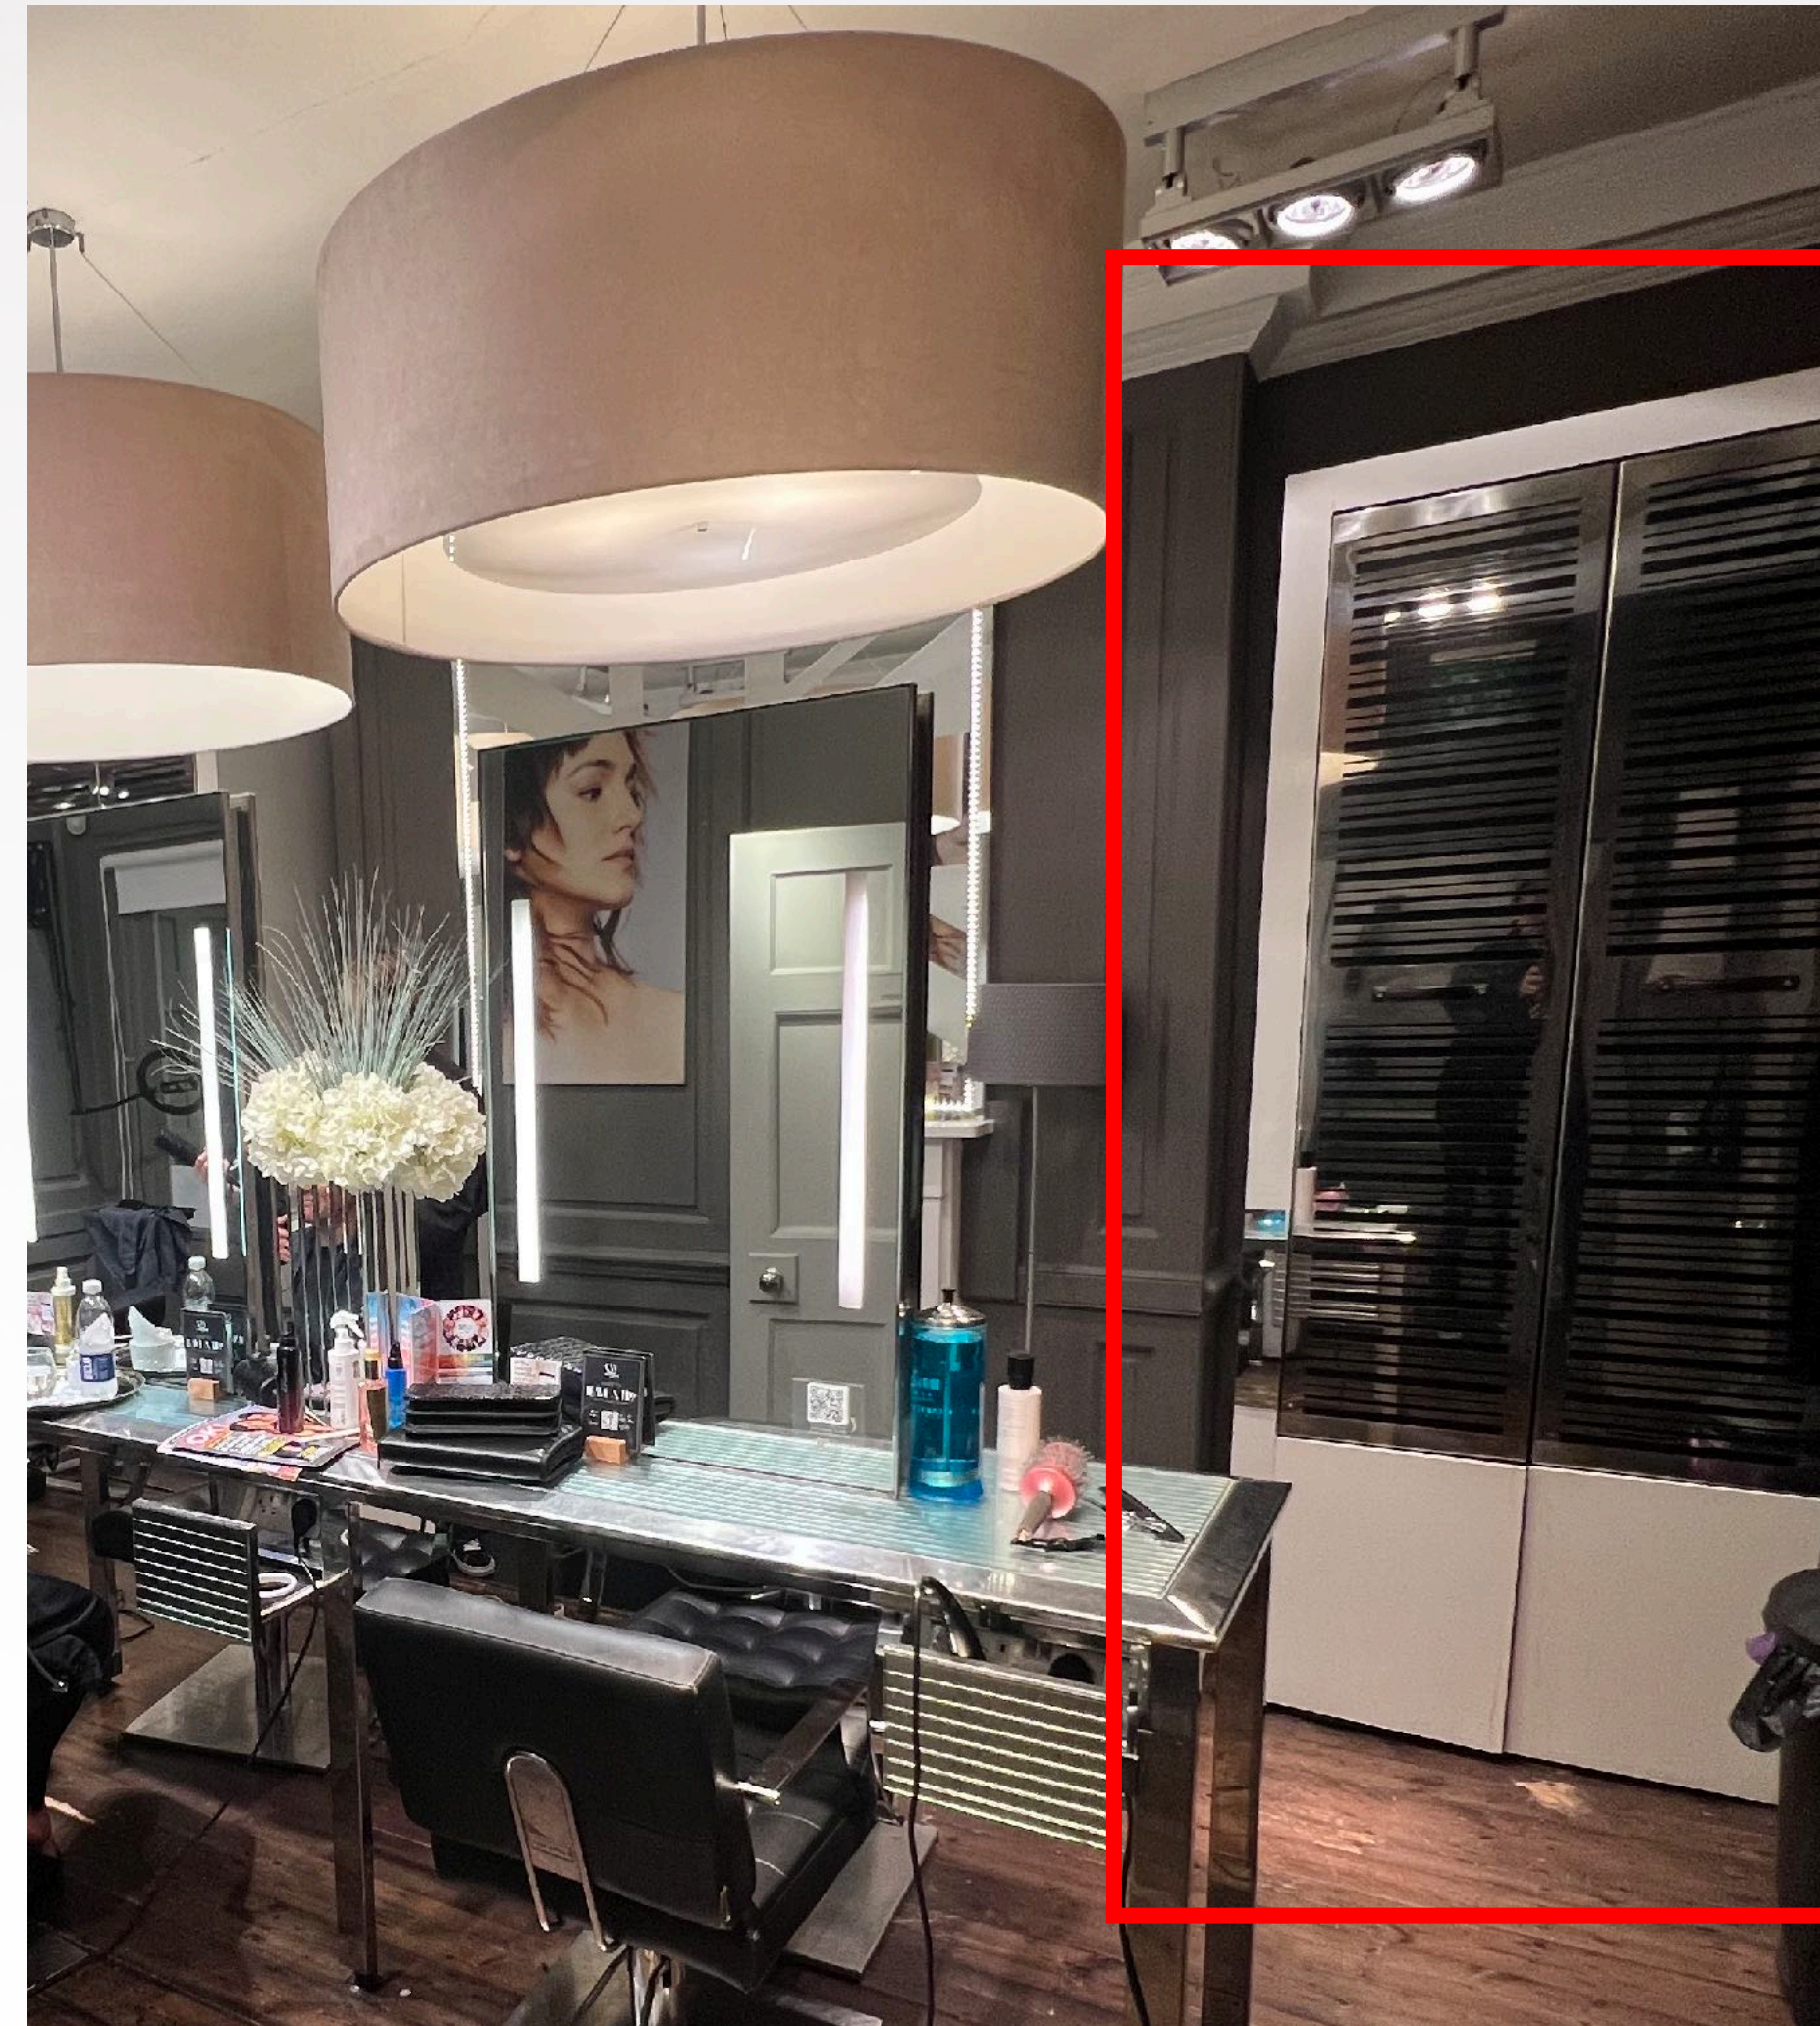
The building is currently served by freestanding air-conditioning units set in the corner of the majority of the main rooms. Additional heat is generated through electric fan heaters concealed in the joinery beneath the windows.

Typical existing air-conditioning cabinetry

All existing cabinetry will be simplified in detail and finished to be visually less intrusive.

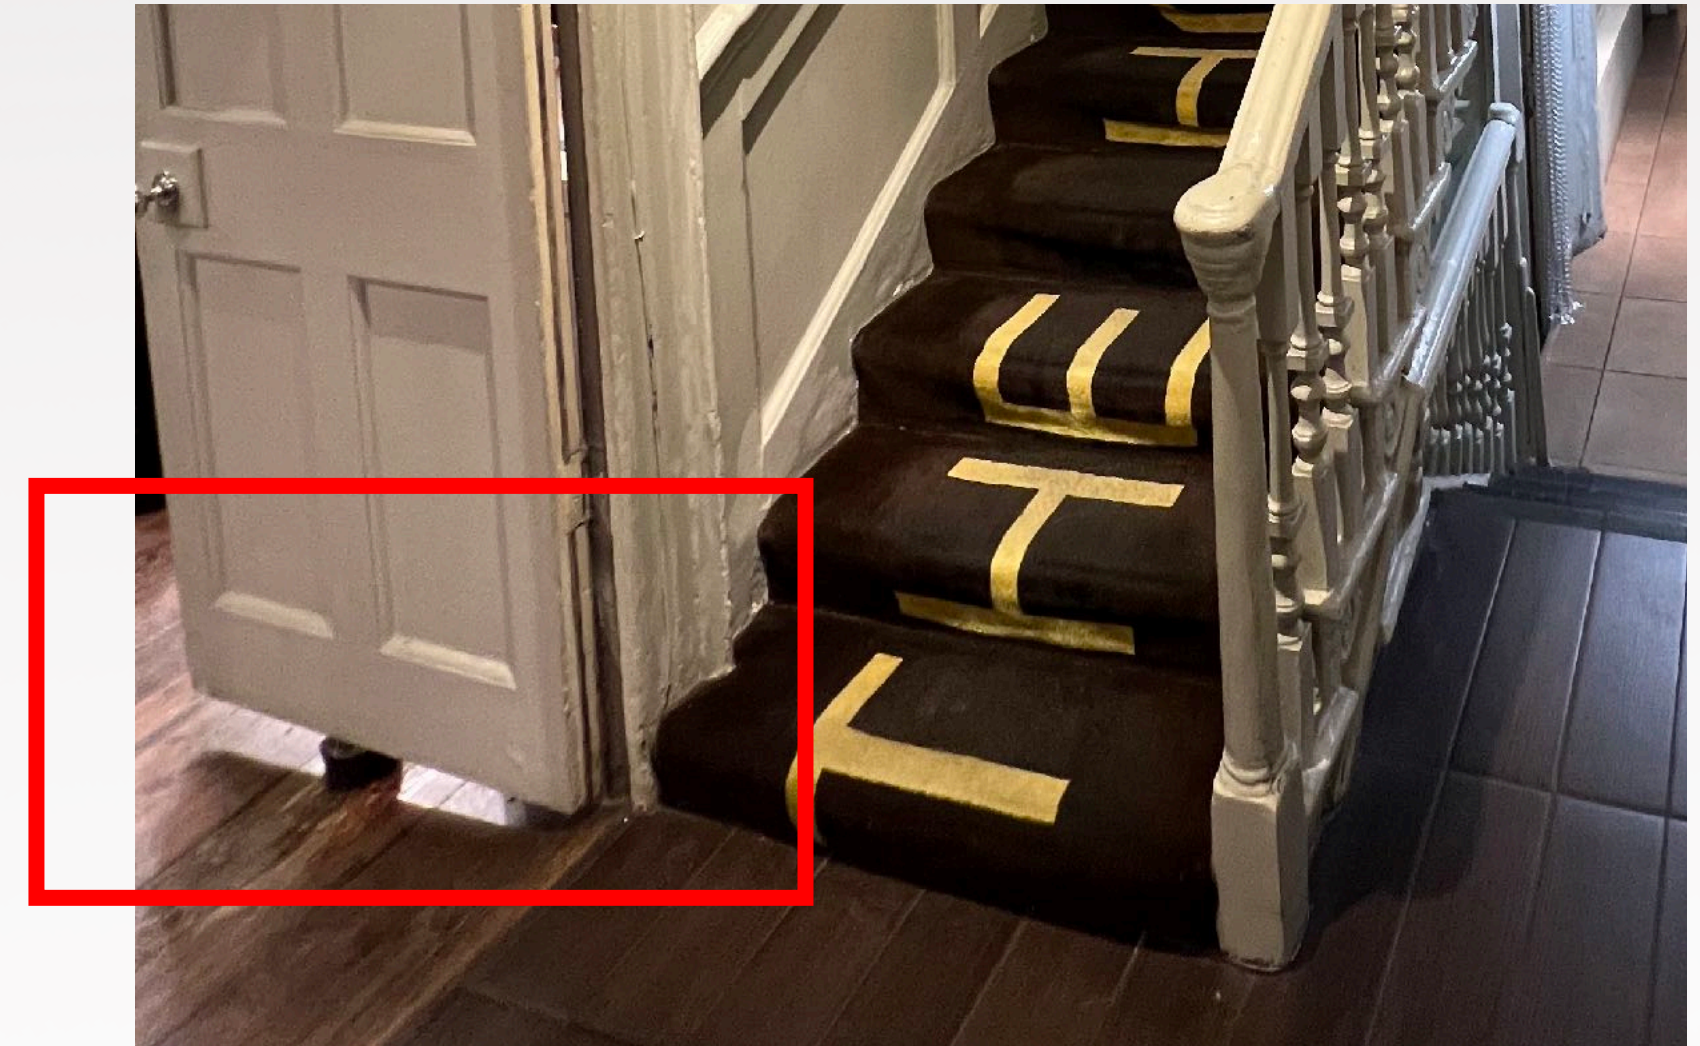
The doors leading onto the staircase require some upgrades to enable as much fire protection as the original door can provide. This will include the replacement of the existing intumescent strips and the installation of fire skirts along the bottom edge.

Typical gap at foot of 'fire doors'

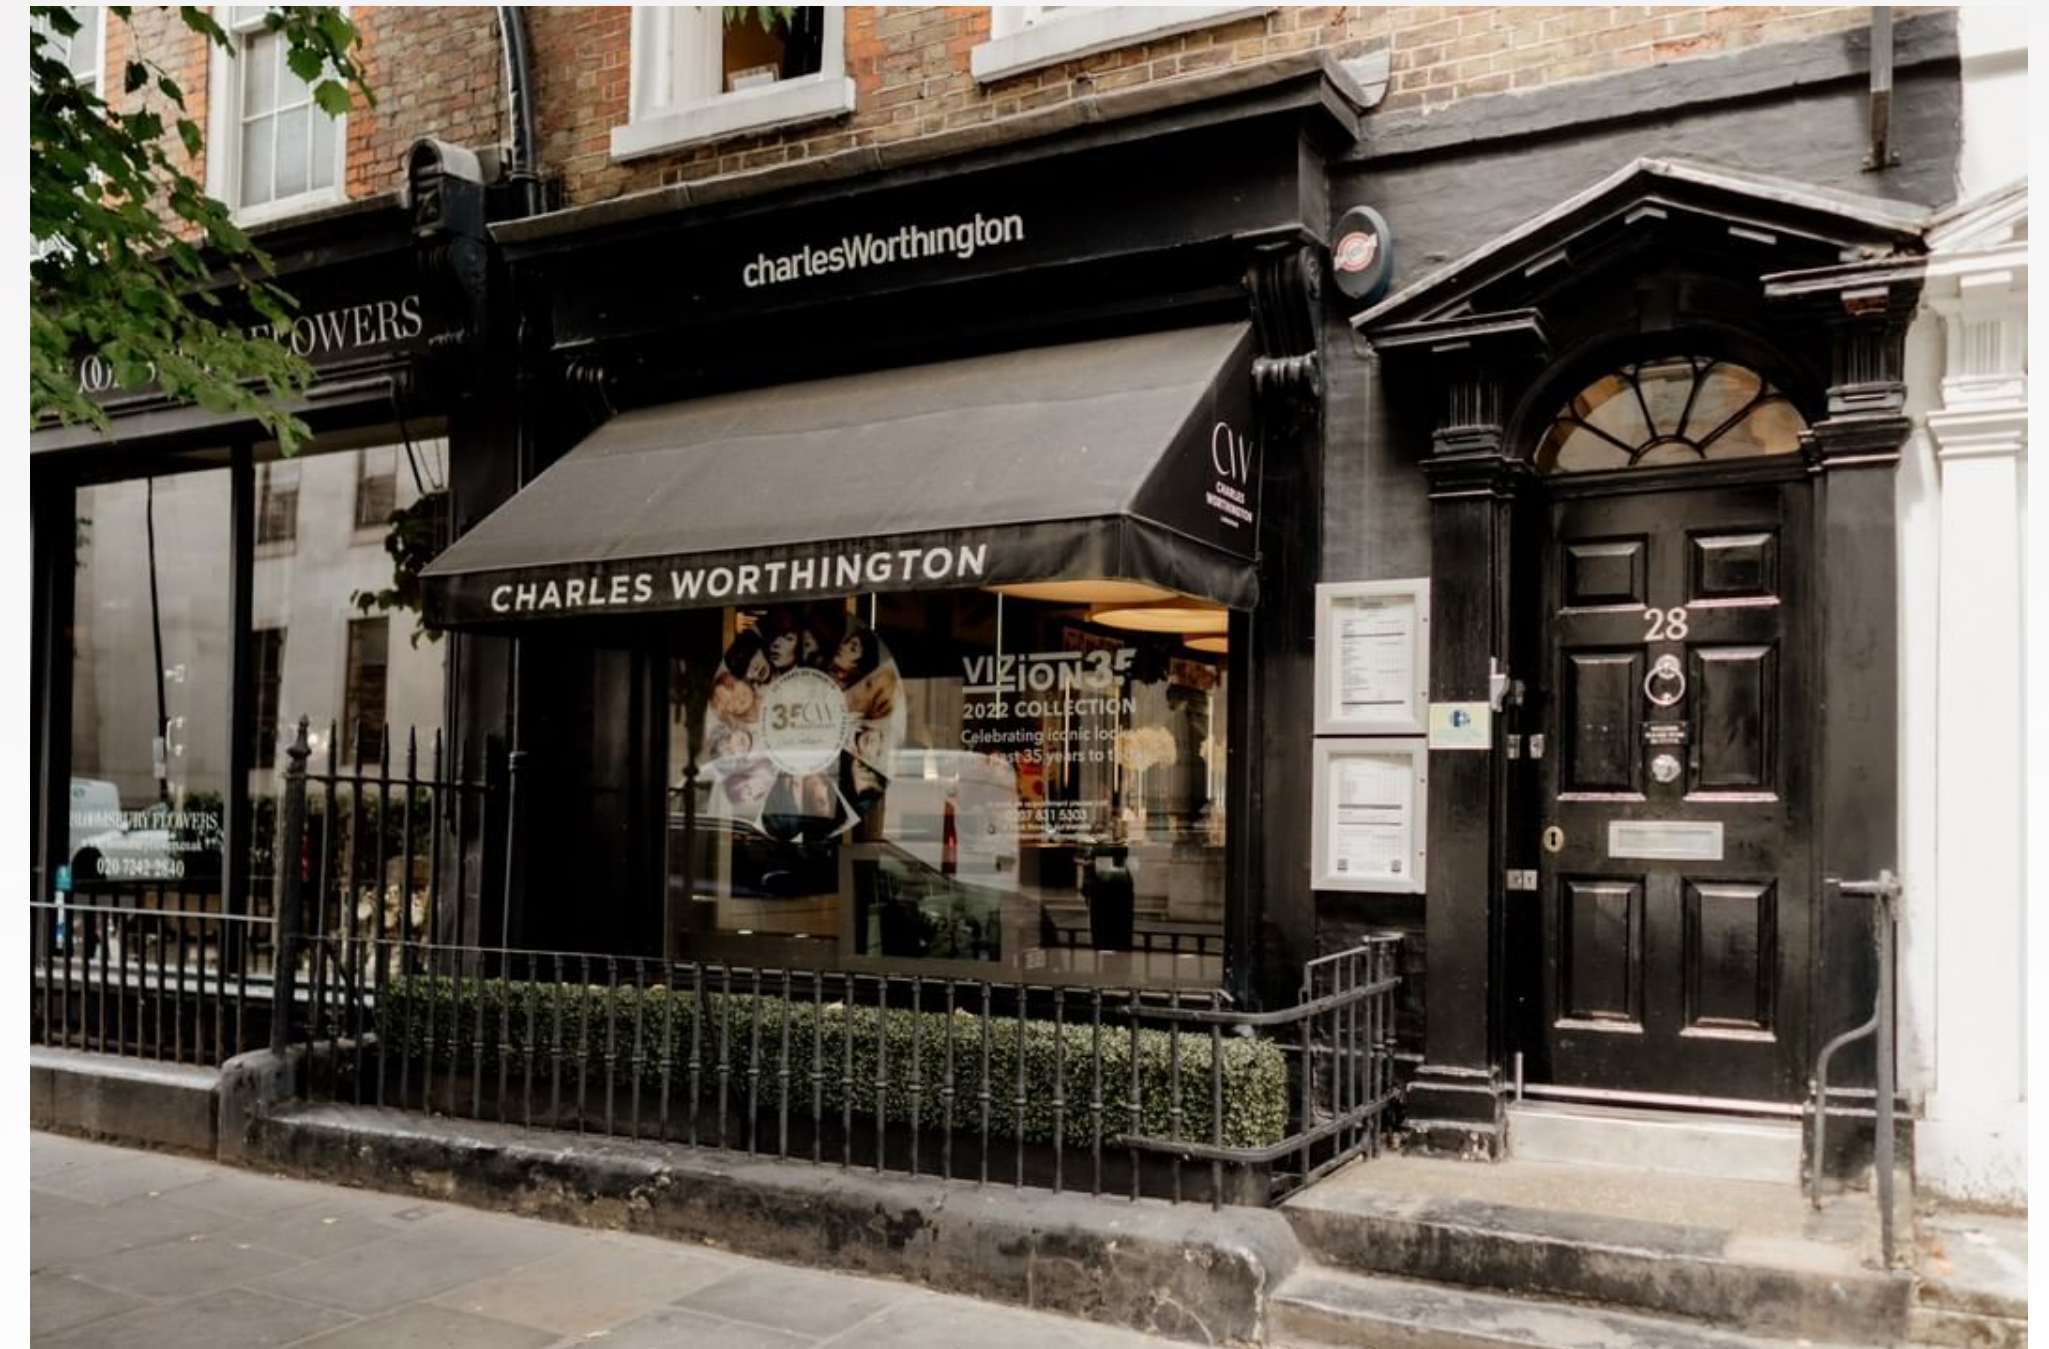
The existing shopfront is painted up to and including the signage fascia. There is a fixed fabric canopy (this has been temporarily taken down by the outgoing tenant) and an illuminated projecting sign. There is fret cut branding on the fascia & projecting sign and printed branding on the canopy.

Existing Shopfront

Repaint shopfront and install new canopy with printed logo to front edge and top to match existing. Install new fret cut signage to fascia (halo lit - pending application) and new fret cut logo to projecting sign. Install partial vinyl etched film to shopfront glazing.

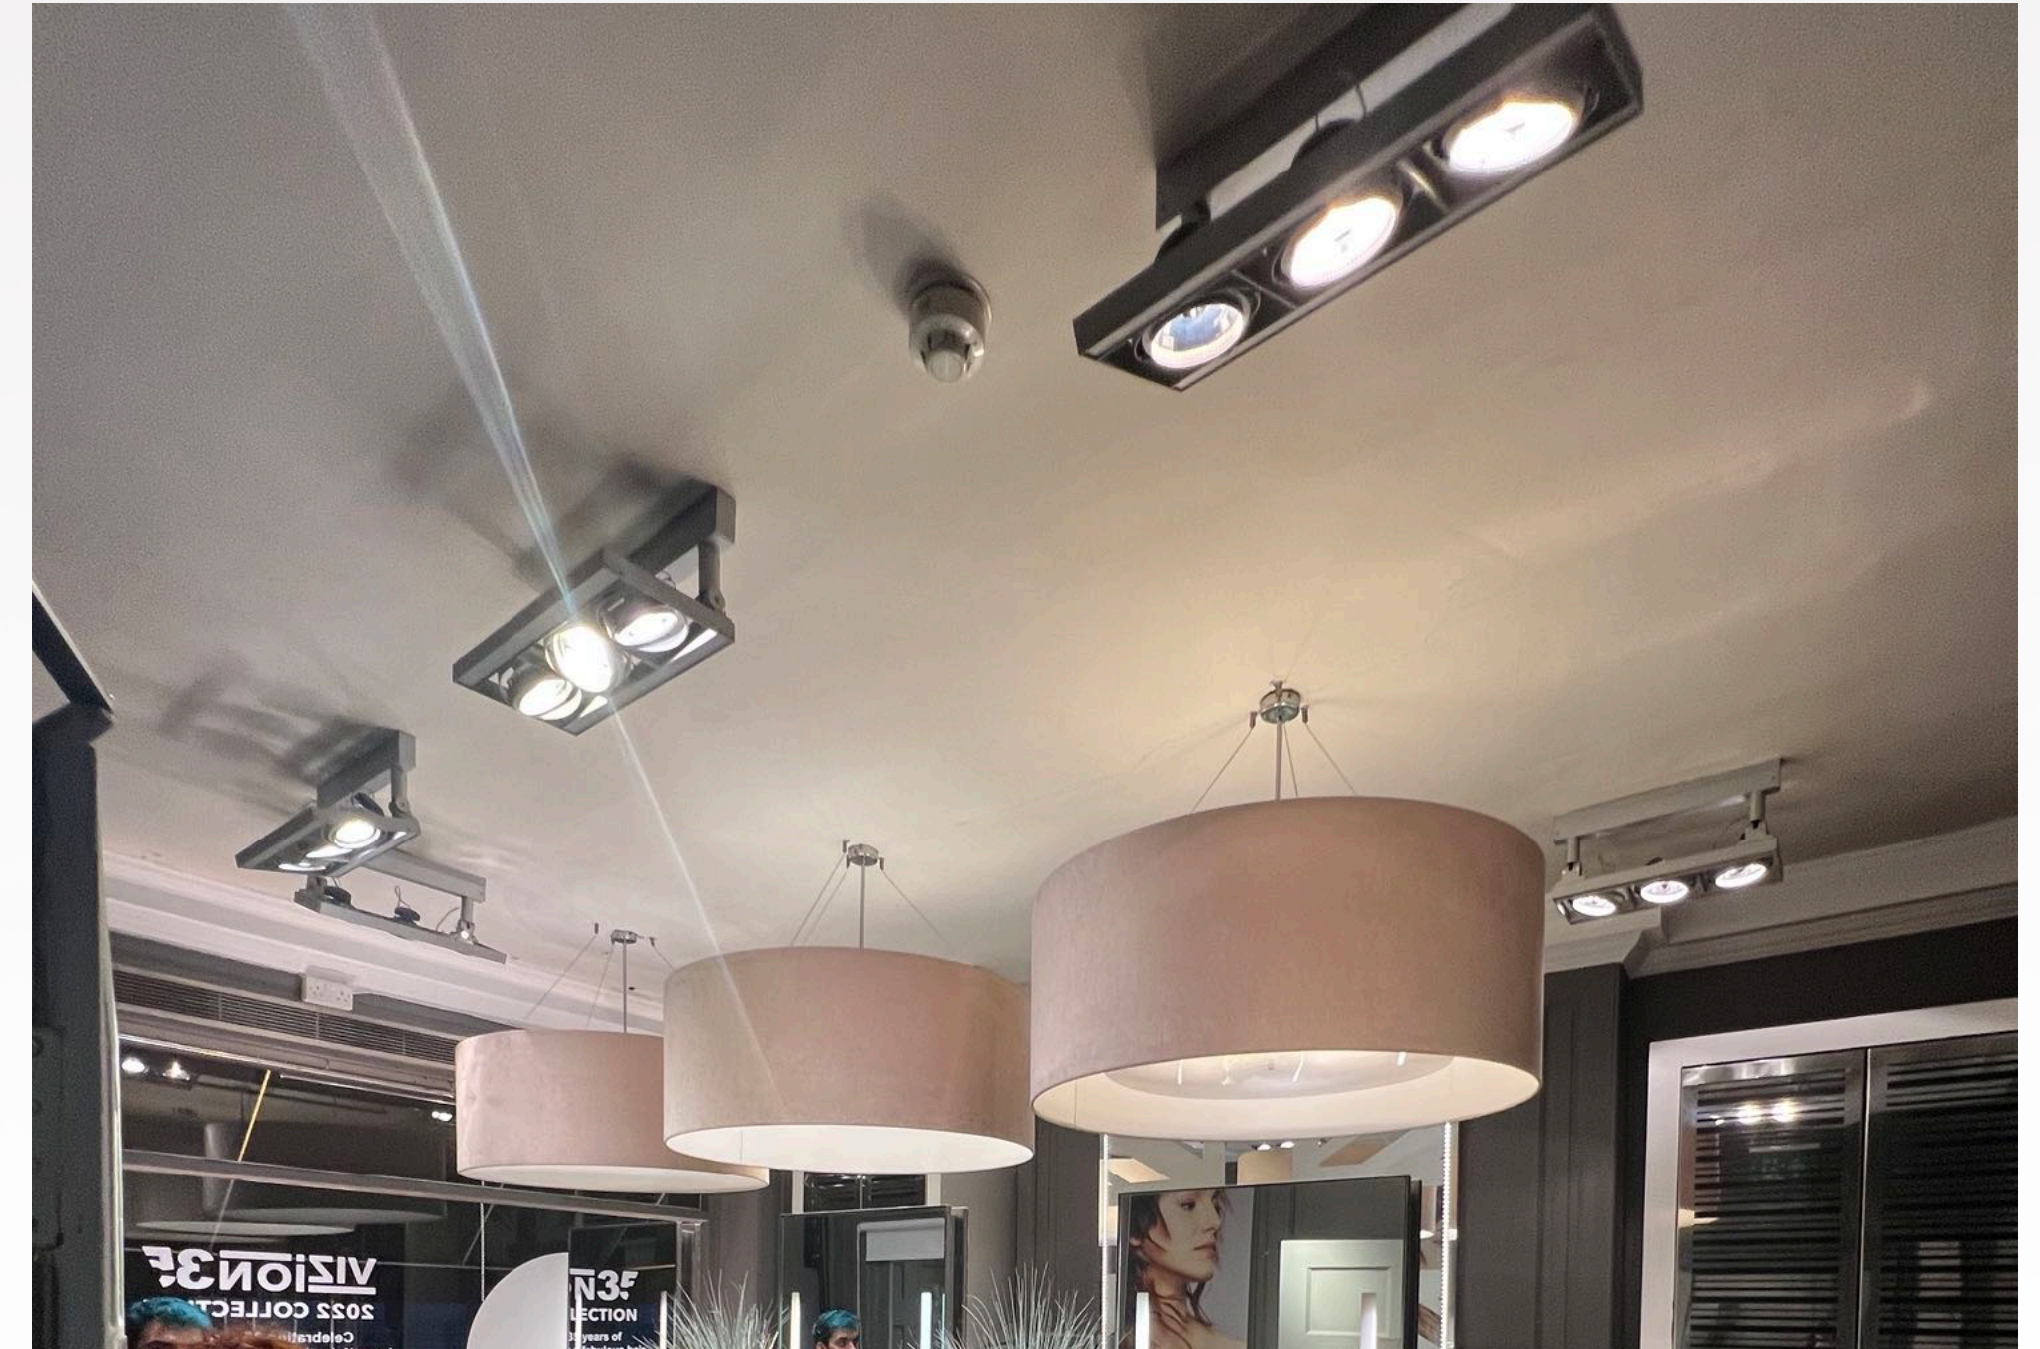
The existing lighting installation consists of between 6 & 8 large surface mounted adjustable spotlights in each room, individually fed from within the ceiling void, and a further set of pendant fittings to the centre of each space.

Typical Existing Ceiling

Carefully remove all existing fittings terminating all but one of the electrical feeds. Make good where existing fittings have been removed matching original materiality & technique.

Install new lightweight lighting track, trimmed to float below the line of the ceiling on rods and fed from a single electrical source.

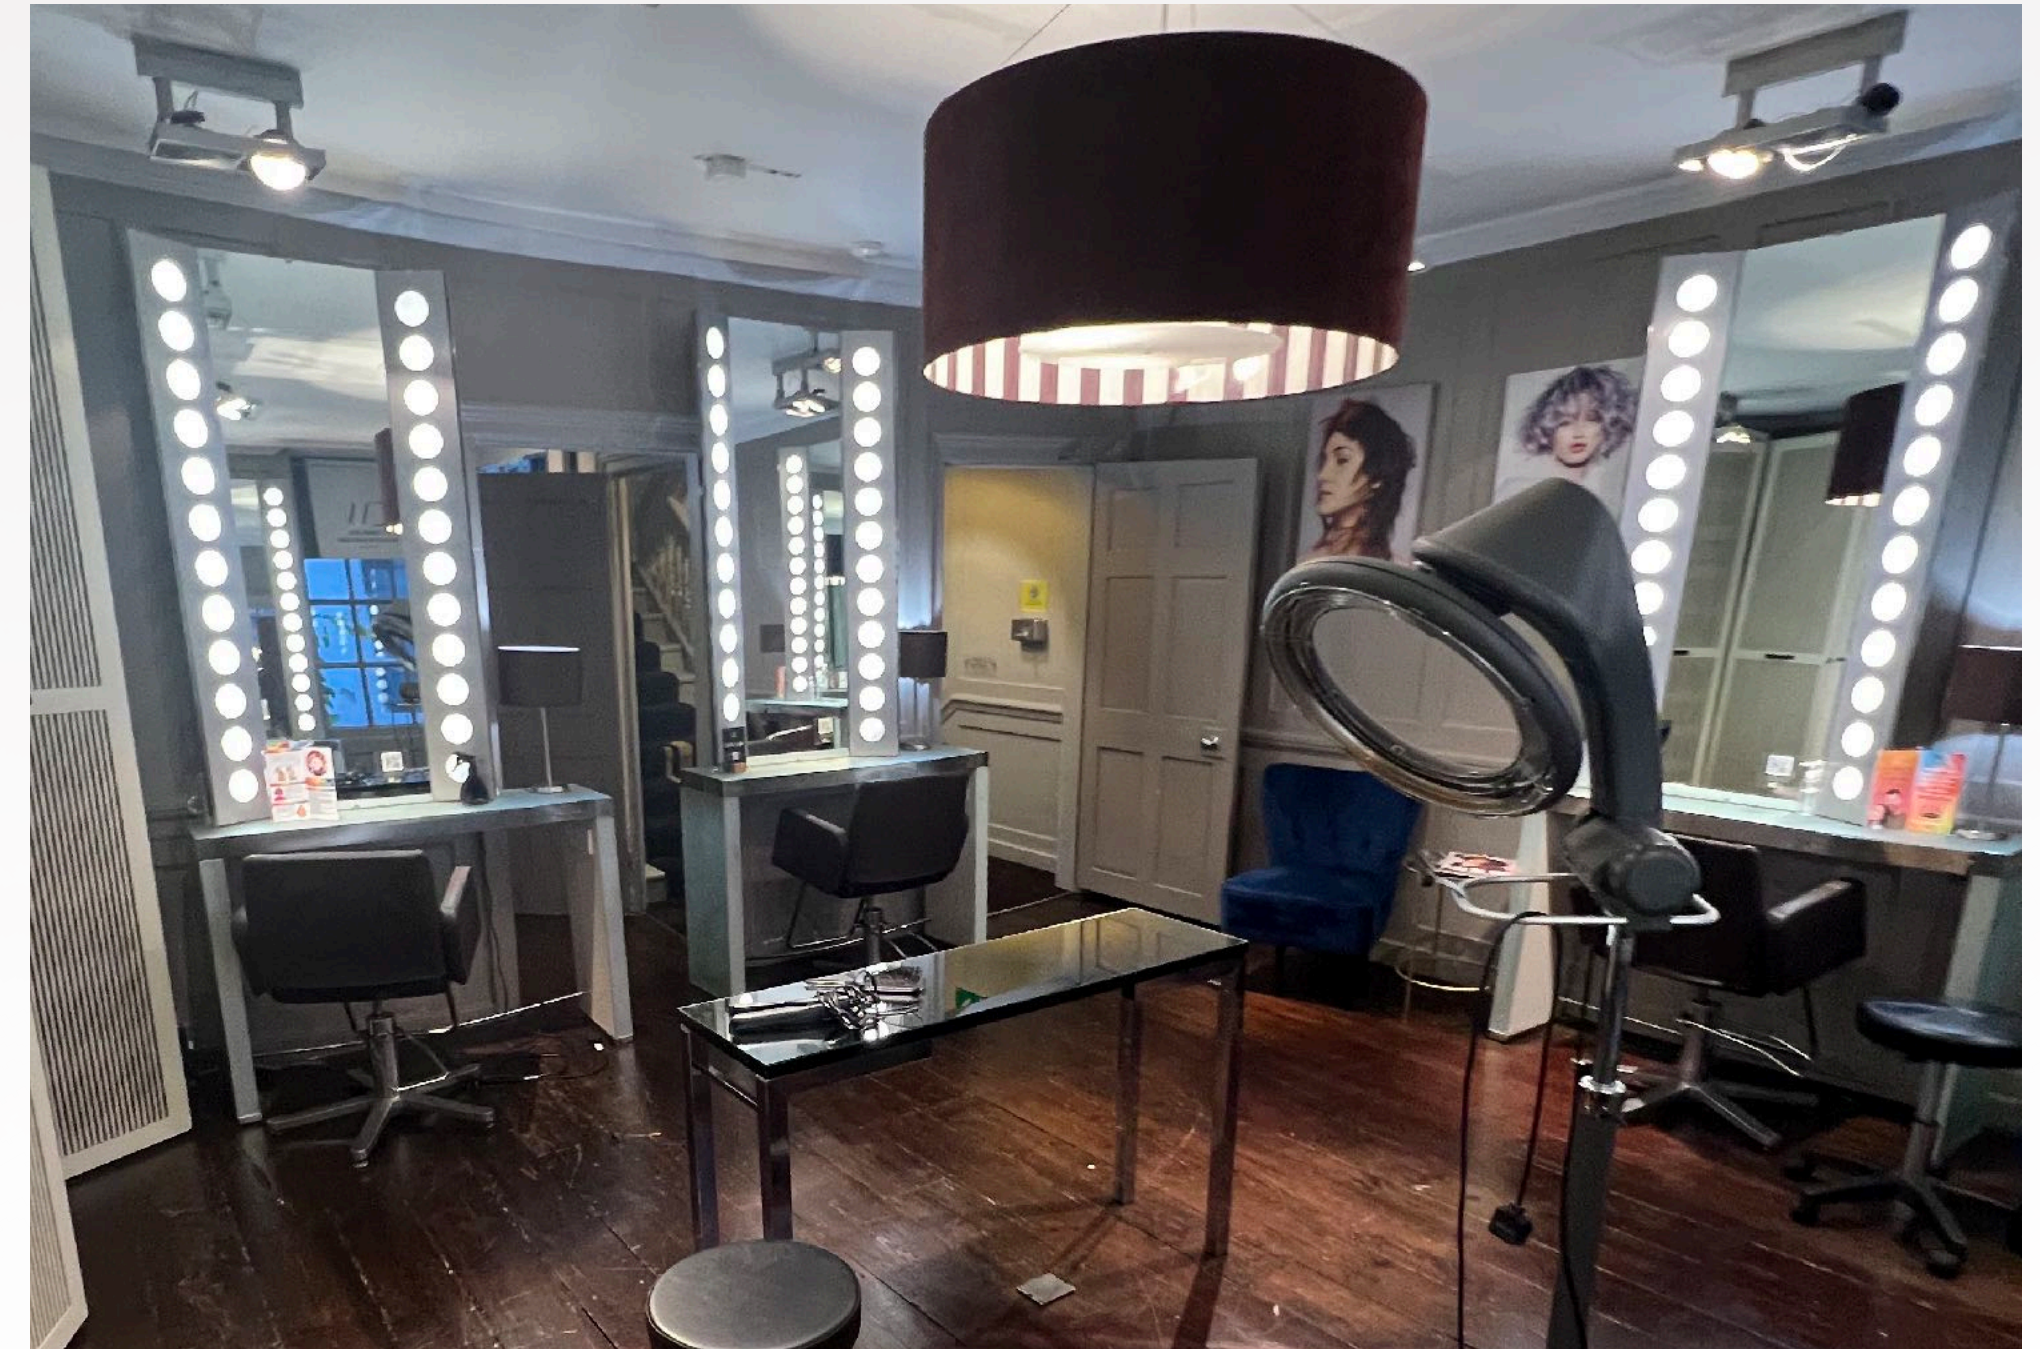
**Typical Existing Workstation**

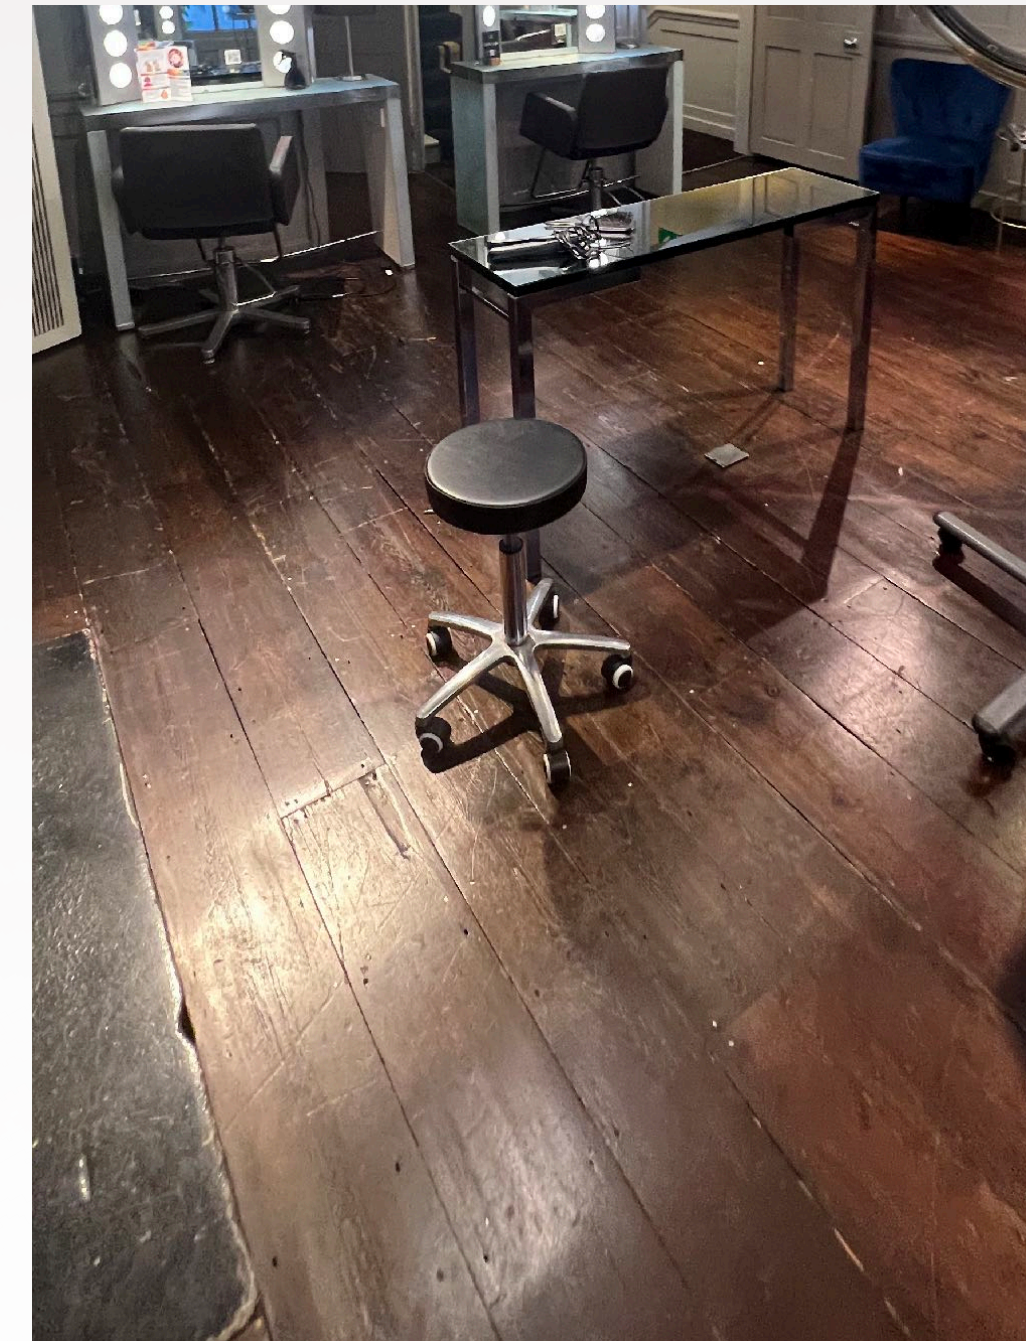
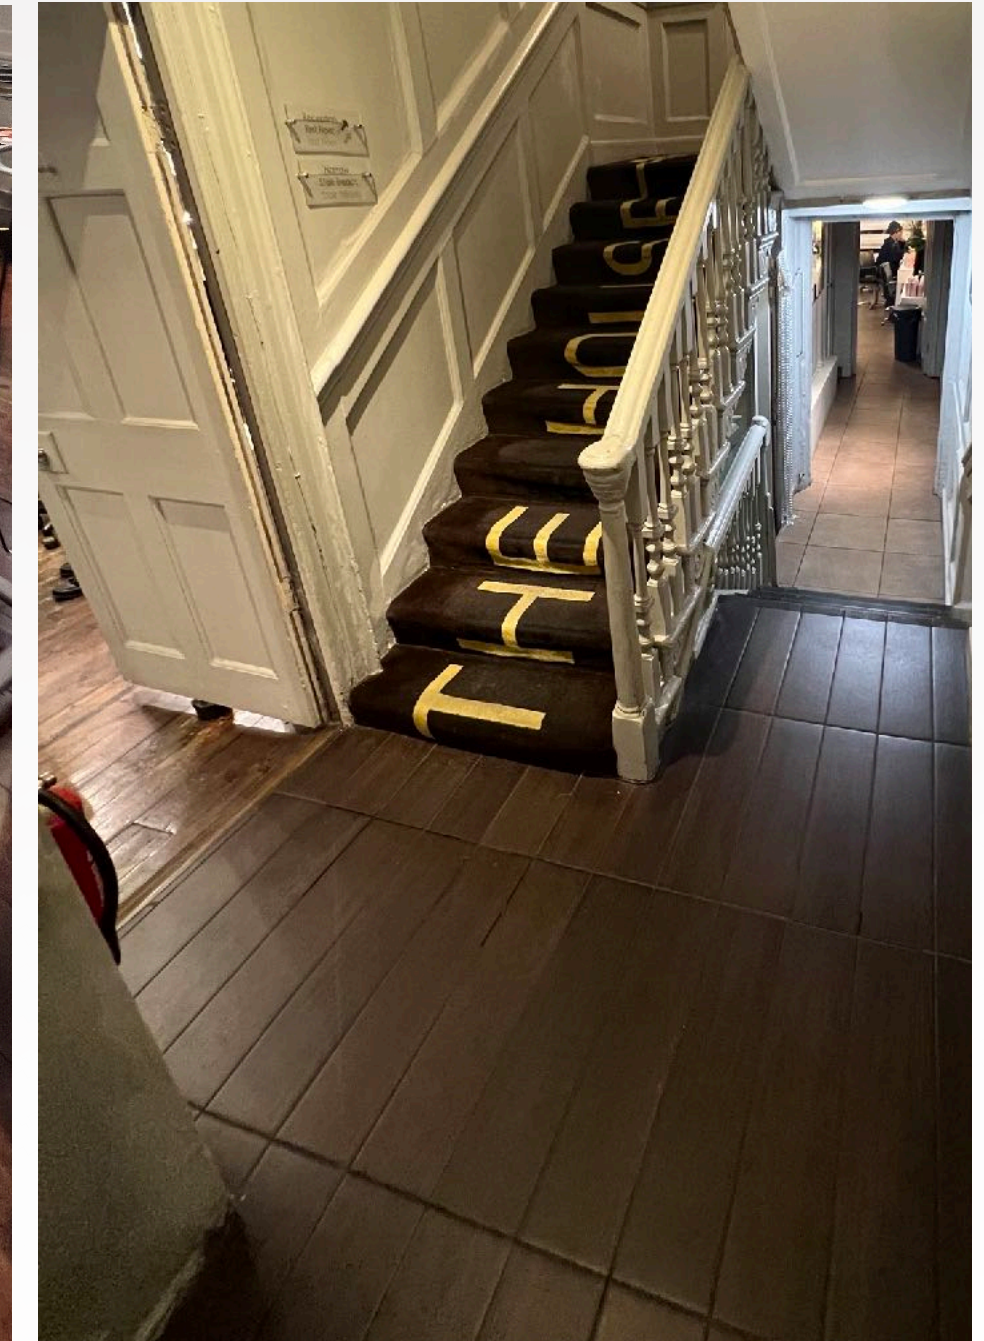
**Typical Existing Floors**

Ground floor: Carefully take up small section existing ceramic tiles and investigate substrate. If that reveals original floorboards, they will be sanded and coated with satin finish varnish. If not, the tiles will be replaced with solid hardwood flooring.

Staircase and landings: remove all existing carpet and replace with new.

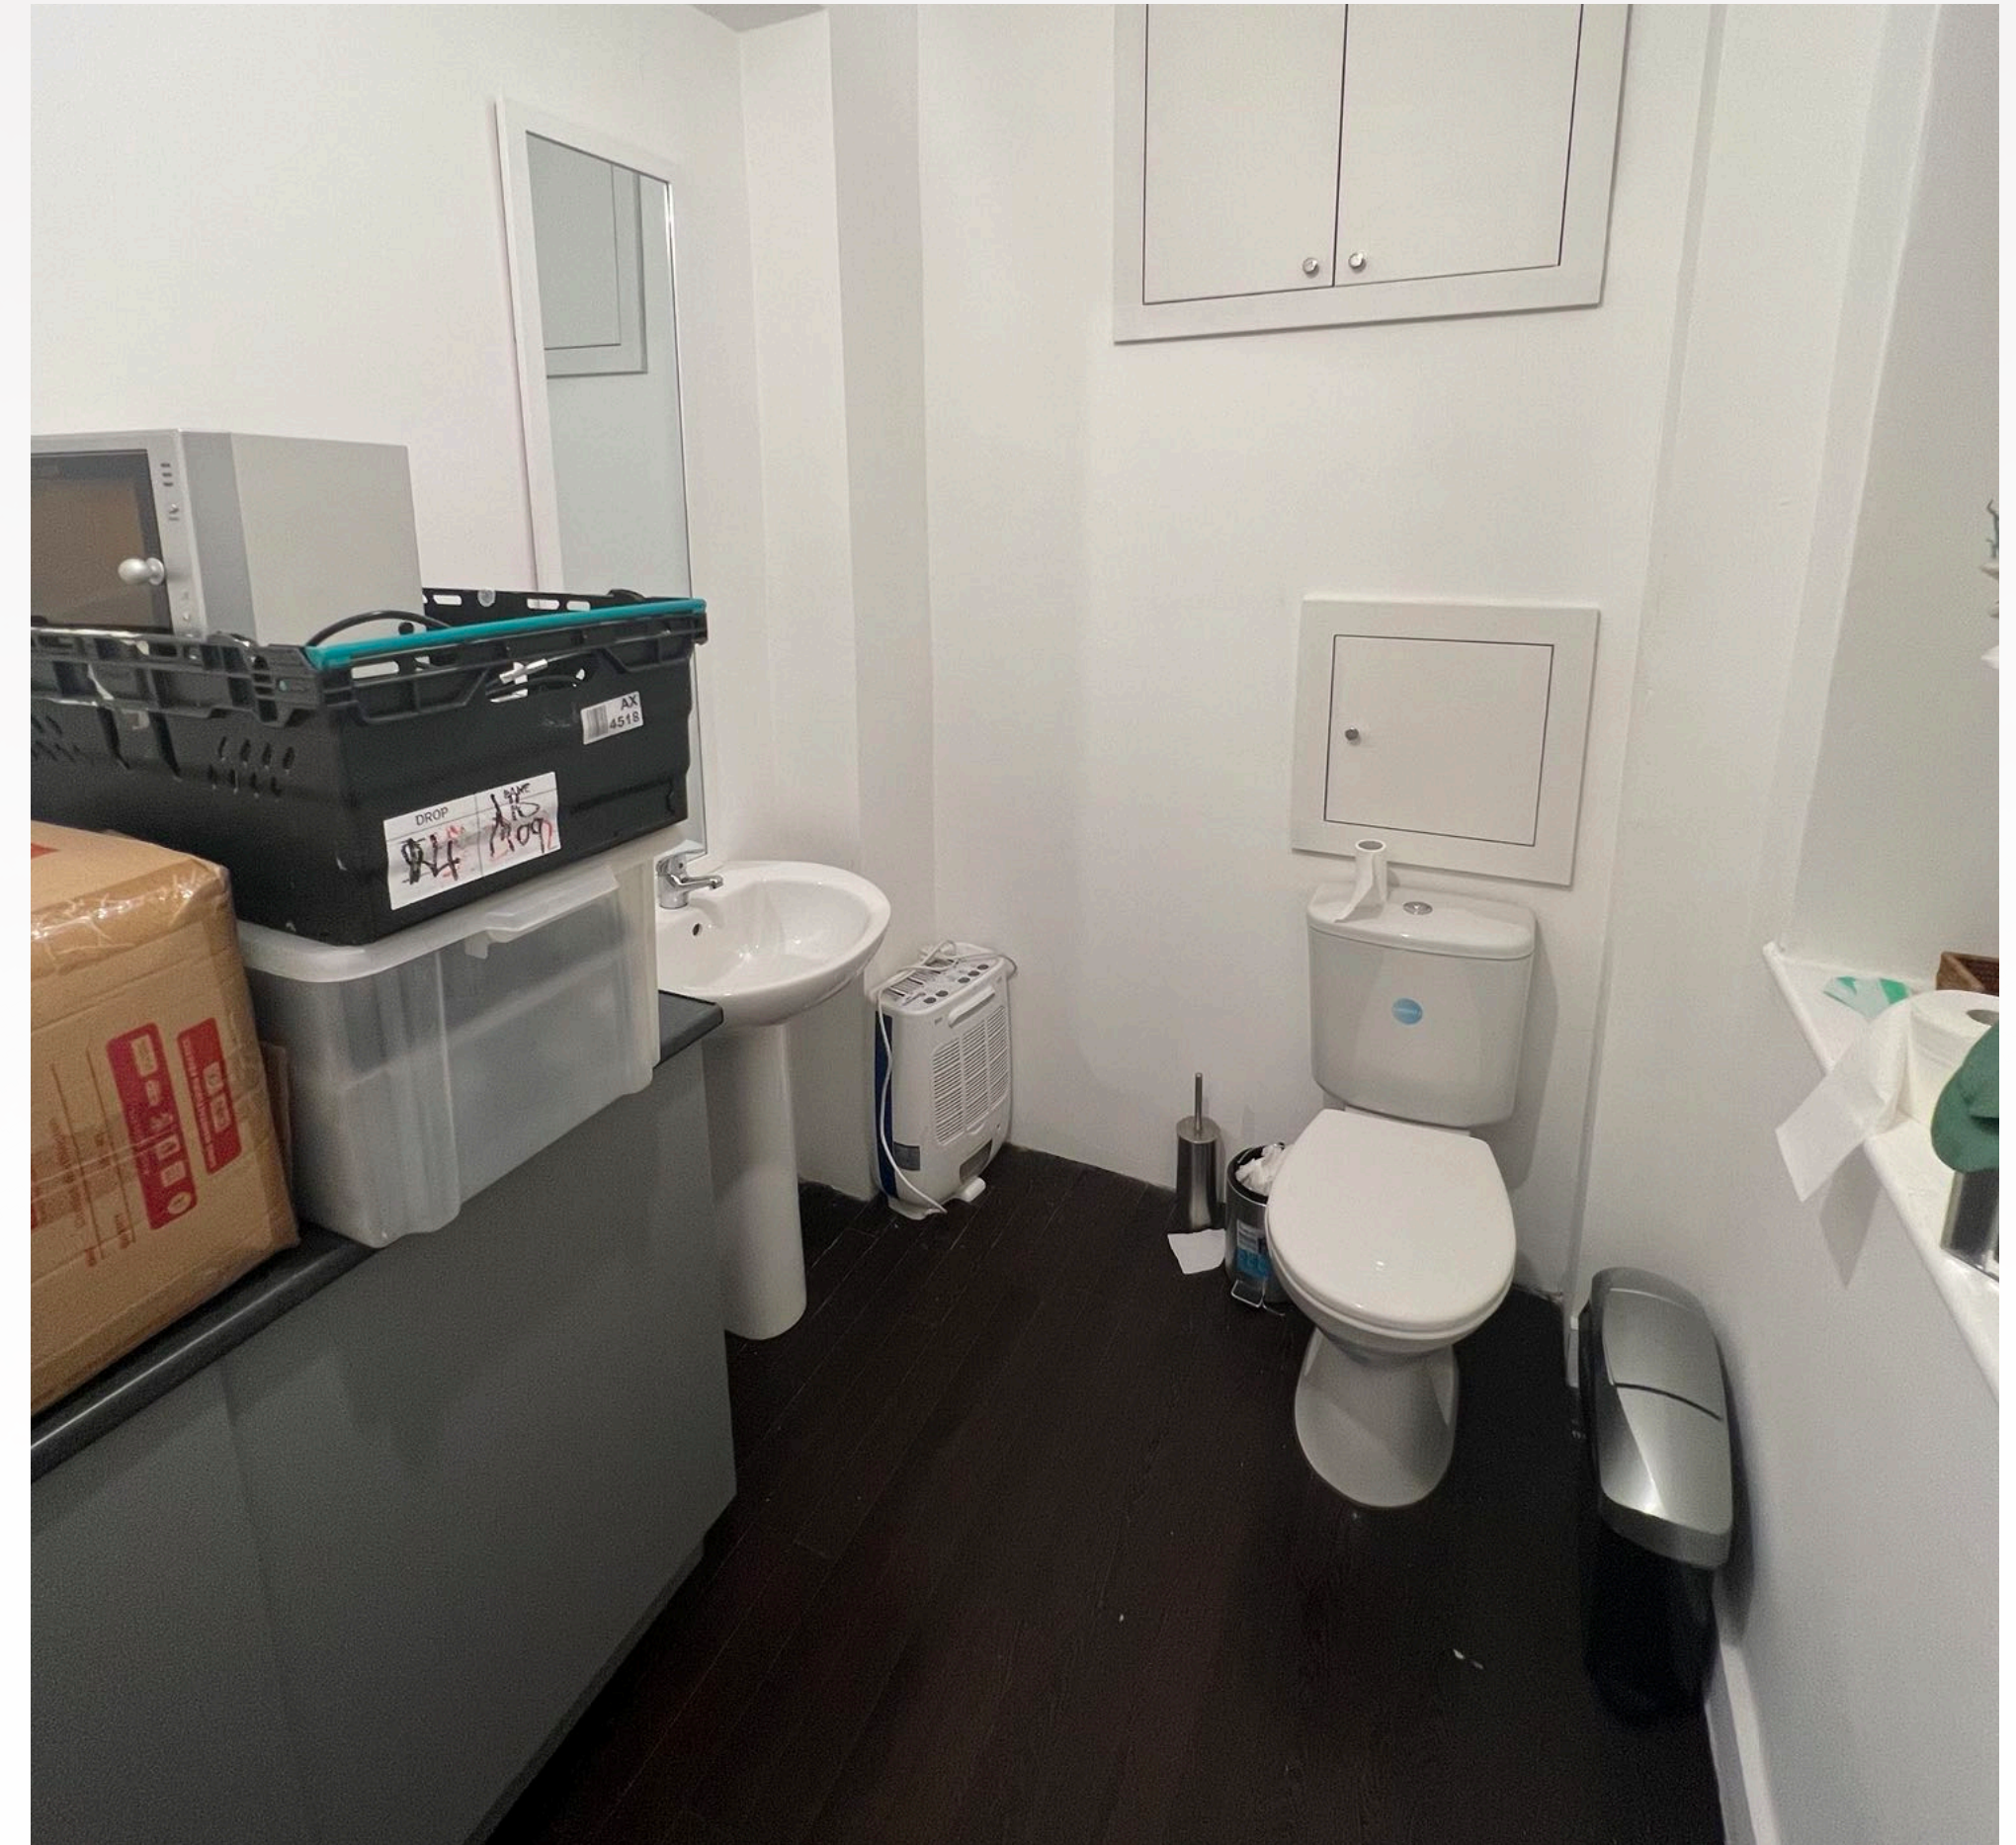
Existing Staff Toilet

The existing staff toilet in the rear room of the basement is made up of one toilet & one hand wash basin.
