# Brooks & Brooks

Heritage Statement - 28 Great Queen Street, London, WC2B 5BB - 22/02/2023

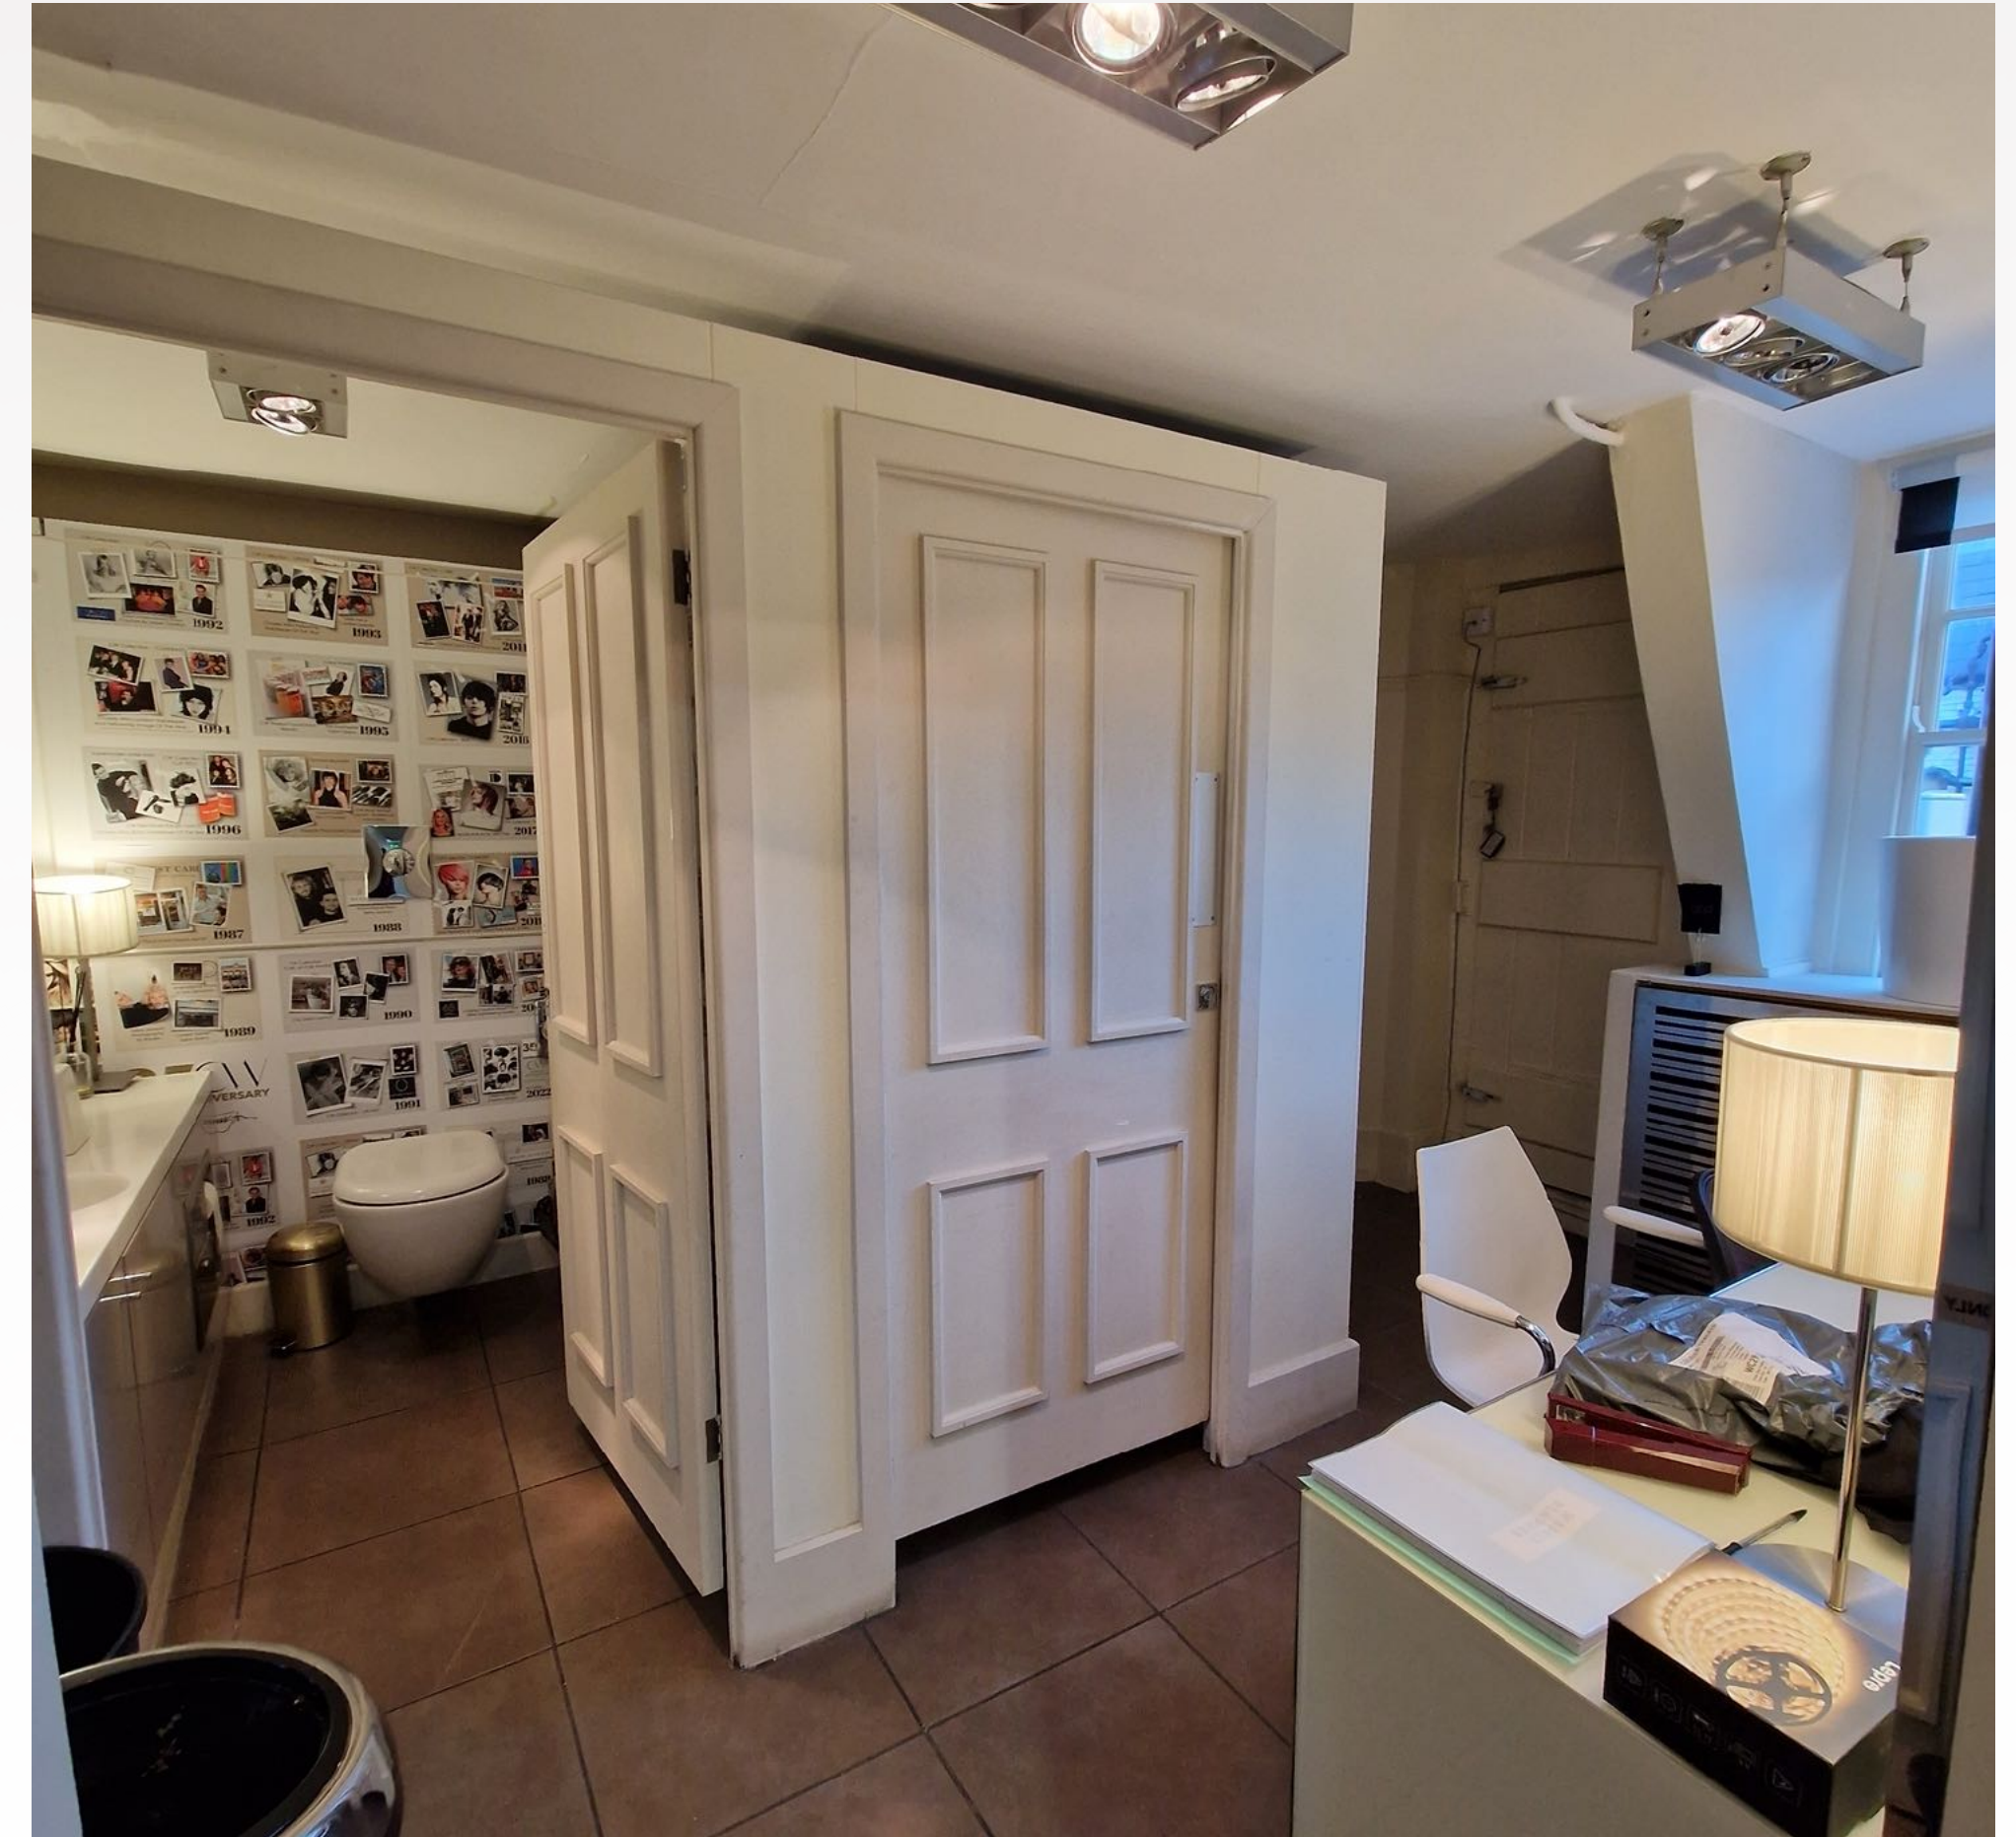
Removal of the toilets in the room at the head of the stairs will return the space to its original volume.

Non Original Toilets

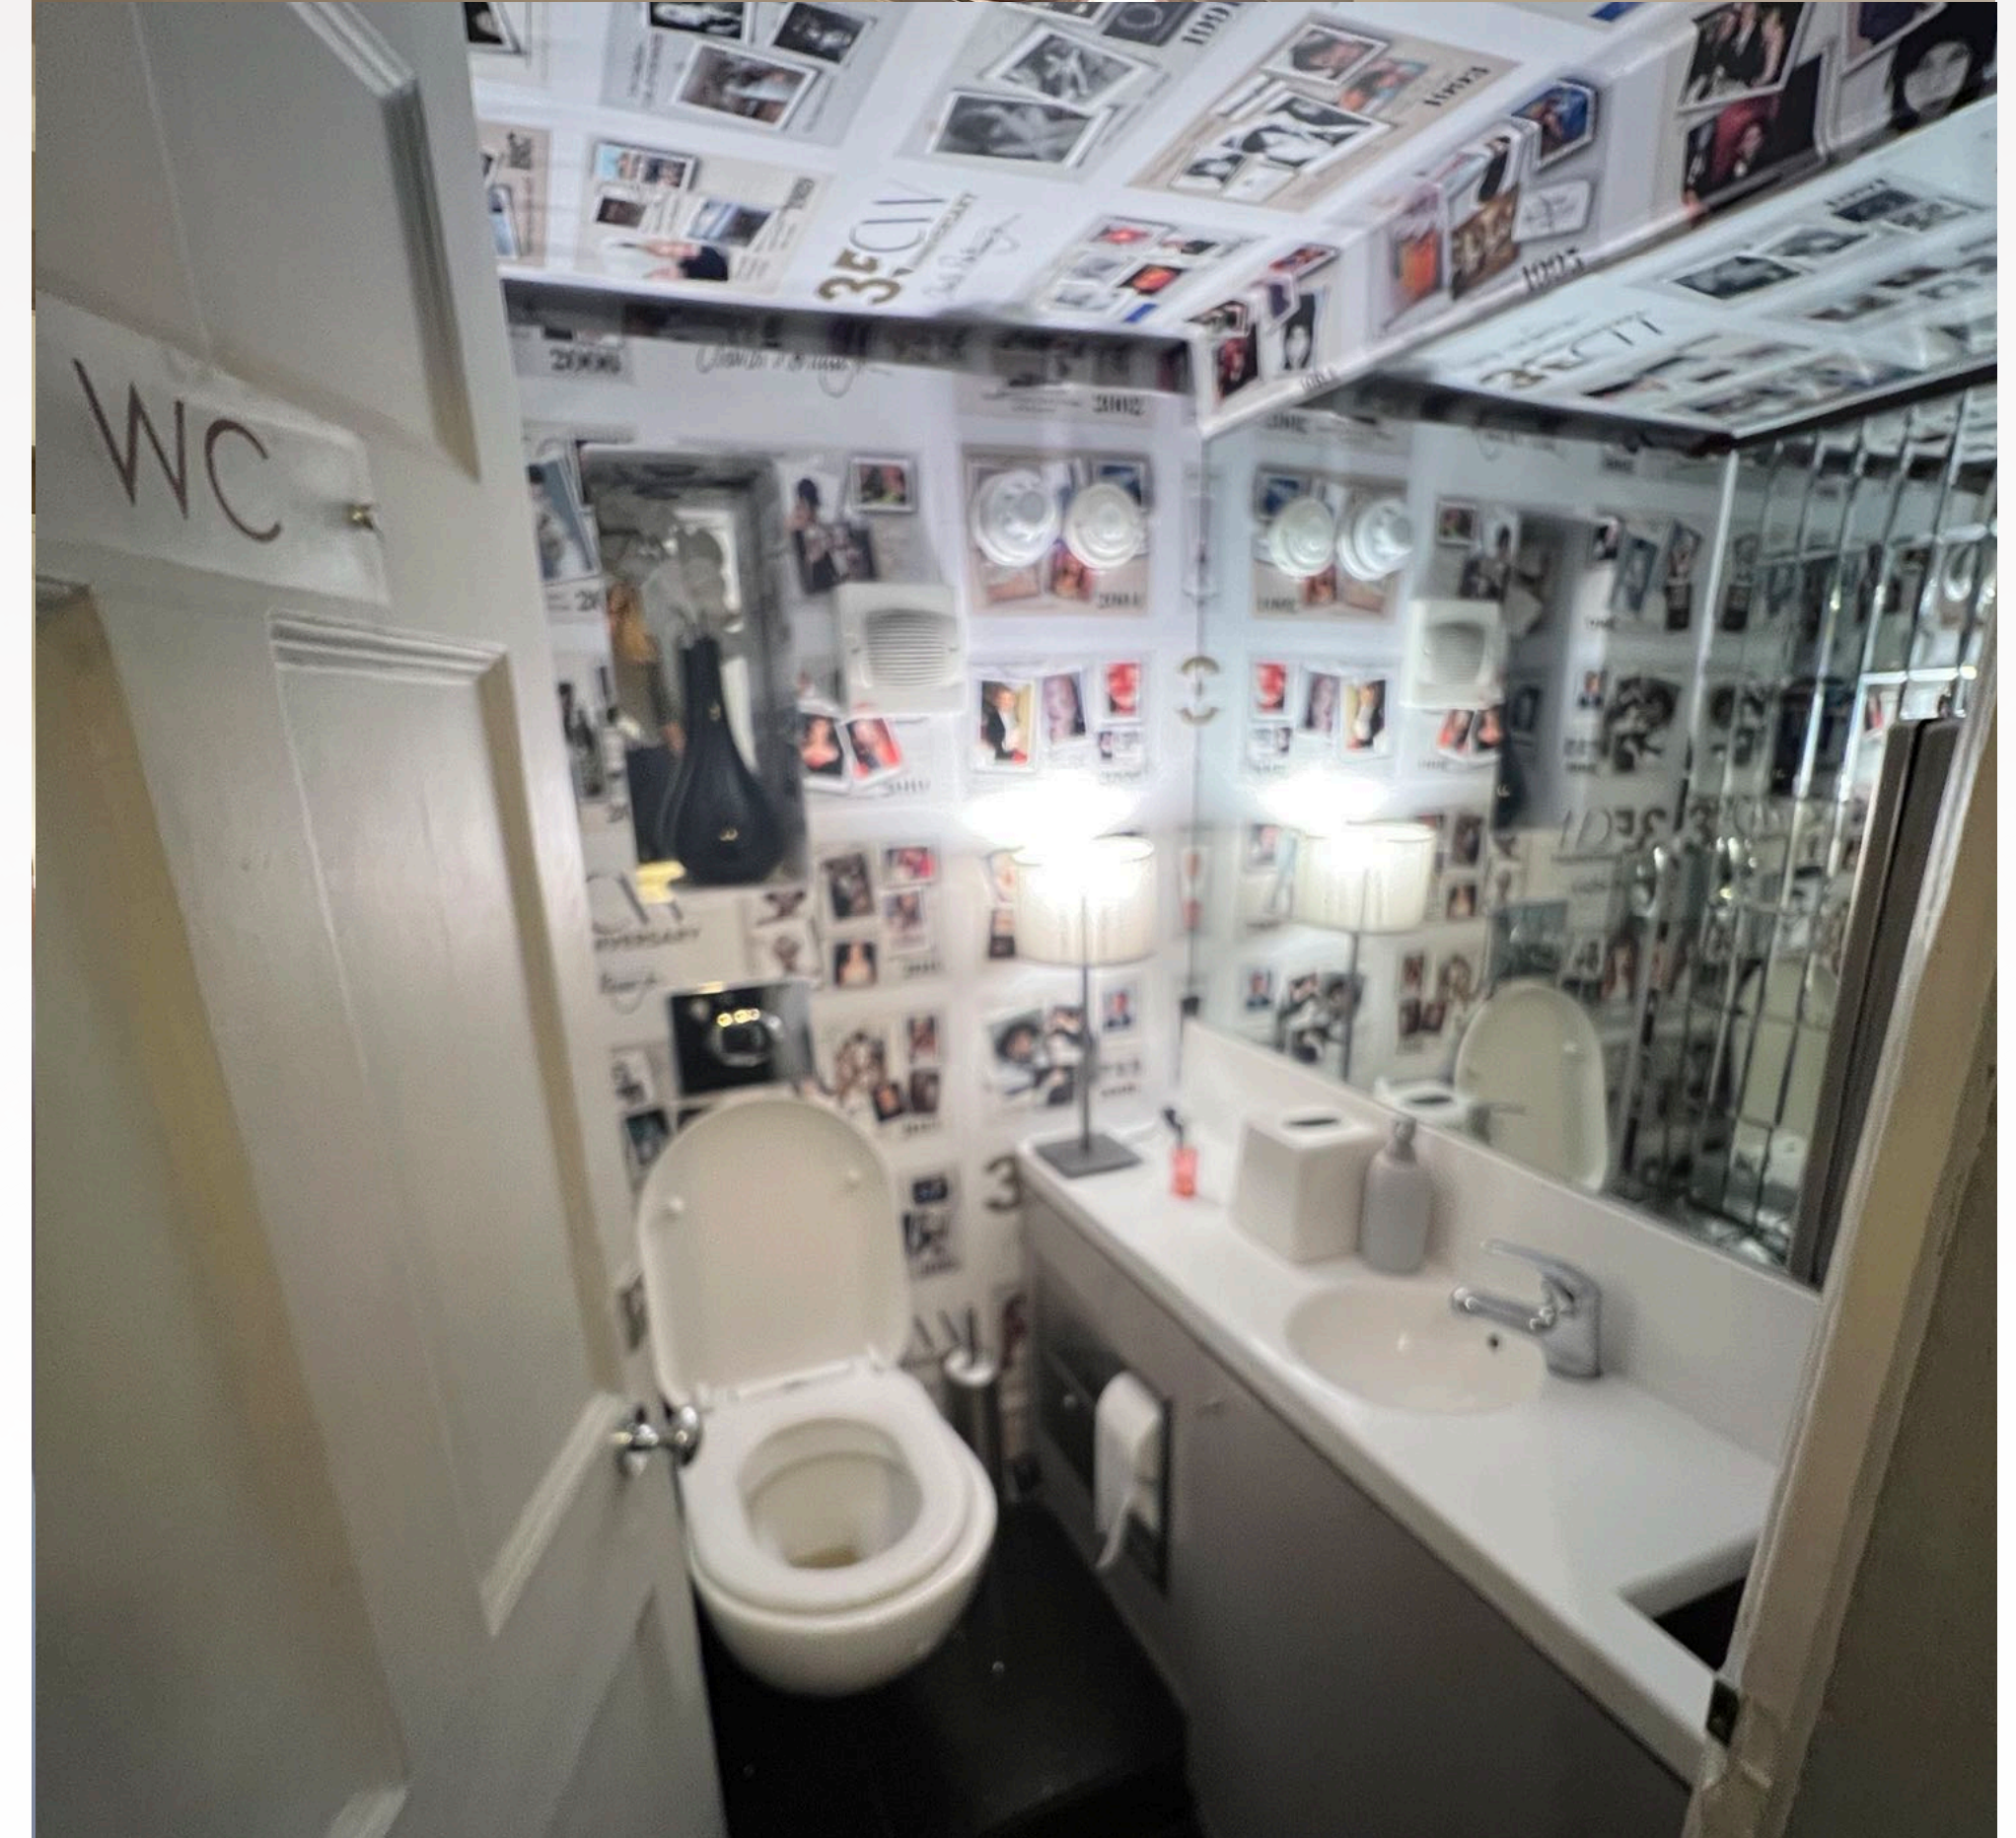
Typical Existing Client Toilet

New hairwash units will be fitted throughout utilising the existing services and pipework, including on the first floor.
