# Arboricultural Method Statement

59 Compayne Gardens Flat 1 London NW6 3DB

220869-PD-13

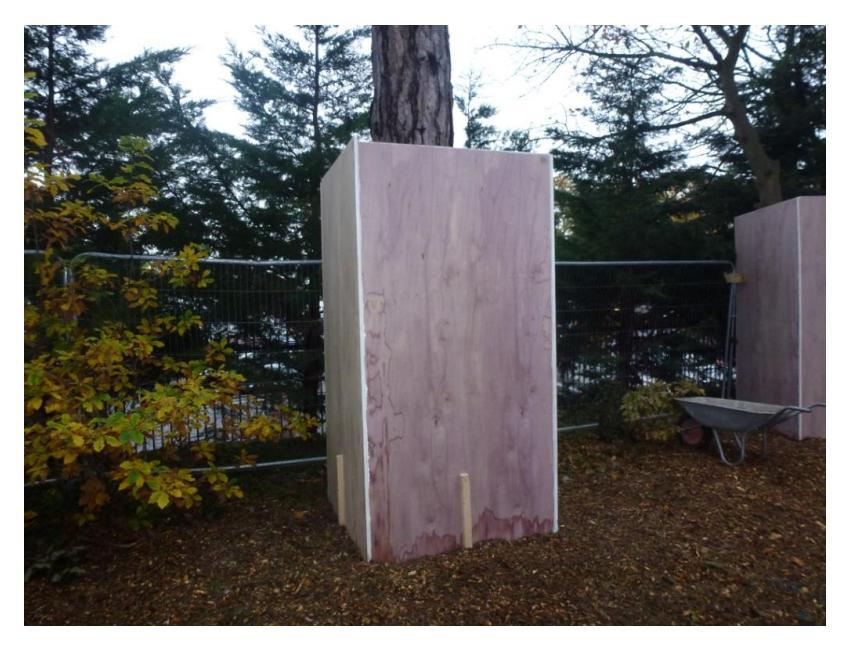
Figure 1: Plywood boxing supported by stakes to be erected to protect the stem of T1 & T3 within the working area.

4.2 Box protection of at least 3no. sides will consist of timber panels that are at least 1.8m tall. These panels will be secured to a timber frame that is located around the main stem(s) of the tree and where possible will provide at least 200mm of clearance from the stem(s). The panels shall be fixed to the ground using small wooden pegs driven into the soil. The frame must be rigid so that it does not move around and strike or damage the main stem(s) of the tree.

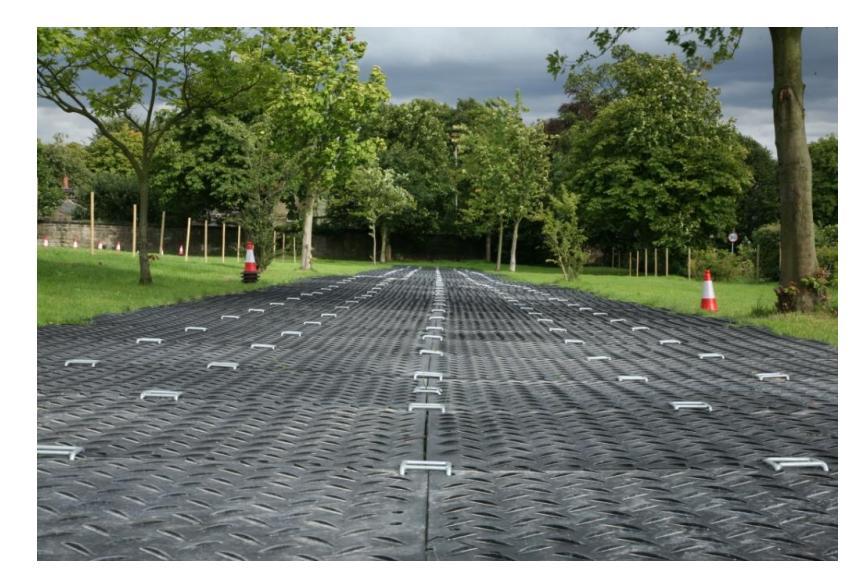
Figure 2: Example of heavy-duty interlinking ground protection mats, for temporary ground protection within the RPAs of adjacent trees.

4.4 Ground protection within affected RPAs shall be manually installed upon the existing ground level and will comprise interlocking pedestrian ground mats (Figure 1).

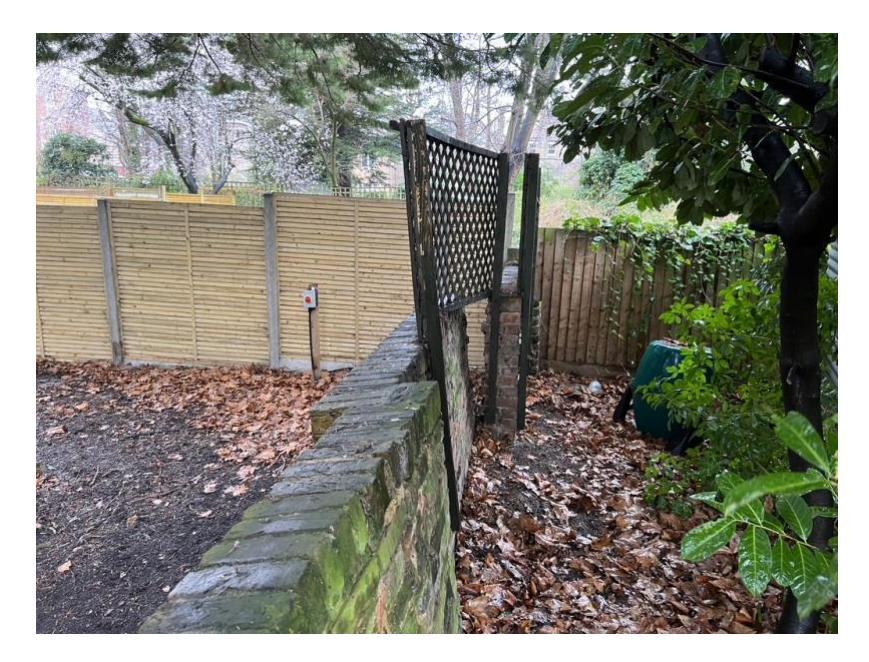
Figure 3: Leaning wall with large separation between two sections. It is assumed the wall was stepped in its construction to avoid a tree now absent. Stem of S2 visible to the right.

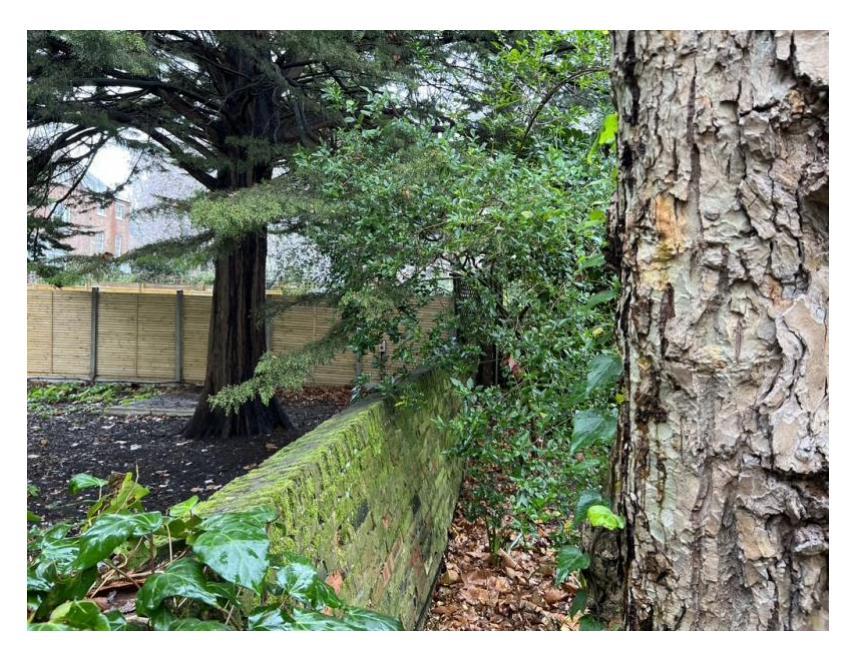
Figure 4: Existing leaning wall with the trunk of T1 in the foreground and T3 left of the wall.

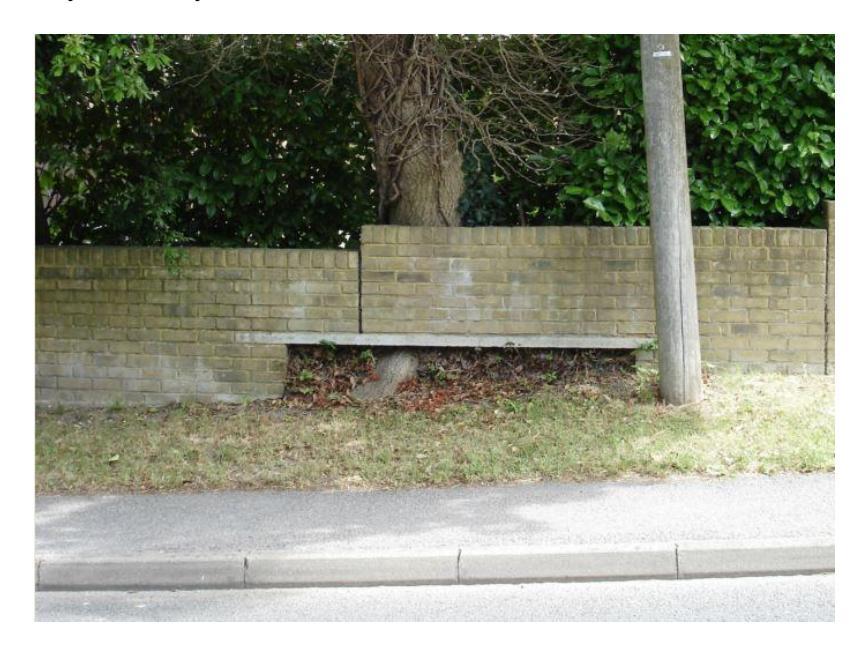
Figure 5: Pre-stressed reinforced concrete beams or RSJs can be used to form a bridge over tree roots to avoid the need to sever roots when building walls close to trees.

- 7.4 The suggested methods for retaining any significant roots uncovered includes the use of concrete lintels or RSJs to bridge particularly large roots or dense masses of roots (Figure 5), or the use of flexible pipe to surround individual roots and allow them to be retained within the mass concrete foundation (Figures 6 & 7).

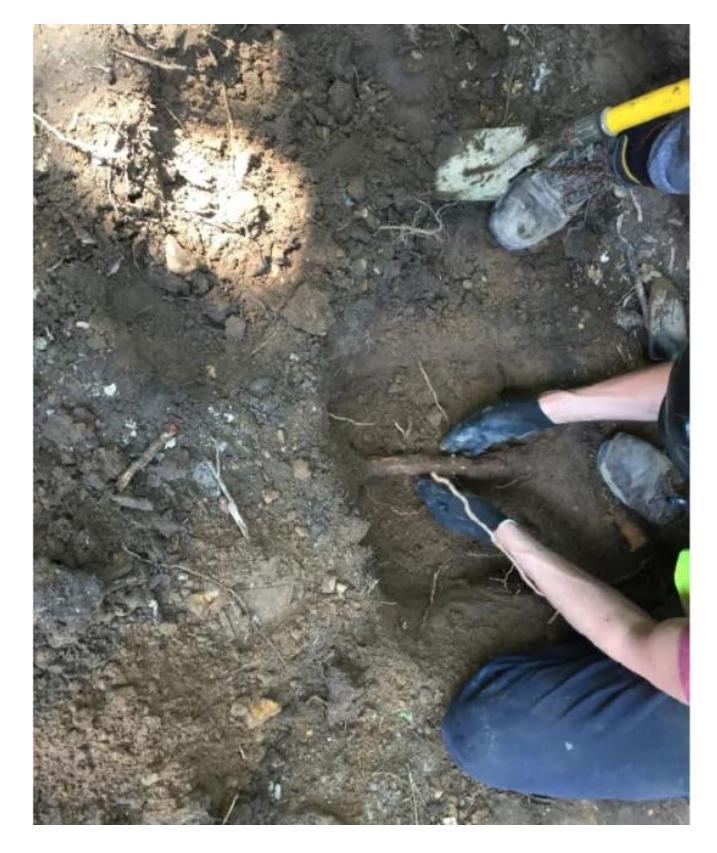
Figure 6: Root carefully exposed to enable installation of a flexible spilt pipe.

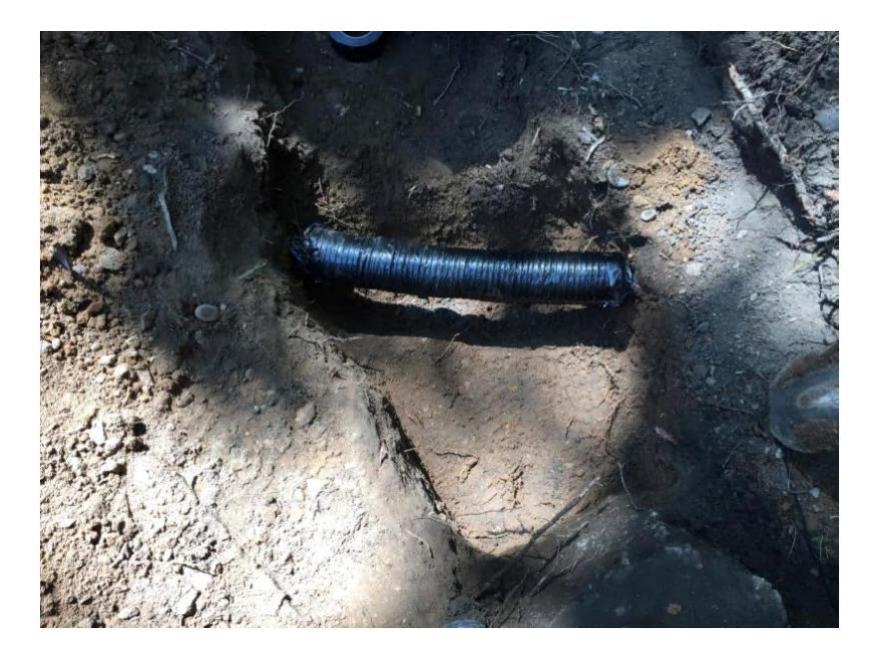
Figure 7: Flexible split pipe installed around the exposed root, with either end of the pipe (and the split along its length) taped closed to prevent cement coming into contact with the root.

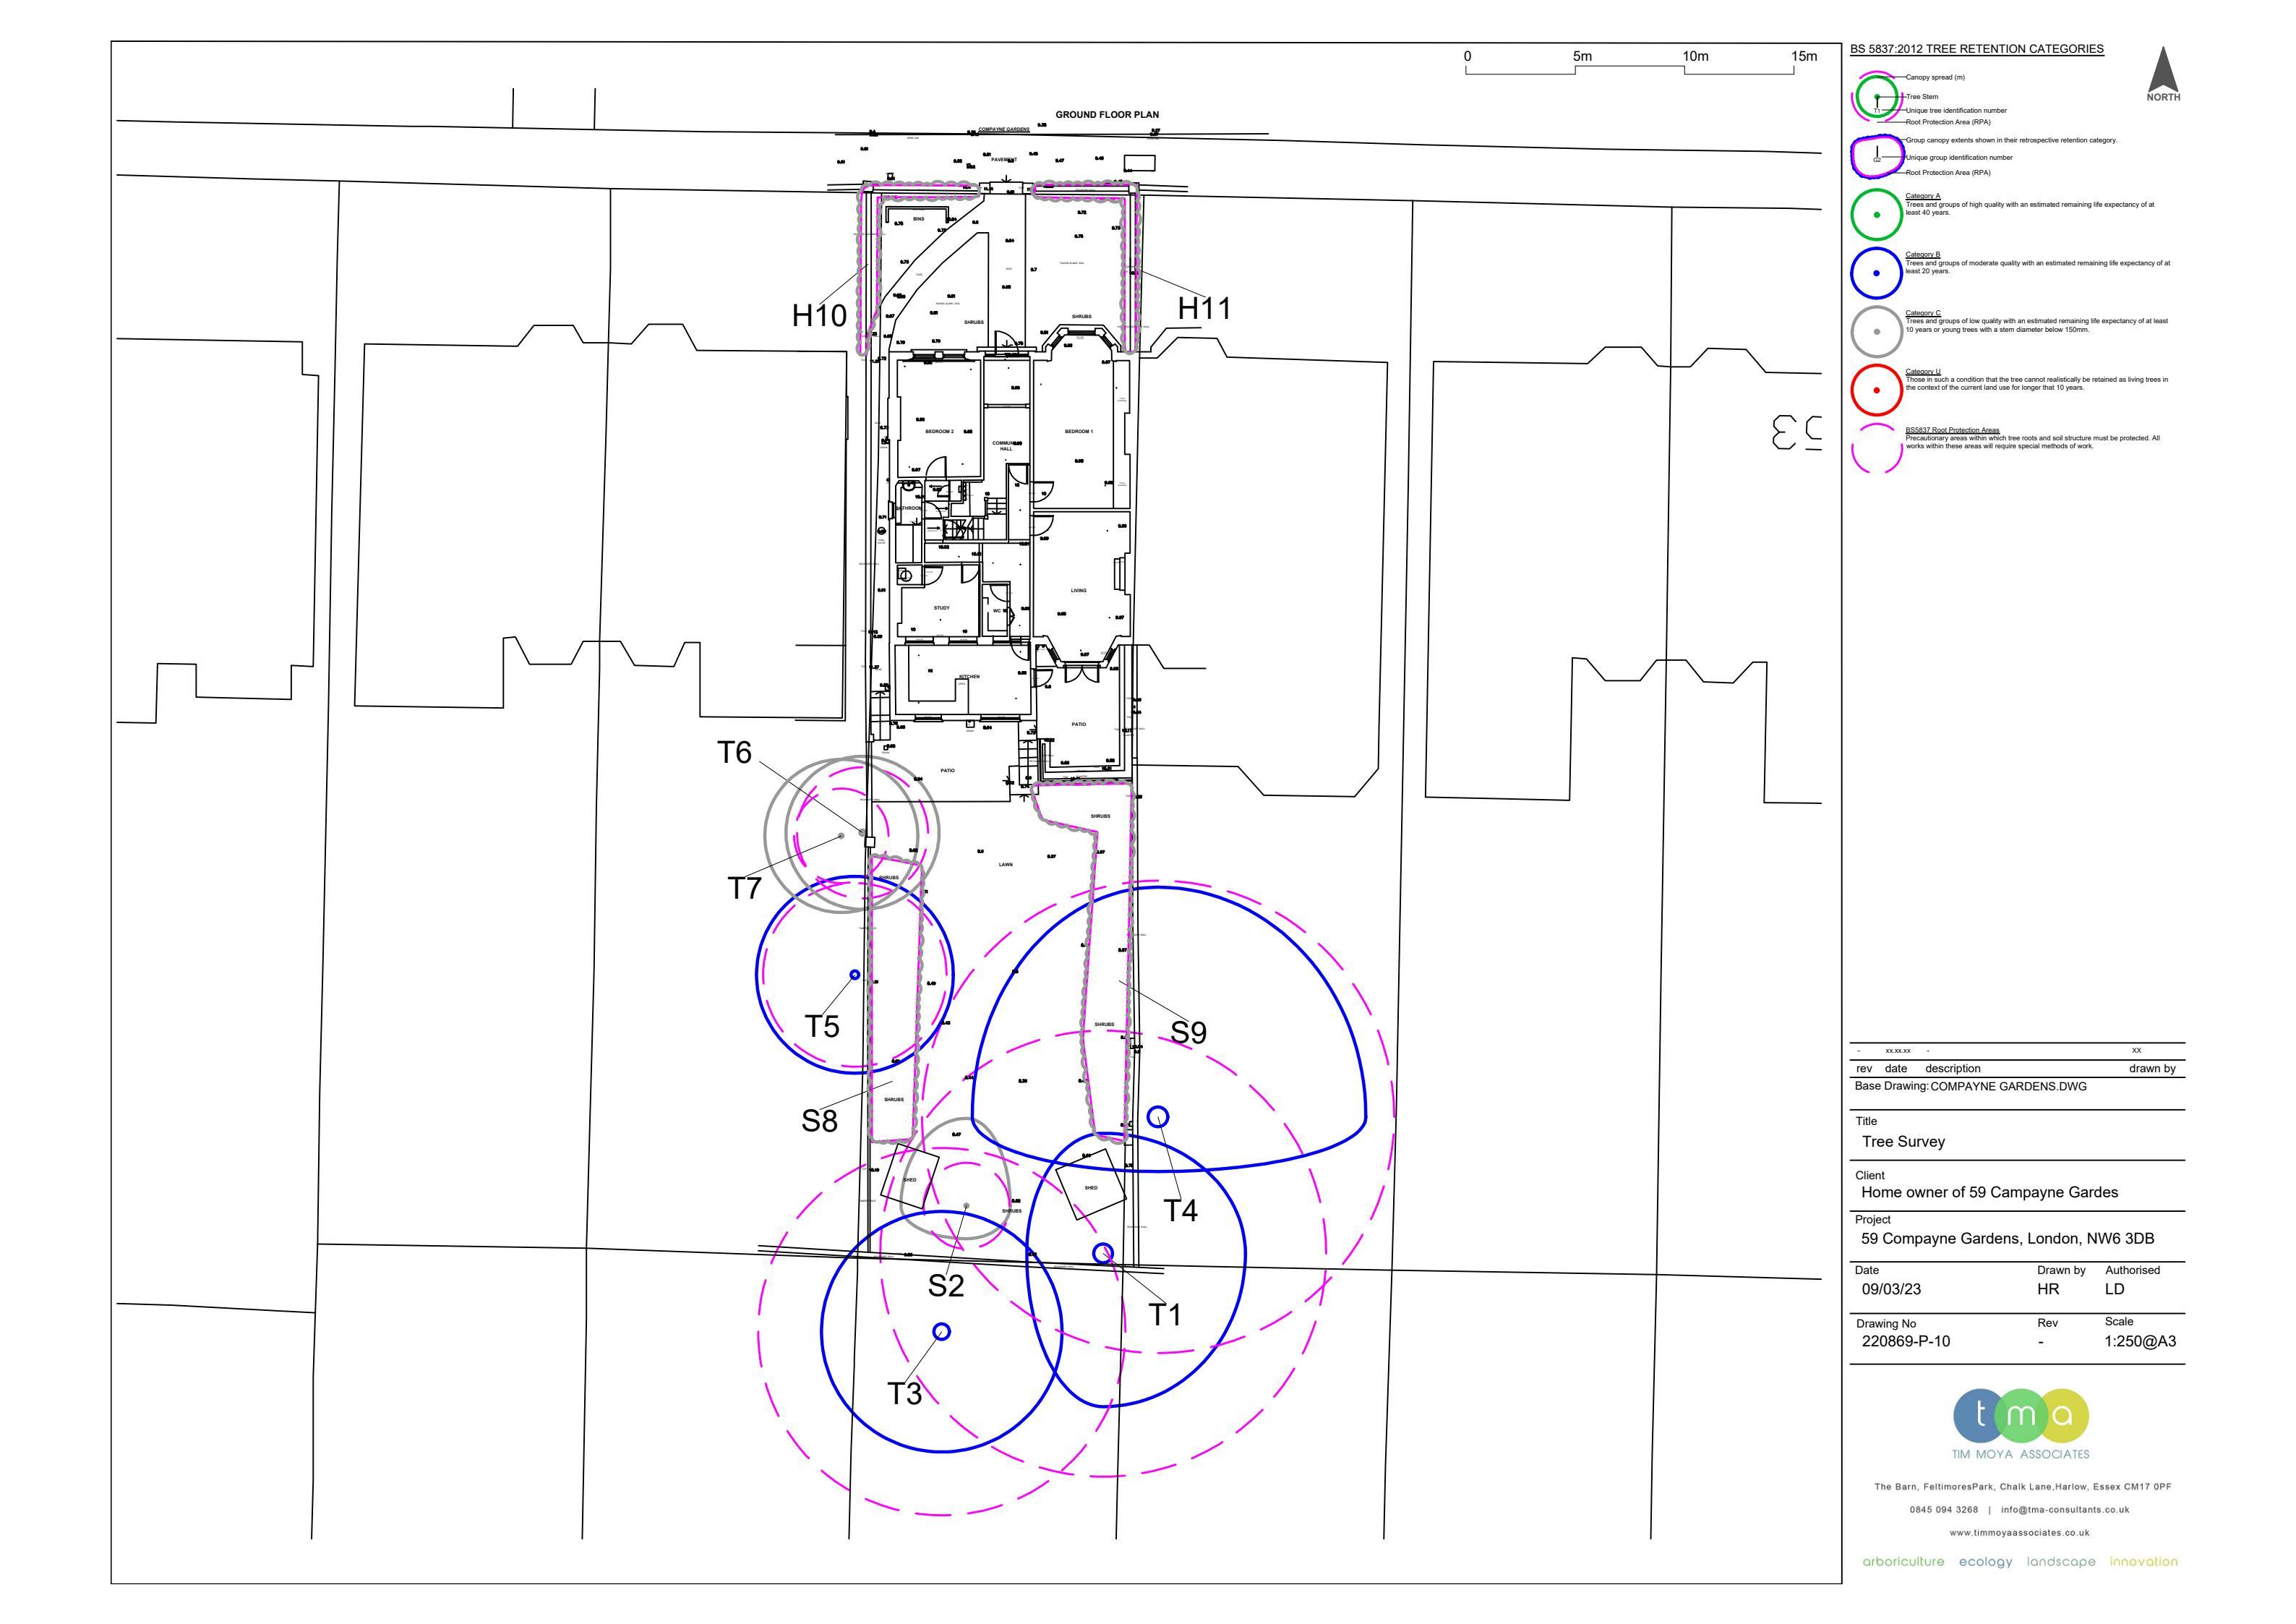
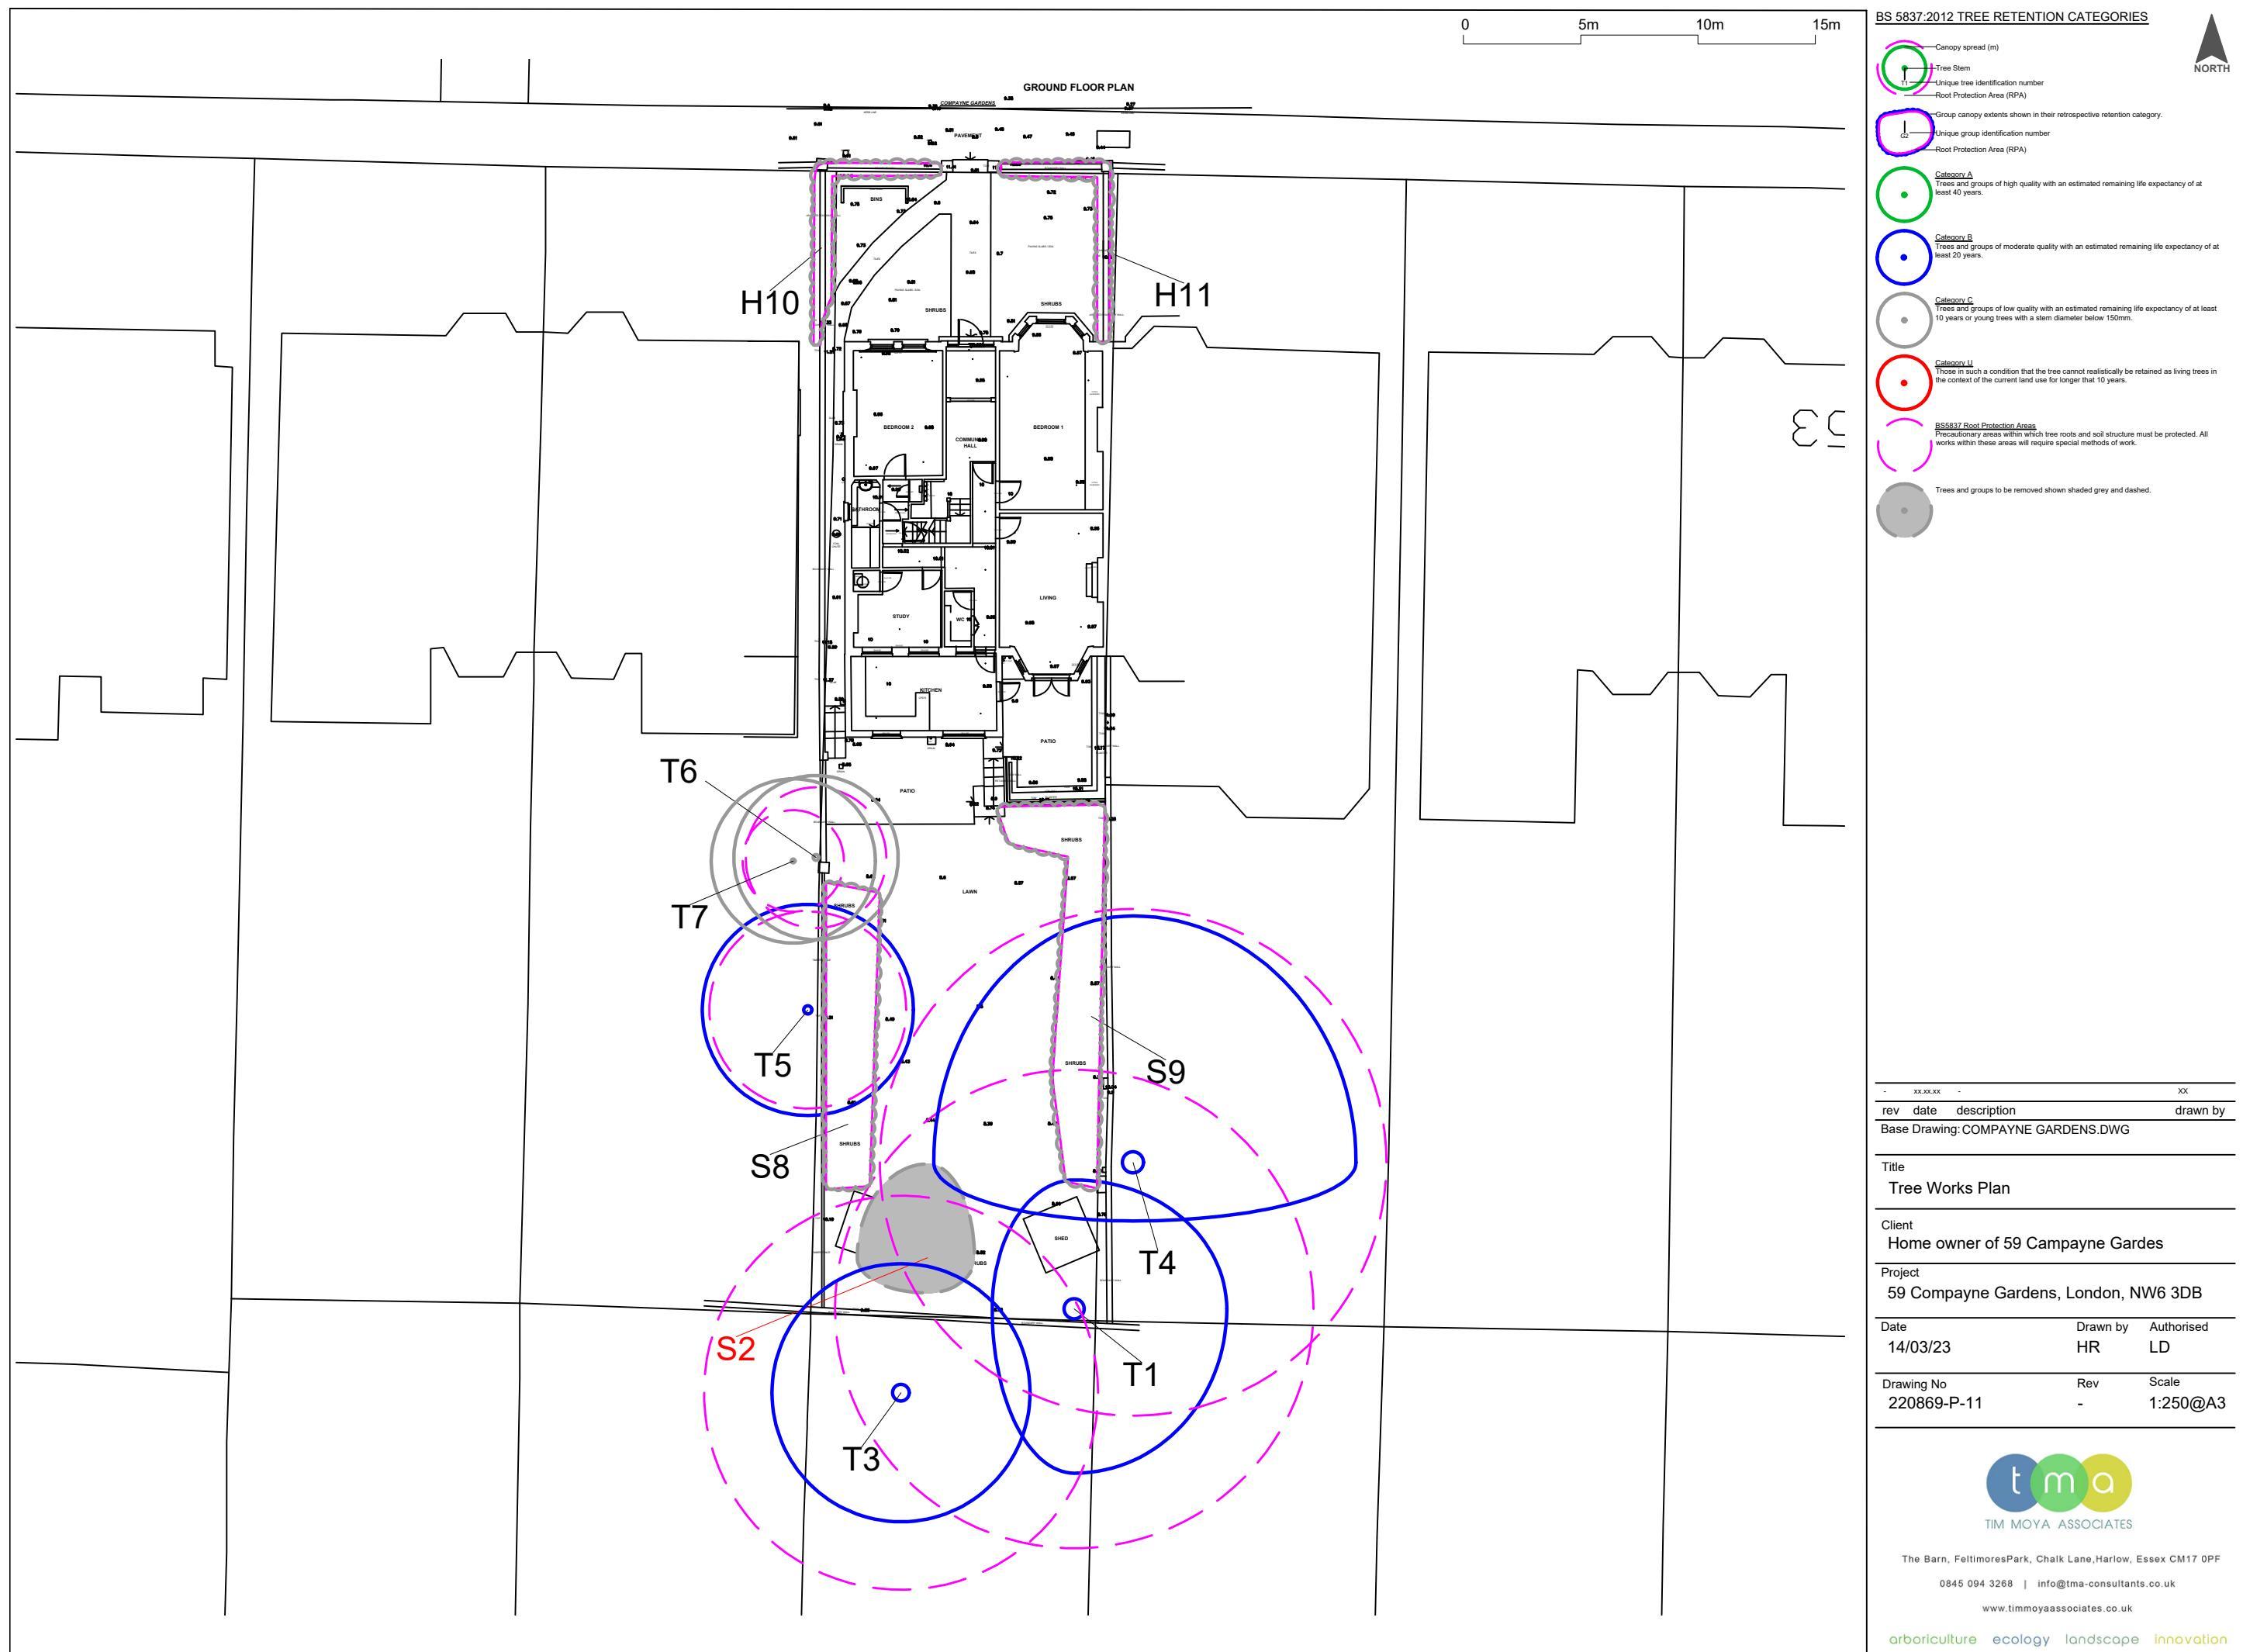
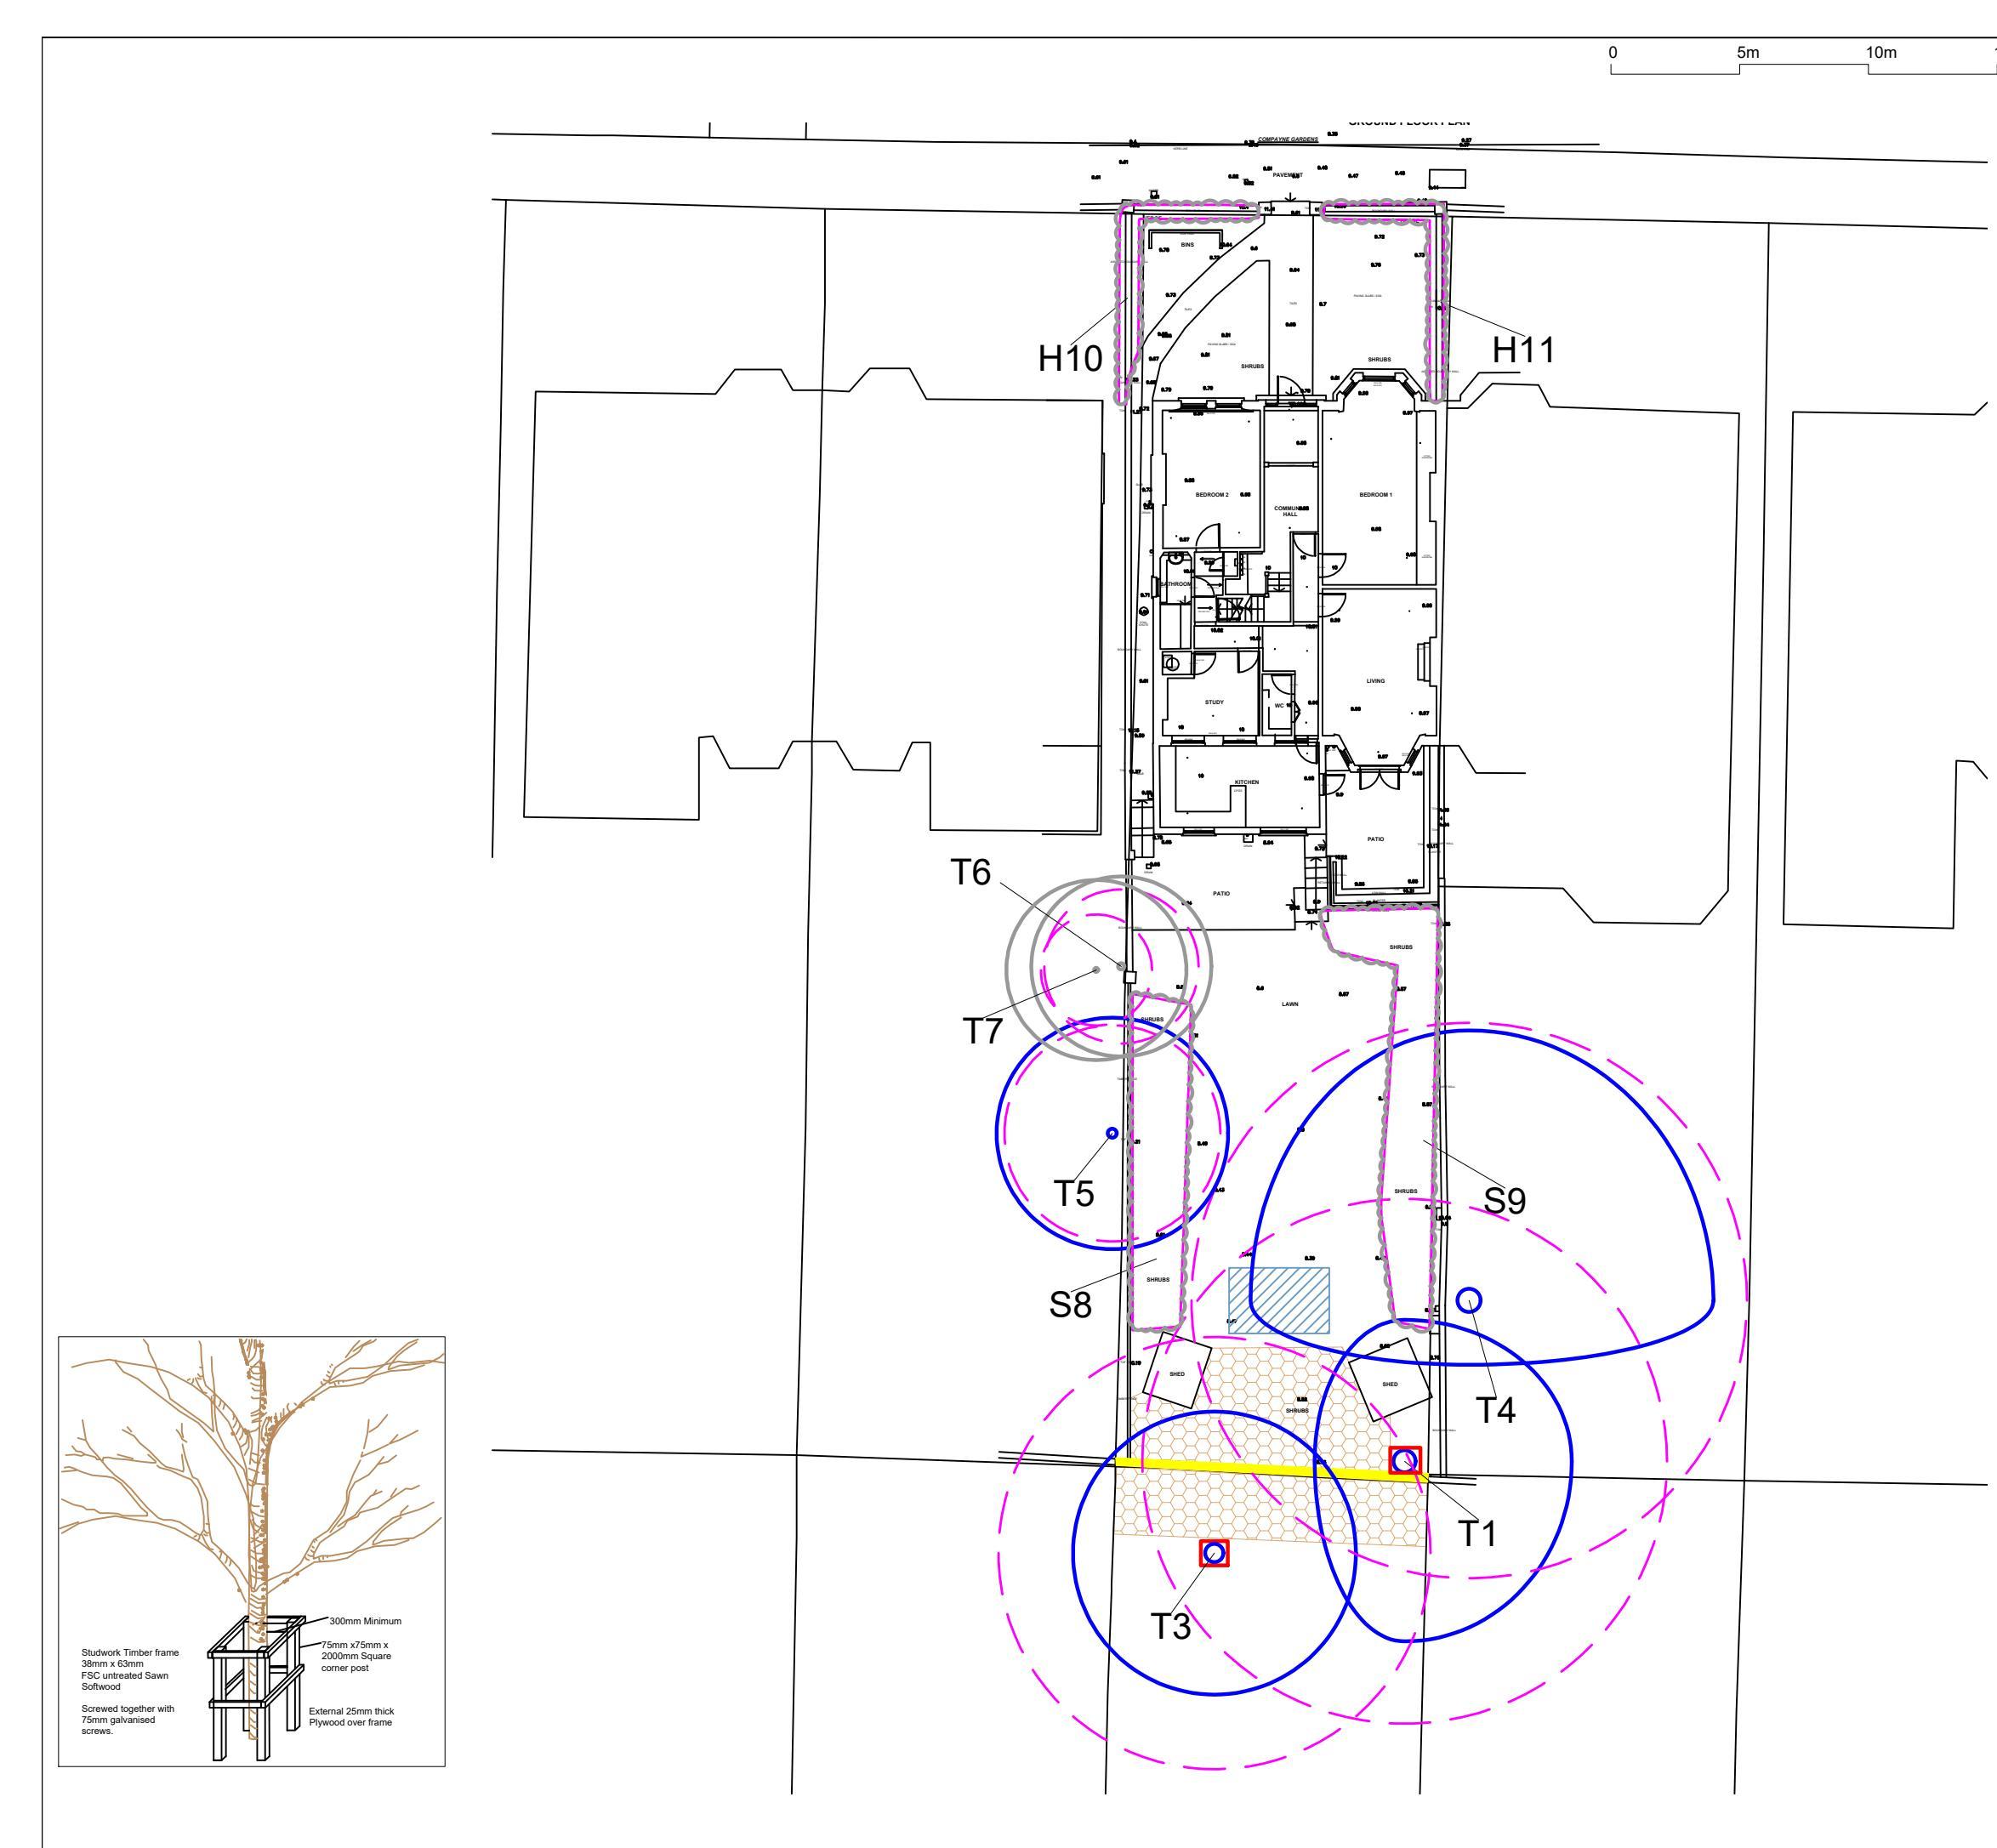
BS 5837:2012 TREE RETENTION CATEGORIES	
Canony arread (m)	
Callopy spread (III)	
Tree Stem NO	ORTH
Group canopy extents shown in their retrospective retention category.	
G2 Unique group identification number Root Protection Area (RPA)	
Category A	
Irees and groups of high quality with an estimated remaining life expectancy of at     least 40 years.	
Category B	
Trees and groups of moderate quality with an estimated remaining life expectancy least 20 years.	of at
Trees and groups of low quality with an estimated remaining life expectancy of at lo 10 years or young trees with a stem diameter below 150mm.	east
$\bigcirc$	
Category U Those in such a condition that the tree cannot realistically be retained as living tree the context of the current land use for longer that 10 years.	es in
$\bigcirc$	
BS5837 Root Protection Areas Precautionary areas within which tree roots and soil structure must be protected. A	AII.

works within these areas will require special methods of work.	
Stem box protection required to prevent physical damage to bark on the main sem these trees. Box protection must not be attached to the tree itself (i.e., no screws or	is of or nails
to be driven into the stem.	ination
of soil within RPA's.	
Ground protection required to prevent compaction of soil within the RPA of nearby Refer to main Report for specification.	trees.
Wall to be carefully demolished by hand and rebuilt using the same bricks.
