REVIEW OF ARBORICULTURAL SUBMISSIONS FOR

APPLICATION 2023/1116/P AT 26 ROSSLYN HILL ON BEHALF OF:

24 Rosslyn Hill London NW3 1PD

Ref: HPM/24RH/RAS/01a

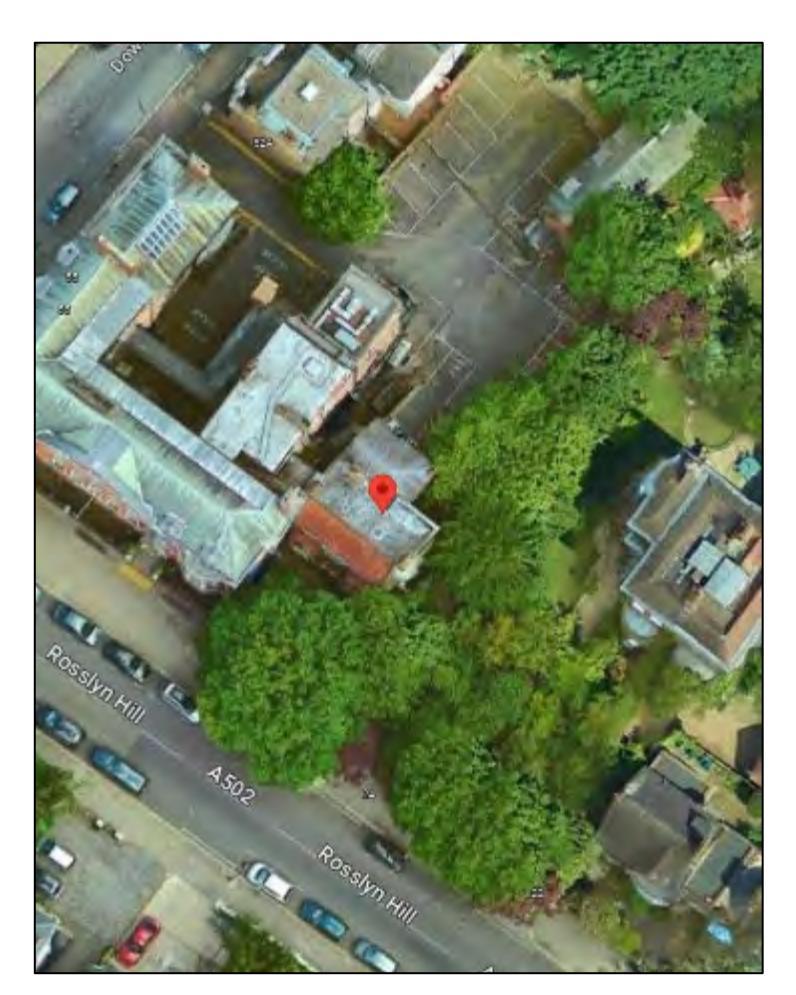
Photograph 1: Aerial photograph showing trees in context (red icon marking 26 Rosslyn Hill) (Source: Google Satellite layer 2023)

3.1.1 26 Rosslyn Hill (marked with red icon in Photograph 1) is a Victorian house which was originally used as police living accommodation, adjoining the former Hampstead Police Station and Courthouse (Grade II listed). 26 Rosslyn Hill has a relatively small front garden standing within which is oak T1; the rear of the site is tarmac. To the east stands 24 Rosslyn Hill, set back within a large garden, part of another Grade II listed building (22 and 24 was originally a detached house which now comprises two residences). The side / rear garden of 24 Rosslyn Hill is well maintained and, as can be seen from Photograph 1, planted with a number of trees – including limes, London plane and purple plum T2 – T6 adjacent to the flank boundary of the application site. (There are also two limes in the front garden of 24 Rosslyn Hill which are included in a Tree Preservation Order, but these are at sufficient distance to be excluded from the scope of this report). The two properties are located on the north eastern side of Rosslyn Hill, close to the junction with Downshire Hill.

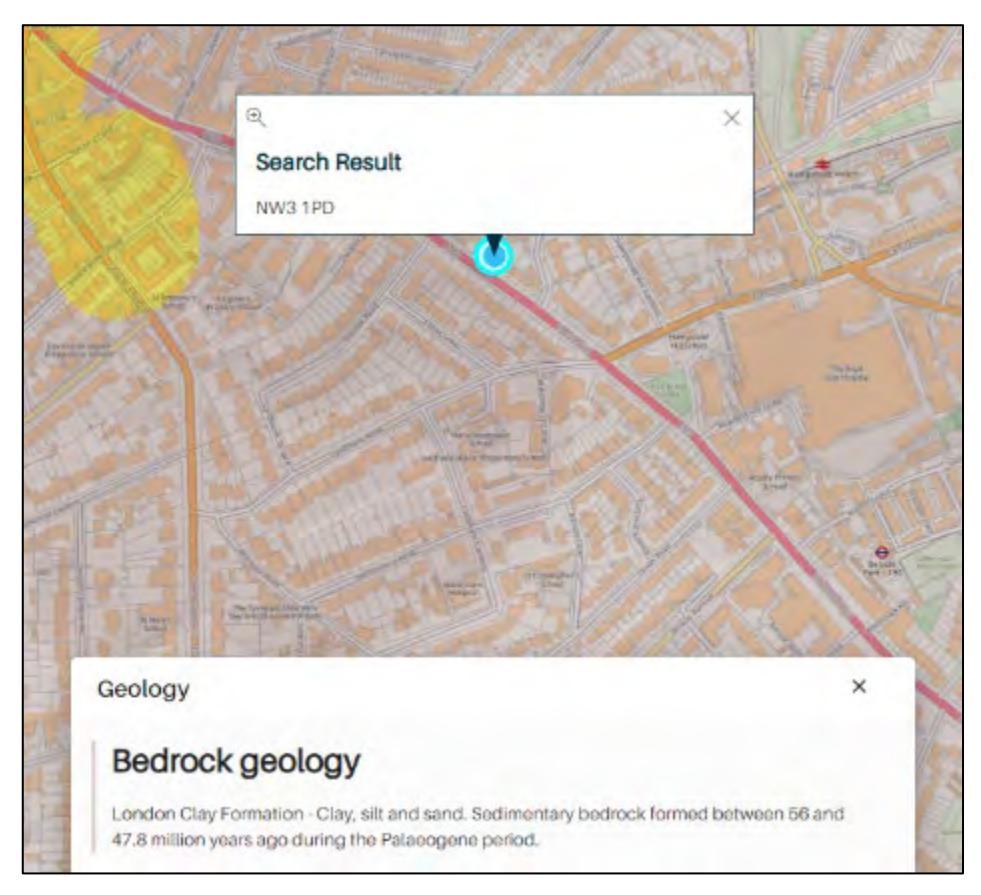
Figure 2: Extract from the BGS Geology of Britain Viewer

- 3.2.1 In terms of the British Geological Survey, the site overlies the London Clay Formation (see indicated location on Fig.1 plan extract above). The associated soils are generally, highly shrinkable clay; e.g. slowly permeable seasonally waterlogged fine loam over clay. Such highly plastic soils are prone to movement: subsidence and heave. The actual distribution of the soil series are not as clearly defined on the ground as on plan and there may be anomalies in the actual composition of clay, silt and sand content.

- 3.2.2 Clay soils are prone to compaction during development with damage to soil structure potentially having a serious impact on tree health. The design of foundations near problematic tree species will also need to take into consideration subsidence risk. Further advice from the relevant experts on the specific soil properties can be sought as necessary.

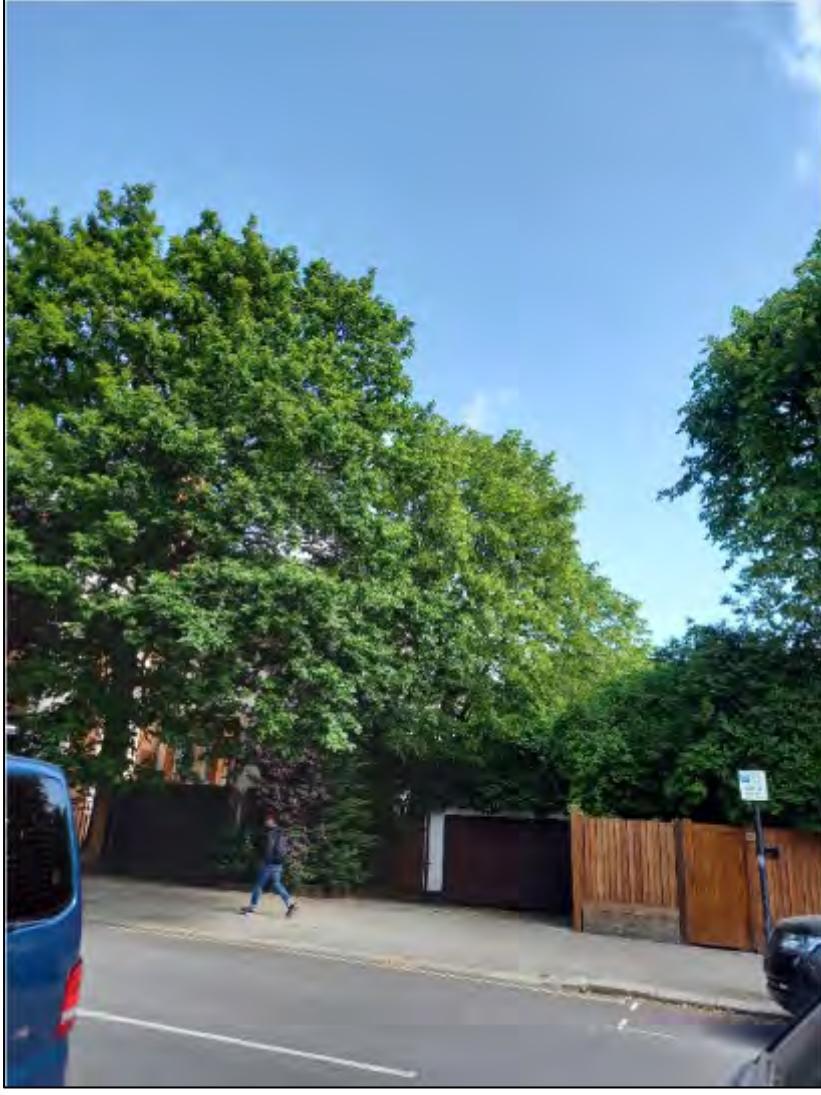
Photograph 2: Oak T1, Lime T2 and part of T3 viewed from Rosslyn Hill

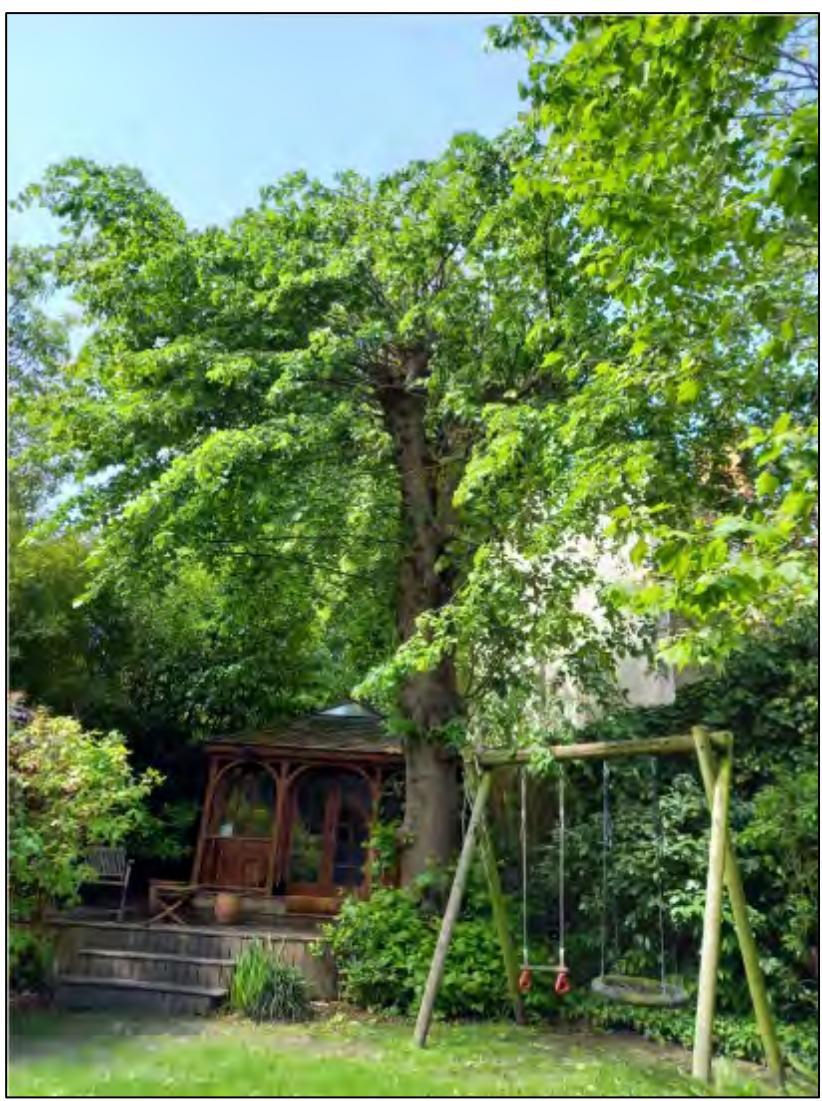
Photograph 3: Lime T3

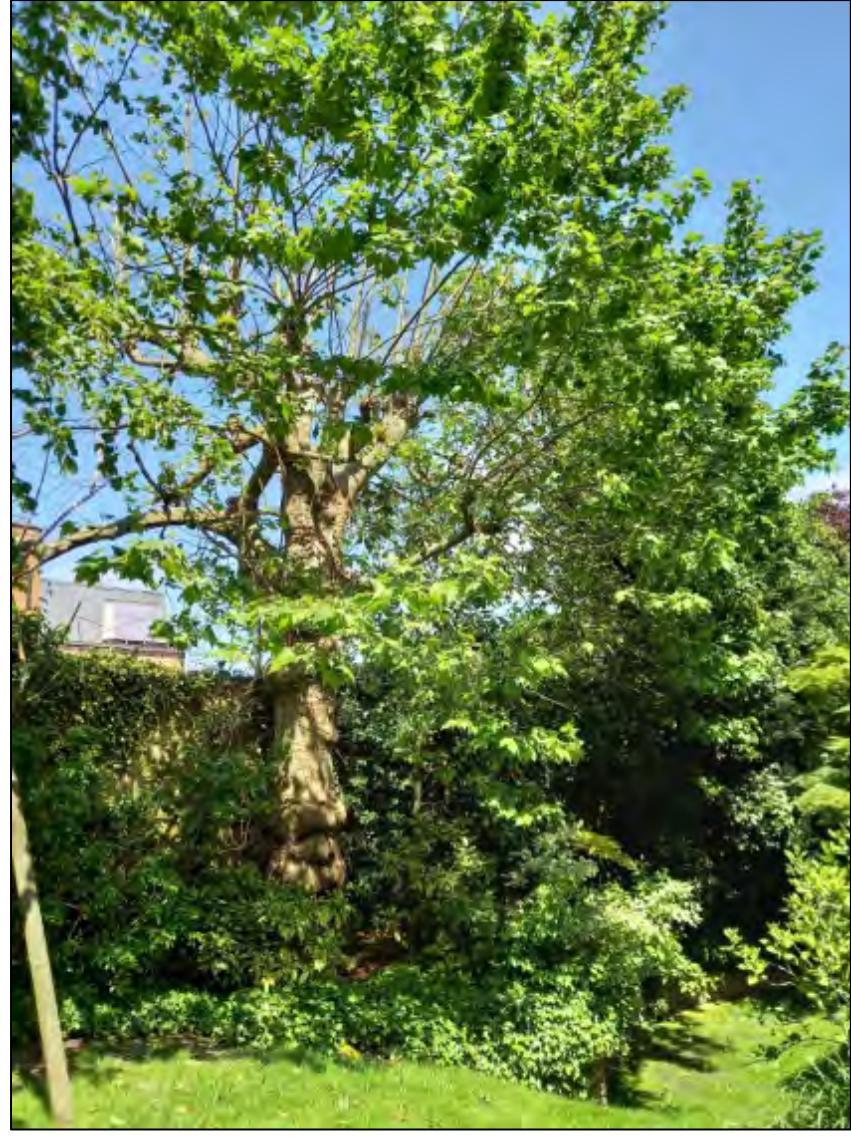
Photograph 4: London Plane T5 also showing steep sloping within 24's garden

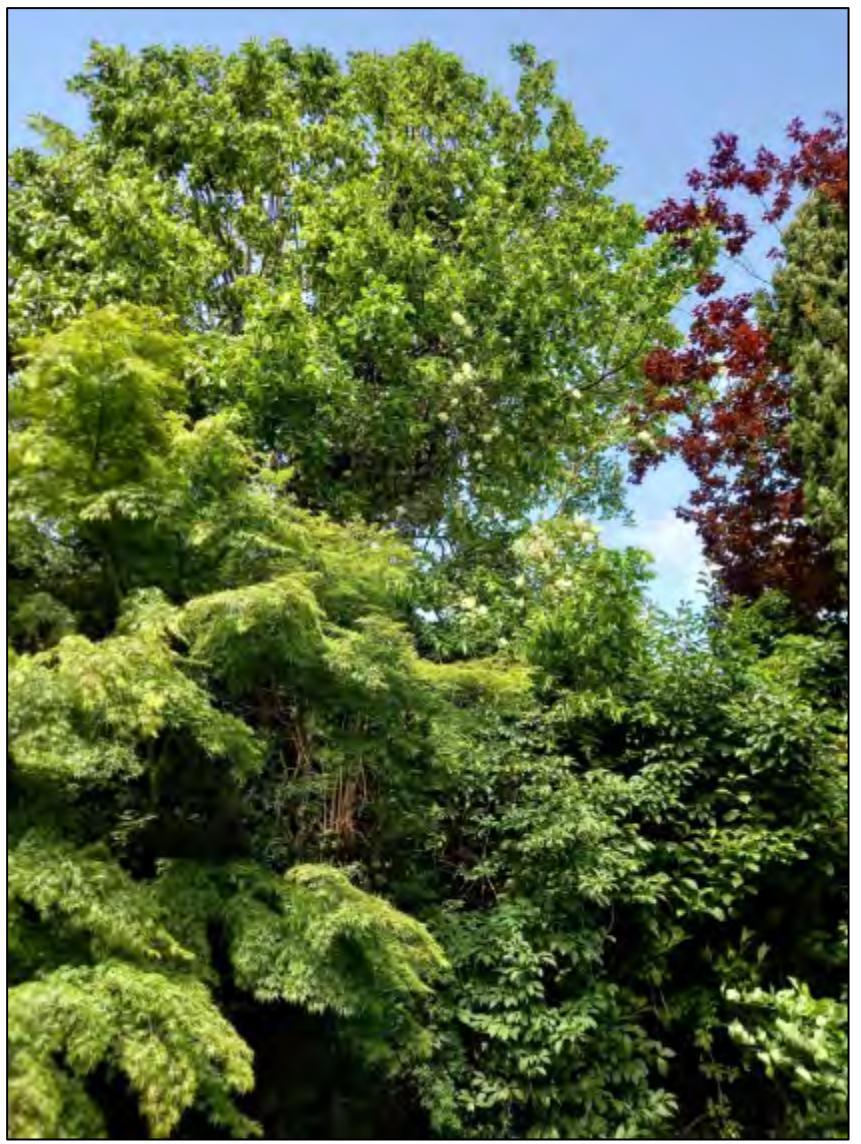
Photograph 5: Lime T5 with part view of purple plum T6

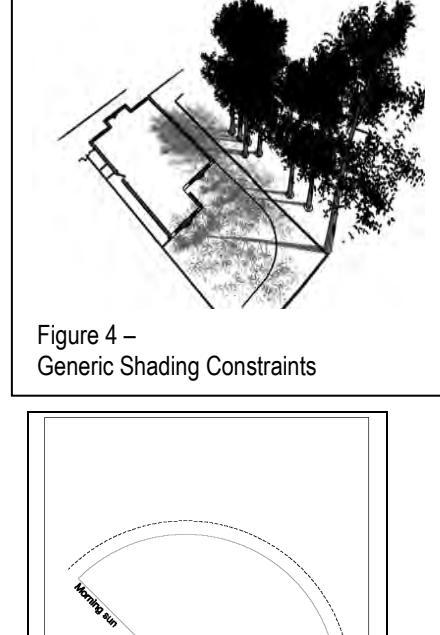
- 4.2.3 This arc (see Figure 5) represents the effects that a tree will have on layout through shade, based on shadow patterns of 1x tree height for a period May to Sept inclusive 10.00-18.00 hrs daily.

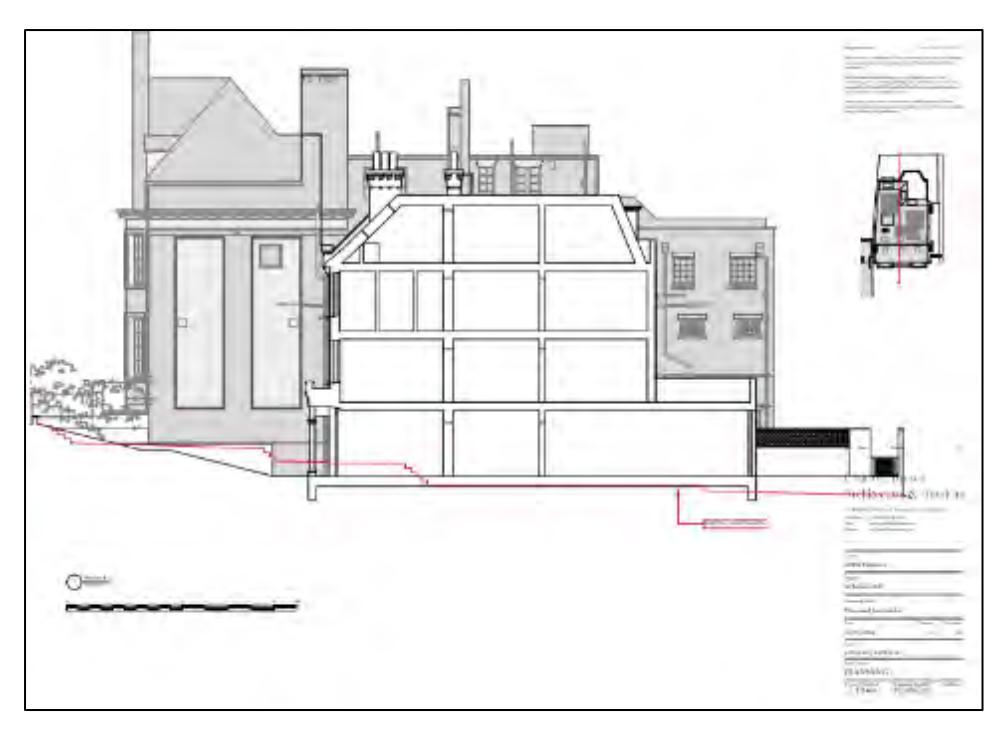
Fig. 6: Proposed Section EE (Source: Proposed plans)

- 6.1.5 The alteration of the ground level at the front would appear to be within the RPA of oak T1 and lime T2; that along the flank and rear within the RPAs of limes T3, T5 and London plane T4. It appears likely to result in root damage to both trees, with consequent impact on their health and appearance.

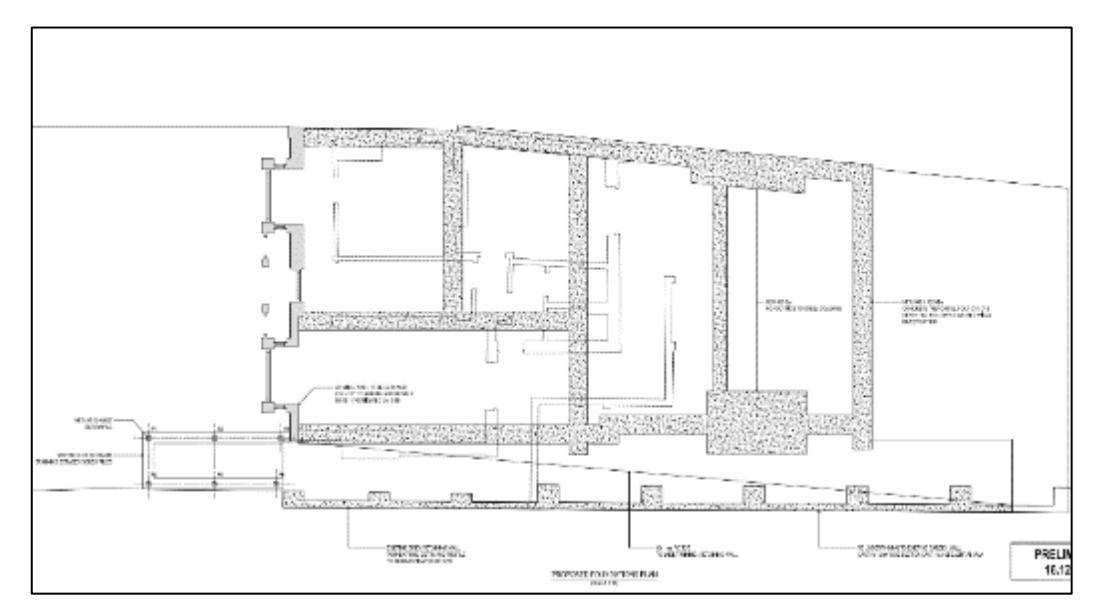
6.1.7 The Structural Report indicates the "main foundations of the new building behind the retained façade [would] consist of a traditional mass concrete trench fill foundation. Based on the structural loading and anticipated ground conditions the preliminary design indicates 600 mm wide and 1.20 m deep foundations centred under the masonry load bearing walls above". It includes a proposed foundations plan (see Fig. 7 below) which can usefully be compared with Landmark's Tree Constraints Plan to indicate the extent of RPA encroachment that Tretec have disregarded.

Fig. 7 Proposed Foundations Plan (Source: Structural Report)

6.1.8 We do of course note that Tretec acknowledge significant roots may be present in the tarmacked area but must object to their assertion that this would automatically infer that they had breached the wall via direct damage and constitute an actionable nuisance. Our first point of objection lies in the assumption that roots within the application site must have grown through (breached as per Tretec) the wall itself. This is far from certain, especially with regard to T4, and we have experience of numerous sites where roots have grown beneath boundary wall foundations to resurface on the far side. Our second point of objection is more nuanced but it is also far from certain that the pruning back of any roots that have penetrated the wall would be subject to an exemption from Conservation Area regulations given it may not be necessary to do so to repair the wall, if this were even required.

- 8.1.1 Trial pit investigations be undertaken to inform:
 - (i) the profile and depth of the existing foundations to boundary wall and front façade
 - (ii) the depth and extent of tree rooting within the application site
- 8.1.2 Detailed proposed levels information is provided to show the extent of level changes within RPAs of all retained trees on and adjacent to the site.
- 8.1.3 A treework specification be provided detailing the extent of any proposed pruning (above or below ground) of all retained trees on and adjacent to the site.
- 8.1.4 A more detailed Arboricultural Method Statement be provided which includes details of tree protection measures in accordance with clauses 6.1, 6.2.3, 6.2.4 and 6.3 of BS5837: 2012 and paragraphs 2.51 2.58 of Camden Planning Guidance Trees March 2019

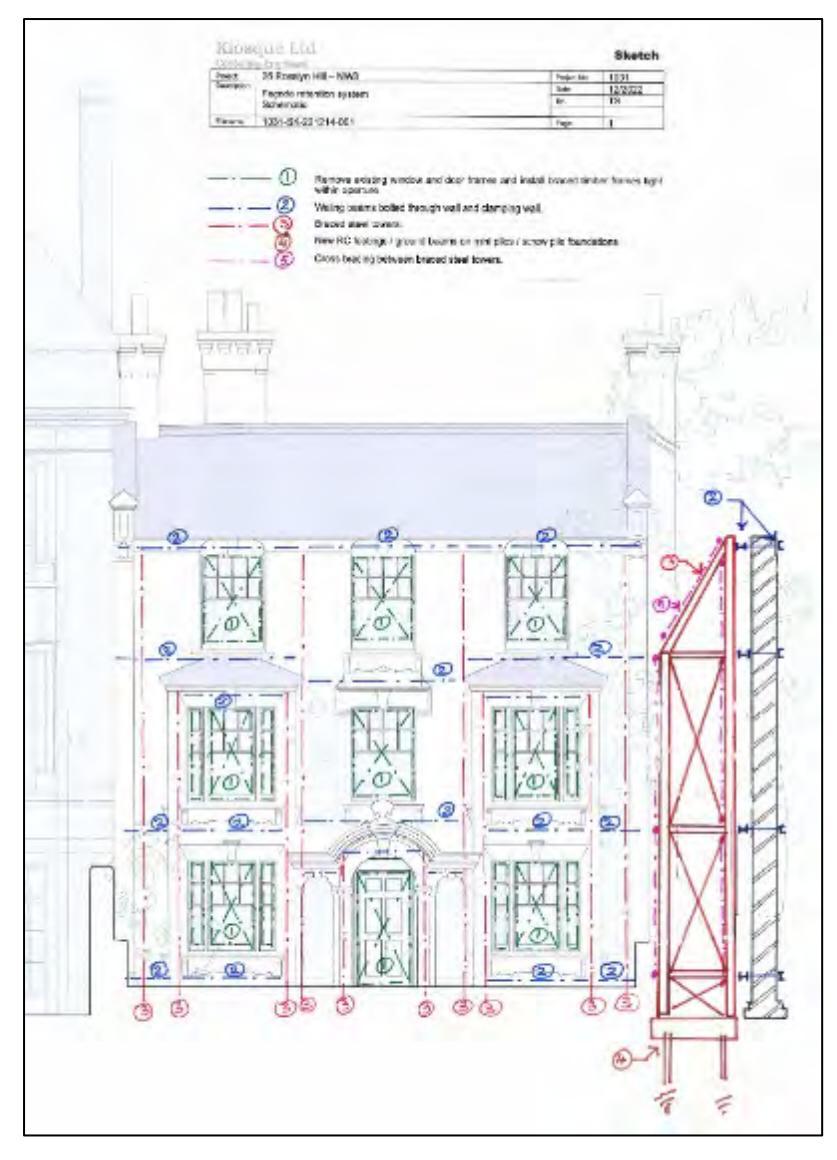
- 6.1.10 Moving to damage to trees arising from wider construction activities, the Structural Report also describes the methodology for the proposed façade retention system. It observes "As the front of the property is within tree T1 root protected area (RPA), the new foundations for the temporary façade retention system consist of a series of reinforced concrete pad foundations / ground beams on screw piles. Therefore, this option minimises the amount of excavations within the RPA." Whilst acknowledging the proposed methodology makes some allowance for the RPA of oak T1 (albeit not for that of lime T2), it is considered that combining this with level changes is likely to have potential impacts for both oak T1 and lime T2. In addition, there appears to have been no assessment of the likely implications for the canopies which are likely to require pruning to facilitate access for installation. Fig. 8 overleaf is a sketch of the façade retention system extracted from the Structural Report:

Fig. 8 Proposed façade retention sketch (Source: Structural Report)
