FRANCIS CRICK INSTITUTE - LEVEL 05 NE

Drainage Note

DRAINAGE NOTE

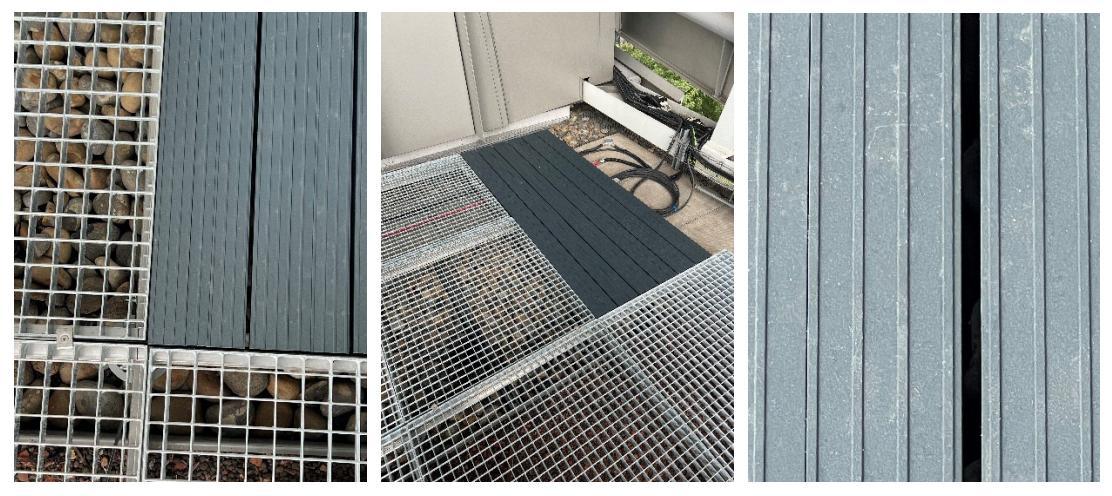
Photographs 2, 3 and 4 – showing the proposed new material alongside the existing grating

- 3.1 Under the original proposals, it was intended to create a raised metal grate deck over the existing brown roof located on the 5th floor level. The raised deck would be created in the form of a gantry / mesh and would include landscaping planters along the eastern edge of the terrace, and a café pod serving drinks at the northern edge.
- 3.2 The raised metal grate deck was installed earlier this year but for reasons set out elsewhere in this application it has been decided to pursue a different approach to the surface material and replace the metal grating with aluminium decking strips each with a 2mm separation between them to ensure water permeability resulting from rainwater and any water from the roof above. The new decking would use the big-foot footing and beam system installed as part of the mesh proposals. The material and design are shown in the following photographs:

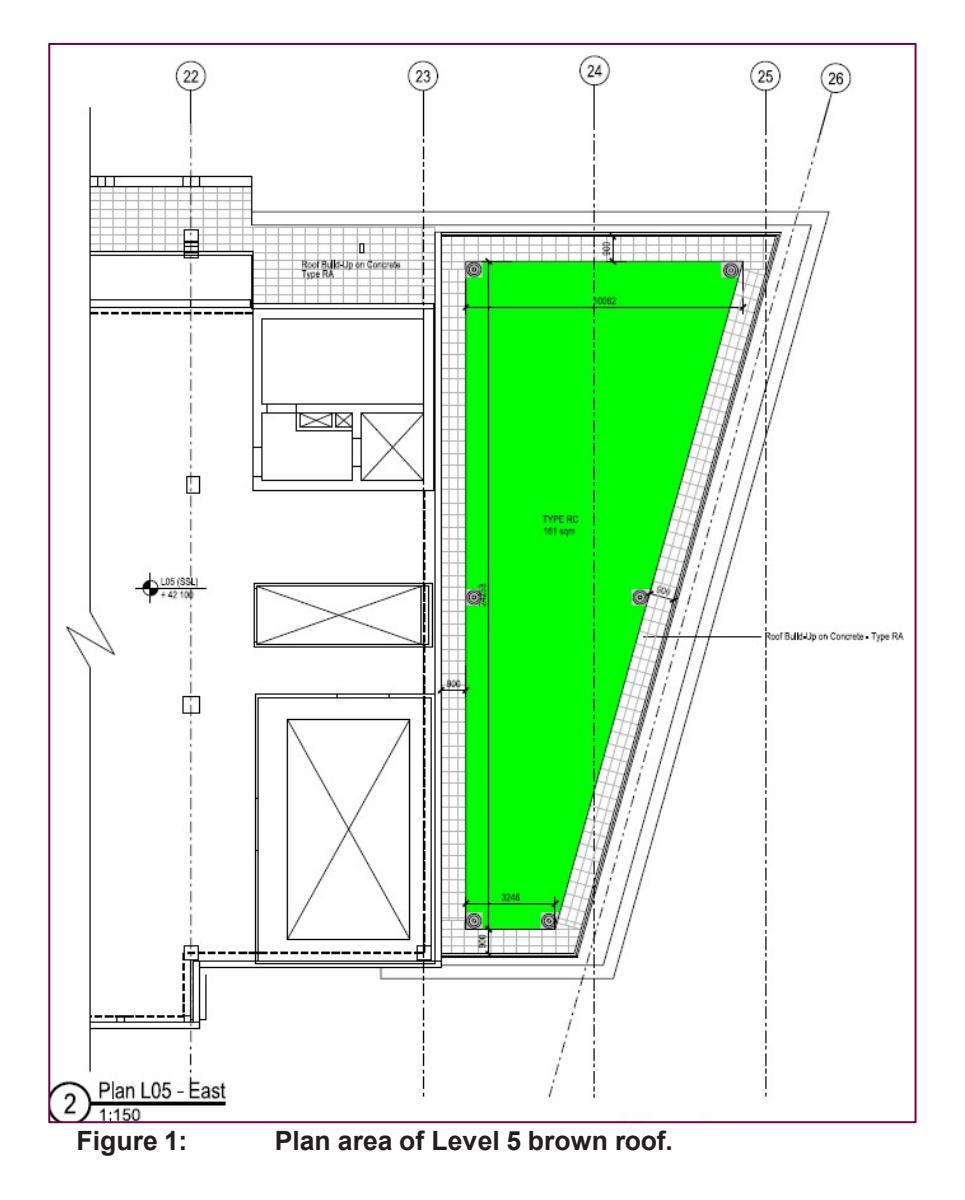
⁽Originator not identified. Drawing Number, A-DTL-8050, Rev 04, prepared for UKCMRI Construction Ltd (FCI). Not to scale)

- 4.3 An extract from the drawings in relation to the design of the Level 5 roof is provided at Figure 1 below.

- 4.2 The brown roof also forms part of the sustainable drainage scheme for the site. The existing brown roof currently supports the Sustainable Drainage Strategy for the wider site, agreed as part of Planning Application 2010/4721/P, whilst also providing biodiversity benefits. The details of the brown roof were secured by Condition 5 of the planning approval which was subsequently discharged in September 2012 under planning reference 2012/4034/P.

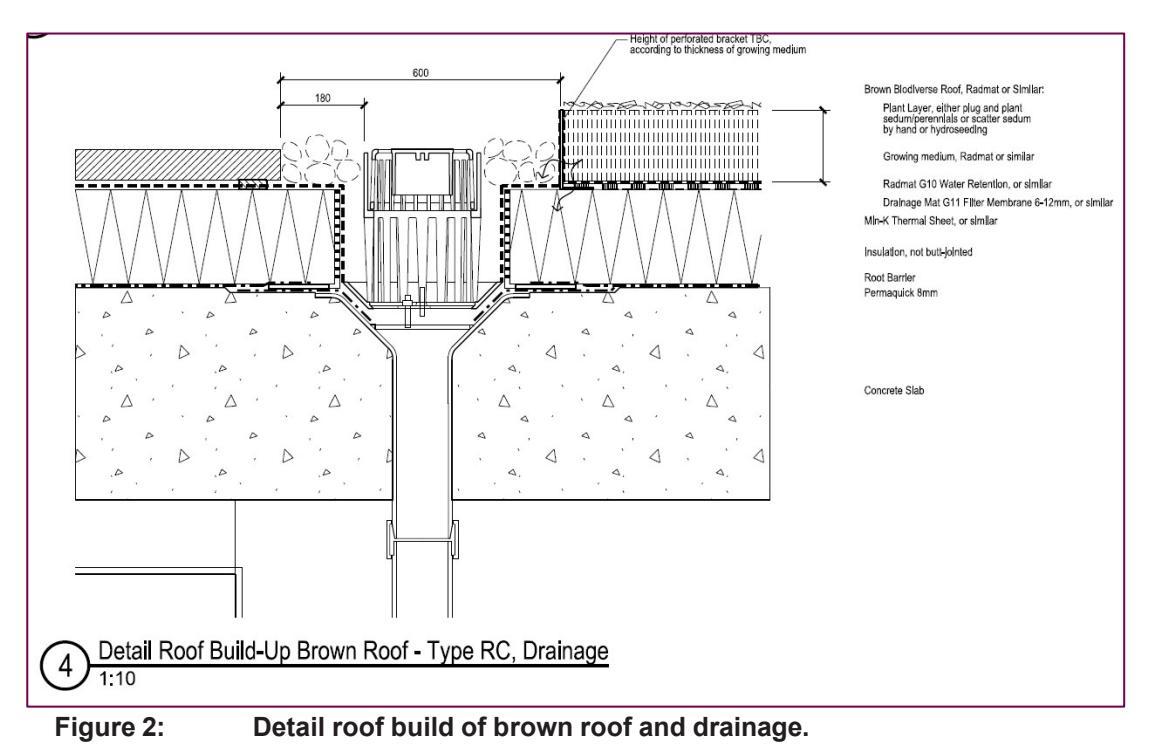
(Originator not identified. Drawing Number, A-DTL-8050, Rev 04, prepared for UKCMRI Construction Ltd (FCI). Not to scale)

4.4 The schematic at Figure 2 below shows a cross section of the make up for the roof and how this ties into the river stone borders sand ultimately passes into the drainage gulley.

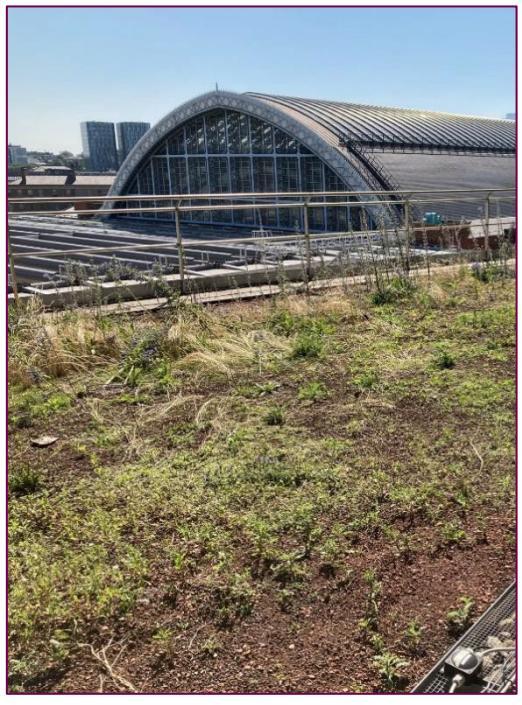
- 5.1 As noted above two site visits have been undertaken, one initially to review the roof and a second during an exploratory 'dig' to confirm the makeup of the roof. Observations are described below:
 - Roof comprises brown roof that was observed to be relatively sparsely vegetated during the summer site visit and slightly more vegetated during the winter site visit, as shown in Photographs 2 and 3 below.

Photograph 2: Roof in |Summer (16 July 2021)

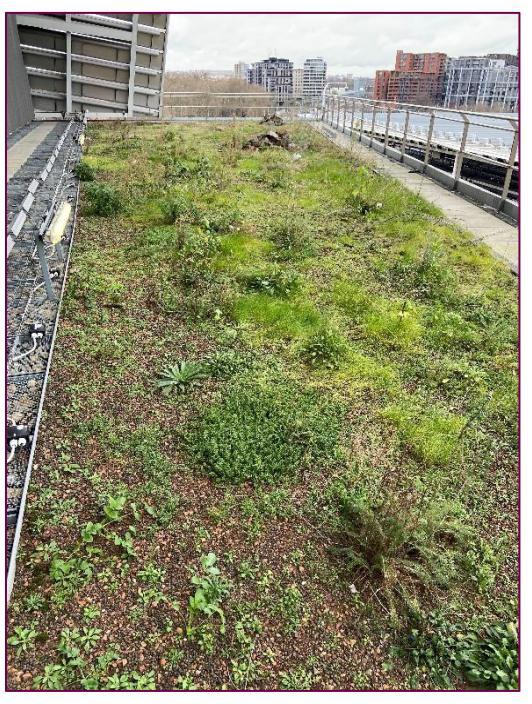
Photograph 3: Roof in winter (3 February 2022)

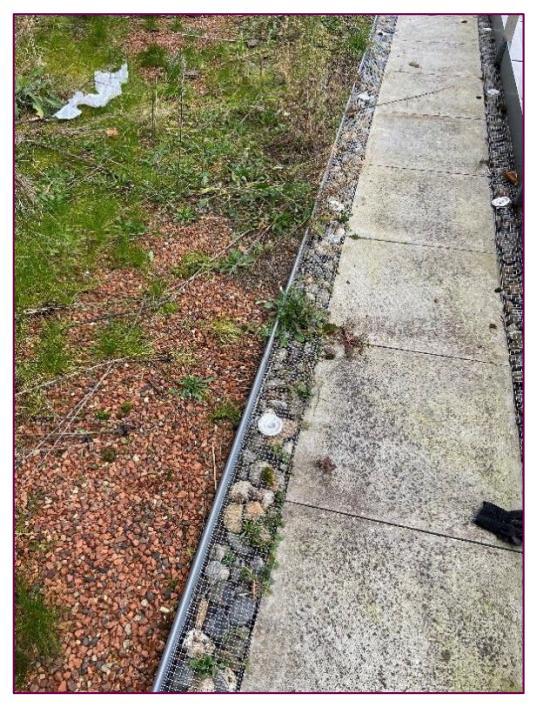
• Make up of roof comprising a sand to gravel material including crushed brick, which is kept in place by a metal edging strip, surrounded by a river stone border, as shown in Photograph 4 below.

Photograph 4: Gravel roof, with metal edging strip and river stone border, with pedestrian walkway

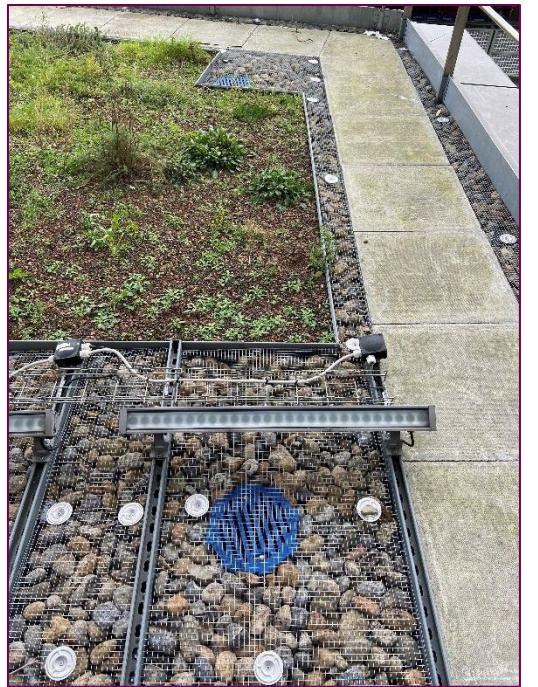
• Gullies were present in each corner of roof and one centrally along the brown roof edge adjacent to the building, providing drainage of surface water runoff, as shown in Photograph 5 below.

Photograph 5: Corner gulley's at southern end of roof.

- 6.2 From this point, water will follow the existing pathways through the roof materials and drainage channels into the gulley's located at five points around the edges, and subsequently into the wider building drainage and attenuation system.

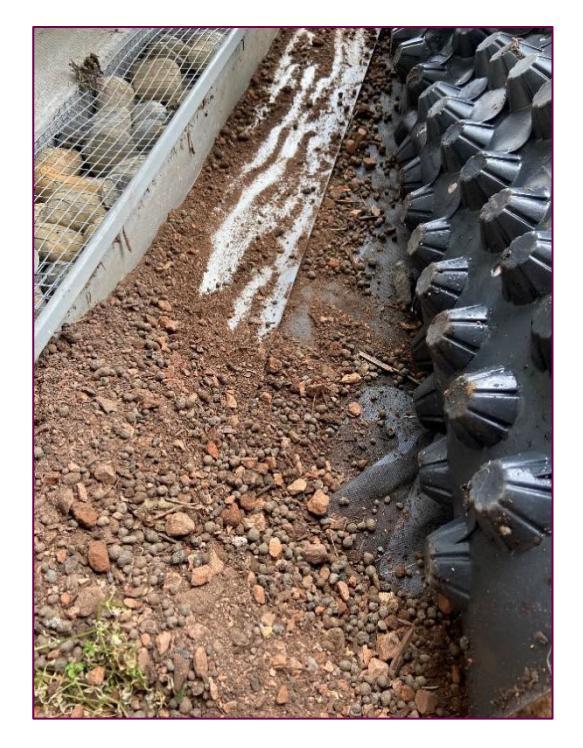
• During the exploratory 'dig' evidence of a filter layer with water storage (plastic 'egg crate' type feature) was observed to retain some water for plant growth, with holes in to allow excess water to drain via a geotextile membrane to the underlying polystyrene insultation, which includes channels to convey water to the river stone boarder and ultimately into the gulley's, as indicated in Photograph 6 below. It should be noted that the Photograph 6 show the 'egg crate' plastic layer lift to view the layers beneath, and ordinarily this would site flat such that the 'cups' would store water to help facilitate the growth of plants.

Photograph 6: Water storage lay with geotextile membrane beneath

- The system allows any excess flows to build up at the surface and pass towards the river stone boarder bypassing the lower layers and ultimately into the gulley's.
- 5.2 It is understood that subsequently drains pass through building before discharging into the wider site surface water attenuation tanks.

- 6.4 The intent is to draw water from the storage element of the existing system for irrigation purposes. The existing system includes a degree of water storage within the 'egg crate' design and filter pumps located at key points will enable some of the stored water to be accessed for this purpose. This will result in an overall minor reduction in water outflow from the roof as a whole.
