Tree Safety Report (Negative/Hazardous reporting only)

Channing School

18 July 2023

Appendix 2: Tree Location Plan drawing (not to scale)

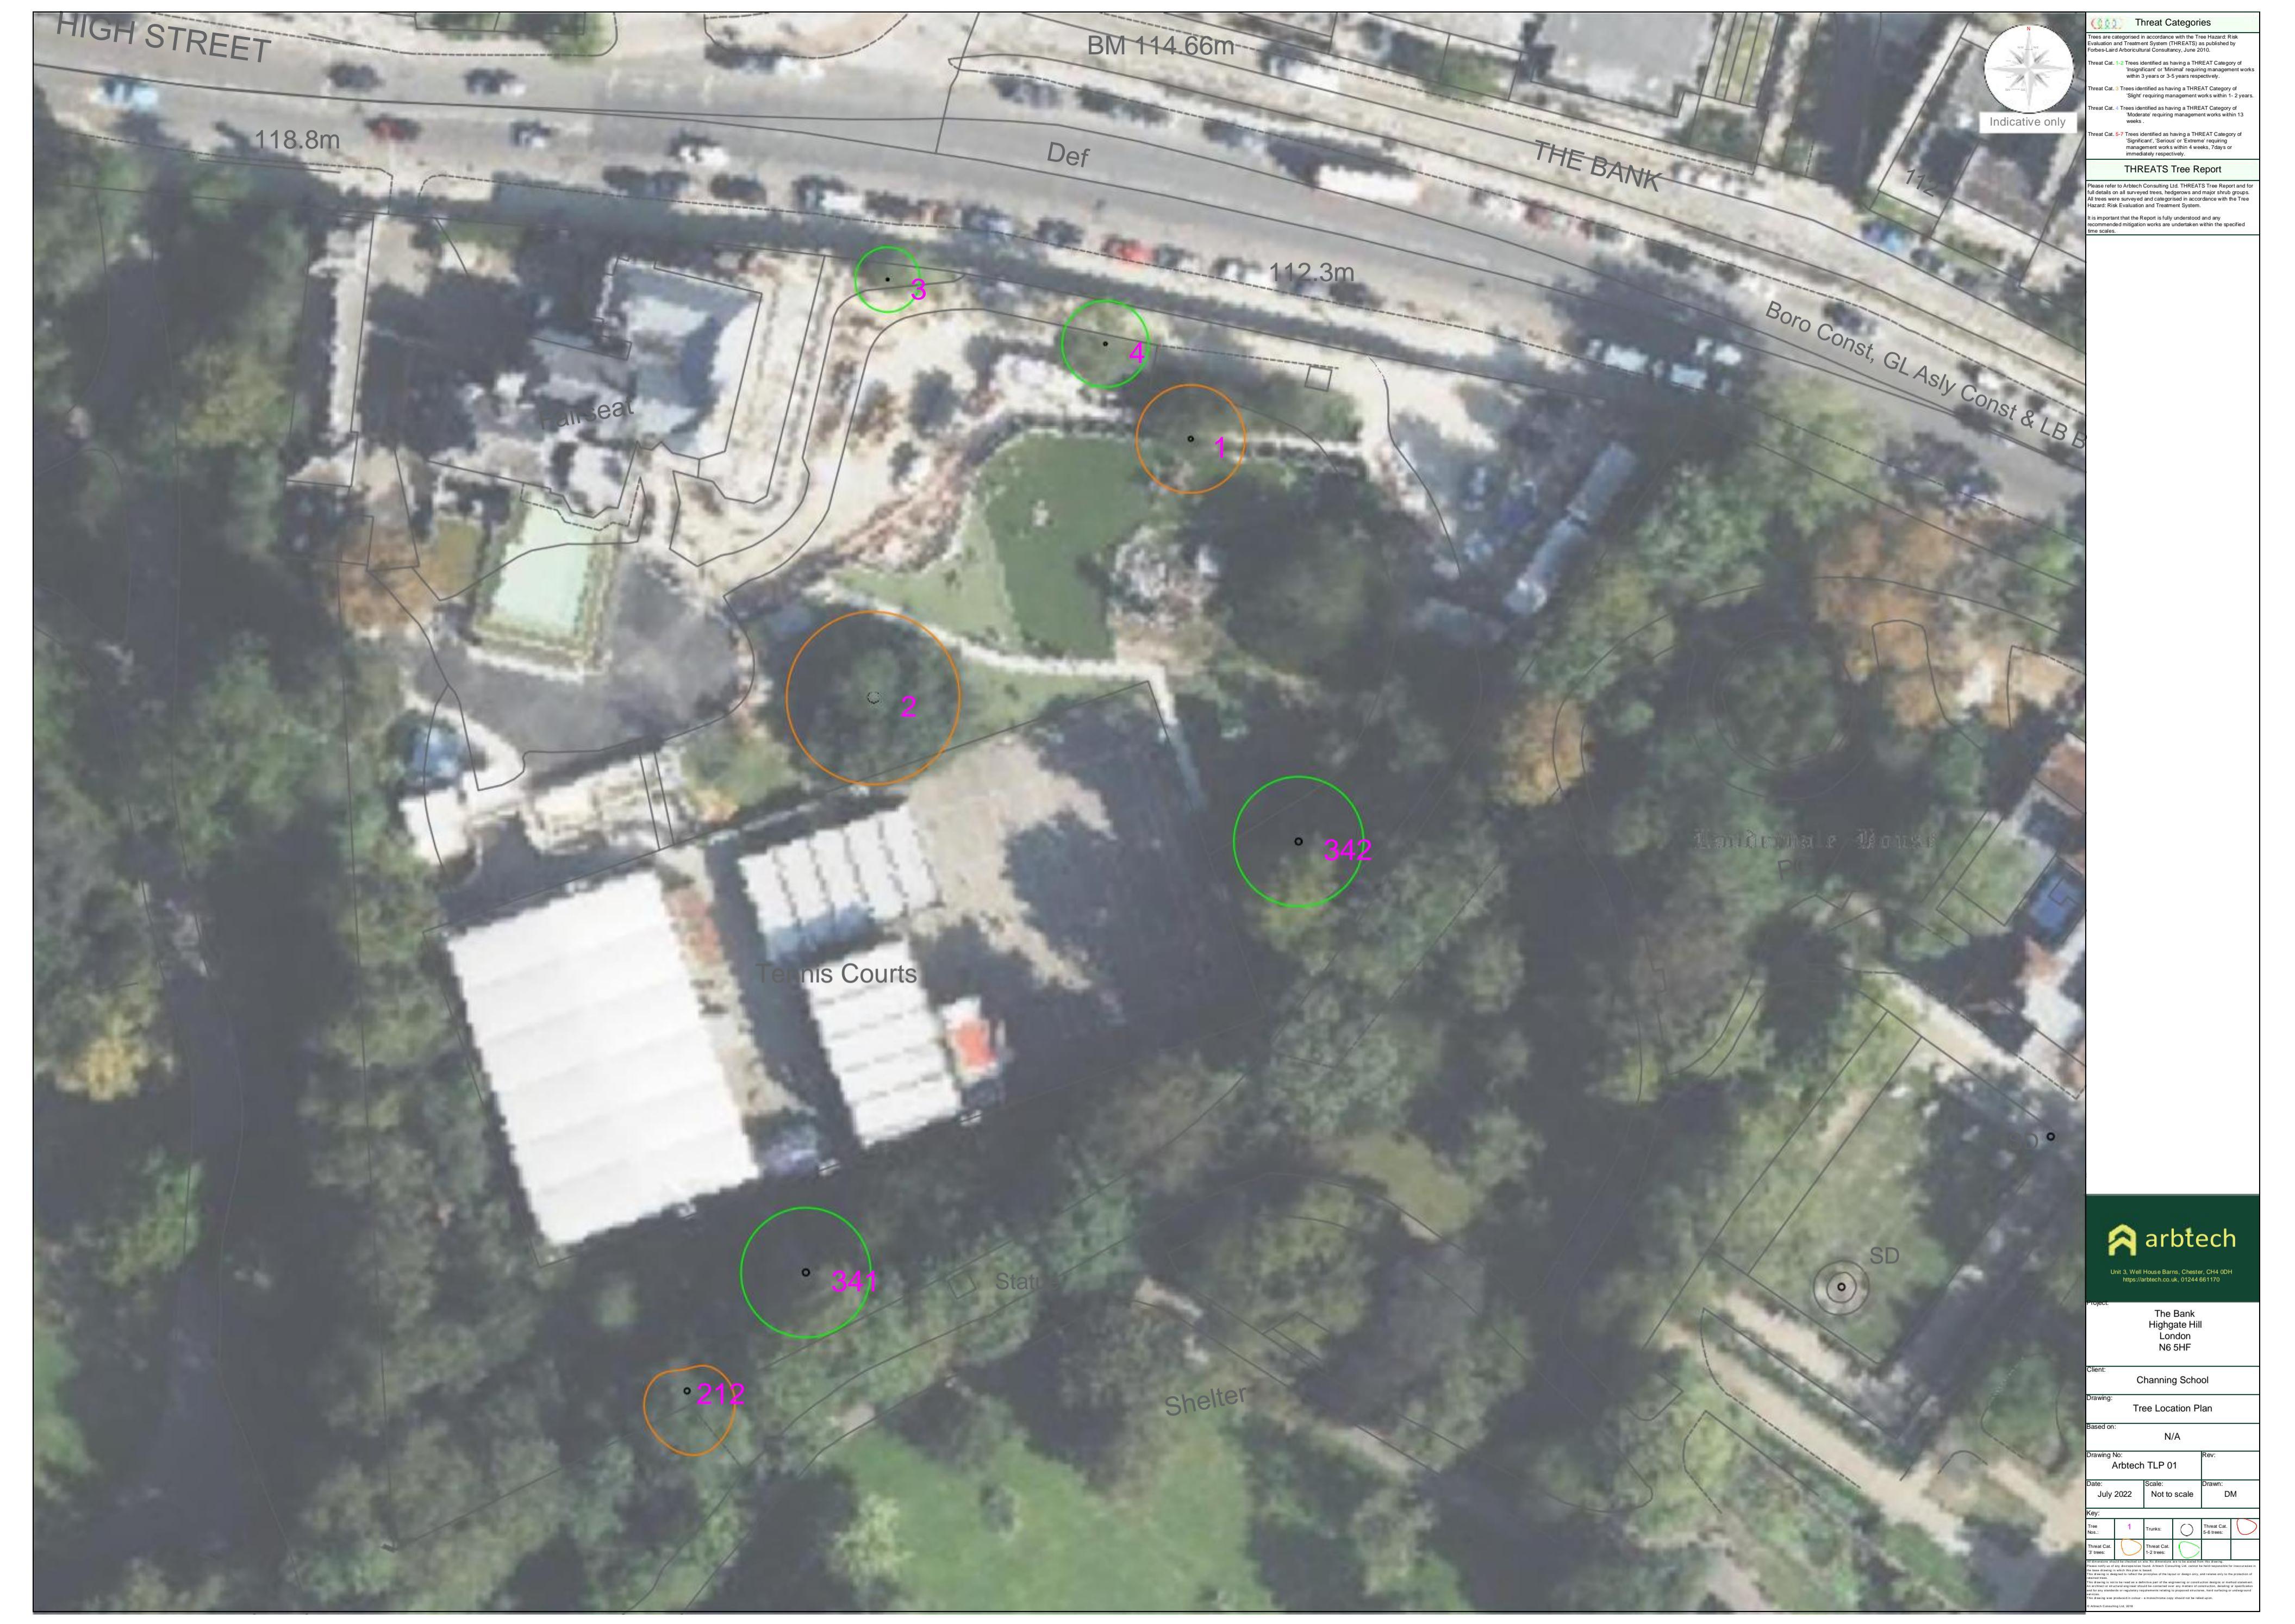
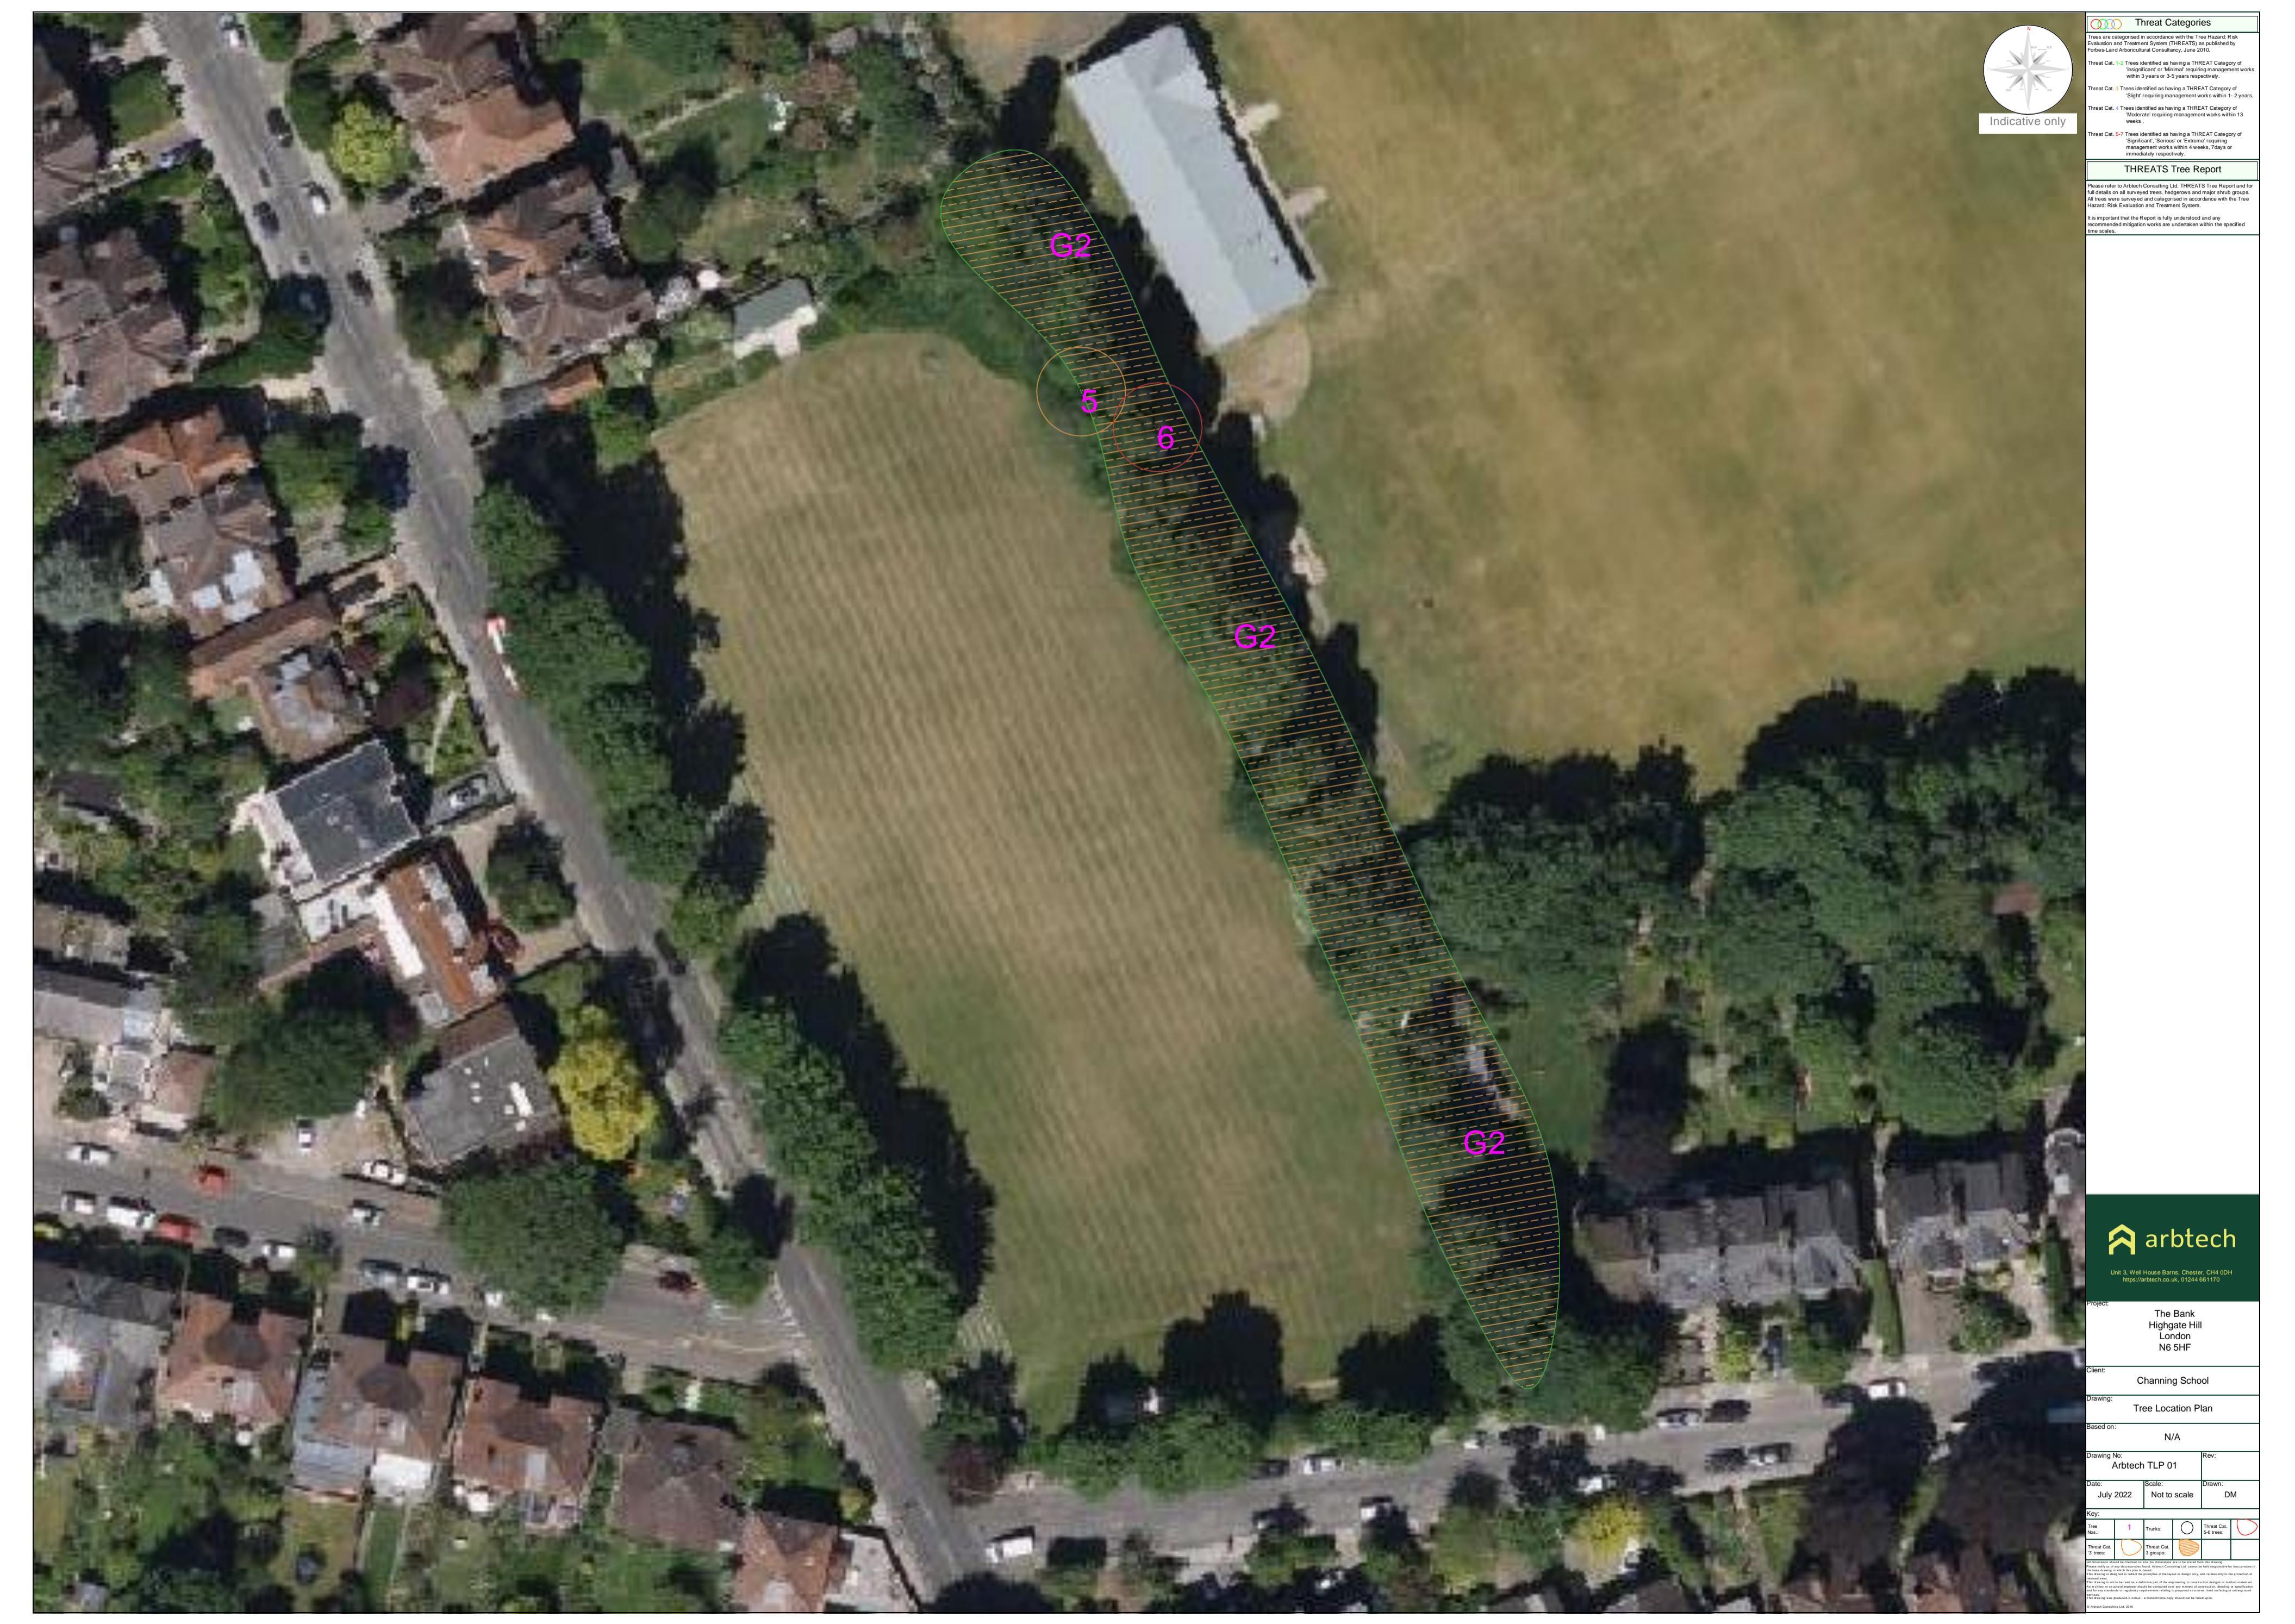
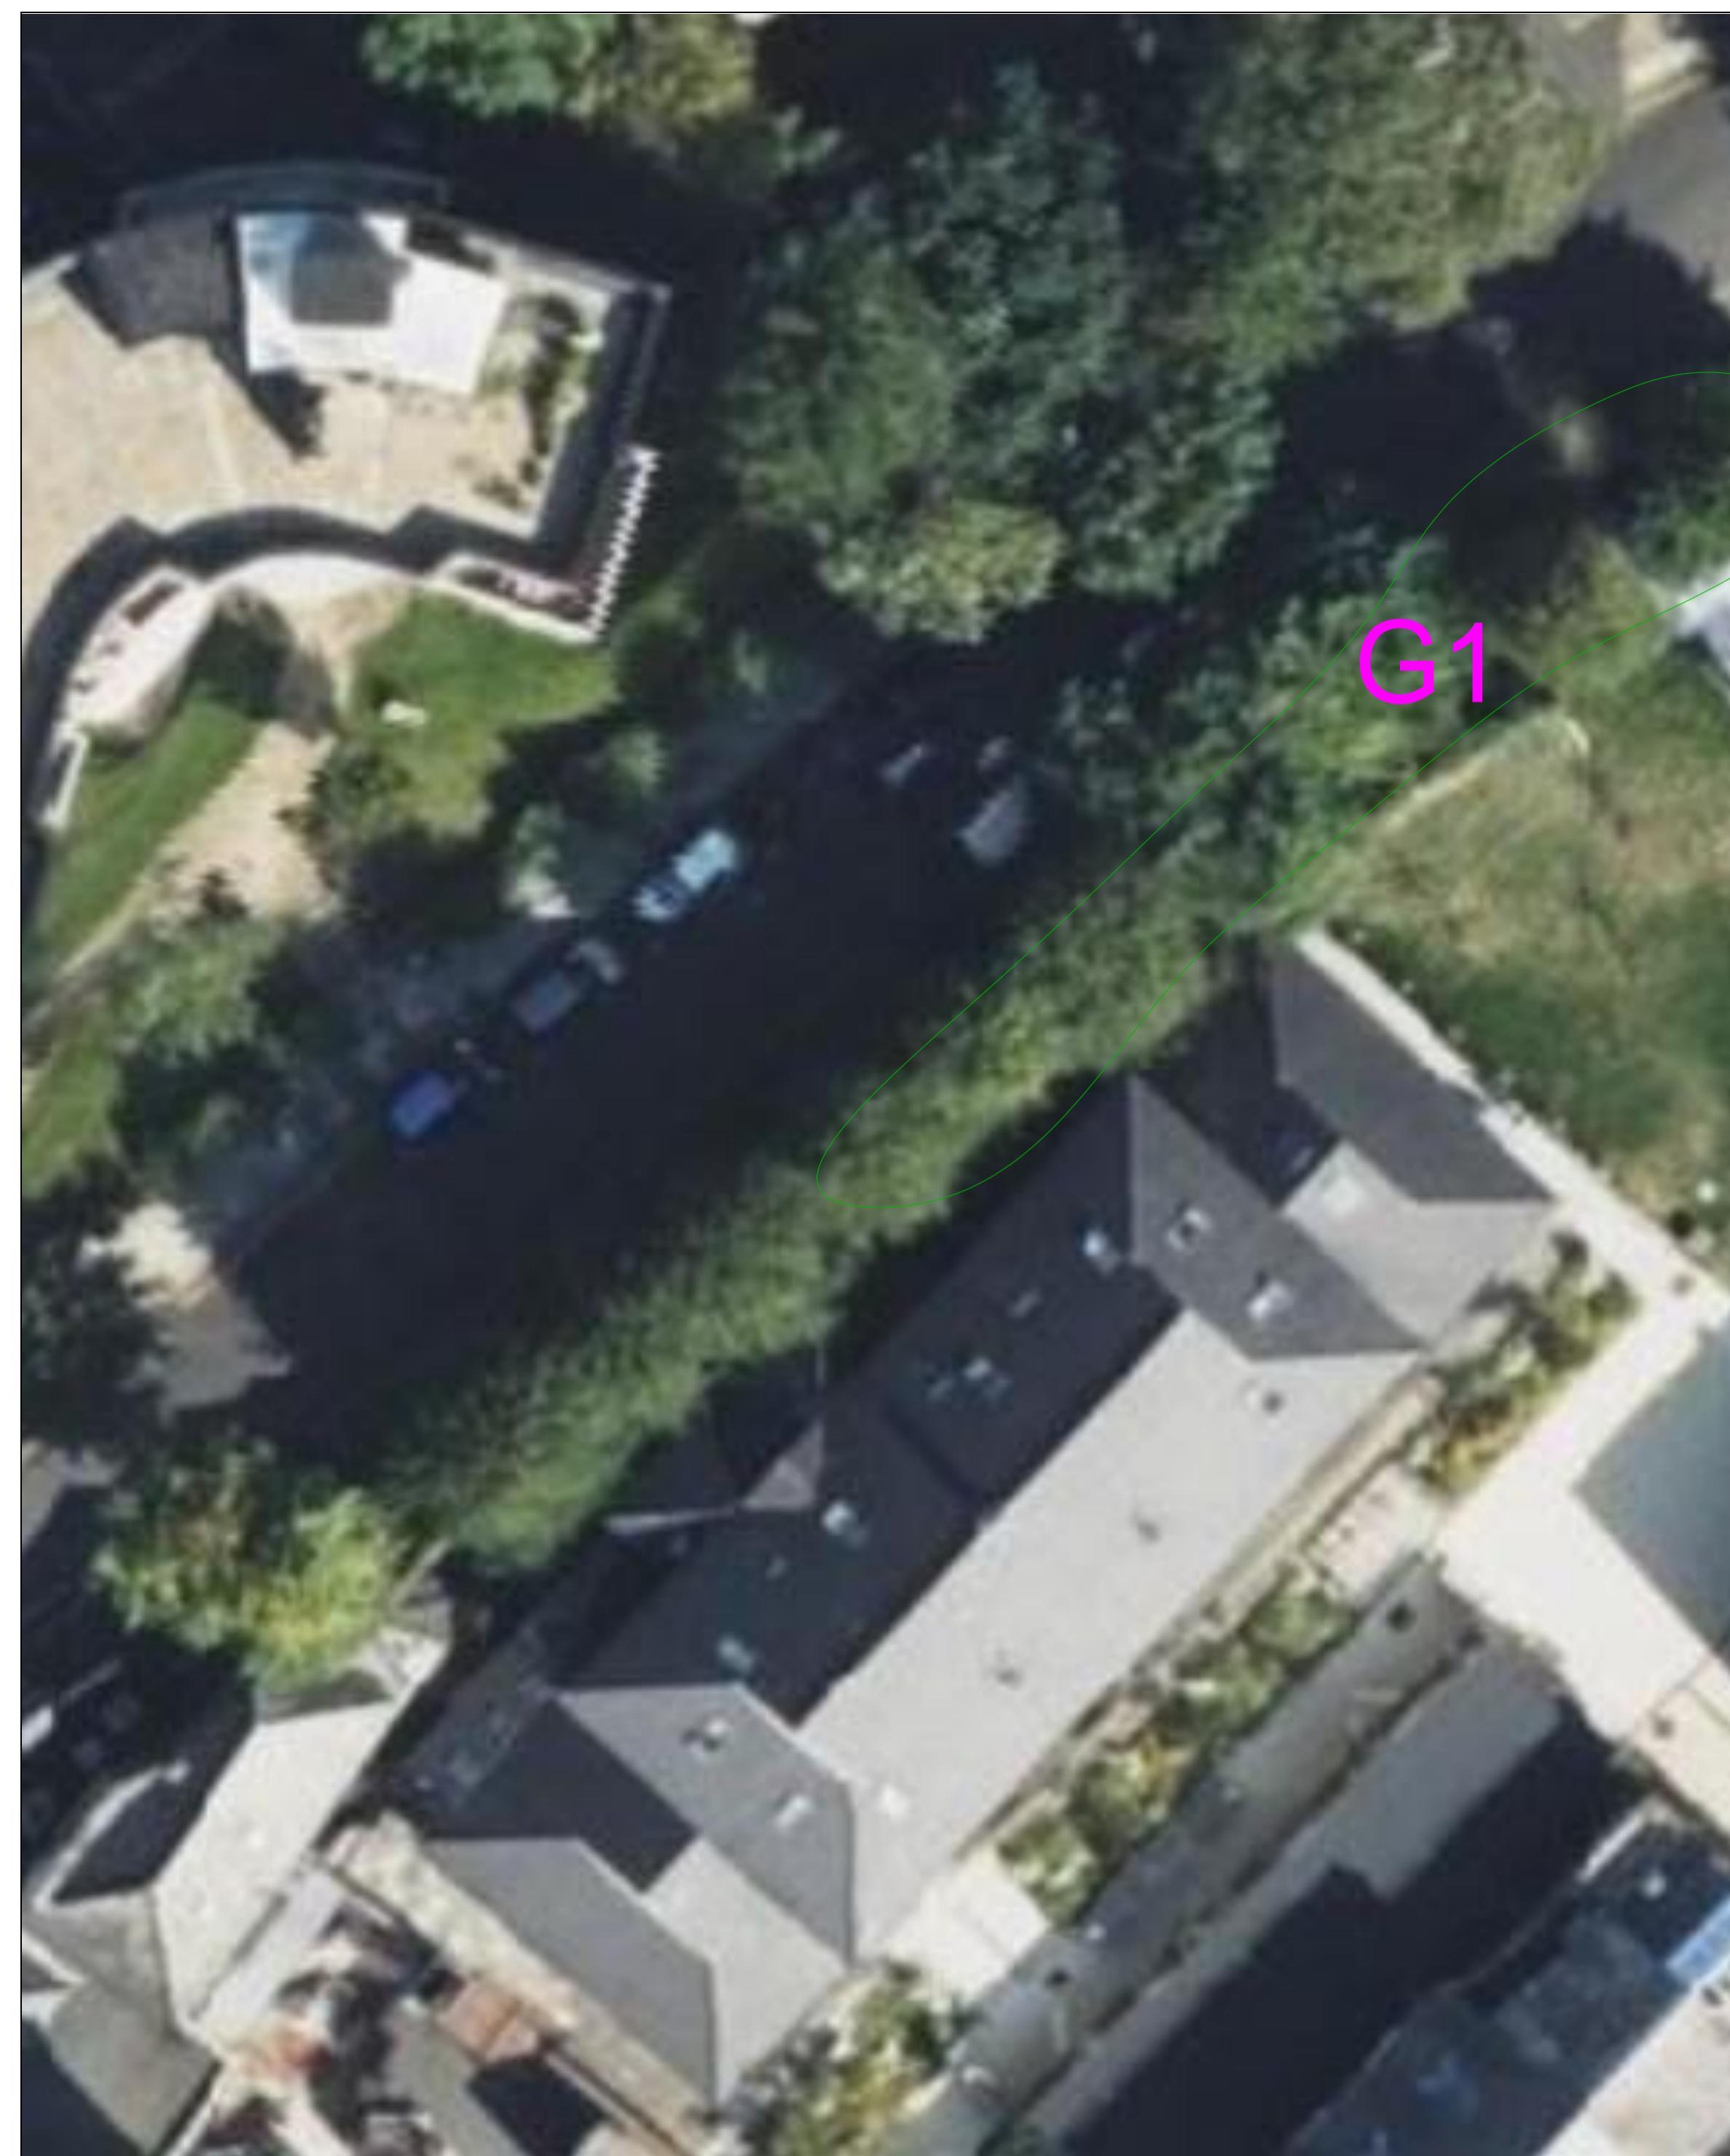
| | To Company | Threat Categories |
|--|--|--|
| | | Siight requiring management works within 1-2 years. Threat Cat. 4 Treesi identified as having a THREAT Category of Moderate' requiring management works within 13 weeks. |
| | | Threat Cat. 5-7 Trees identified as having a THREAT Category of Significant, Serious or Extreme requiring management works within 4 weeks, 7days or |
