Arboricultural Method Statement

Weeping Ash Oak Hill Park London NW3 7LP

July 2024

240628-PD-15a

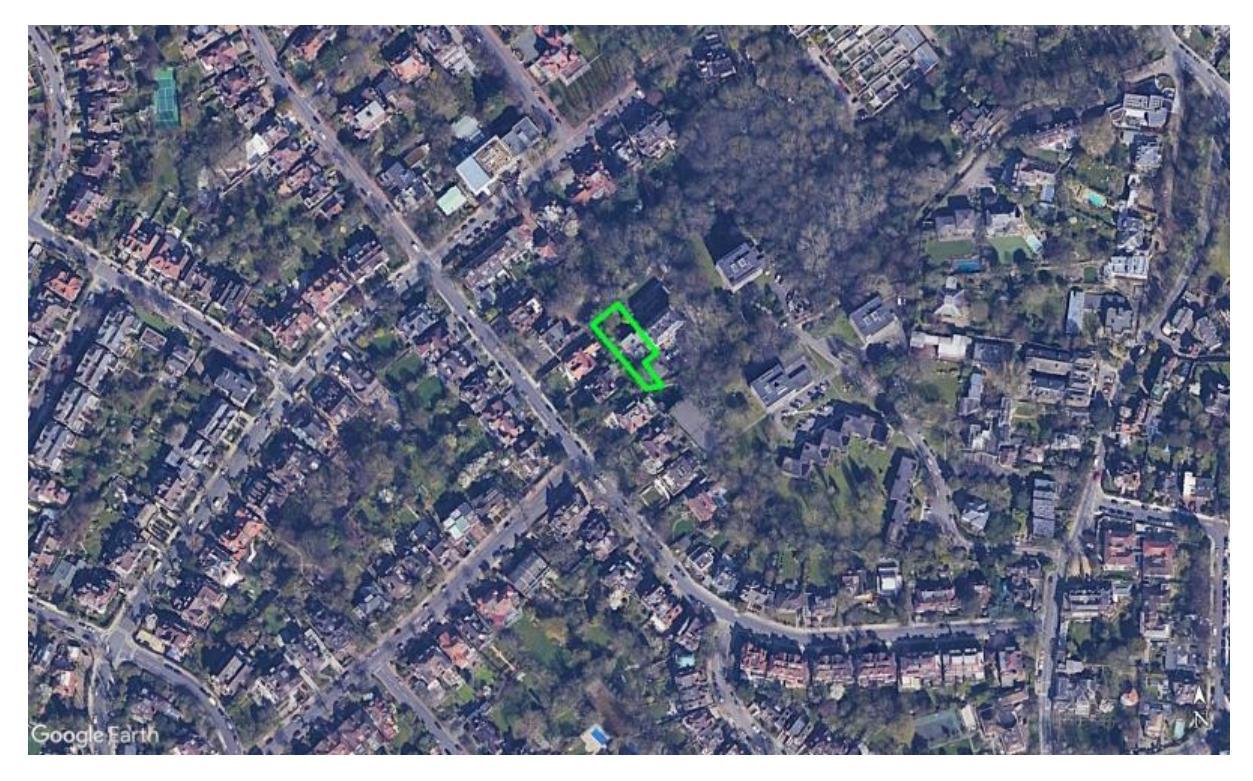
Figure 1: Showing the area discussed in this AMS within the green line and sourced from Google Earth (note: this is not the red line plan of the Site).

1.1 This Arboricultural Method Statement ('the AMS') has been instructed by Rula Theocharis Interiors ('the Client'), in order to discharge Condition 6 of the Householder Application 2024/0465/P ('the Planning Permission'), with regard to tree protection matters at Weeping Ash ('the Site' - see Figure 1).

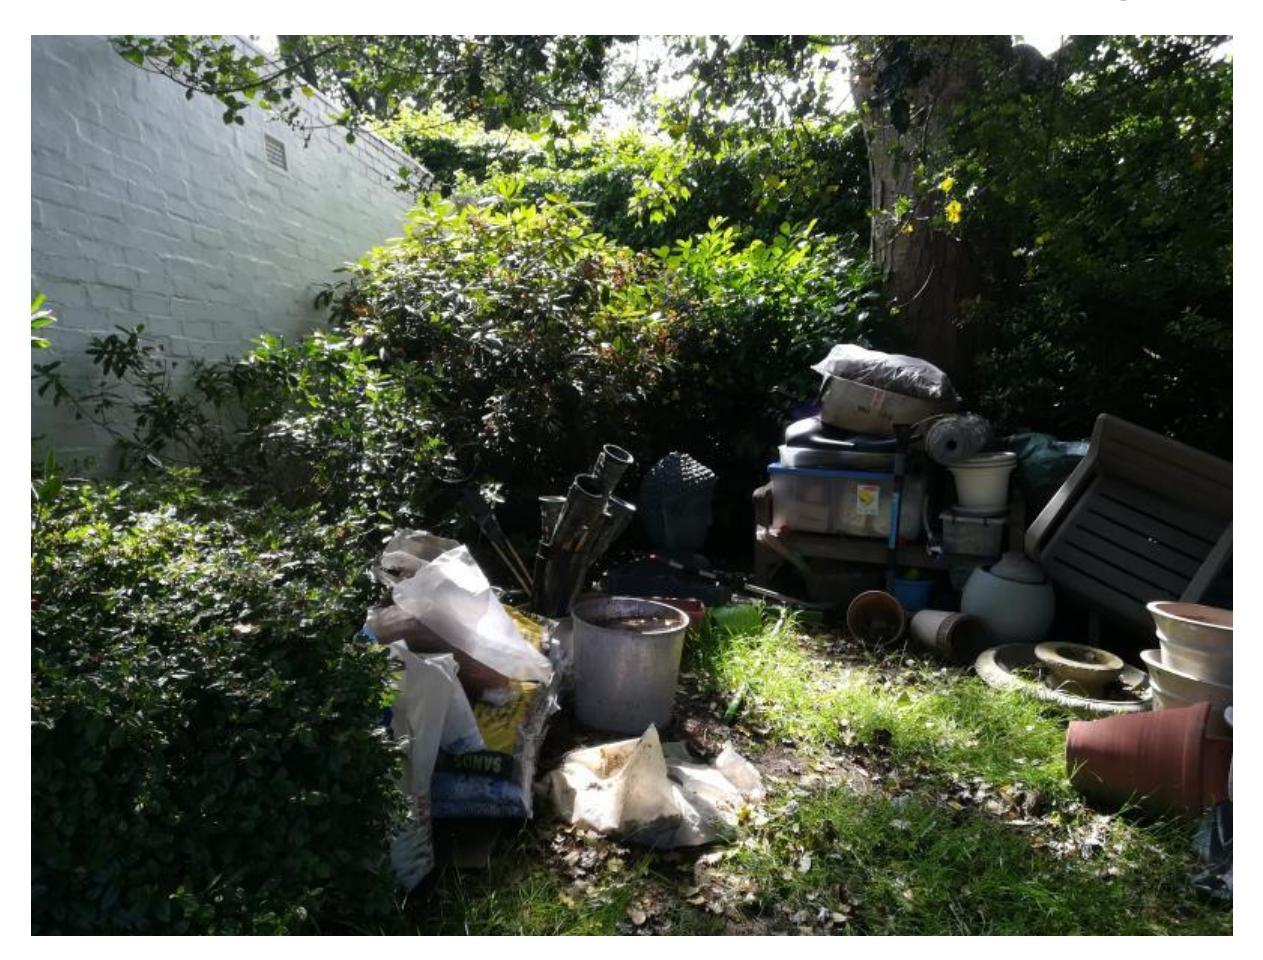
Figure 2: Looking south-east along the rear of the garage building (front left), showing T1 (front right) as a point of reference in relation to the general position of the acoustic enclosure (i.e., to the front left where the shrubs are located - see also Figure 4).

- 1.2 For clarity, the Planning Permission is formally described as follows: "*Installation of external plant within an acoustic enclosure*"; this enclosure is situated at the southern end of the Site behind the adjacent garage block (see *Figure 2 & Figure 4*).
- 1.3 Furthermore, the wording of Condition 6 is as follows: "Prior to the commencement of any works on site, details demonstrating how trees to be retained shall be protected during construction work shall be submitted to and approved by the local planning authority in writing. Such details shall follow guidelines and standards set out in BS5837:2012 "Trees in Relation to Construction". All trees on the site, or parts of trees growing from adjoining sites, unless shown on the permitted drawings as being removed, shall be retained and protected from damage in accordance with the approved protection details."

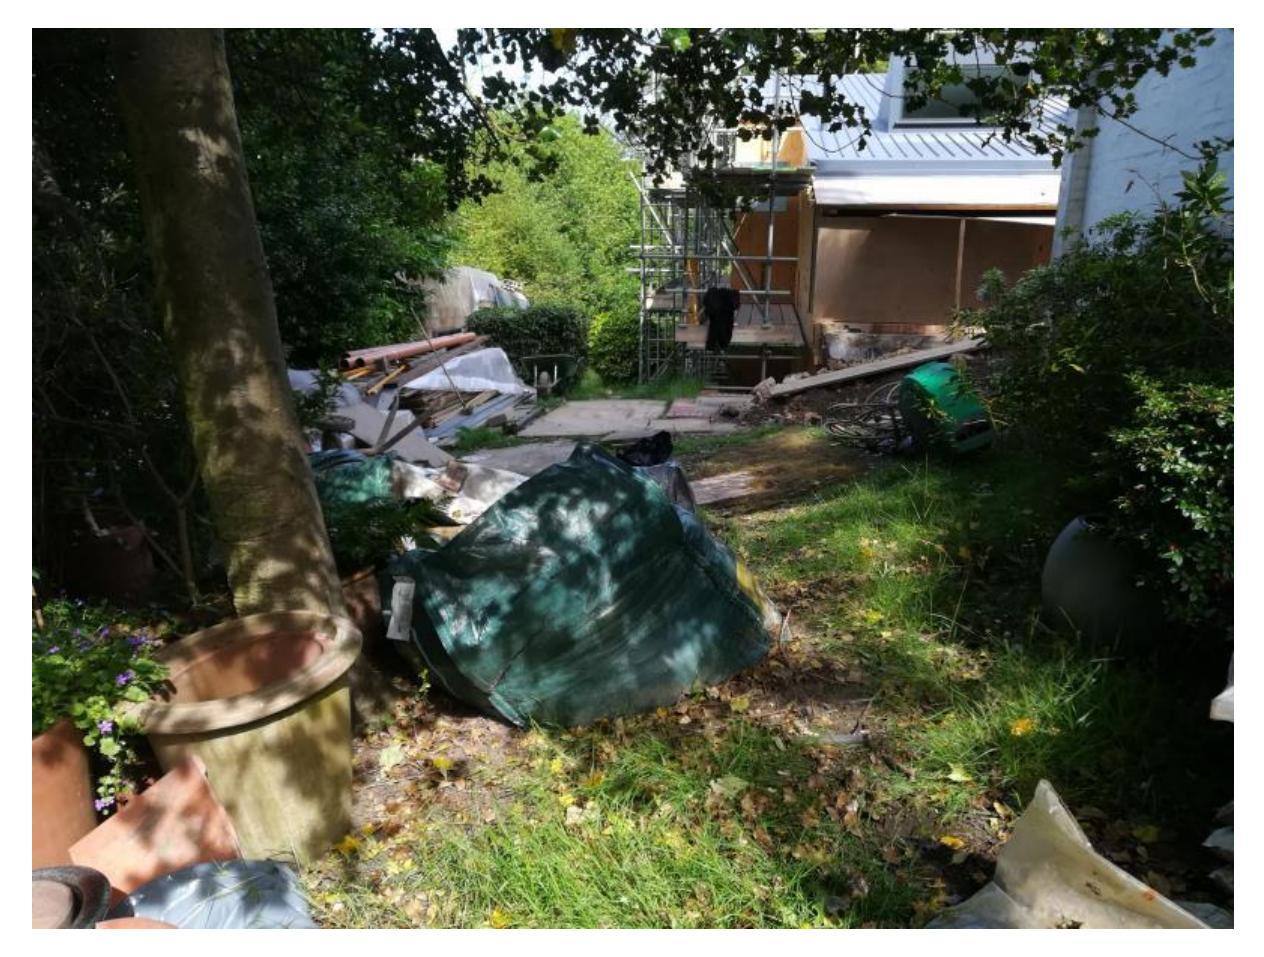
Figure 3: Looing north-west towards the main dwellinghouse (far right) showing the works that are being implemented, showing T2 (front left) as a point of reference within the southern garden area used for the storage of garden materials (that are also visible in Figure 2).

1.4 In addition, works are currently ongoing at the Site to implement various other Householder Applications (see Figure 3) - this is understood to include the following, which all relate to works to the existing dwellinghouse and garage building: 2023/4272/P, 2023/5055/P, and 2023/5001/P. There is no further reference to these other 3no. planning details within this AMS, though they are noted here for completeness as works to implement this Planning Permission may coincide with works to implement these other permissions.

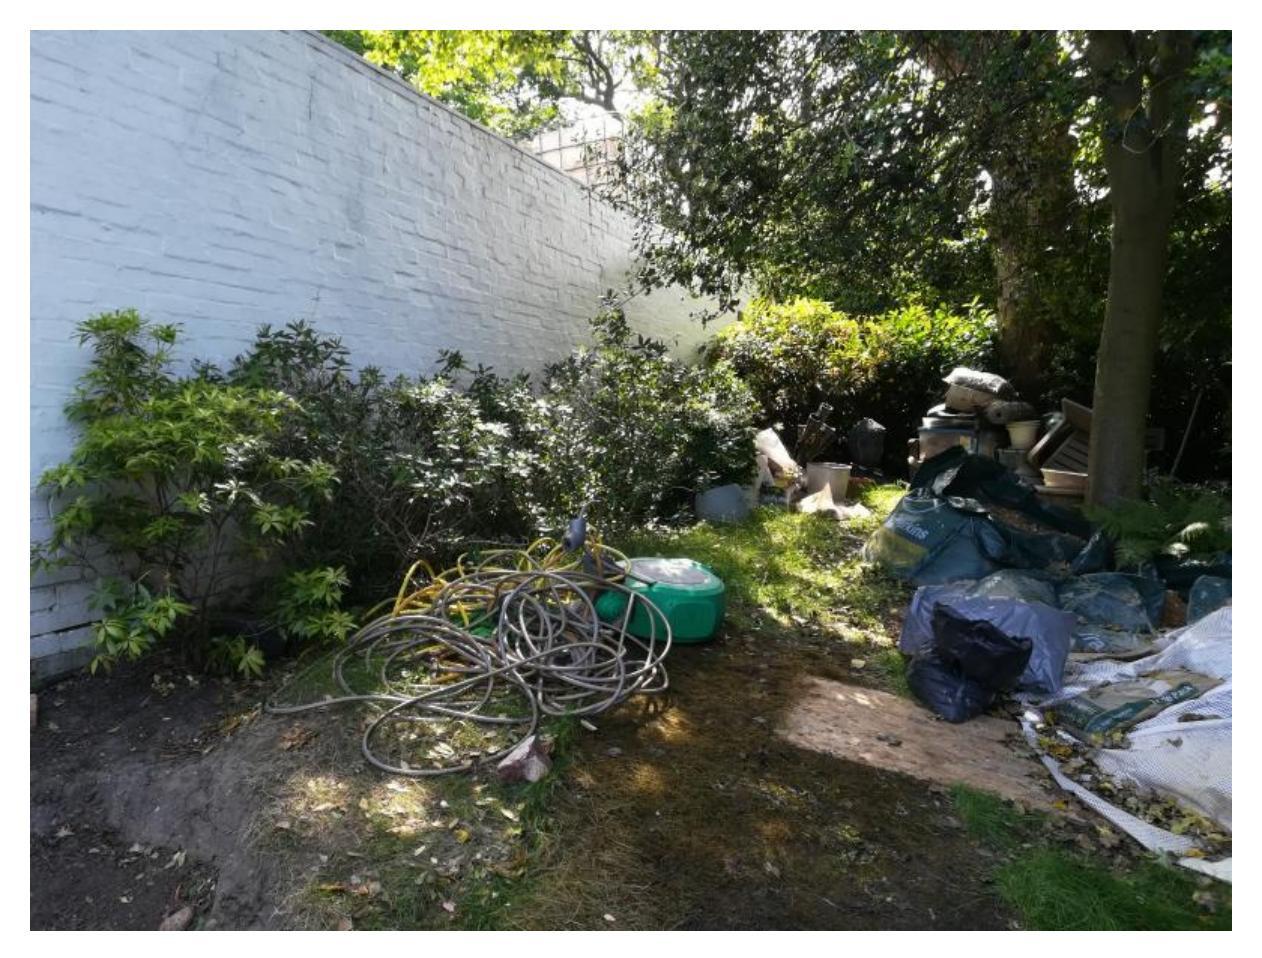
Figure 4: Looking south-east towards the area for the acoustic enclosure (front left), in relation to T1 (far right) and T2 (front right).

- 6.1 The process of implementing the Planning Permission will include the necessary removal of some of the shrubs within the affected area of the Site (see *Figure 4*). This work will be completed in adherence to the following performance principles, in order to ensure that the adjacent trees are suitably protected:
 - all operations will be completed manually;
 - the management of the stump elements of the shrubs will include careful removal that avoids any disturbance to the surrounding soil (beyond that which is directly necessary to remove the stumps); and
 - any holes or depressions in the soil following stump removal works will be filled in with topsoil to establish a consistent ground level (onto which the acoustic enclosure will be formed).

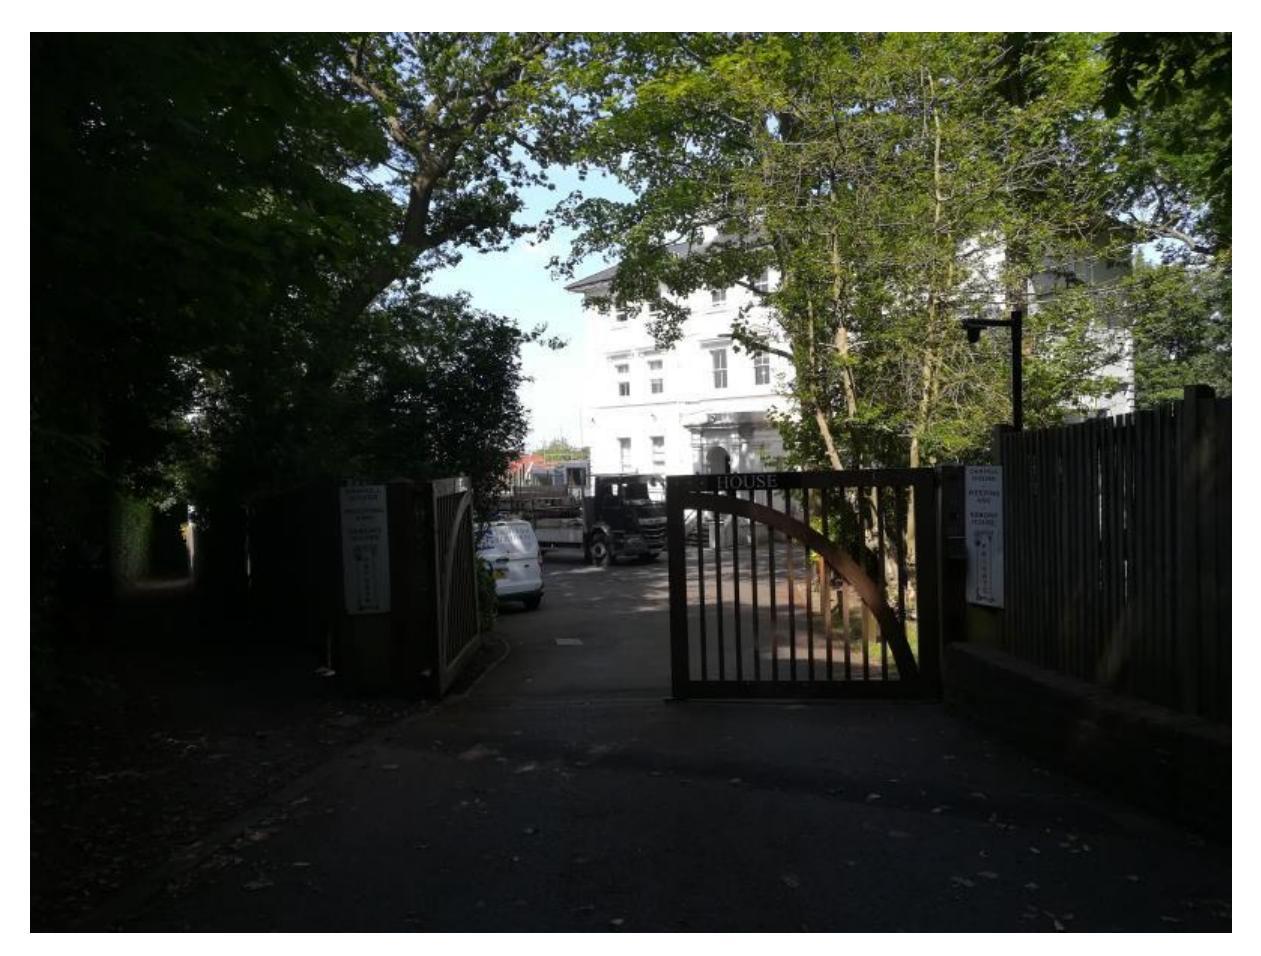
Figure 5: Looking north-west into the front courtyard area of the Site and the adjacent larger building, showing the vehicular access point from Oak Hill Park.

- 5.1 The existing means of access into and out of the Site will be used, throughout the process of works specifically, this includes access via the main gate with parking and material storage in the main drive area (see *Figure 5 & Figure 6*), and the subsequent movement of pedestrian-only traffic into the area of the Site that is affected by the Planning Permission.
- 5.2 The compound area for the works to implement the Planning Permission will be located either in the front courtyard area, the existing garages (as is currently the case for the works ongoing), or within the main dwellinghouse - the garden area of the Site will not be used as a compound.

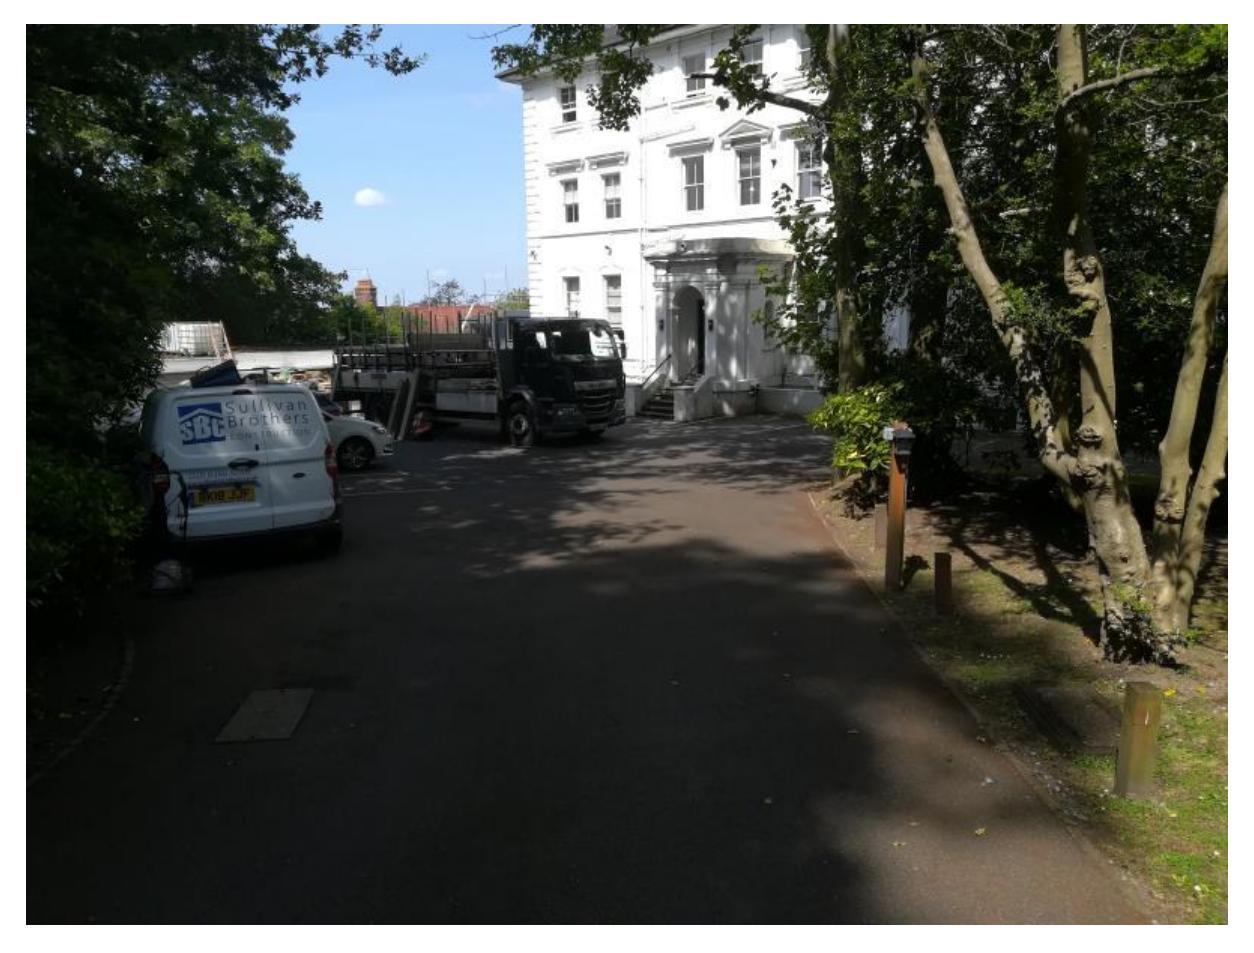
Figure 6: Looking north-west into the front courtyard area where car parking and material storage will occur, showing T1 (far left) as a point of reference.

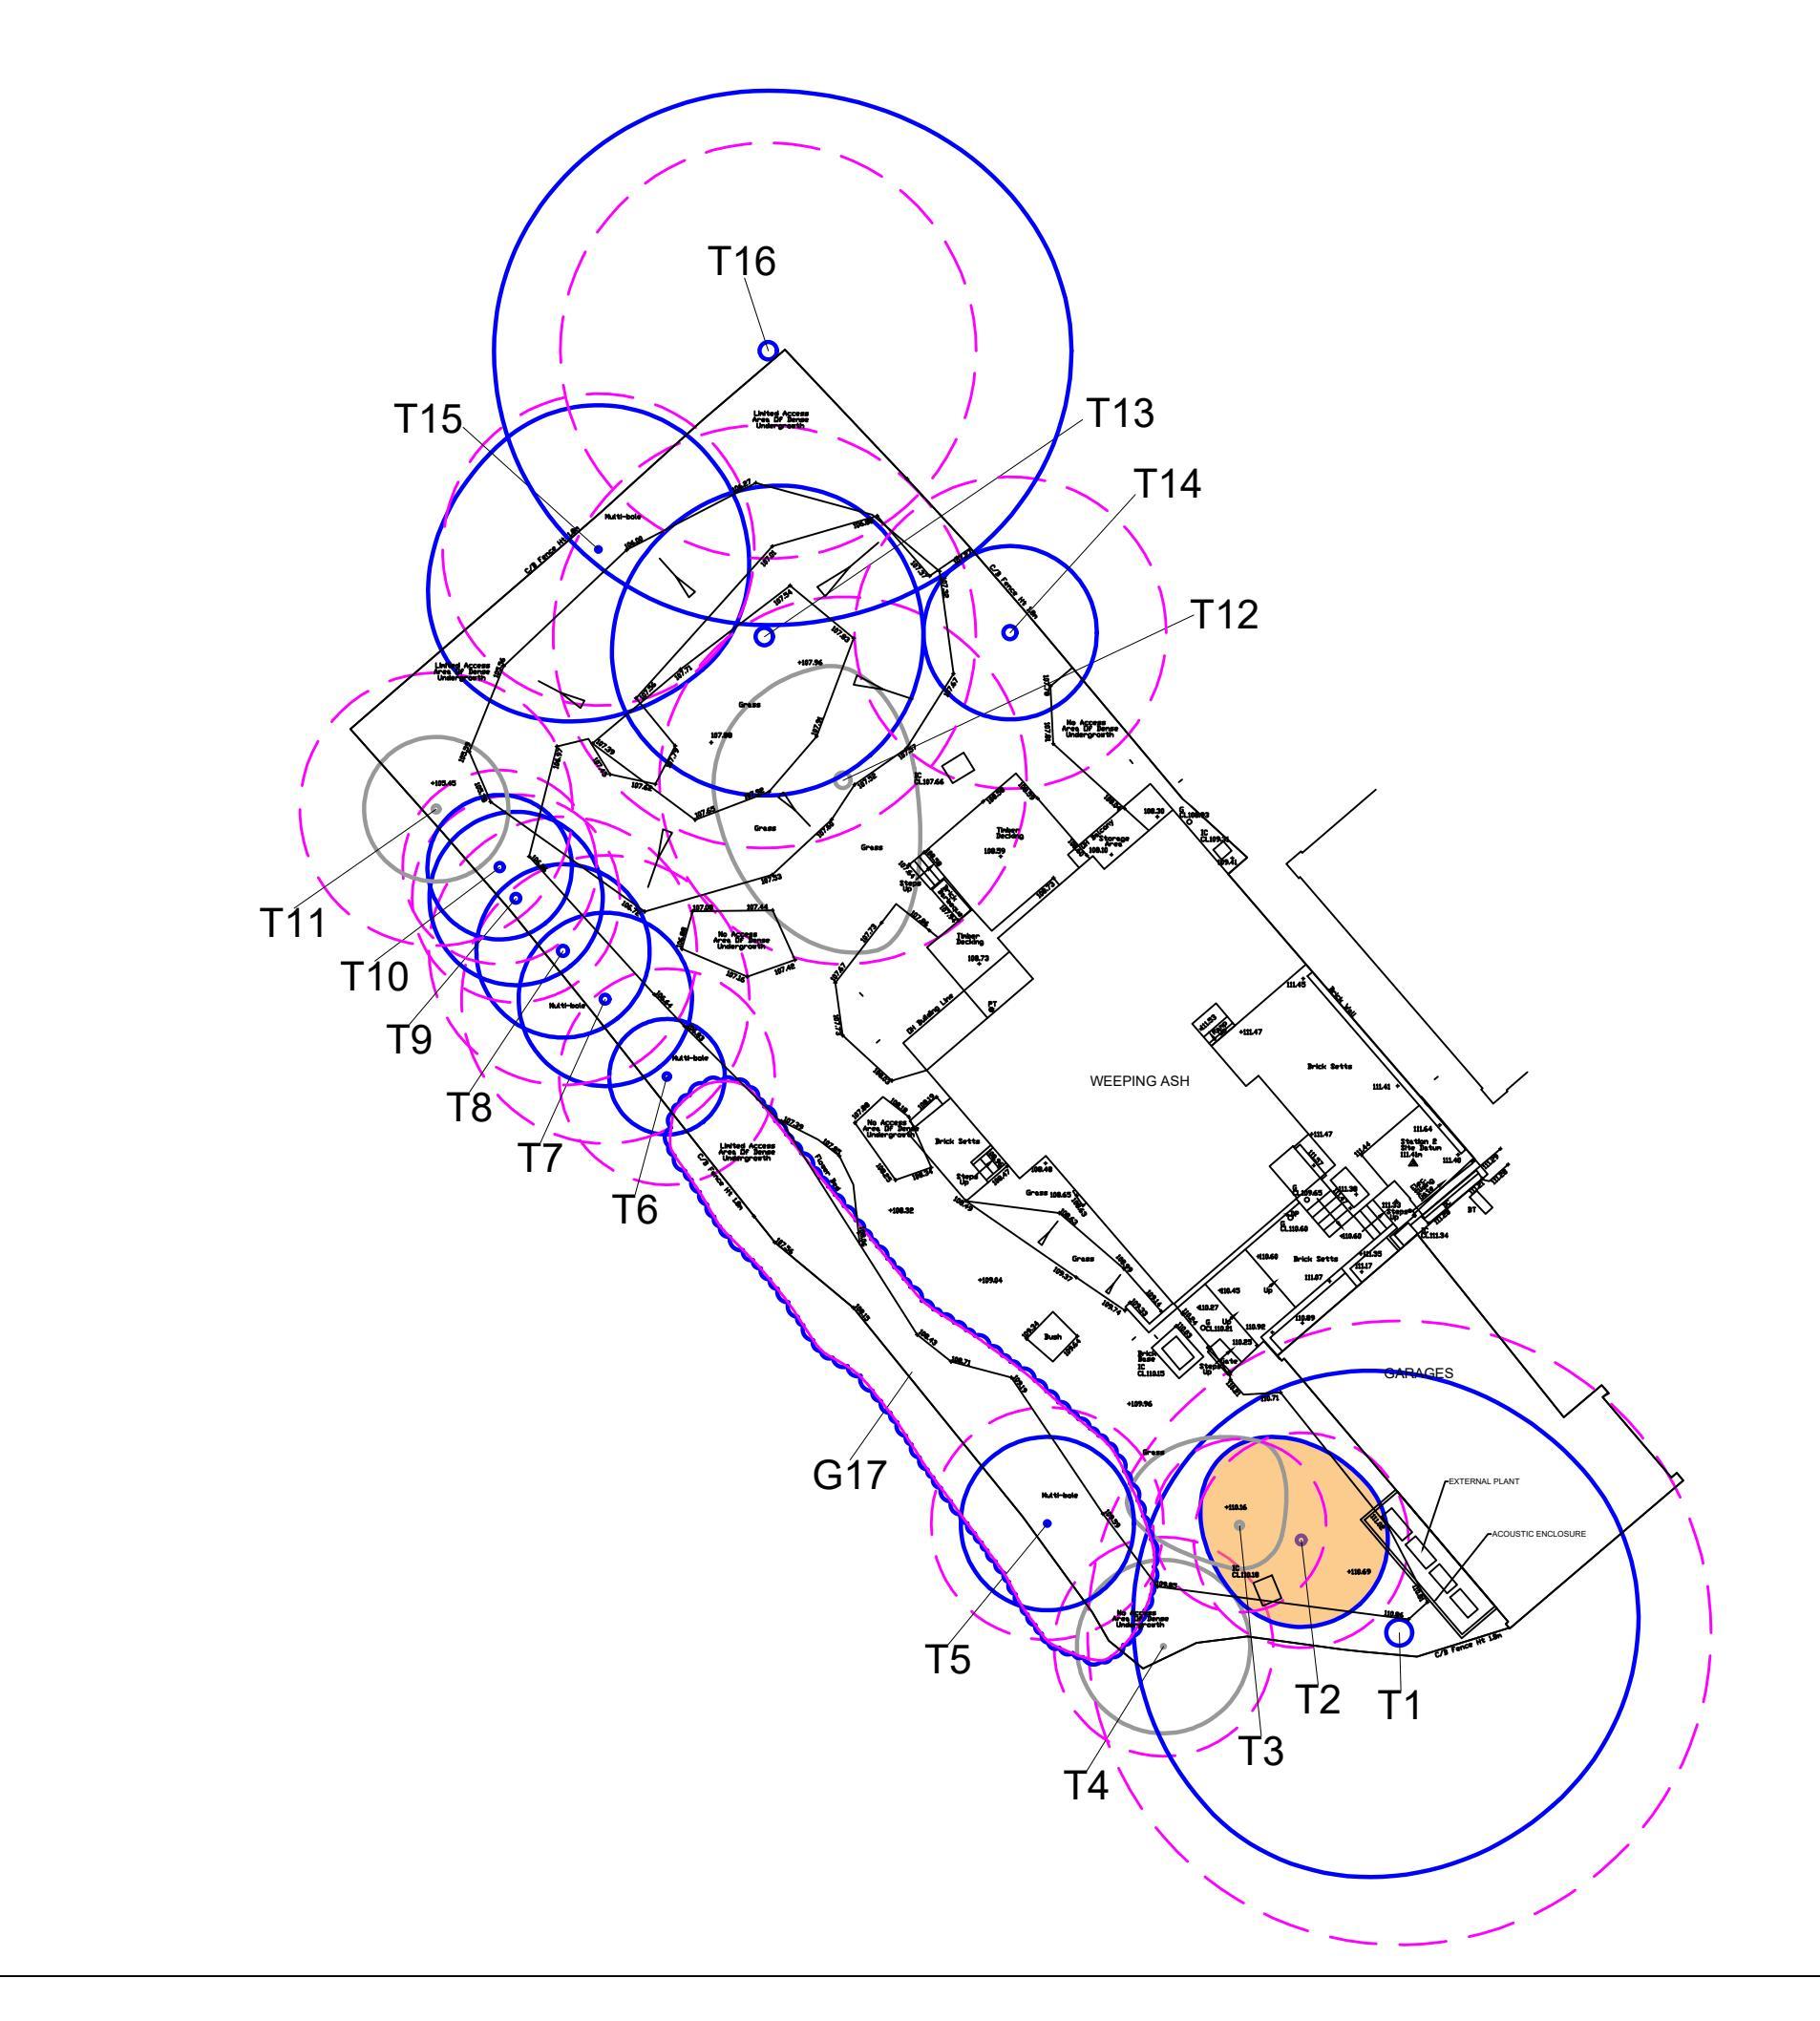
Drawing No Rev 240628-P-12 -
tmo

Canopy spread (m)
Unique tree identification number Root Protection Area (RPA)
G2 Unique group identification number Root Protection Area (RPA)
Categord A Trees and groups of high quality with an estimated remaining life expectancy of at least 40 years.
Category B Trees and groups of moderate quality with an estimated remaining life expectancy of at least 20 years.
Category C Trees and groups of low quality with an estimated remaining life expectancy of at least (0 years or young trees with a stem diameter below 150mm.
Contercore U Those in such a condition that the tree cannot realistically be relatived as living trees in the context of the current land use for longer that 10 years.
B55637 Root Protection Areas Precautionary areas within which tree roots and soil structure must be protected. All works within these areas will require special methods of work.
The crown of this tree that overhangs the acoustic enclosure will be lifted to establish a clearance from ground level of 3.5m.

The layout of the Site is not reflected exactly by the topographical survey; there are ongoing development works to the main dwellinghouse. However, the tree locations and the garage structure are considered to be reflective of the current Site conditions, based on the topographical details provided.
· · · ·
rev date description drawn by Base Drawing:GIC-015
Title Proposed Layout and Tree Works Plan
Client Rula Theocharis Interiors
Project Weeping Ash, Oak Hill Park, London, NW3 7LP
DateDrawn byAuthorisedScale24/06/2024HRCW1:250@A3

3.1 With regard to tree works specified within this AMS, this affects only T2 (a mature holly) to the following extent: *Establish a crown clearance of 3.5m from the existing ground level, in the area of the acoustic enclosure (i.e., above its footprint)*. The works to remove the shrubs to the immediate rear of the garage building are discussed from paragraph 6.1, in the context of tree protection.

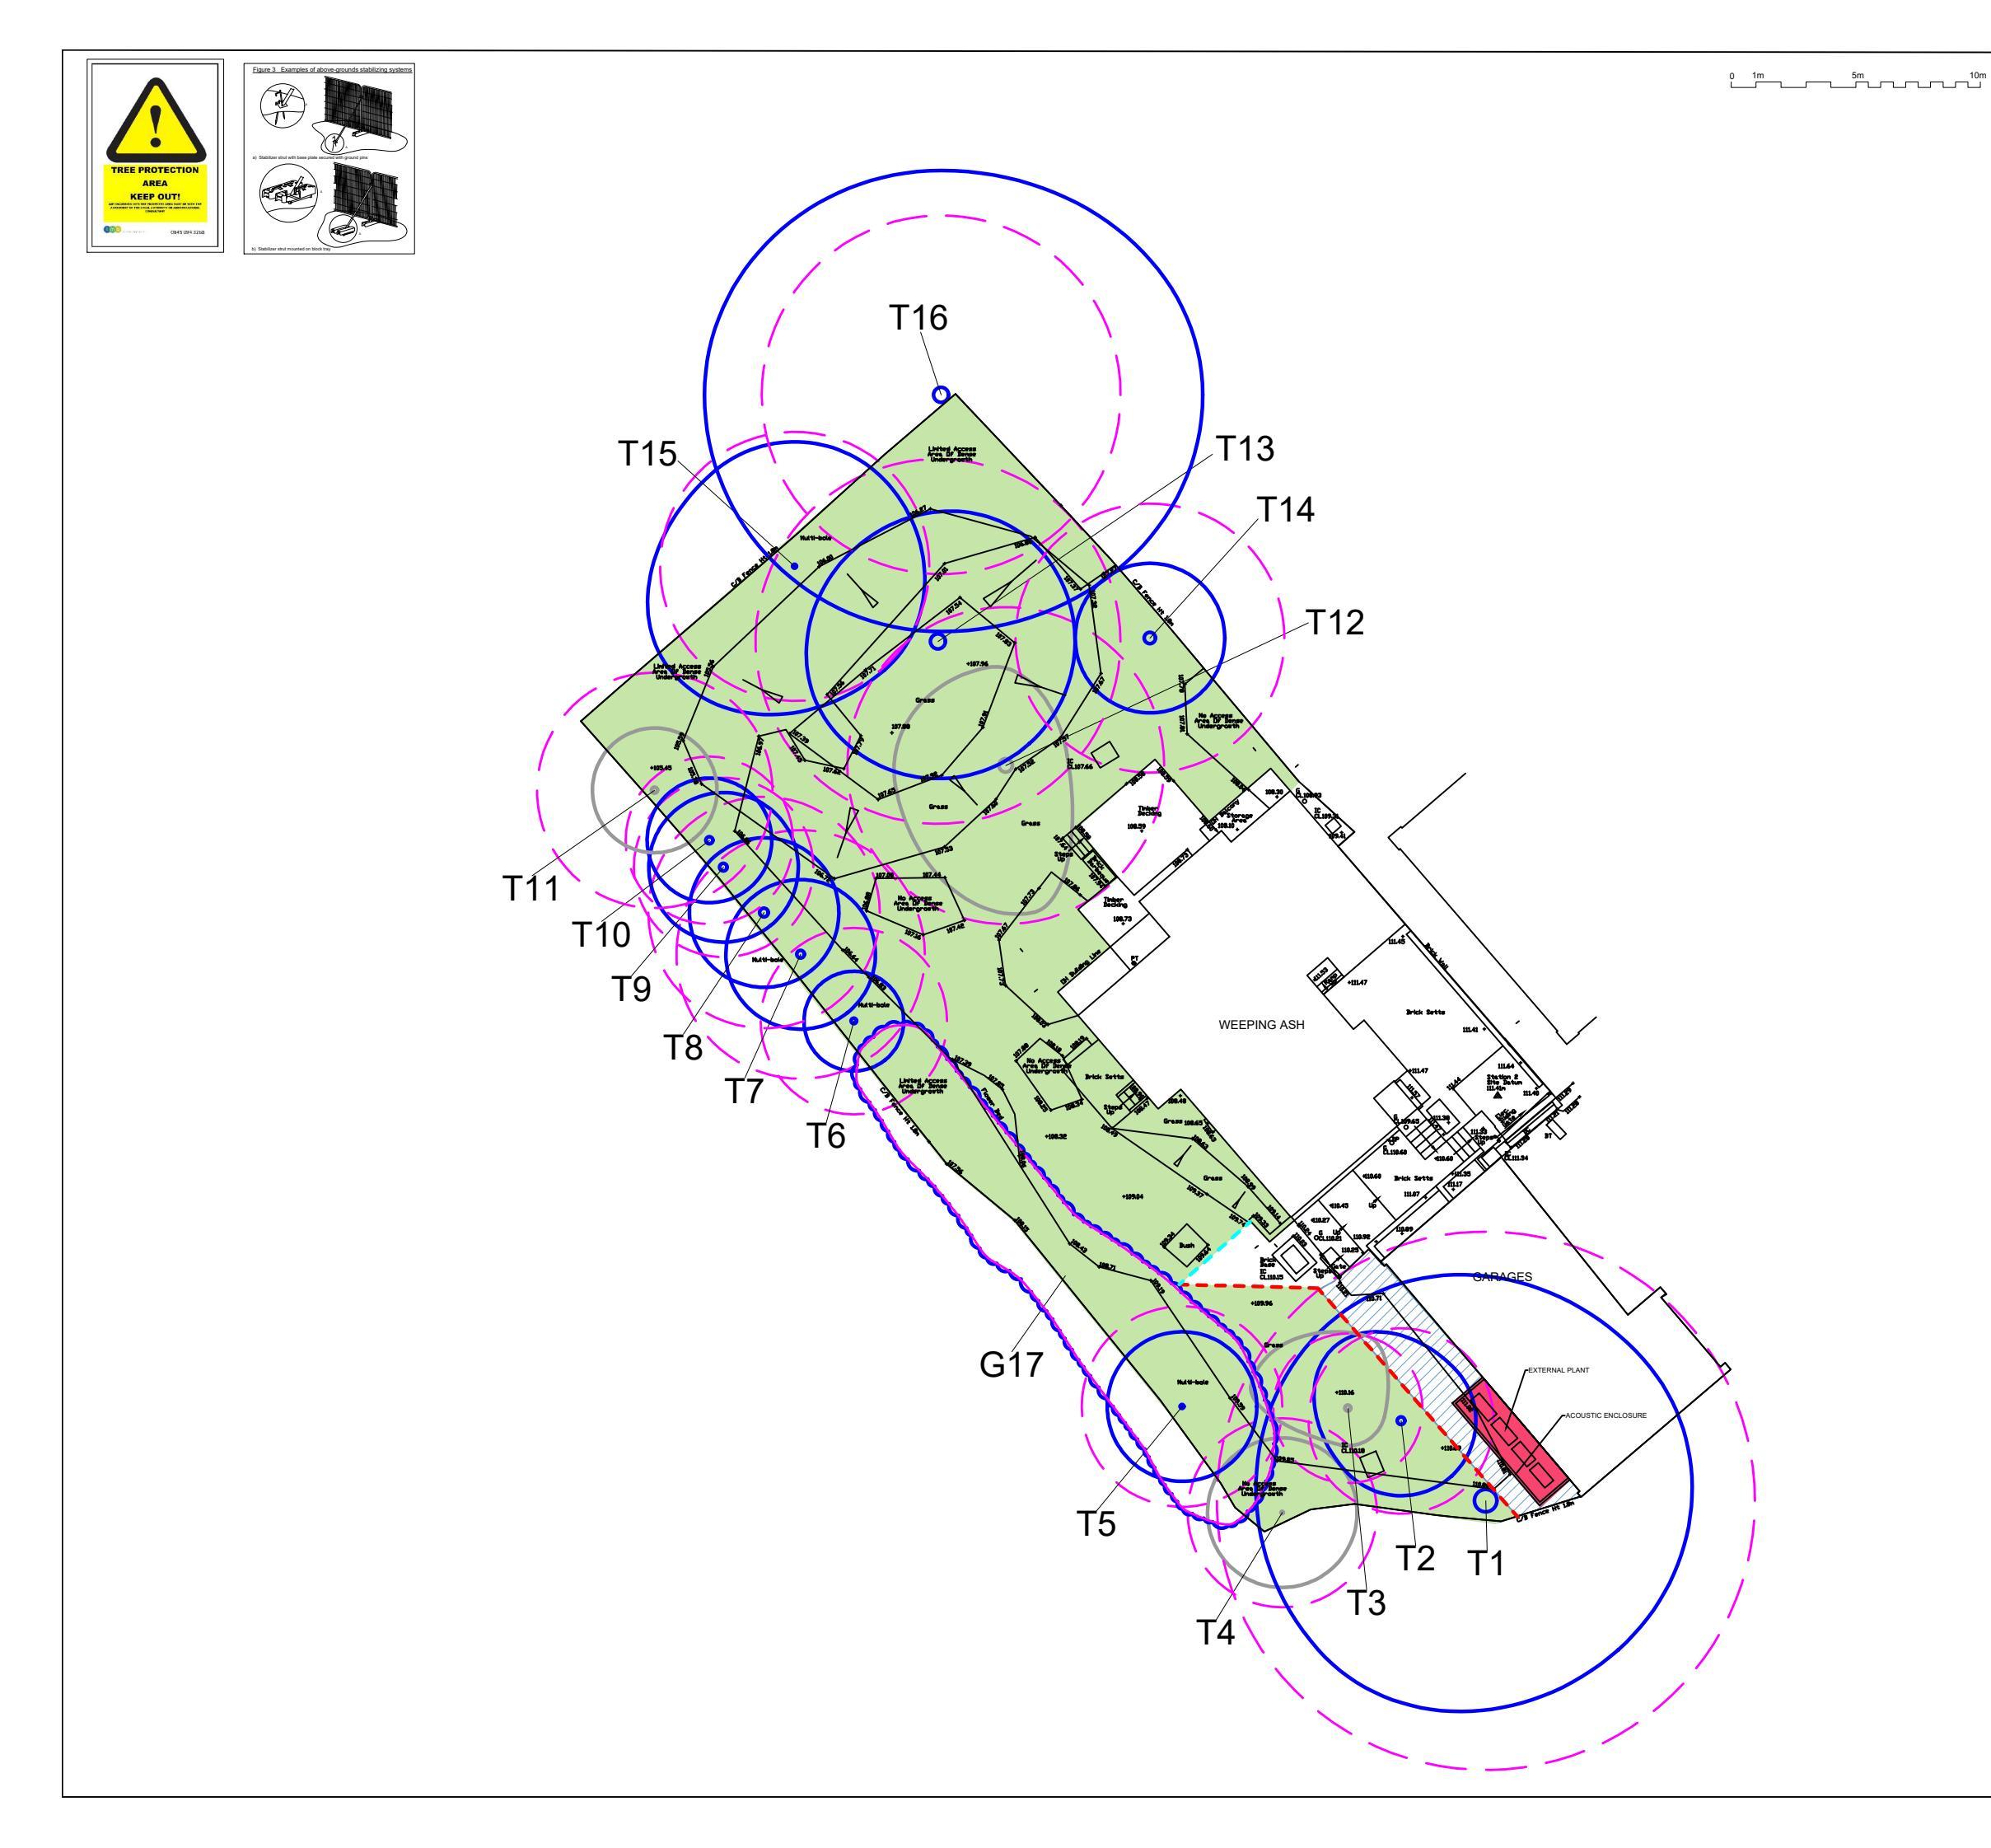
BS 5837:2012 TREE RETENTION CATEGORIES opy spread (m) NORTH 1 ee Sterr we tree identification number rotection Area (RPA) canopy extents shown in their retrospectiv que group identification number oot Protection Area (RPA) <u>Category A</u> Trees and groups of high quality with an estimated remaining life expectancy of at least 40 years. • egory <u>B</u> es and groups of mod at 20 vears. uality with an estimated remaining life expectancy of a • Category C Trees and groups of low quality with an estimated remaining life expectancy of at leas 10 years or young trees with a stem diameter below 150mm. . $\frac{Category \, U}{Those in such a condition that the tree cannot realistically be retained as living trees in the context of the current land use for longer that 10 years.$ BS5837 Root Protection Areas Precautionary areas within which tree roots and soil structure must be protected. All Position of barrier protection. Barriers to be installed prior to the commencement of any other works associated with implementing the Planning Permission and otherwise to the specifications outlined within the Arboricultural Method Statement to which this plan is appended. to access beyond this point of the Site, in the context of implementing the Planning Permission. All works to be contained within the front area of the Site. one into which no activities will occur, in the context of imple ociated with implementing the Planning Permissio tlined within the Arboricultural Method Statement usition of the acoustic enclosure. No excavations into the ground are to occur, to cilitate its construction. For further technical details, refer to the specifications ou thin the Arboricultural Method Statement to which this plan is appended. The layout of the Site is not reflected exactly by the topographical survey; there are ongoing development works to the main dwellinghouse. However, the tree locations and the garage structure are considered to be reflective of the current Site conditions, based on the topographical details provided. a 22.07.24 adjustments to TPP HR rev date description drawn by Base Drawing: GIC-015 Title Tree Protection Plan Client Rula Theocharis Interiors Project Weeping Ash, Oak Hill Park, London, NW3 7LP Date Drawn by Authorised Scale 24/06/2024 HR CW 1:250@A3 Drawing No Rev 240628-P-13 а

4.1 Barrier protection will be installed at the locations highlighted on the TPP at Appendix A and to the specification provided below. All barriers will be fit for the purpose of excluding construction activity and appropriate to the degree and proximity of work taking place around the retained trees. Barriers shall be maintained to ensure that they remain rigid and complete.

4.5 Ground protection will be installed at the locations highlighted on the TPP at Appendix A and to the specification provided below. All products utilised will be fit for the purpose of protecting the ground from direct damage and compaction, and shall be maintained to ensure that they remain unbroken.

4.6 Ground protection within the identified area on the TPP will be manually installed upon the existing ground level, immediately following the careful clearance of shrubs to the immediate rear of the existing garage building. This will comprise a single thickness of scaffold boards placed on top of a compression-resistant layer (i.e., 100 mm depth of woodchip) that is itself laid onto a geotextile membrane.
