1MCo3 Main Works – Contract Lot S1

HERITAGE AGREEMENT METHOD STATEMENT HAMS - MONITORING AND CONSERVATION MANAGEMENT OF GROUND MOVEMENT DUE TO BELOW GROUND CONSTRUCTION AT 22 PARK VILLAGE EAST - ADP-ESCT-02

Document no: 1MCo3-SCJ-EV-MST-SSo1_SLo3-000015

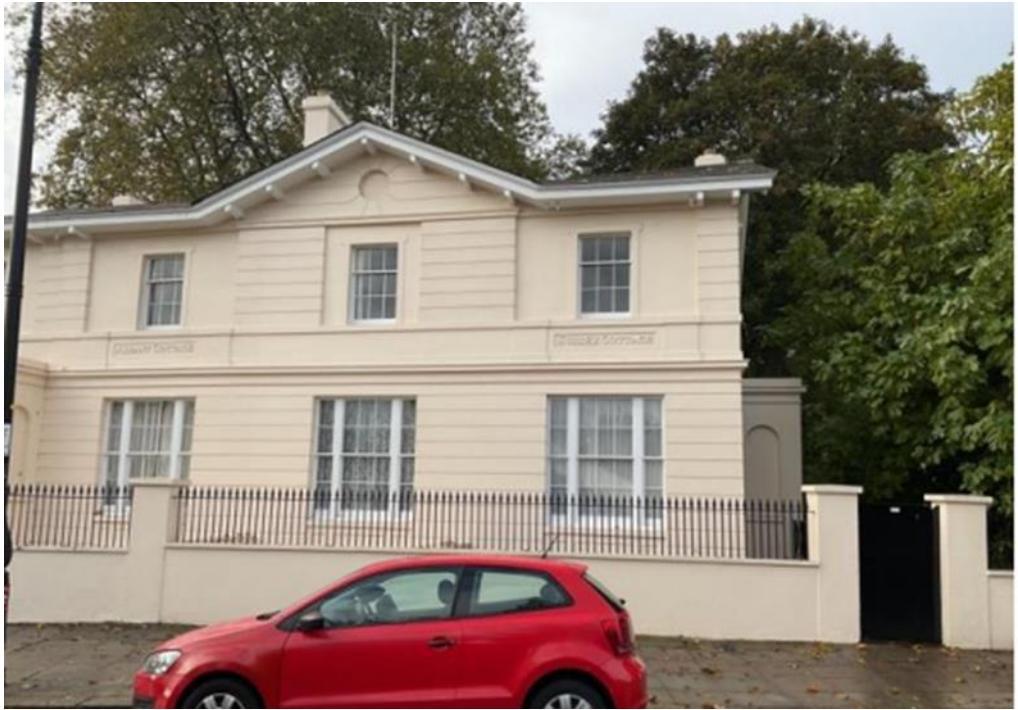
Figure 3 - 22 Park Village East side (north) elevation

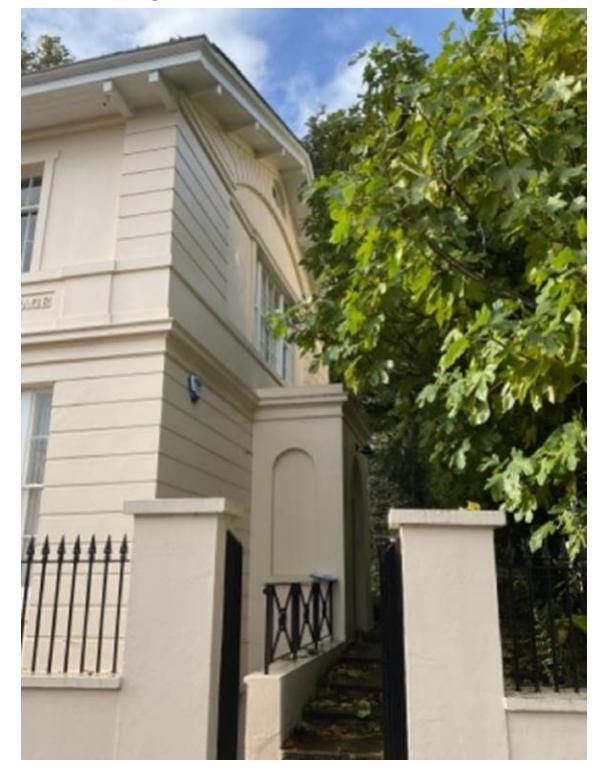
Figure 4 22 Park Village East Garden (west) elevation

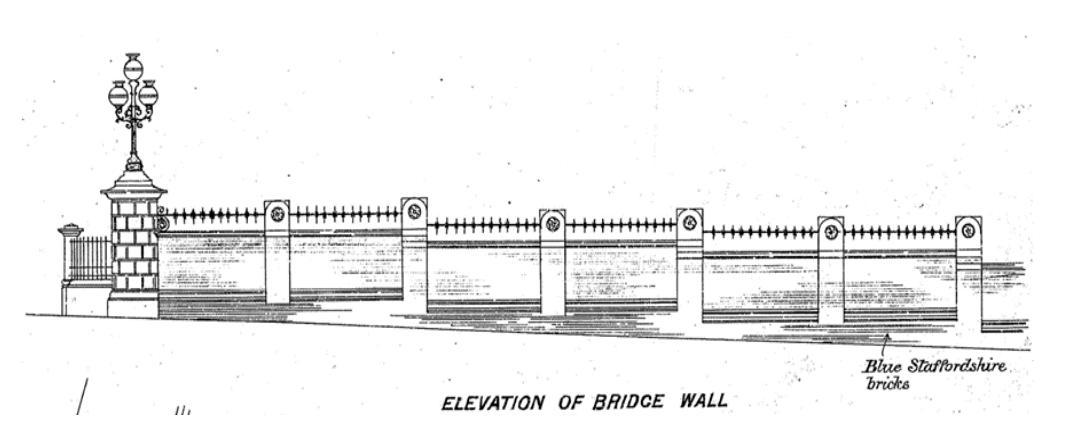
Figure 9 'L.&.N.W.R. EUSTON WIDENING Details of Boundary walls and Ironwork', 1900. (Source: Network Rail Archives)

BOUNDARY AND DWARF WALL TO PLANTATION (TWO CATES TO EACH PLANTATION)

4.2.8 The new 60 m wide 17m deep cutting was supported by monumental brick retaining walls that employ closely spaced shallow buttresses, carried up to form piers with decorative ball finial stone caps at street level. Architectural design aesthetics match the quality and refinement of Stephenson's older work but use blue engineering brick instead of the earlier red stock brick; does not rely on the curved batter for structural integrity; and at street level replaces

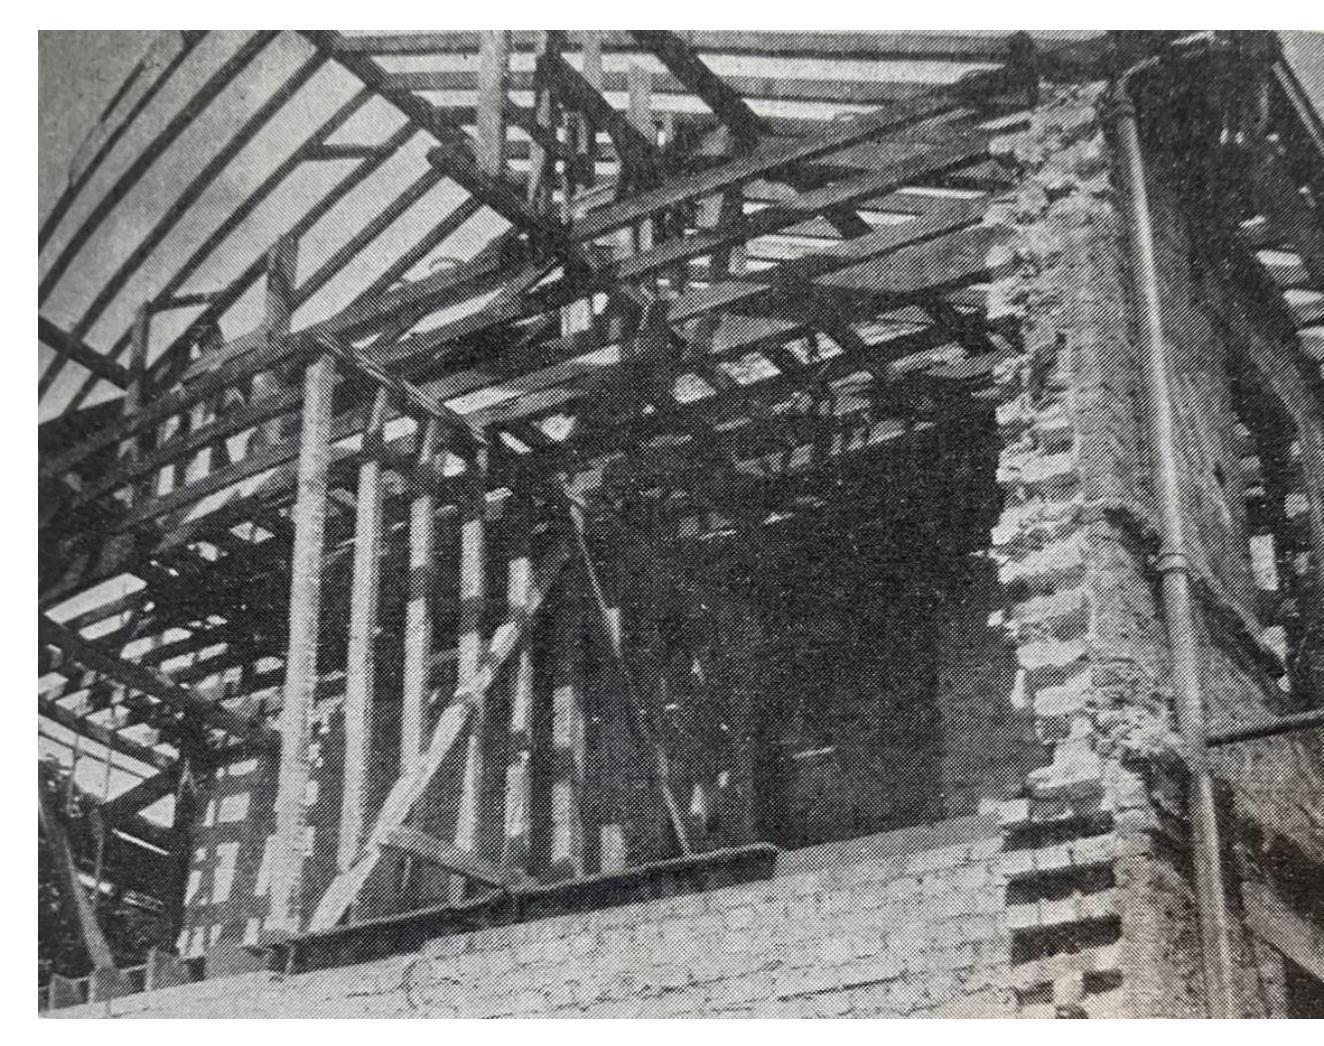
Figure 11 - Reconstruction of roof and side (north) elevation to 22 Park Village East

4.2.11 Post-war reconstruction at Park Village East coincided with a change in governance under the newly created The Crown Estate, the controversial 1950-60s reconstruction of the Nash Regent's Park Terraces; and transfer of ownership of 32 acres of land to St Pancras Borough Council, which it redeveloped as social housing i.e. Cumberland Market and Regents Park Estates.

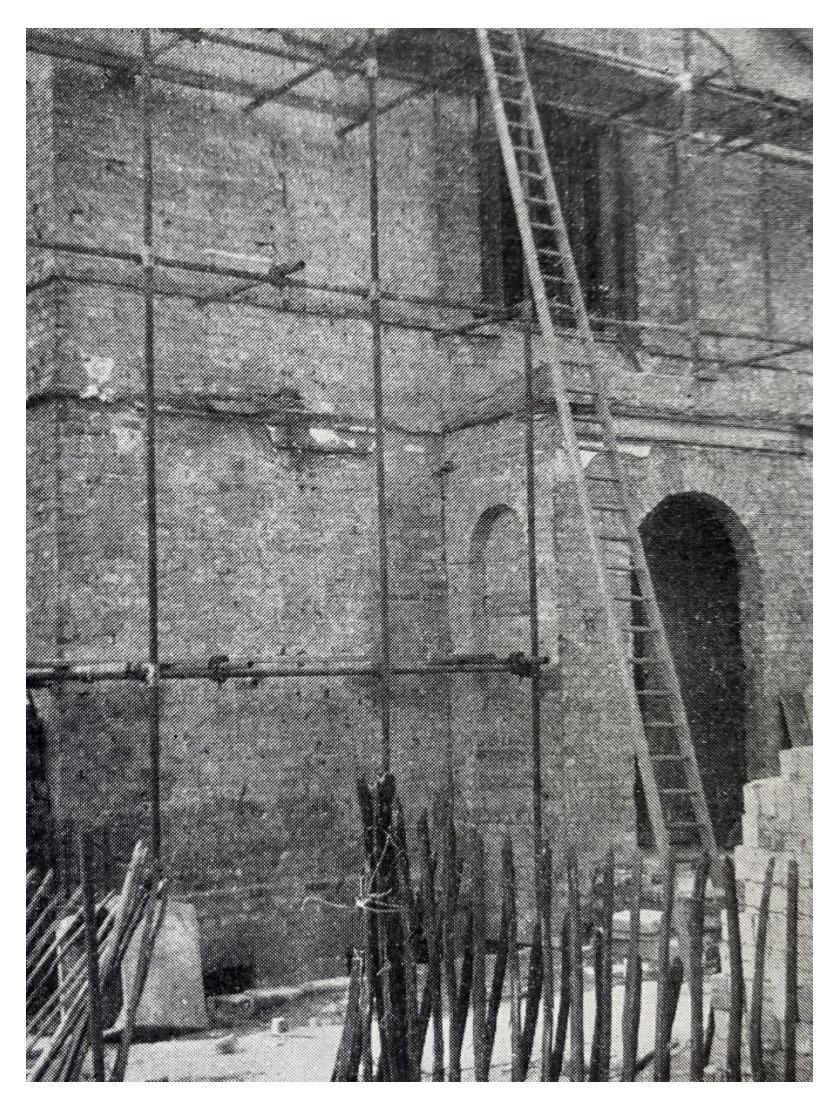
Figure 12 - Rebuilt side (north) elevation to 22 Park Village East

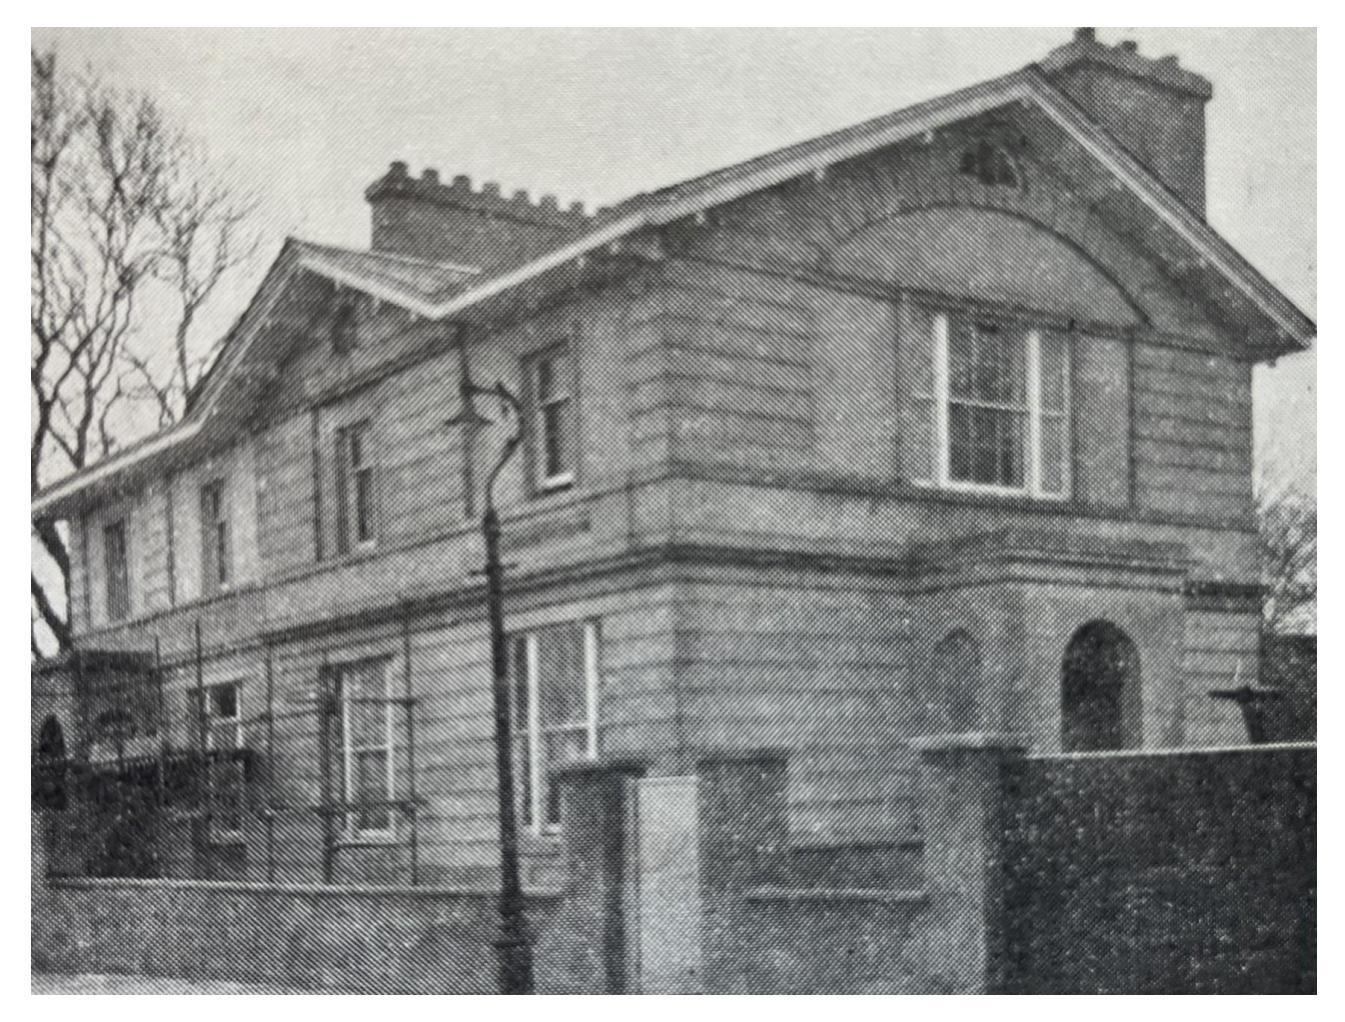
Figure 13 – Reinstatement of stucco architectural detailing to 22 & 24 Park Village East

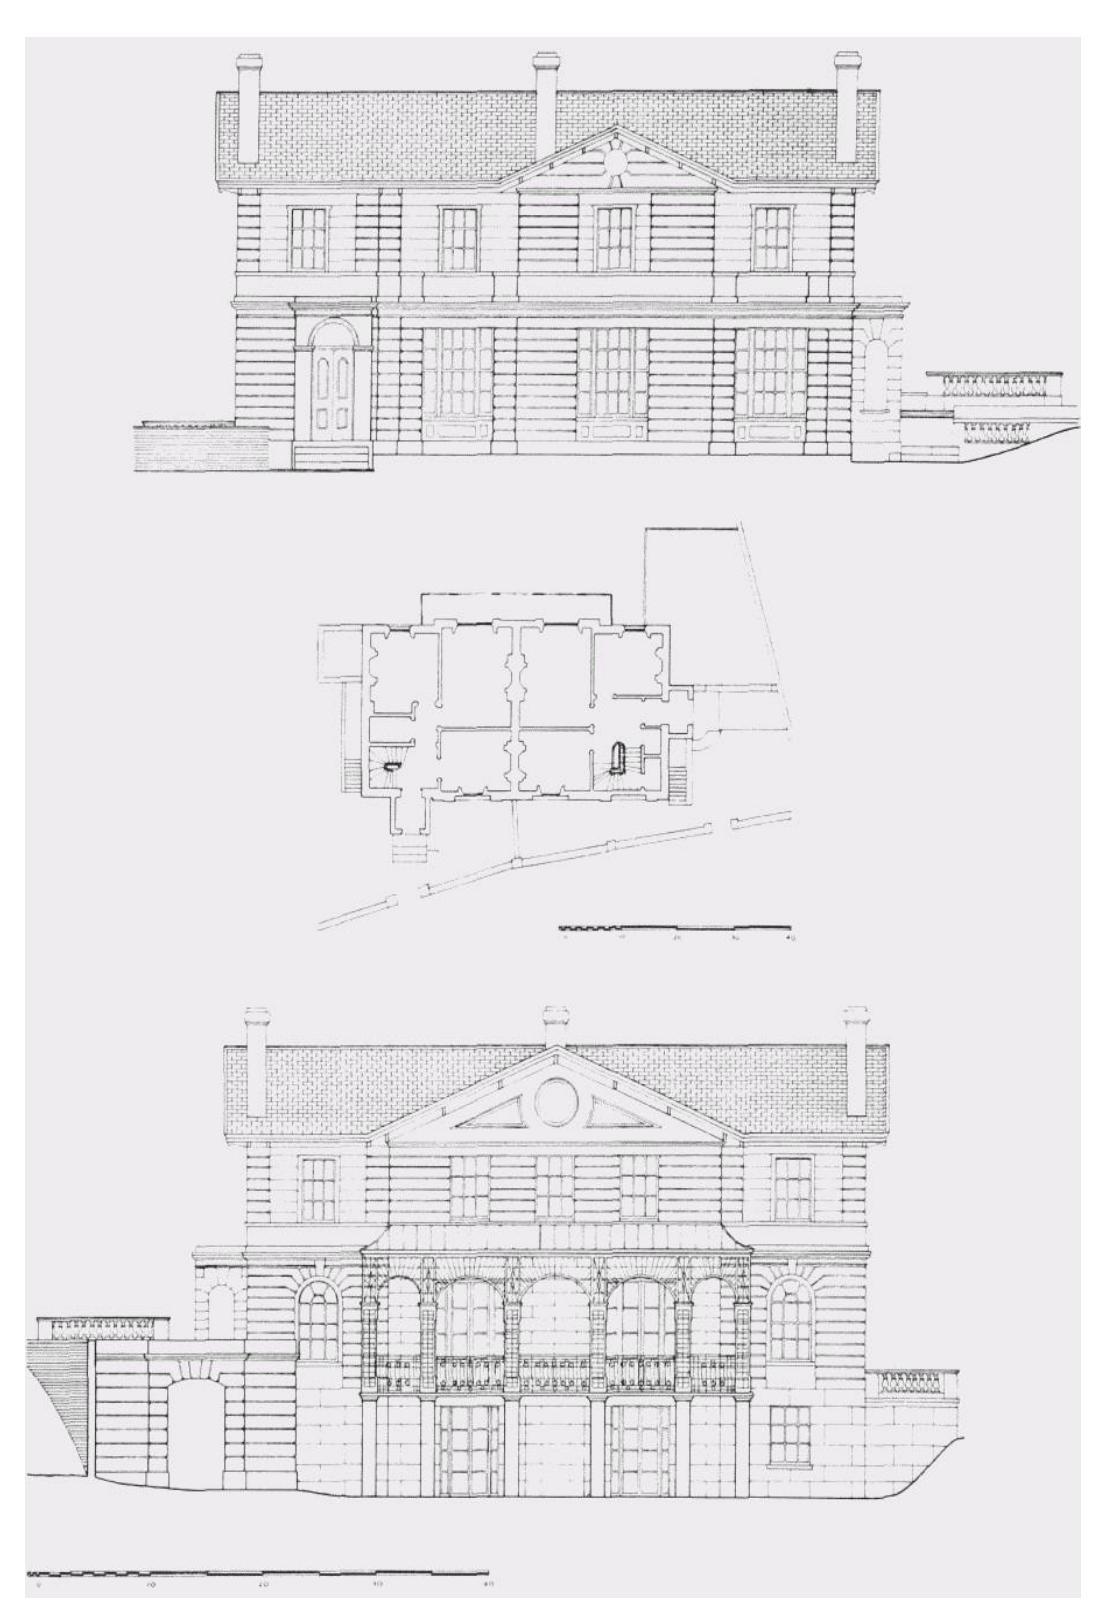
Figure 14 - Survey of London (from National Building Record) 22 -24 Park Village East

Nos. 22 and 24....., show an elaborate classical design, the stucco being deeply channelled with horizontal joints to imitate masonry. A picturesque effect is cleverly contrived from an almost symmetrical plan by slightly recessing the left part of the front and cantering the remainder on the window of the front rooms of No. 22, over which the deep eaves are sloped up in pedimental form. There is much play with slightly-recessed surfaces and the jointing is omitted here and there. The accidental effect is increased by the different treatment of the entrances. No. 22 is entered from a side porch, aided by dwarf balustraded terraces, while No. 24 has a front porch in its recessed façade. The back elevation is of equal interest. It is of three storeys, completely balanced in its parts. A large pediment spans the centre, which has a veranda and an elaborate roofed trellis balcony to the middle floor. The side windows in this storey has semicircular arches.

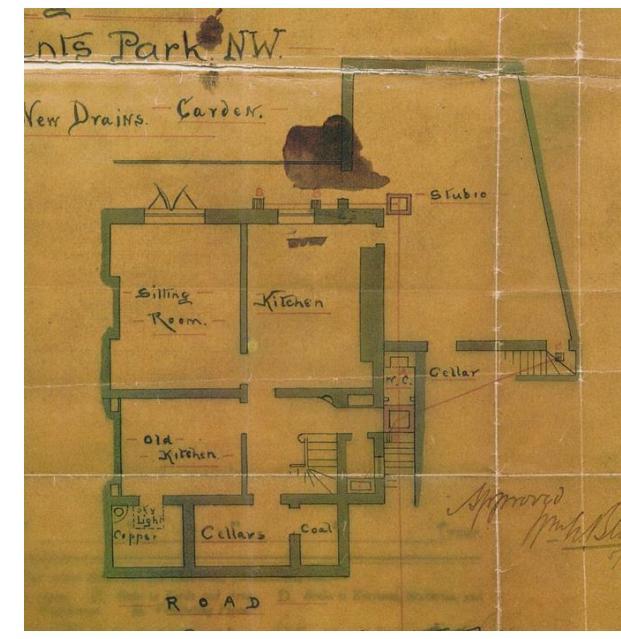
Figure 16 1894 lower ground floor internal layout

- 4.3.17 The 1894 and 1948 layouts of lower ground floor show significant changes (Figure 13 and 14). The sitting room/dining room, which still retains its form and decorative detailing, gained new access to the garden via French doors. Other changes are more utilitarian:

- former cellars, coal store and laundry room are reconfigured to create larger lightwell below the street. This illuminates a new window insert to the 'old kitchen', now referred to as 'maid's room'.

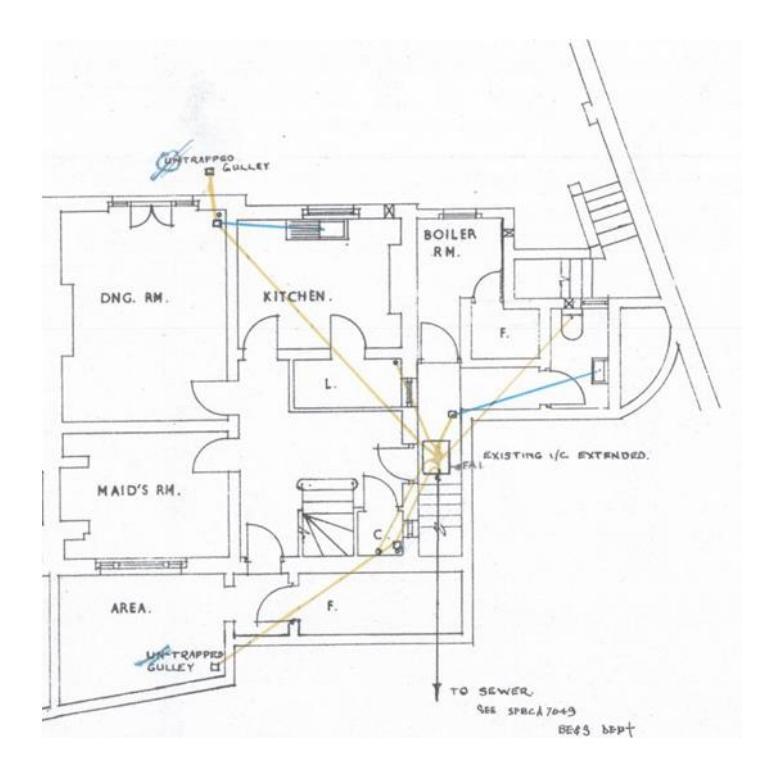
Figure 17 1948 lower ground floor internal layout

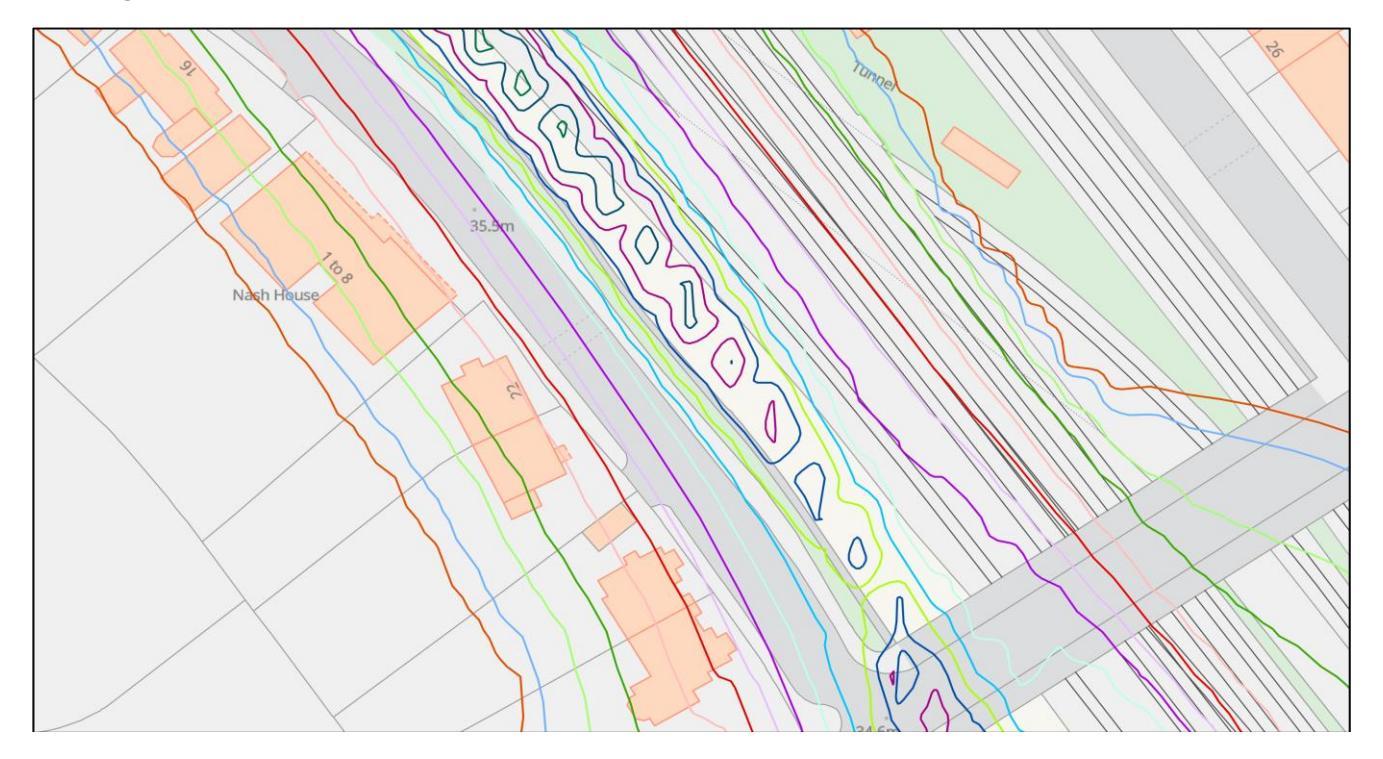
Figure 18 Phase 2 GMA contour

- 5.1.3 22 Park Village East is located within the HS2 project zone of influence, as defined by Phase 2 GMA 1mm contour (SCS Railways JV Maps GIS system (Figure 14) and is at risk due to potential ground movements induced by HS2 construction.

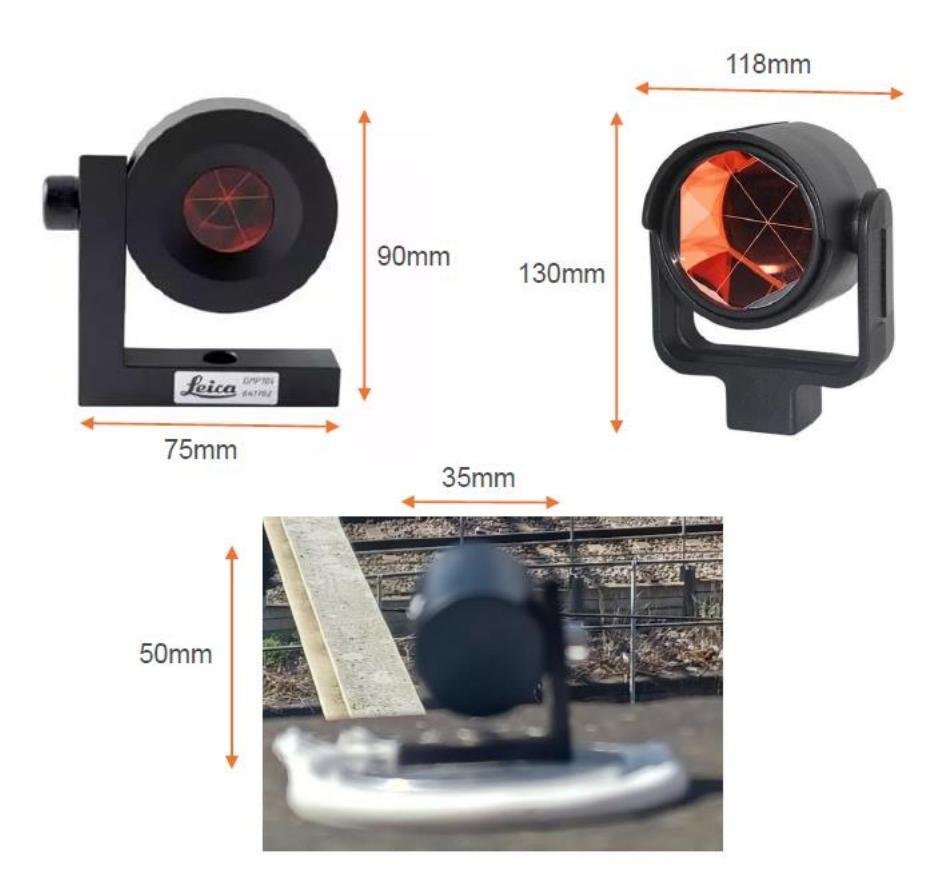
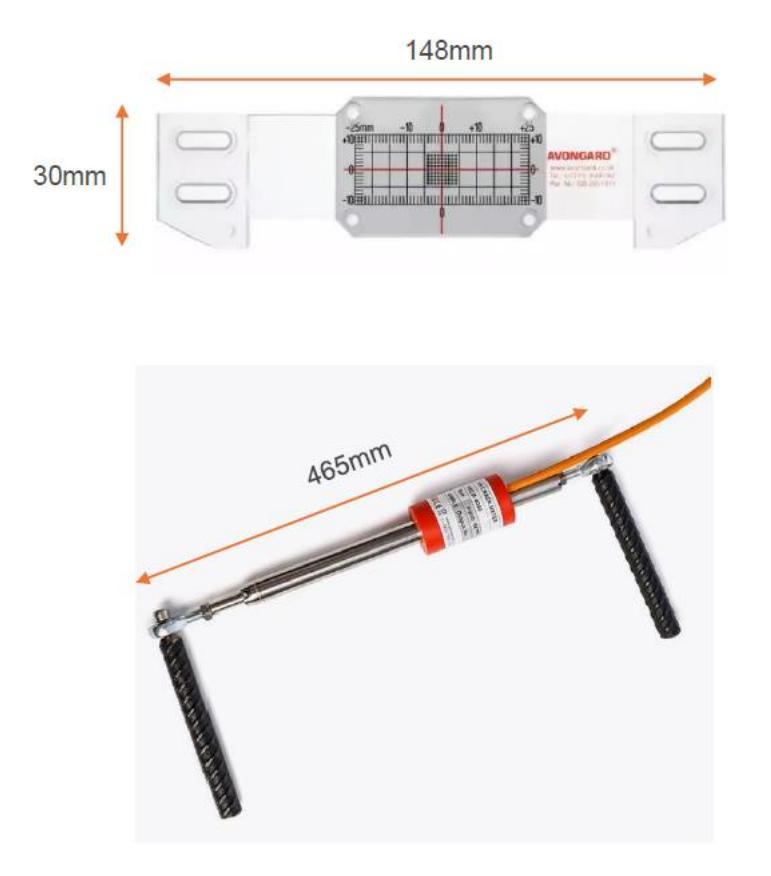
On appearance, internal and external cracks will be monitored using tell tales or monitoring studs (Figure 17).

Figure 20 Example manual crack monitor (top) and automatic crack sensor (bottom)

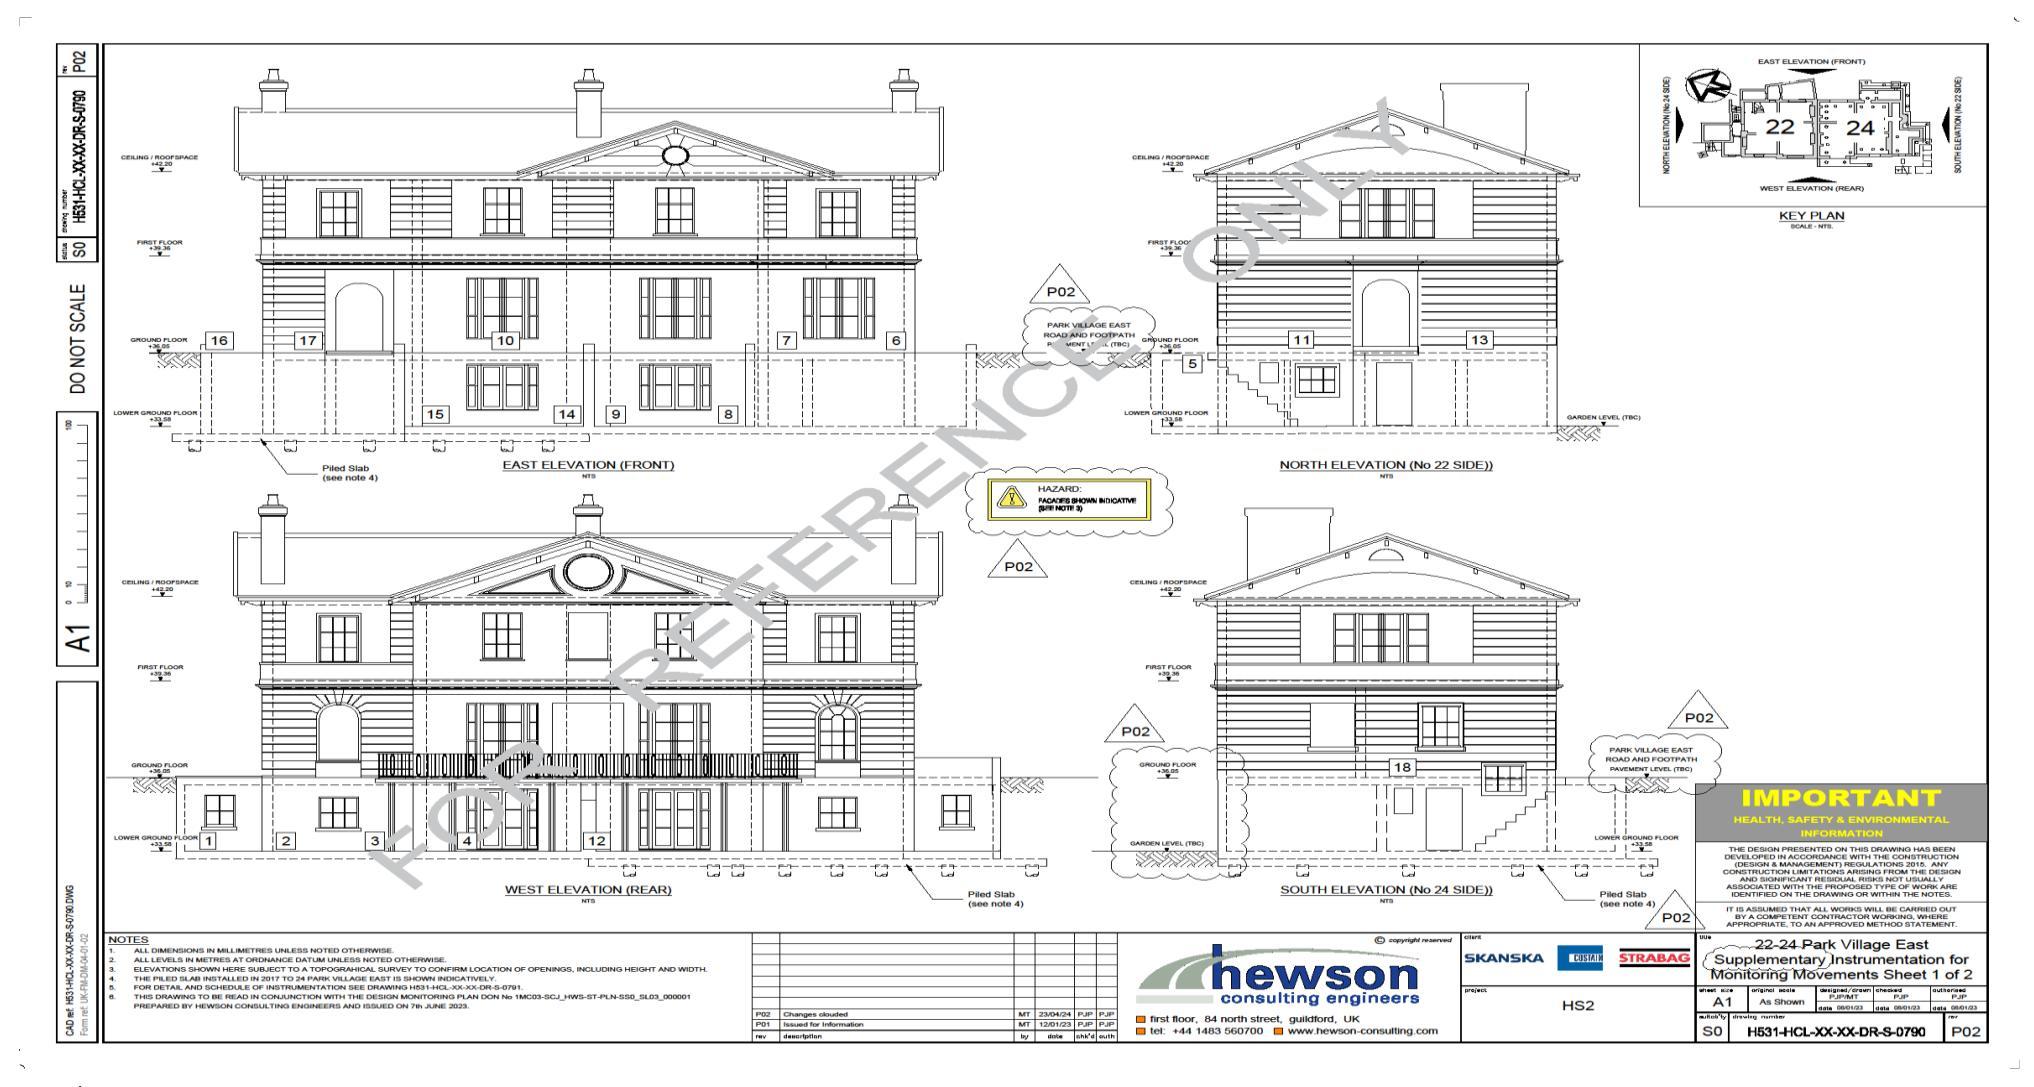
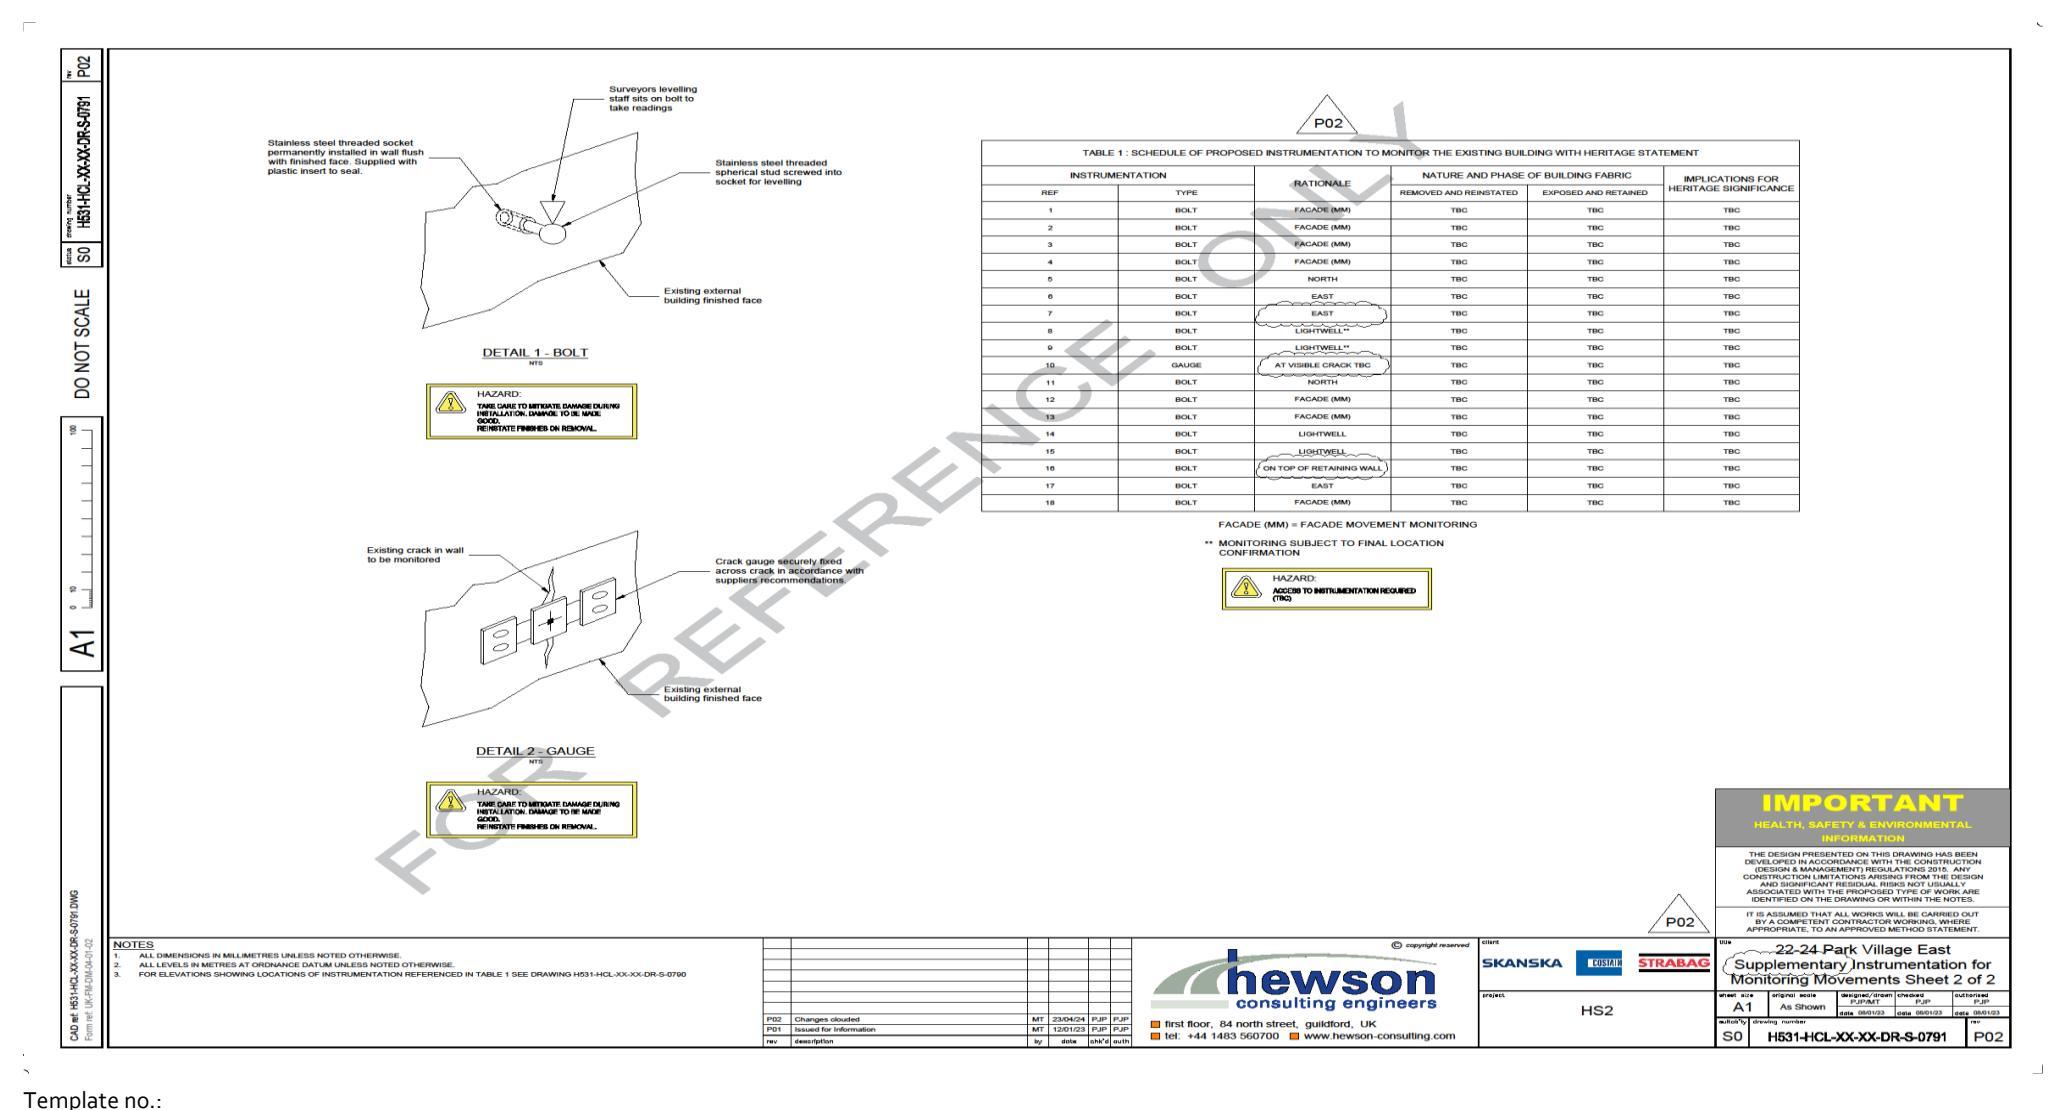
Appendix A – Instrumentation Design Drawings (as proposed in Asset Specific Mitigation Designer's Monitoring Plan, 22-24 Park Village East, Asset Protection Area East-Euston Throat West Buildings Package 2 ADP-ESCT-02 Document no.: 1MC03-SCJ_HWS-ST-PLN-SS01_SL03-00001)

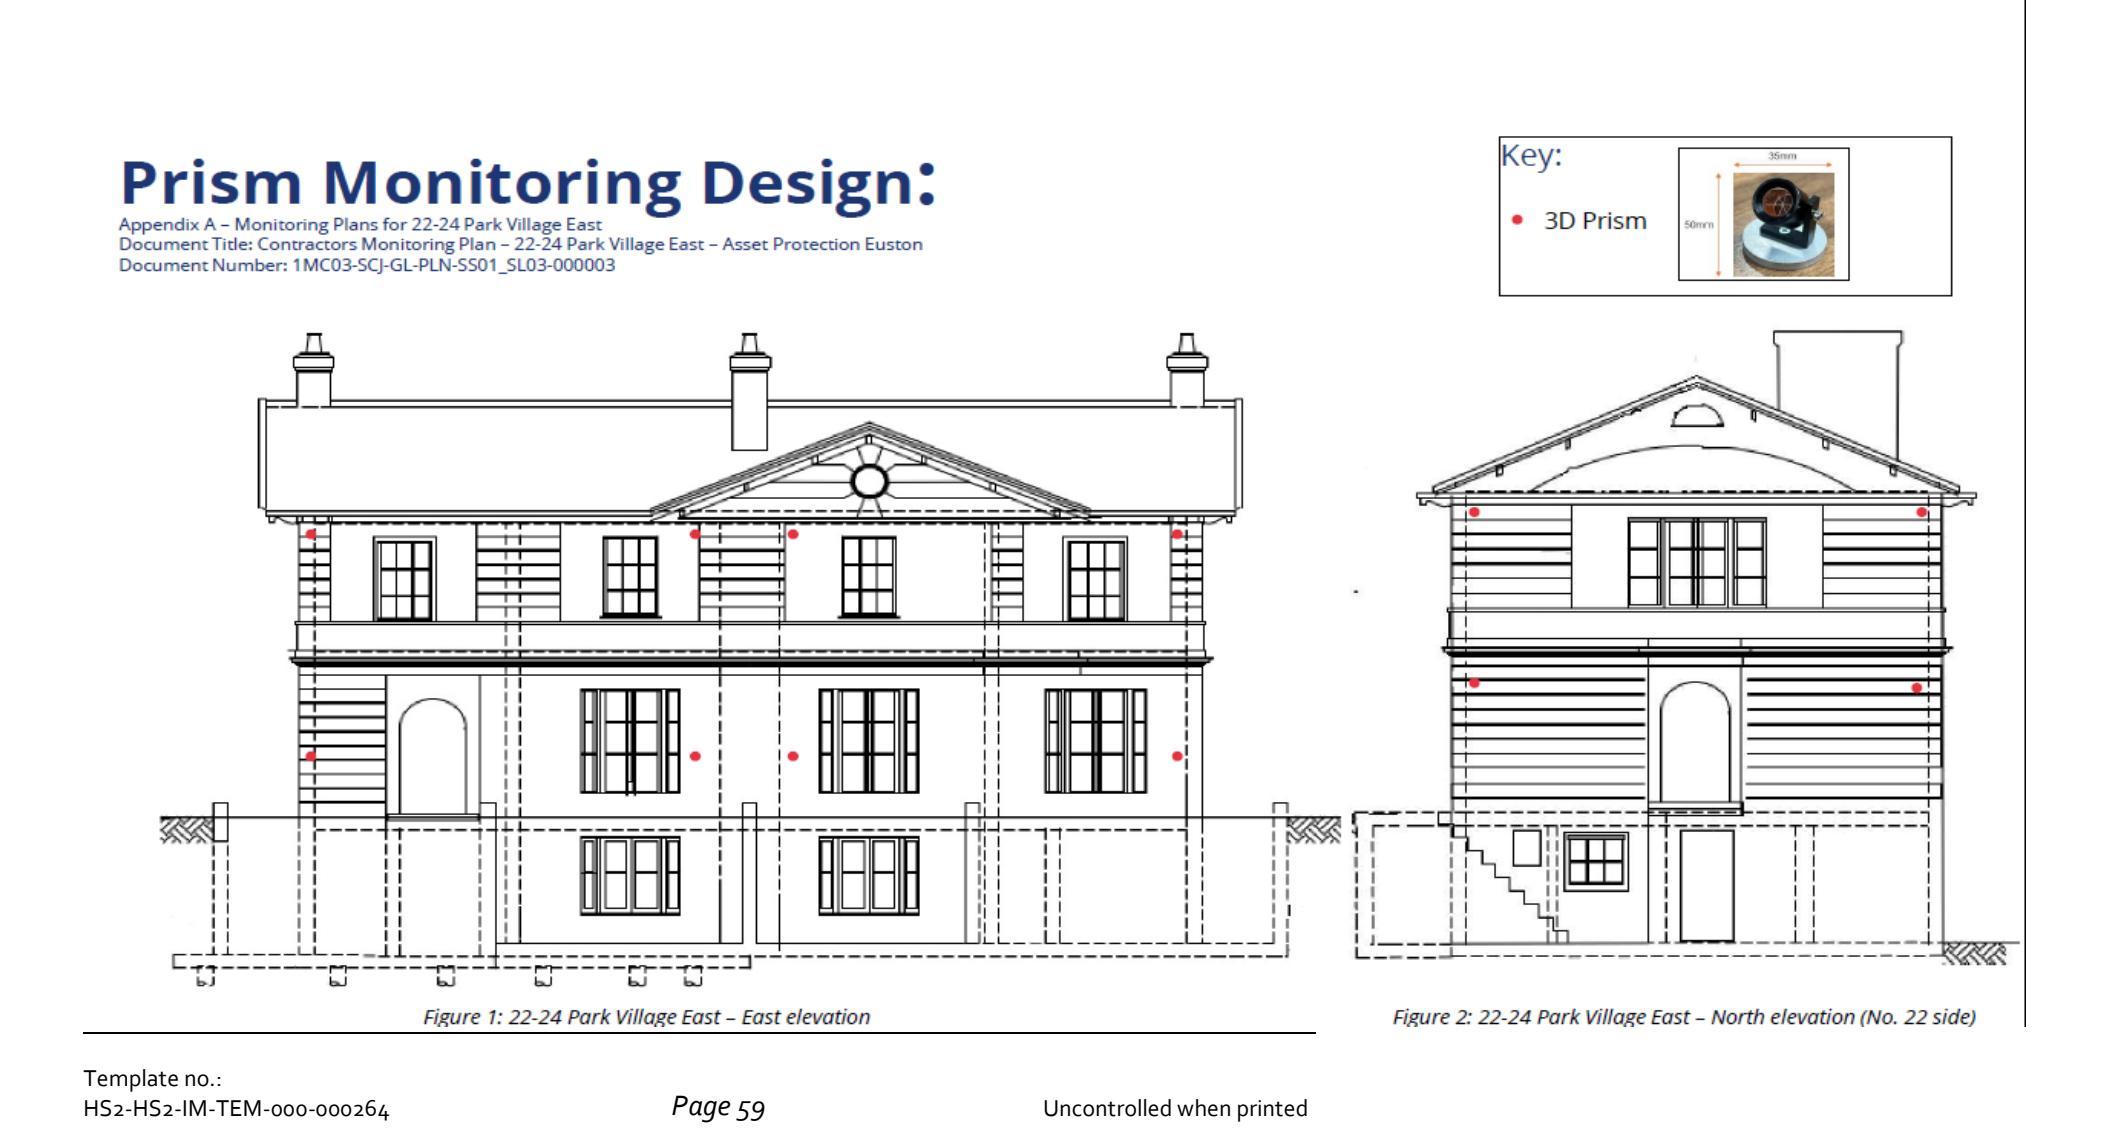
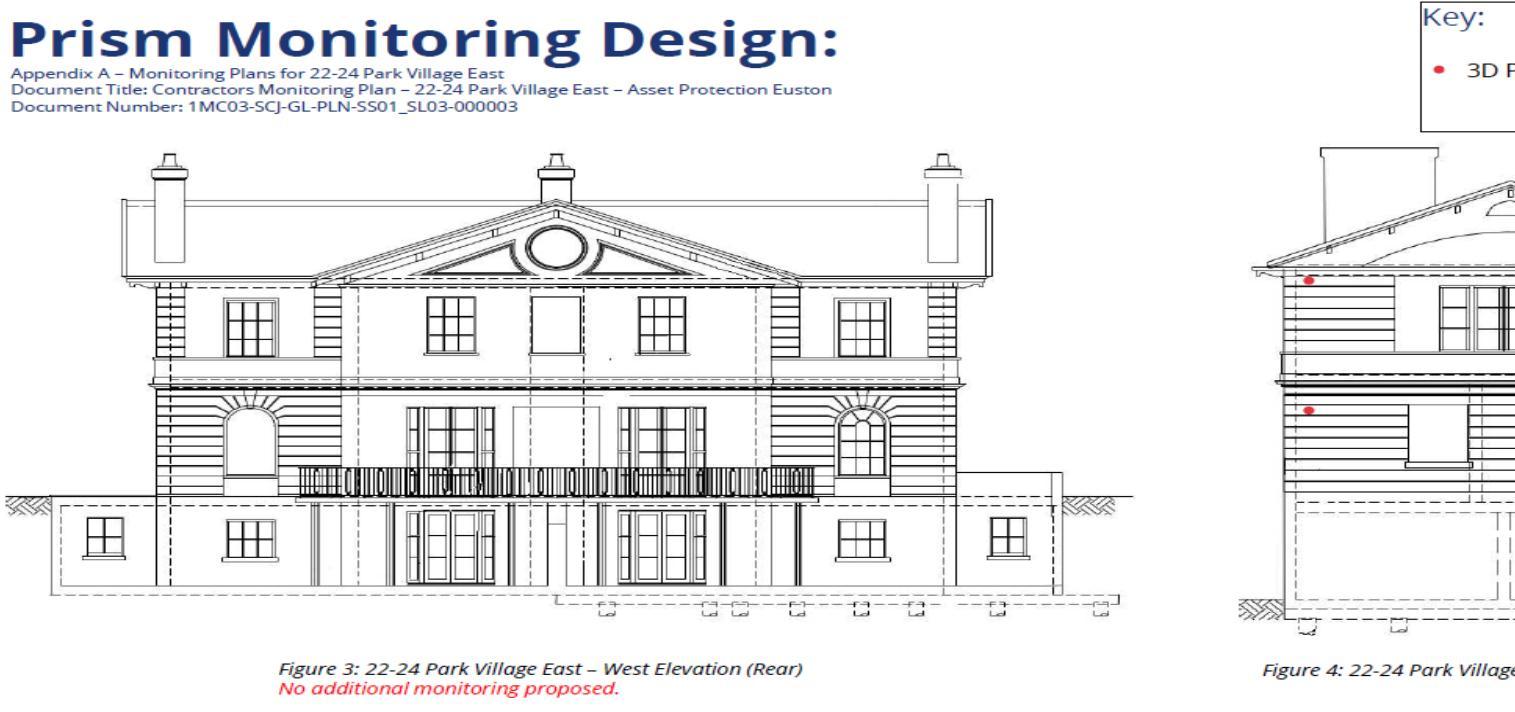
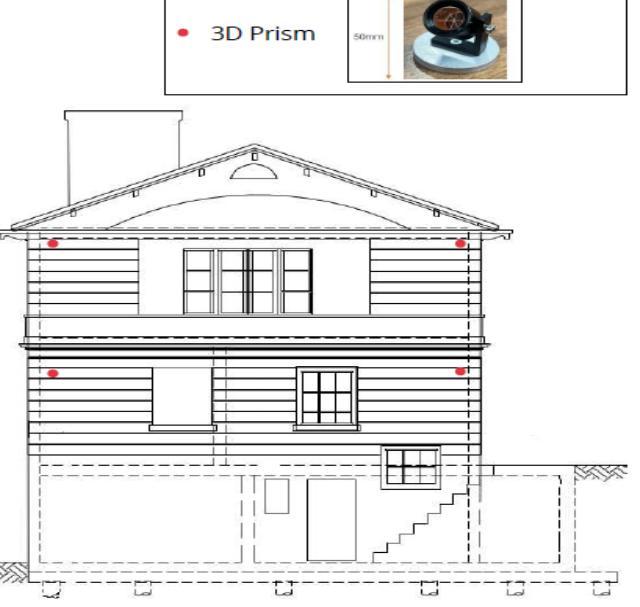
Figure 4: 22-24 Park Village East – South Elevation (No. 24 side)

Appendix B – Instrumentation Design Drawings (as proposed in SCSjv Contractors Monitoring Plan - 22-24 Park Village East -Asset Protection Euston - APD-ESCT-02, Document no.: 1MC03-SCJ-GL-PLN-SS01_SL03-00003)
