TPO TREE WORKS APPLICATION

The Lodge North End Avenue London NW3 7HP

Report Reference: AS/0232/24

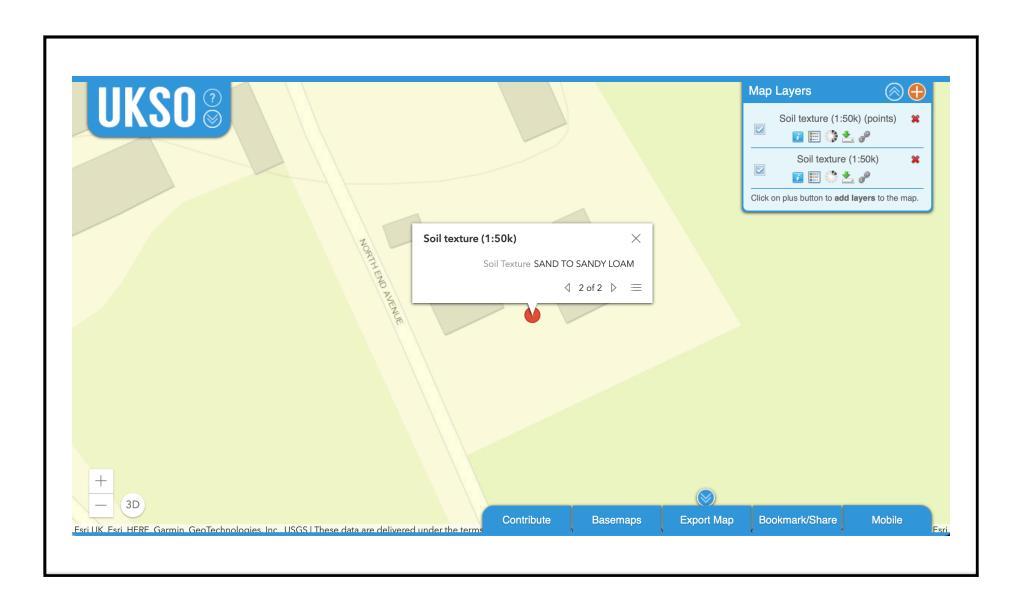
2.4 The underlying soil to this area is classified as 'sand to sandy loam' within the UK Soil Observatory - <u>www.ukso.org</u> - a light to medium soil mix as confirmed below. Whilst clay soils can experience substantial volume changes when vegetation extracts moisture from the ground, other soils are not as susceptible; the soil is deemed as being of light to medium texture. Any foundations should also be designed in accordance with the recommendations contained within NHBC Chapter 4.2 (National House Building Council, 2010) and should account for the possibility of both subsidence and heave.

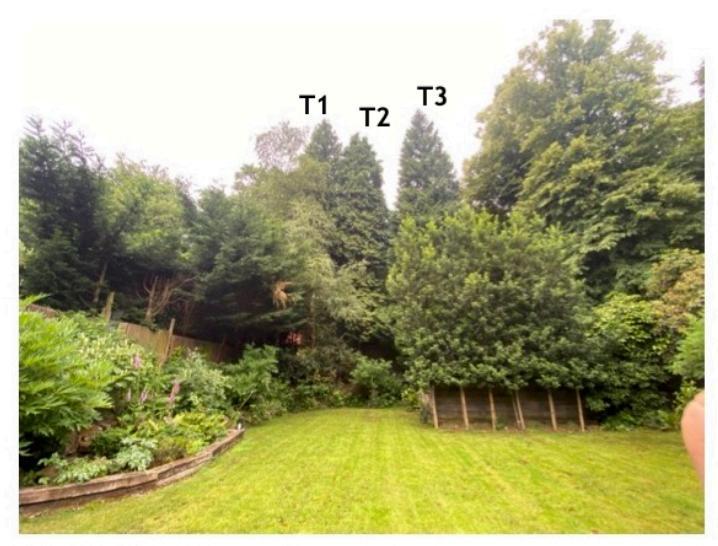
(I) Lapsed managed screening trees - planted as rear boundary hedge; hedge form lapsed

T1-T3 viewed to south

TREE WORKS SCHEDULE							
Tree No.	Common Name	Tree Works	Reasons for works				
T1	Western red cedar	Reduce height 6m Trim spread to balance / retain even and flowing upper crown outline	General management				
T2	Western red cedar	Reduce height 5m Trim spread to balance / retain even and flowing upper crown outline	General management				
Т3	Lawsons cypress	Reduce height 6m Trim spread to balance / retain even and flowing upper crown outline	General management
