Design, Access and Heritage Statement for

University College School, Hampstead – External Masonry Repairs

24th January 2025

UCS Hampstead, Senior School, Frognal, Hampstead, London, NW3 6XH

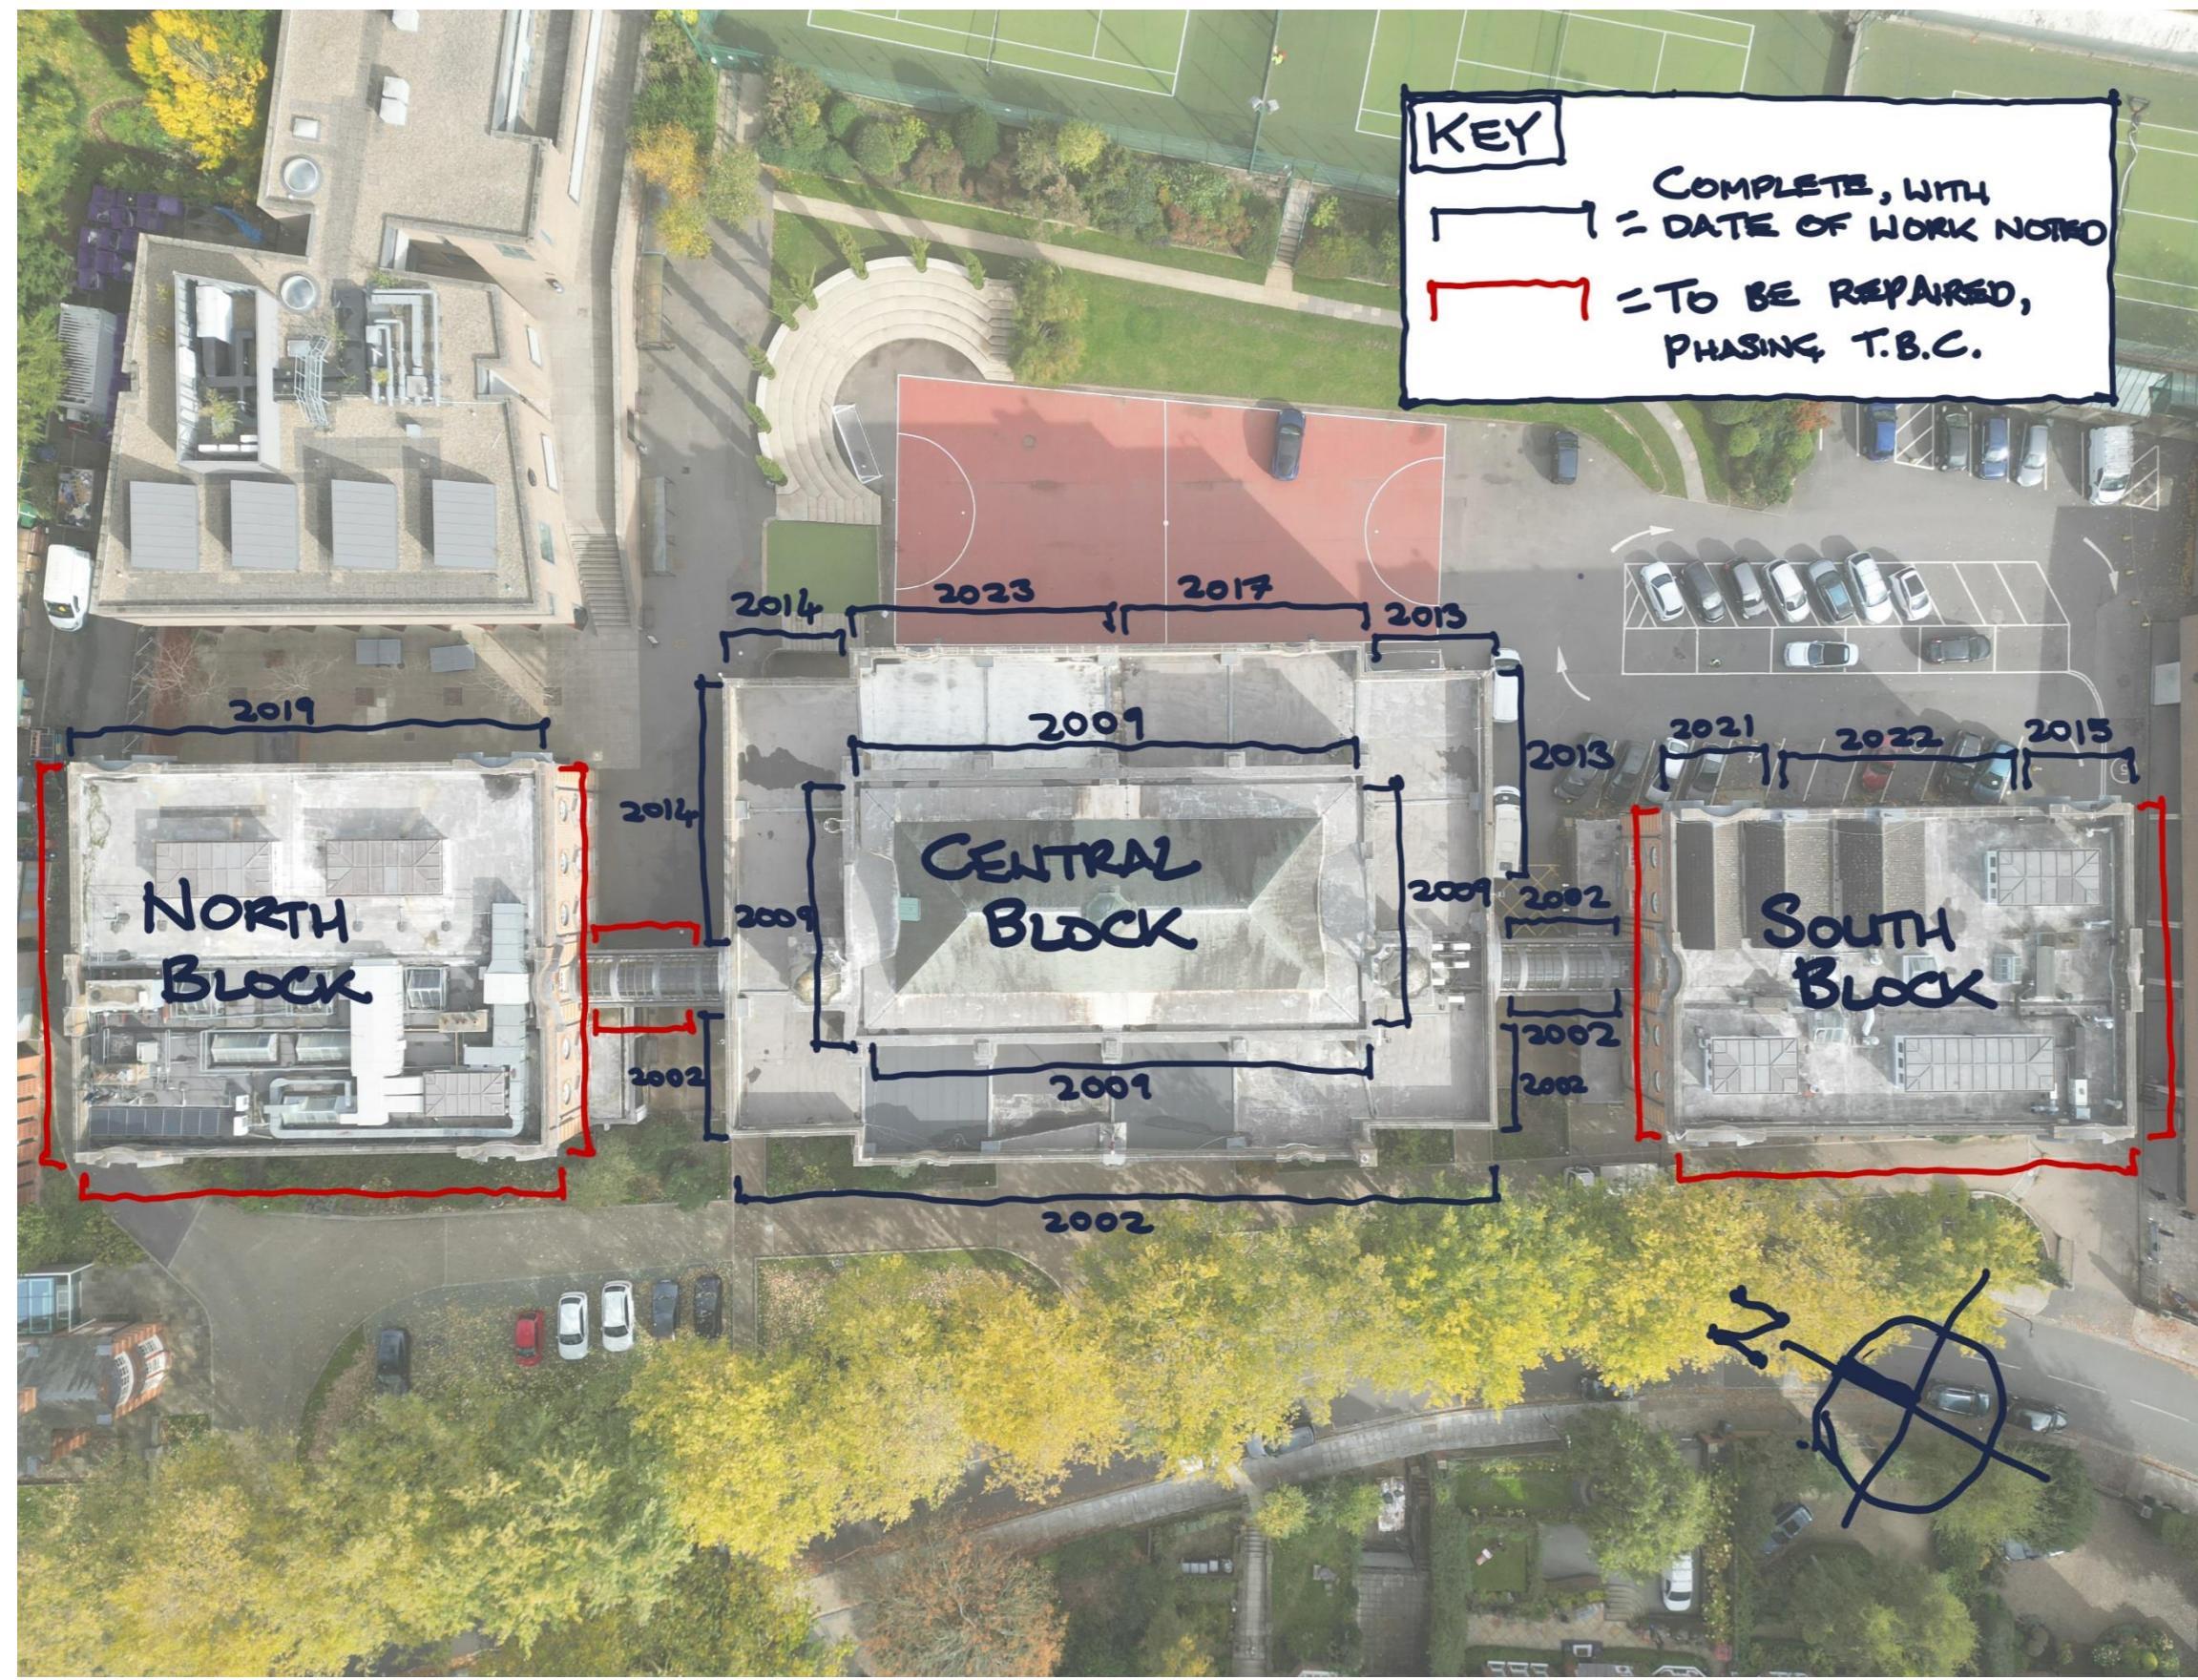
Fig 1: Phasing Diagram – This roof plan illustrates the previous phases of works, carried out between 2001 and 2025, as noted on the previous page of this document.

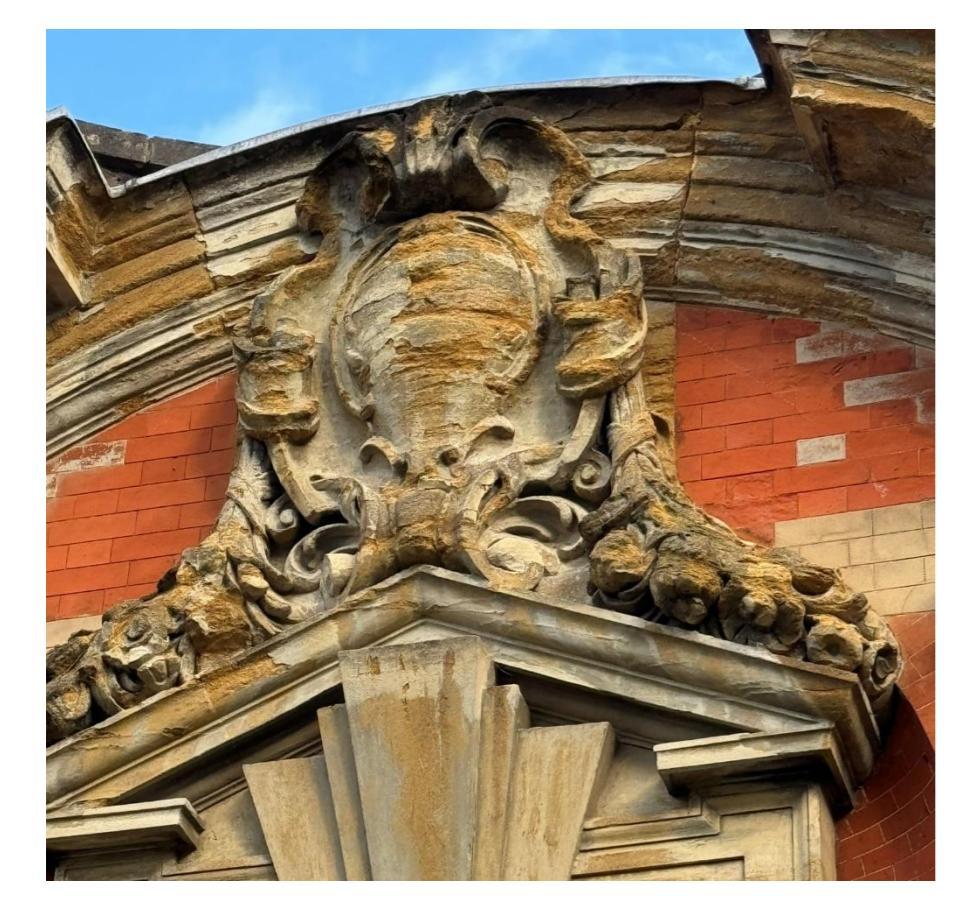
-There are **cementitious coatings** to the intricately carved Ham Hill stonework elements (Figure 8).

Fig 8: Cementitious coatings - This example is one of the more decorative cartouche overthrows, over a pedimented window surround. The greyish cementitious coatings can be seen over the honey coloured Ham Hill stone below. Once the cement has been removed, little salvageable stonework will remain.

- Removal of **cementitious coatings** to the intricately carved Ham Hill stonework elements (Figure 13).

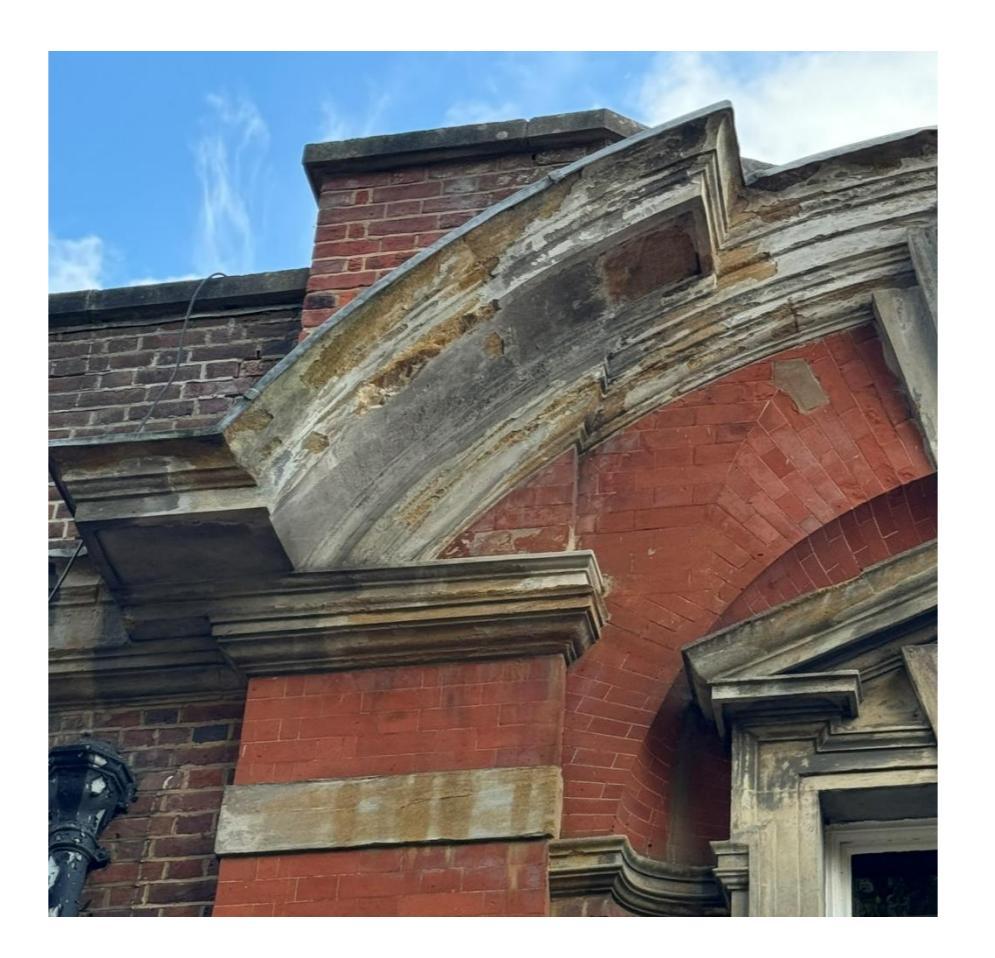
- Other more linear sections of stone which have smaller defects and cement repairs (such as window surrounds and cornicing) which are of less significance to the Neo-Baroque design detailing of the building (Figure 9).
- The brick parapets are unstable and appear saturated, with hard cementitious struck pointed joints, and numerous friable faces (Figure 10).
- There are portions of brickwork, including general walling, but in particular rubbed brick arches below split pediments, which are in poor condition (Figure 11).
- There are portions of sky facing surfaces which either do not have lead cappings and flashings, or have undersized or missing portions, which is exacerbating deterioration of the stonework below (Figure 12).

Fig 9: Smaller defects and cement repairs - This image demonstrates two related defects. As the stonework is eroded, decorative detail is lost (here to the kneeler/corbel at the base of the slope). The extent of staining due to coping erosion, particularly around perpend joints is very visually clear in the dark staining extending down the face of the gable stonework.

- Repairing **smaller defects and cement repairs** (such as window surrounds and cornicing) which are of less significance to the Neo-Baroque design detailing of the building (Figure 14).
- The **brick parapets** where unstable and saturated are proposed to be rebuilt, reusing existing salvaged bricks where possible (Figure 15).
- Where brickwork, including **rubbed brick arches** below split pediments have cracked or become cavitated and friable, the bricks are proposed to be replaced with new red rubbers (Figure 16).
- Where sky facing surfaces either do not have **lead cappings and flashings**, or have undersized or missing portions, it is proposed to instate new leadwork to Lead Sheet Association best practice guidance (Figure 17).

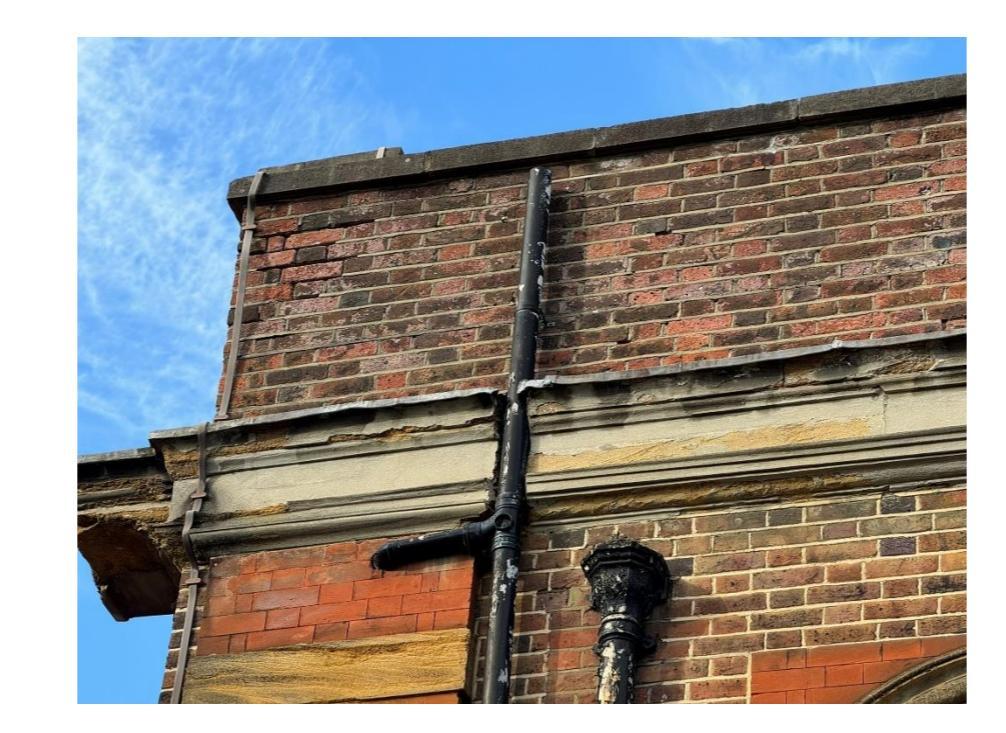
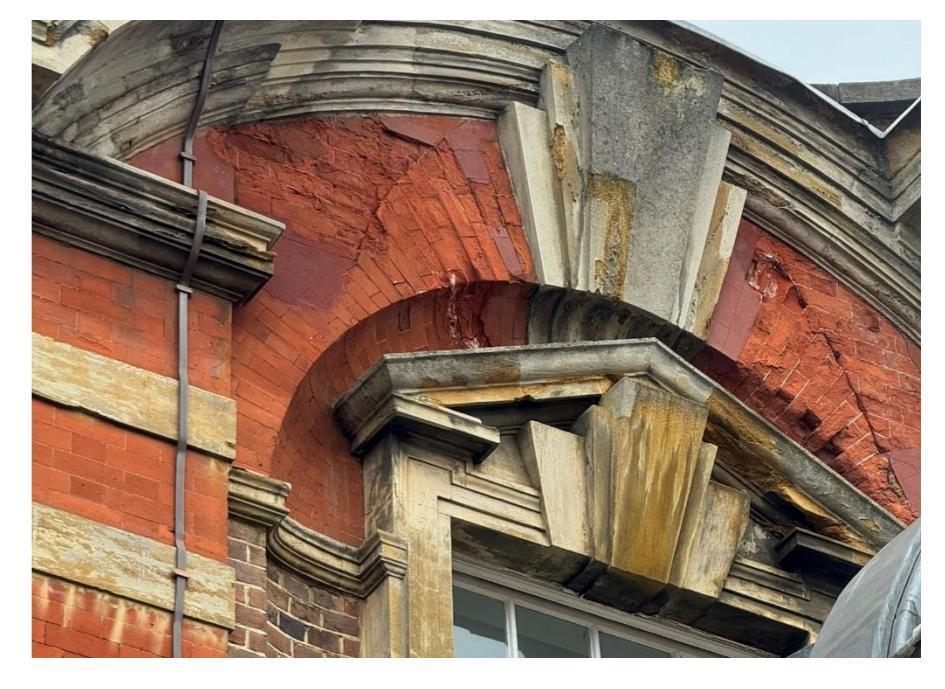
Fig 10: Brick parapets - This is a typical example of the condition of the brick parapets above cornice level. The bricks are spalling, and the

sections adjacent and above.

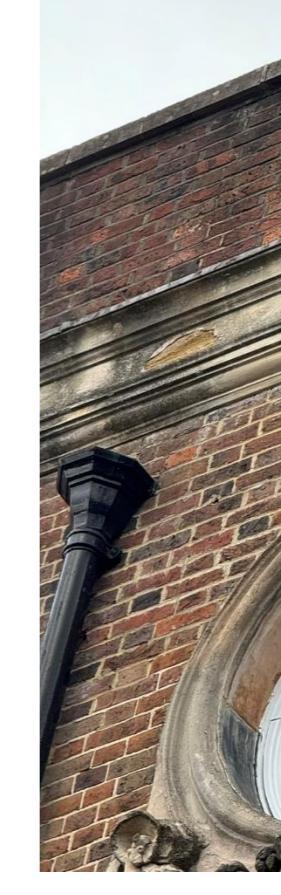
Fig 12: Missing or undersized lead flashings - Here to an ocular window and cornice above, examples of leadwork defects can be seen. To the cornice, the lead is undersized and does not project sufficiently far to protect the stonework below (note the erosion). To the window, there is a lead flashing to the lower sky facing surface, though this discharges onto the garland below (exacerbating erosion of this stonework) and there is no flashing to the top window edge.

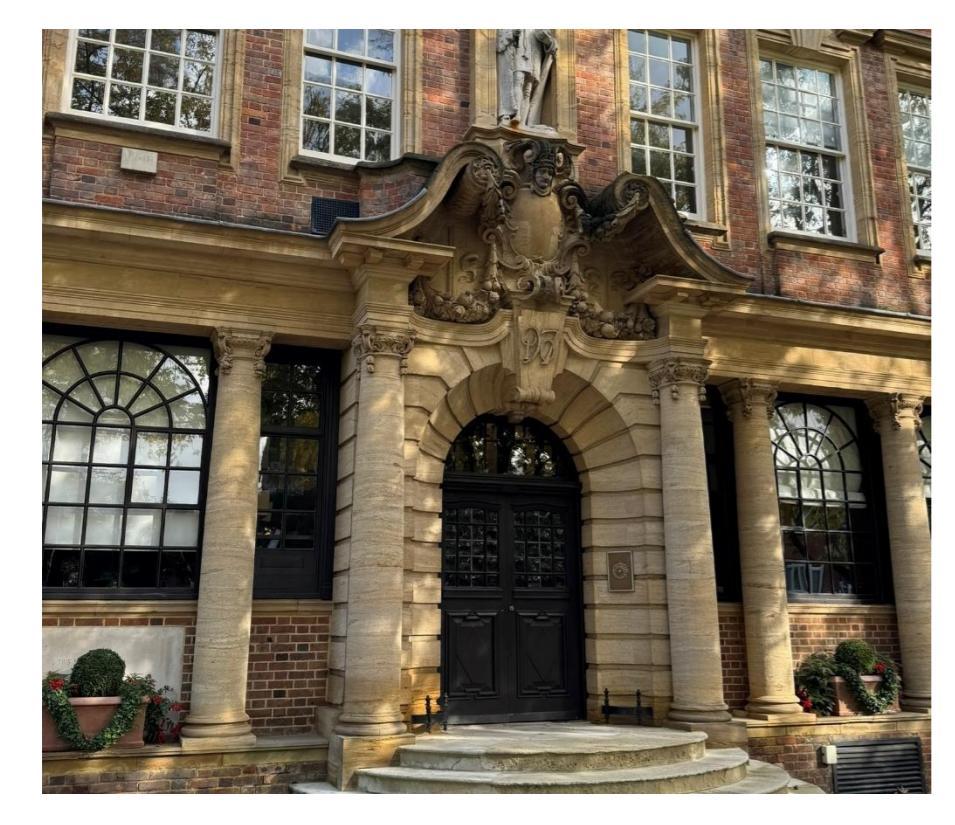
Fig 13: Reinstatement of historic carved details – Here, to the centre of the Central Block's street facing western elevation, some of the earlier repairs of intricate stonework (circa 2002), repairing and reinstating cartouches, garlands, rustication and capitals.

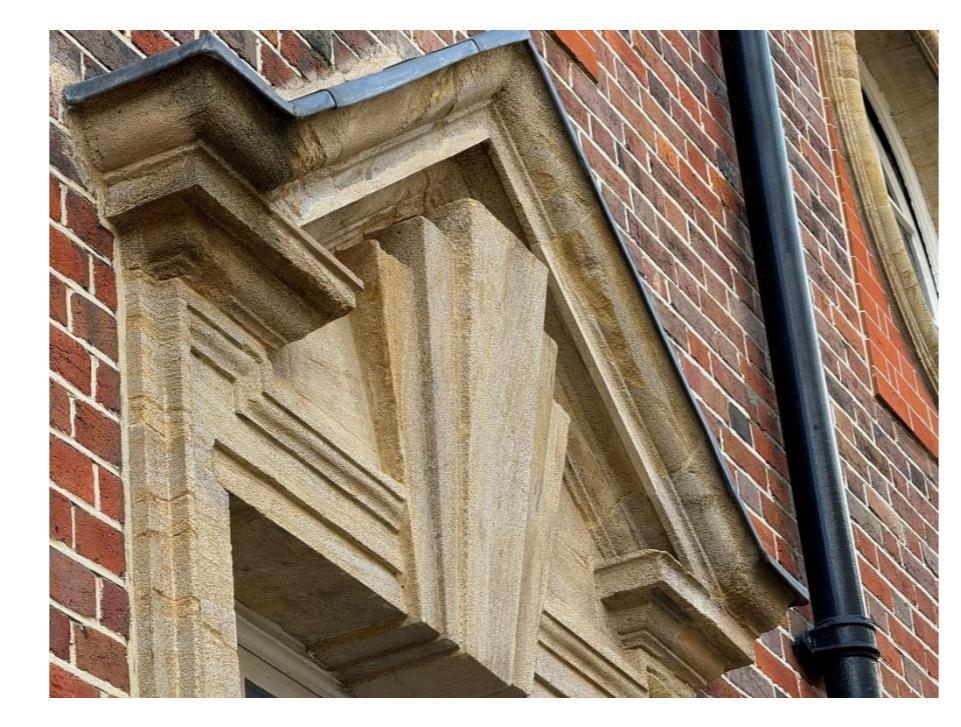
Fig 14: Lime mortar repairs – Through careful sampling, lime mortar mixes were developed which blend well with the host Ham Hill stonework, fixed to brass armatures to adhere the mortar repair to the stone substrate.

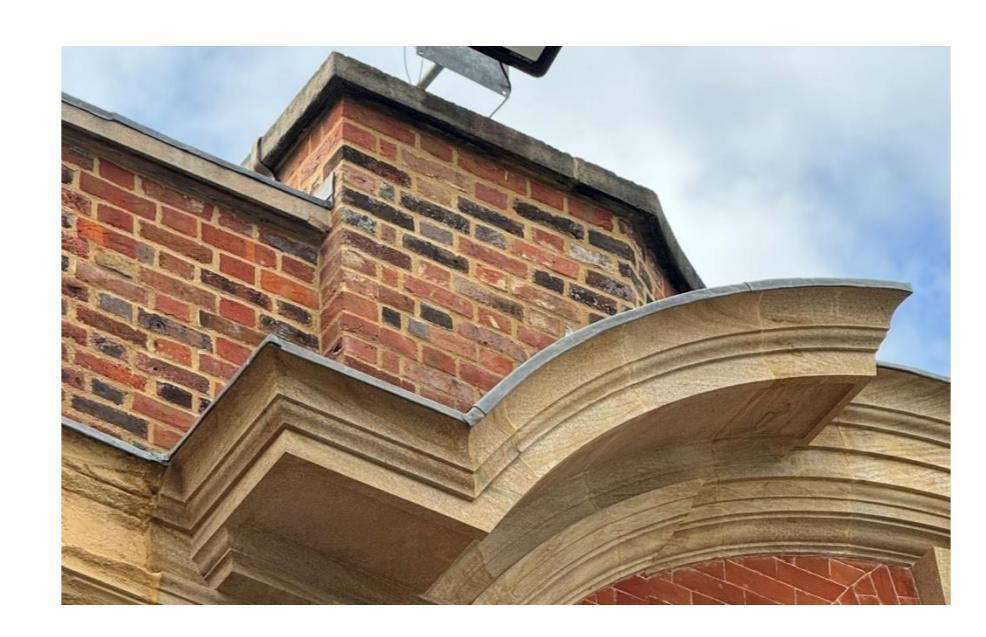
Fig 15: Brick parapets – This is a portion of brick parapet which has been taken down and rebuilt, reusing salvageable bricks (with new bricks to match), all set in a soft lime mortar mix.

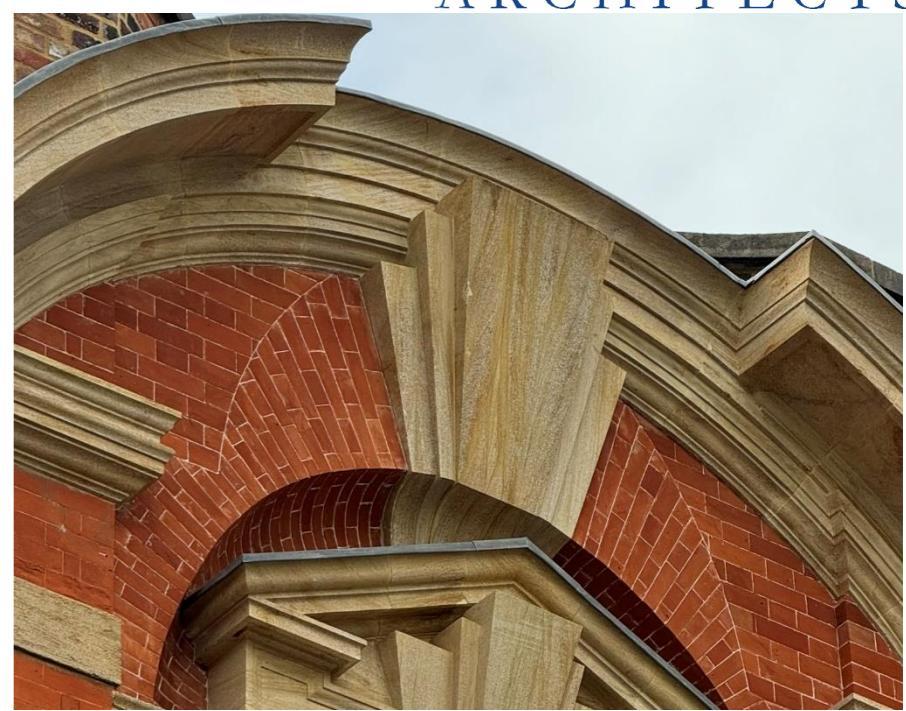
Fig 16: Brick arch deca previously friable.

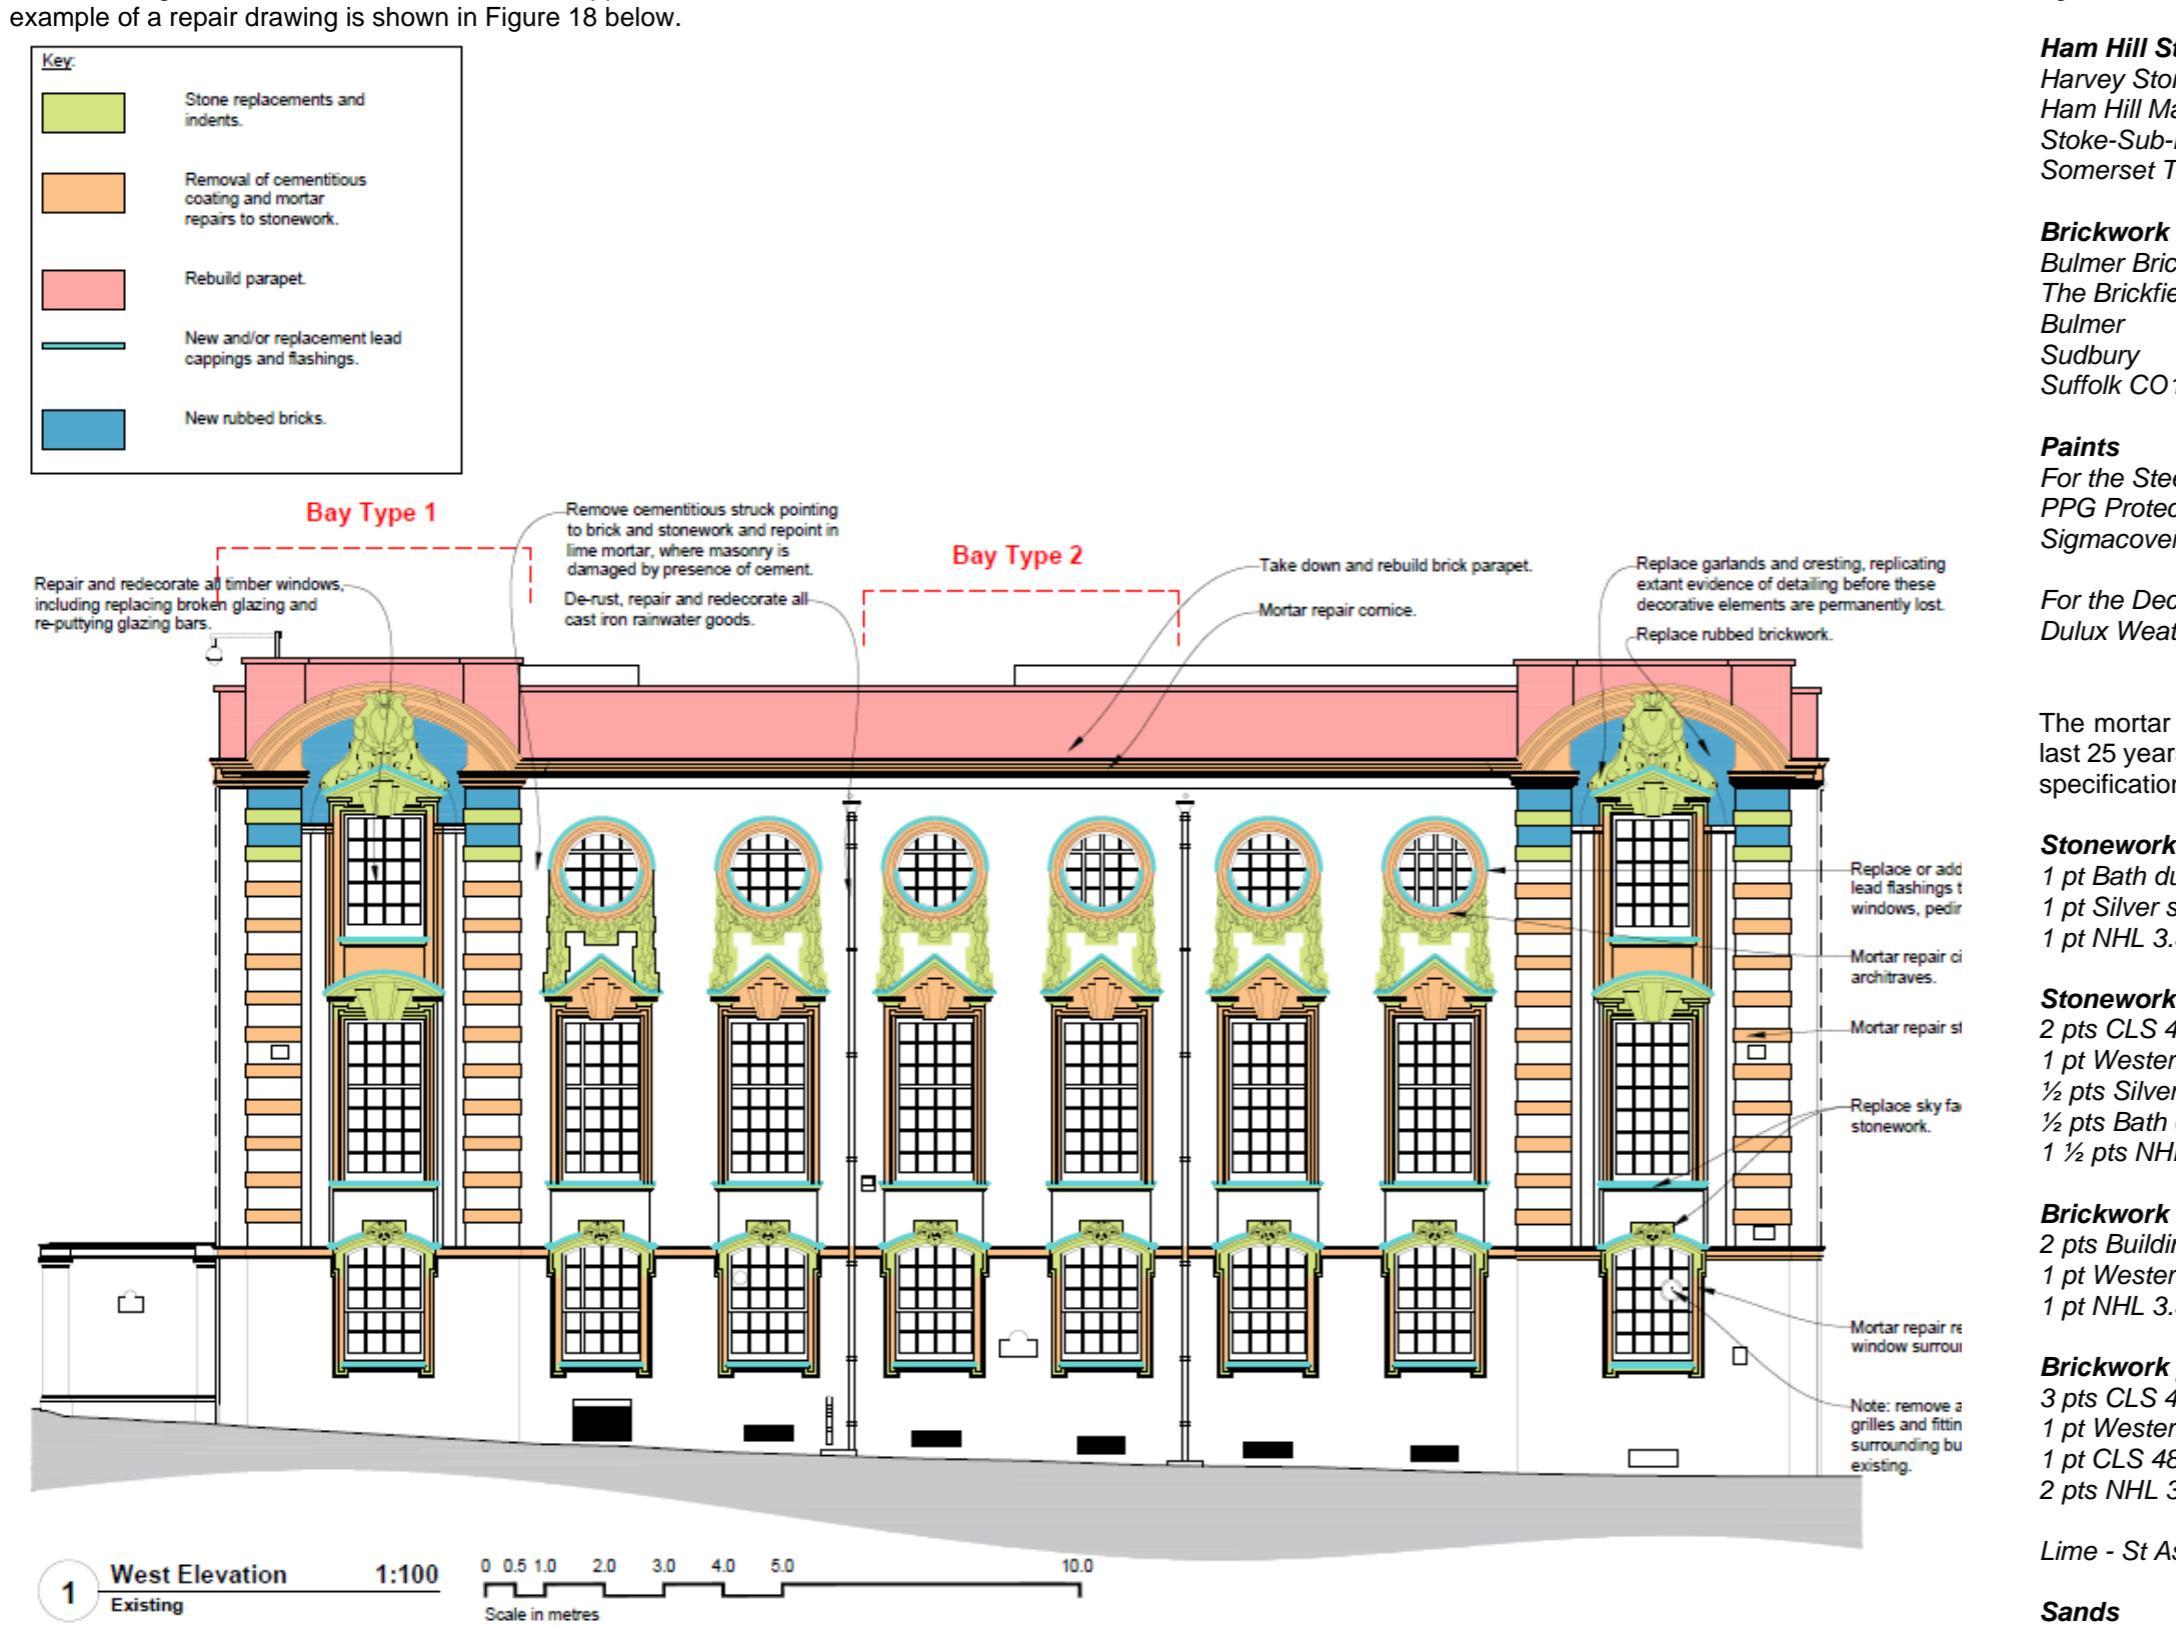
Figure 18 - Elevation drawing extract (South Block, West Elevation) - the elevations have been prepared based on existing survey drawings, and in discussion with the appointed masonry contractors DBR Ltd (who have carried out the previous phases of repair). The extent of repairs is based upon their experience, with a view to proposing the 'worst case scenario', scaling back the repairs if this found to be possible on site.
