Preliminary Roost Assessment

Lytton Court, Barter Street, London Borough of Camden

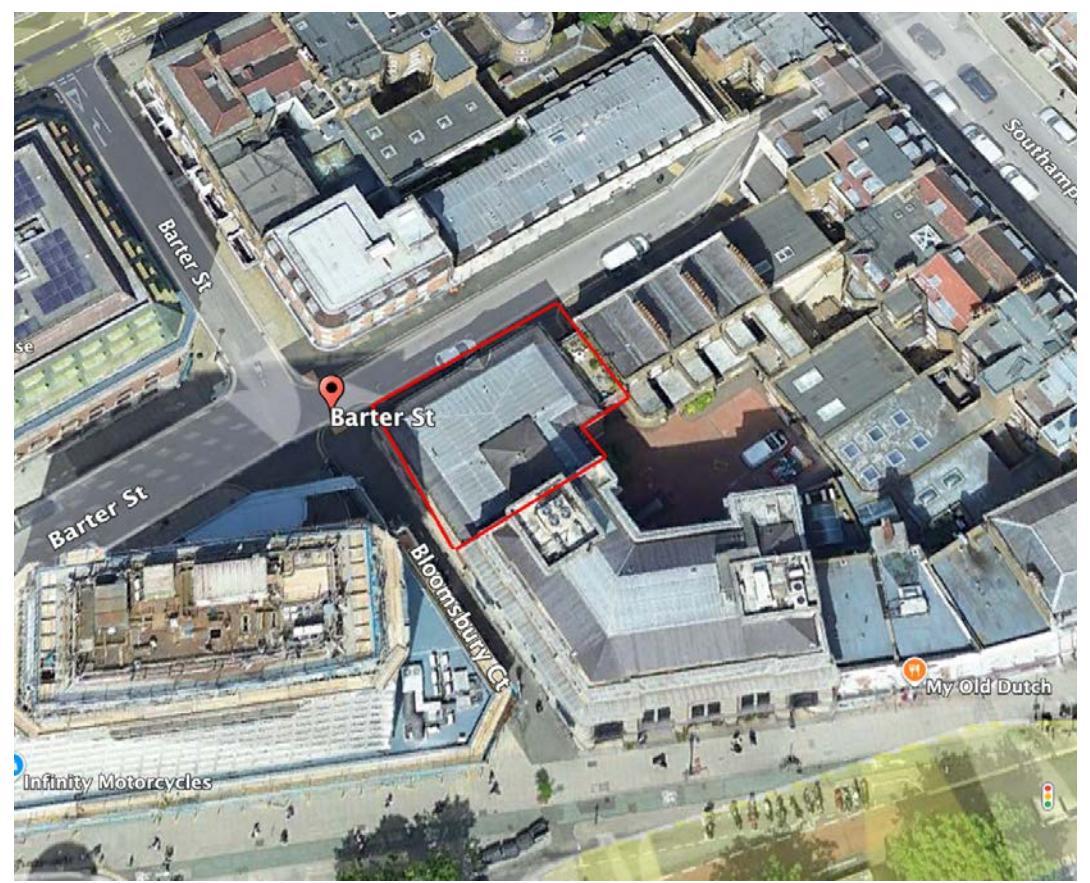
Figure 1: Building subject to PRA within the red line boundary of the site.

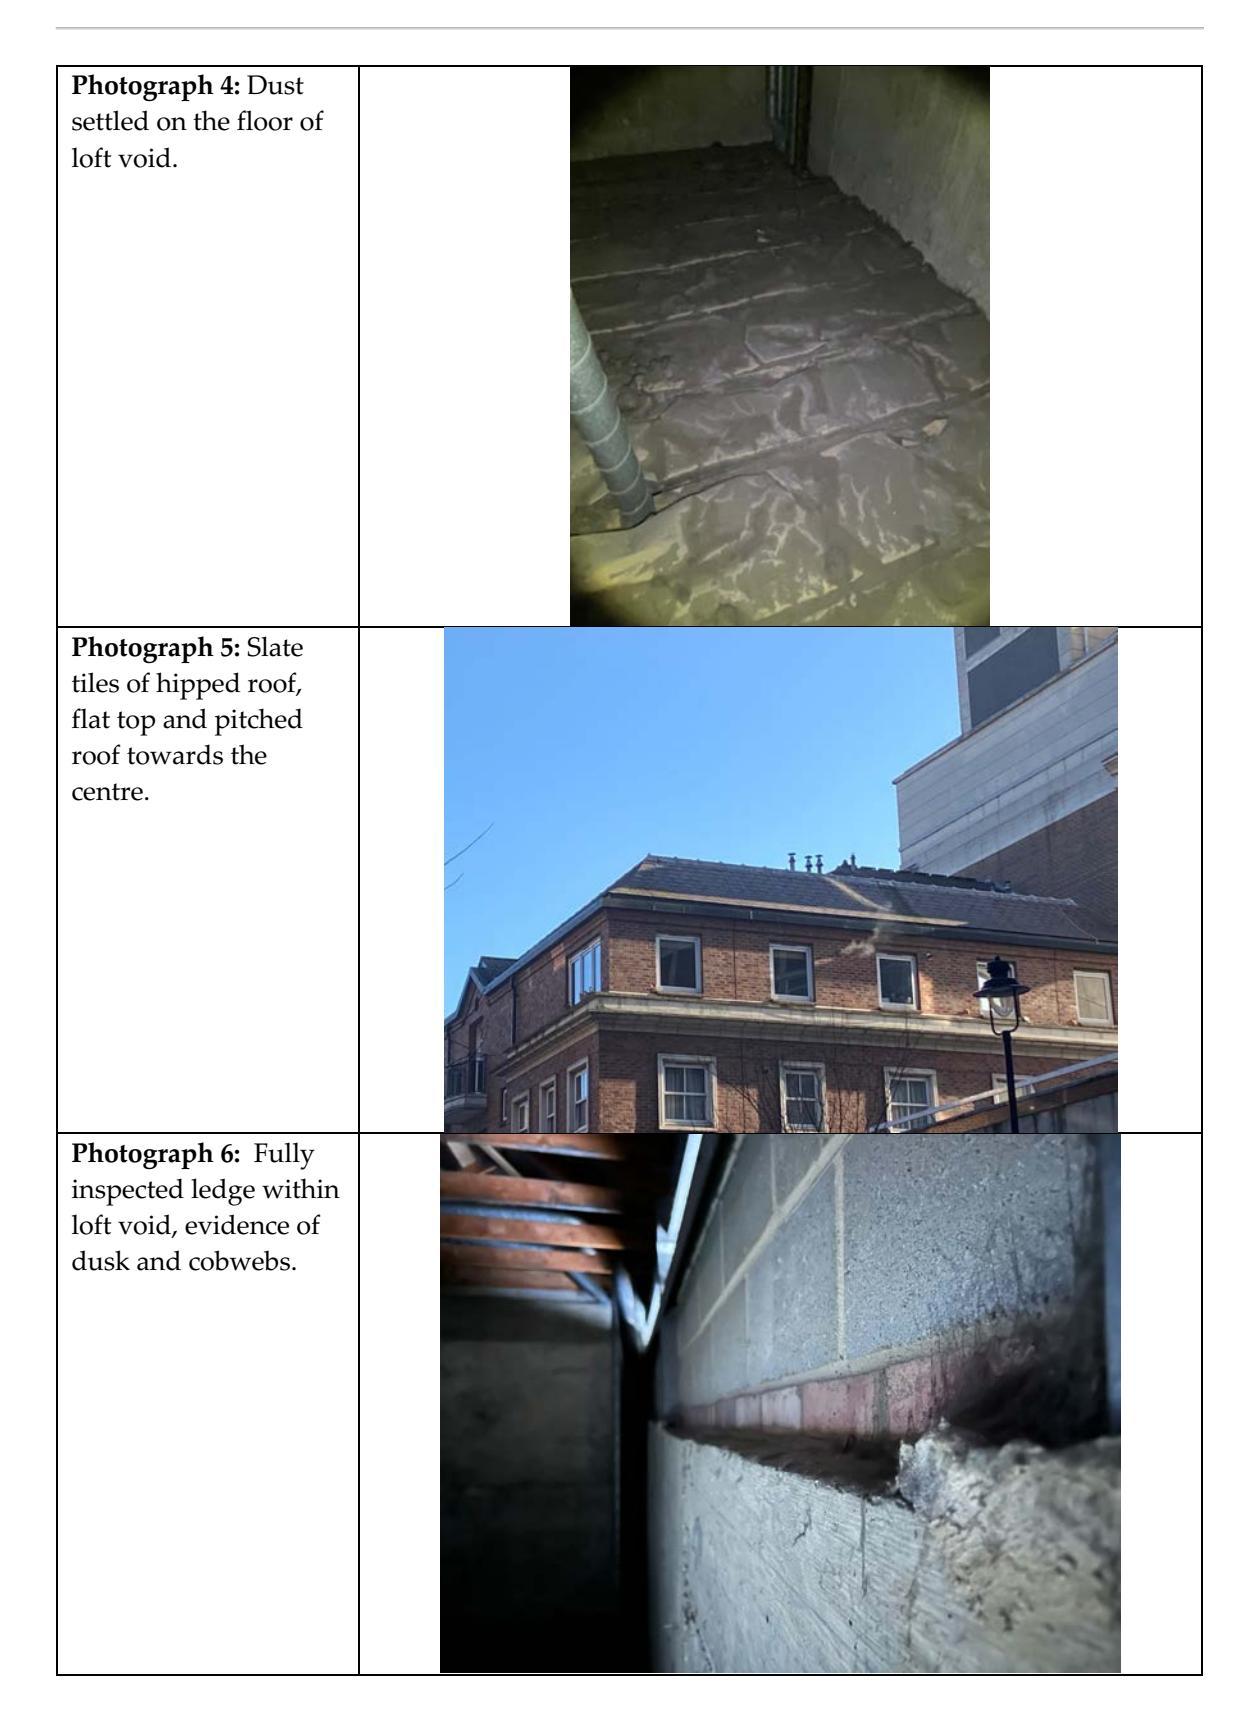
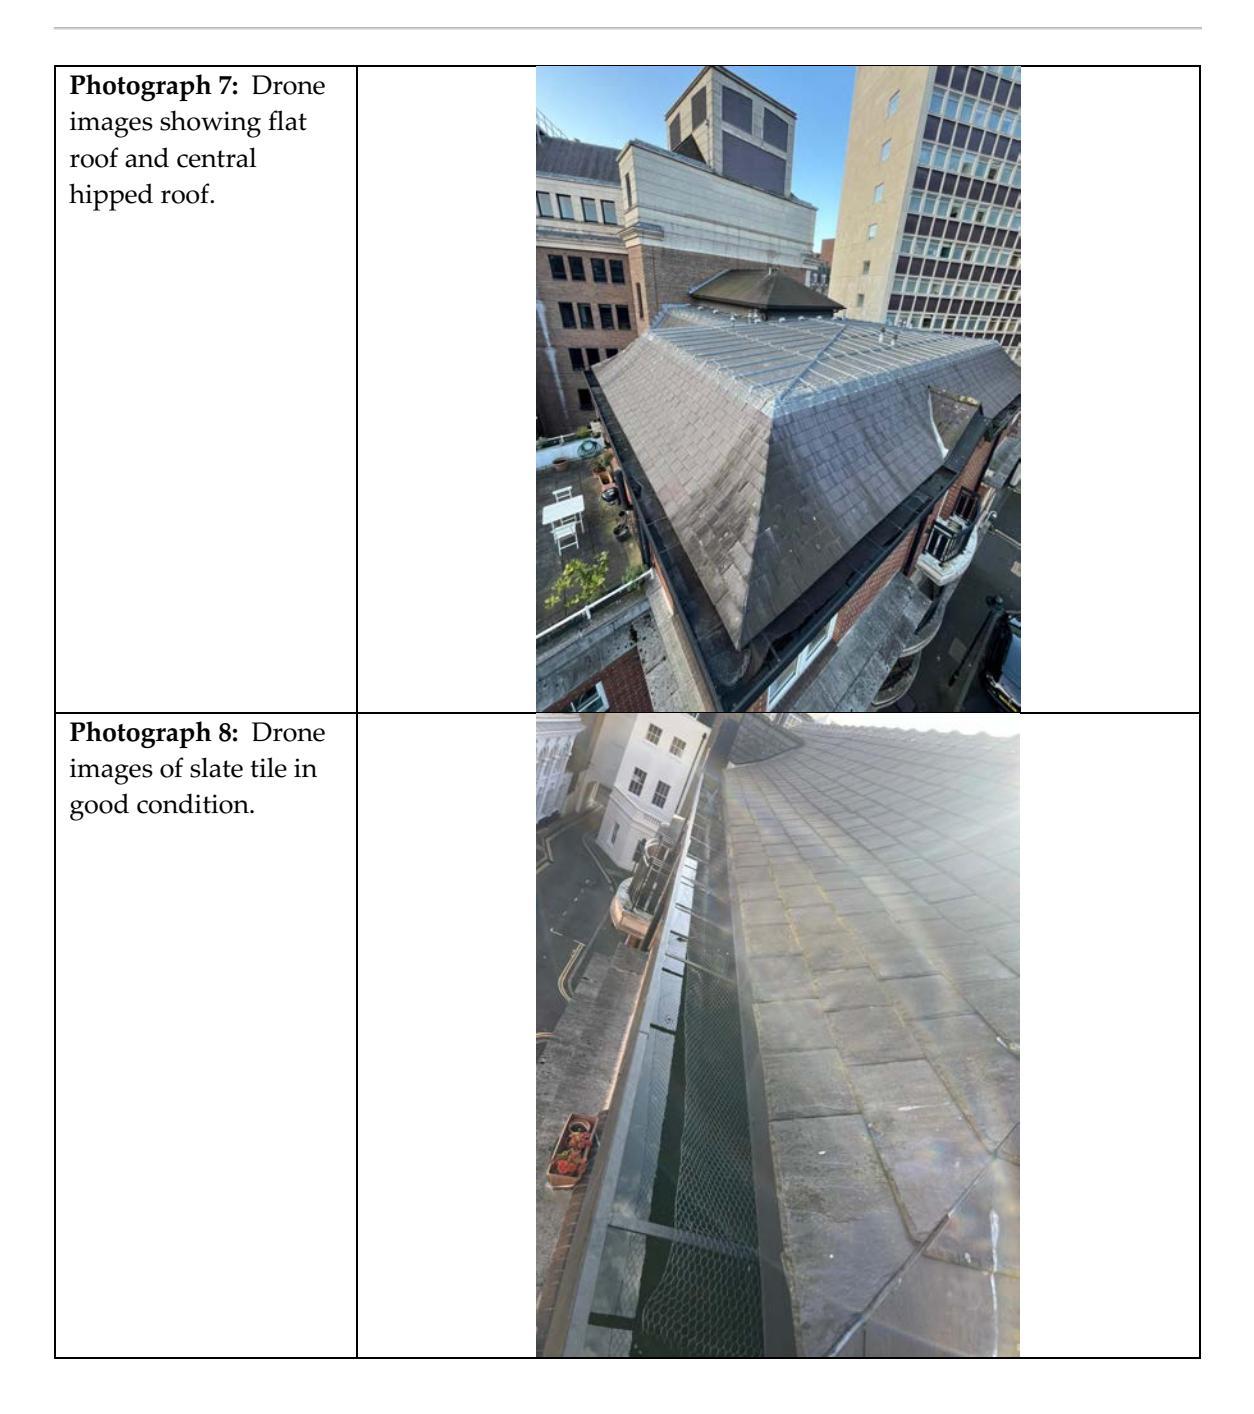
Photograph 1: View of loft void, showing air vent and lining in good condition.	
Photograph 2: Apex of loft void showing timber beams and plastic lining in good condition.	
Photograph 3: Air vent, which extended along each wall of the loft void. Mesh grate present on inside of vent.

- 3.6 Internally, only the central hipped roof loft void of the building was assessable. This hipped roof supported a large loft void, comprising timber beams and a plastic lining. The loft void was dark, and the lining appeared new and in good condition. This loft void was fully accessible at the time of the survey and no bats or evidence of bats were observed, with no droppings or feeding remains identified. The loft void was very dusty, supporting cobwebs which were undisturbed, suggesting limited movement within the void. An air vent ran along all aspects of the void; however, this was supported by a metal mesh grate, limiting internal access for bats. No other clear entry or exit points for bat were identified throughout the survey.
