Arboricultural Method Statement & Tree Protection Plan – In Accordance with BS 5837:2012

Proj. No 11118	The Edinboro Castle, 57 Mornington Terrace, Camden, London, NW1 7RU								
	Clie	Baxter Glaysher C	onsulting Limited						
Date of F	Report:	23/12/2024	Revision:	Original

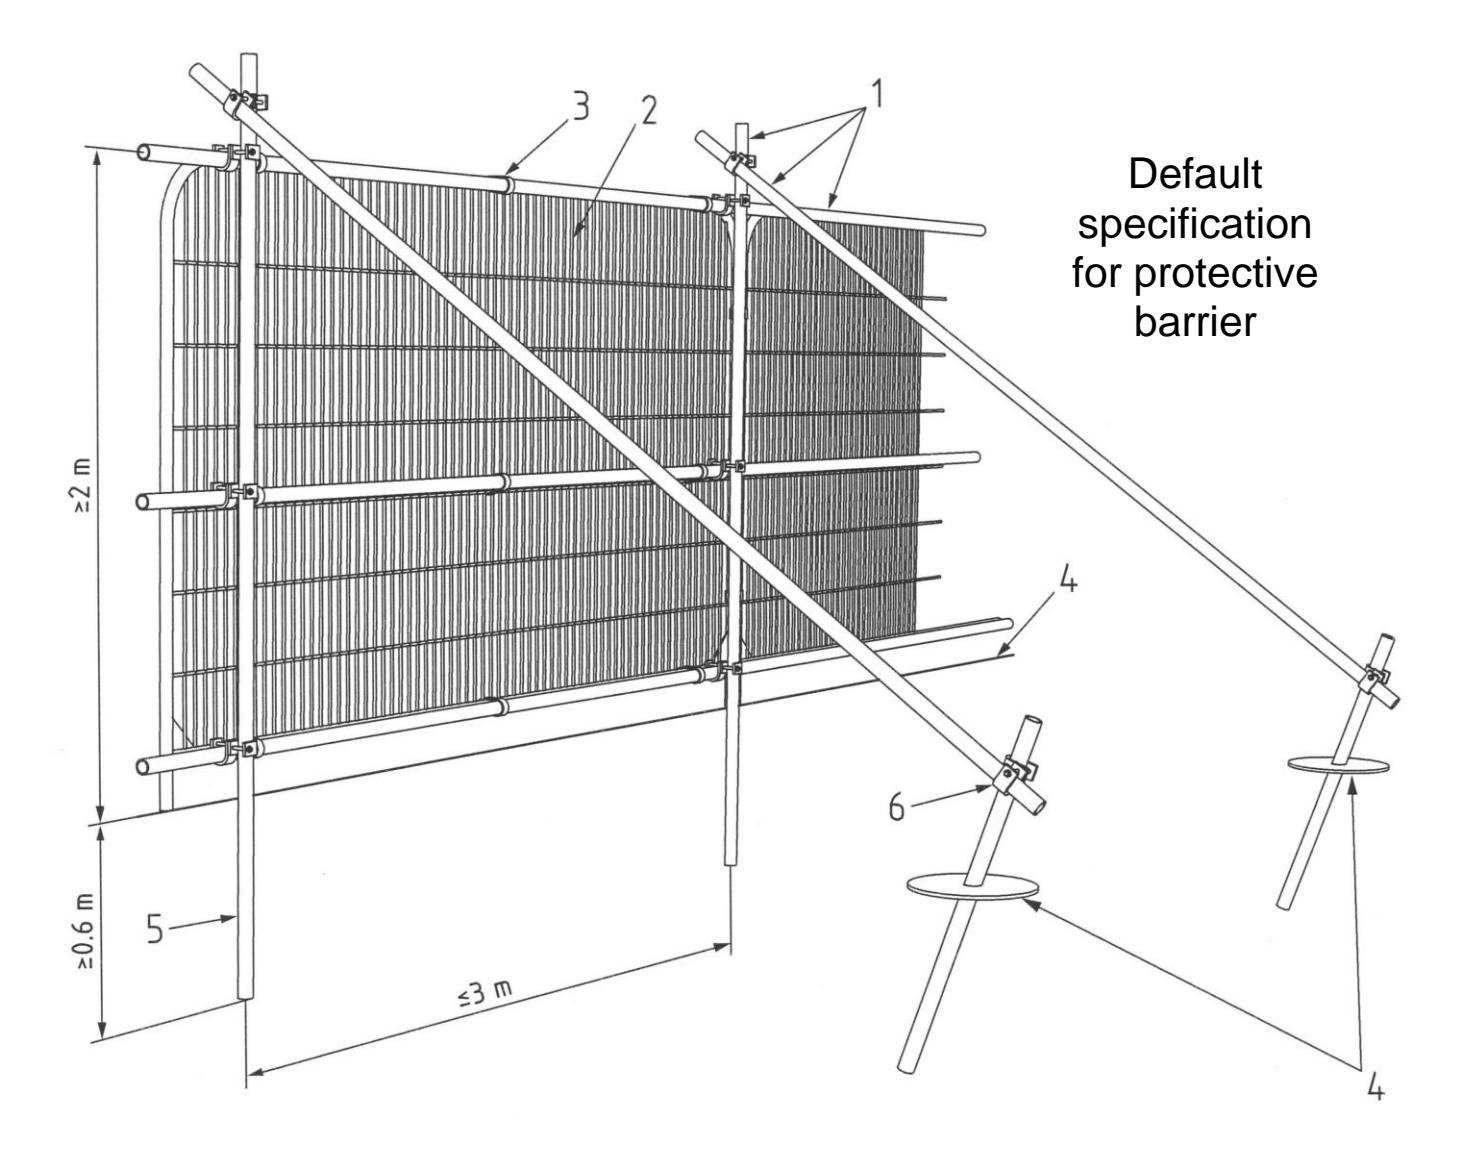
Key

- 1 Standard scaffold pole
- 2 Heavy gauge 2m tall galvanised tube and welded mesh infill panels
- 3 Panels secured to uprights and cross-members with wire ties
- 4 Ground level
- 5 Uprights driven into the ground until secure (minimum depth 0.6m
- 6 Standard scaffold clamps

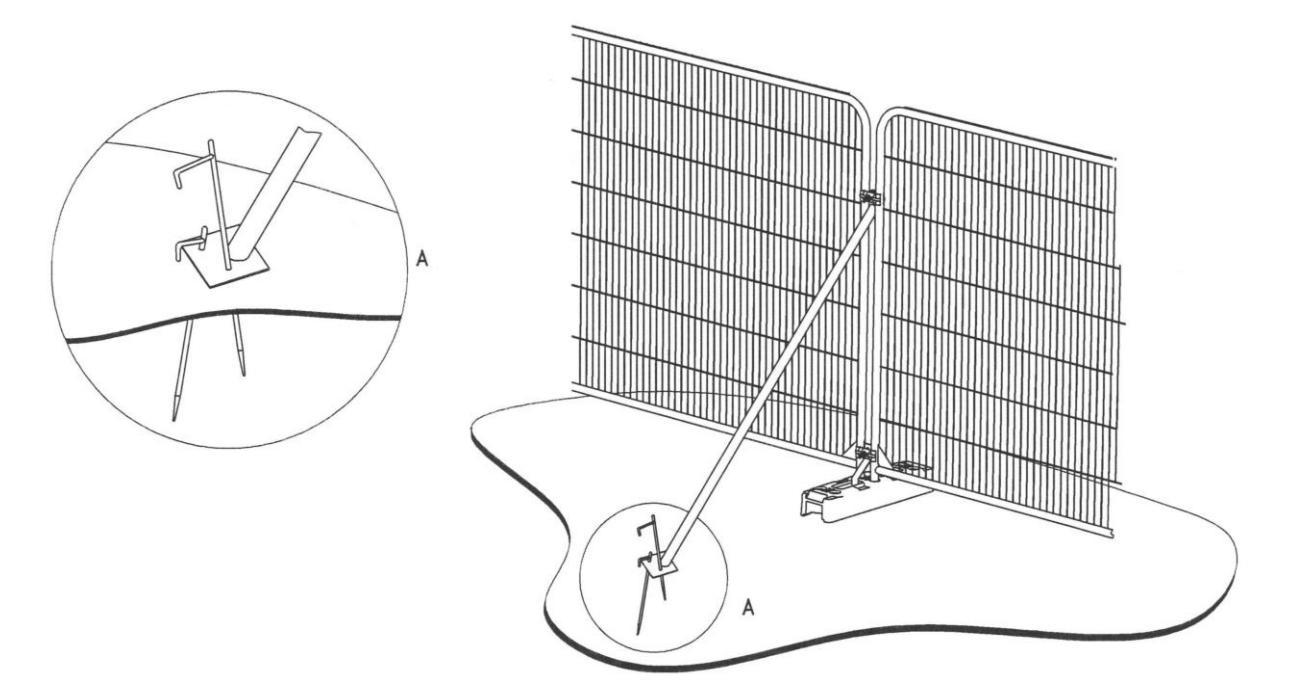
4. BS 5837:2012 Figure 3: Examples of above-ground stabilizing systems

a) Stabilizer strut with base plate secured with ground pins

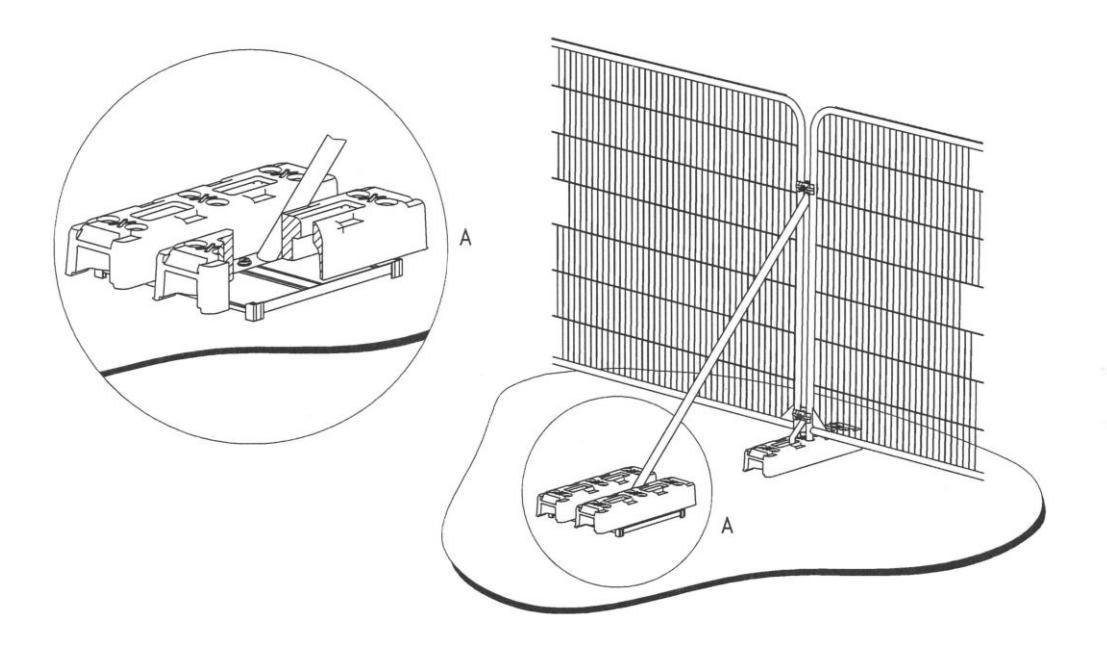
b) Stabilizer strut mounted on block tray

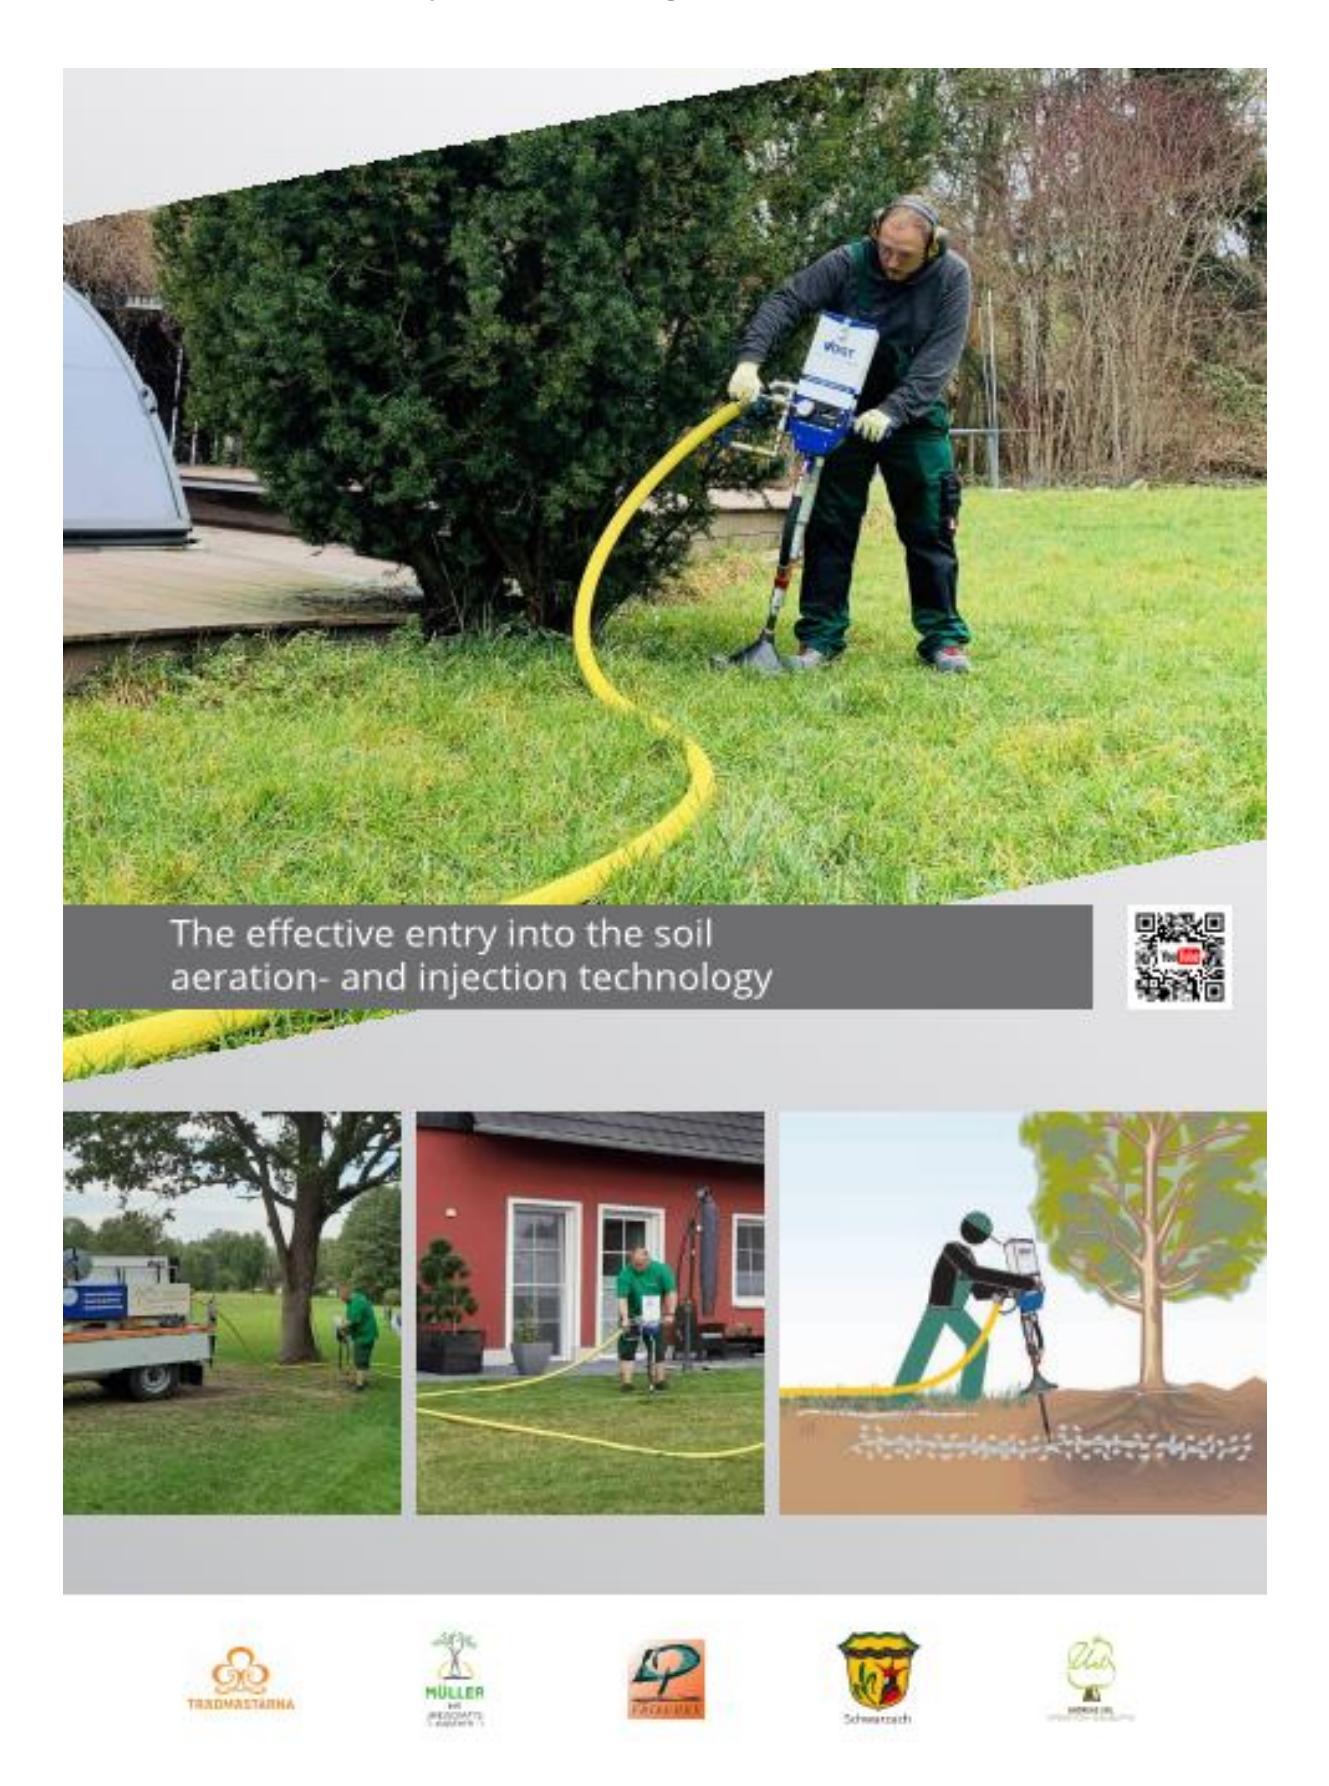
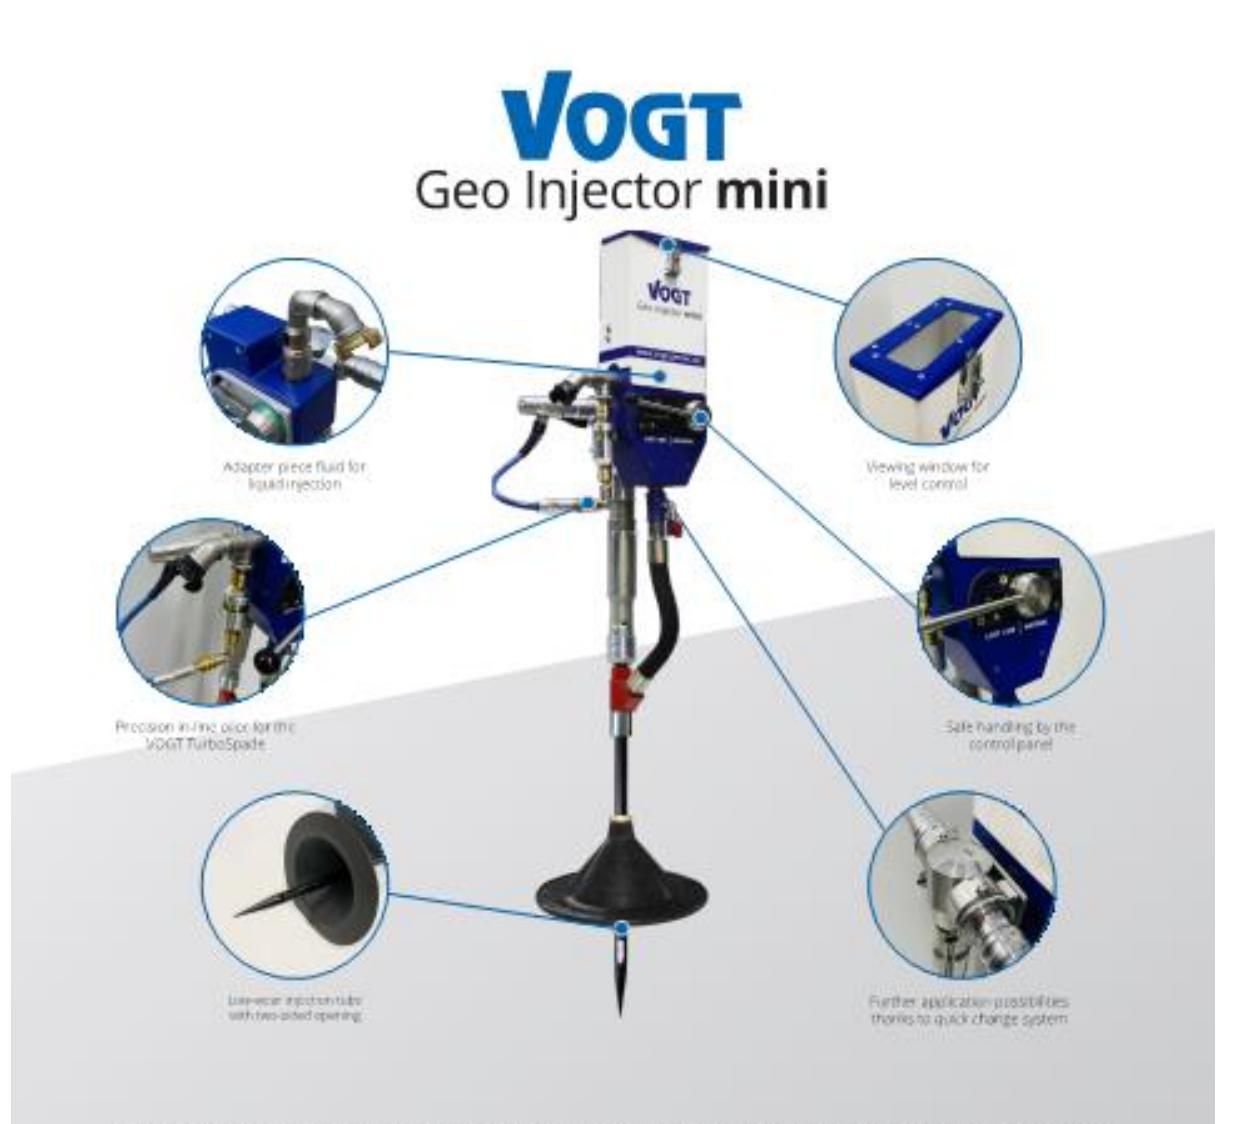
7. VOGT Soil Aeration and Injection Technologies

The smallest soil aerating- and injection device of the Geo Injector family enables the injection of granules, water storage, liquid fertilizers, water and air.

The container holds 2 liters of granules (max. grain size 4mm) and can be filled quickly and easily. The integrated viewing window enables level control. By the engaging lever in the control panel the aeration or injection takes place. This process can be done individually in different depths. With a quick release fastener, the granule tank. can be exchanged with the optional fluid adapter piece. This makes it possible to use water and liquid fertilizer with an inlet pressure from 2 bar (pump, domestic water pipe). The VOGT Turbo-Spade can also be used for grave-stem and compaction works.

- 2.6.4 Once the piling mat and existing hard surfacing has been removed, soil decompaction and mulching will be undertaken. This will be completed using a machine such as a VOGT Soil Aeration system or equivalent. The mulch to be used must be a humus rich mixture with added biochar.

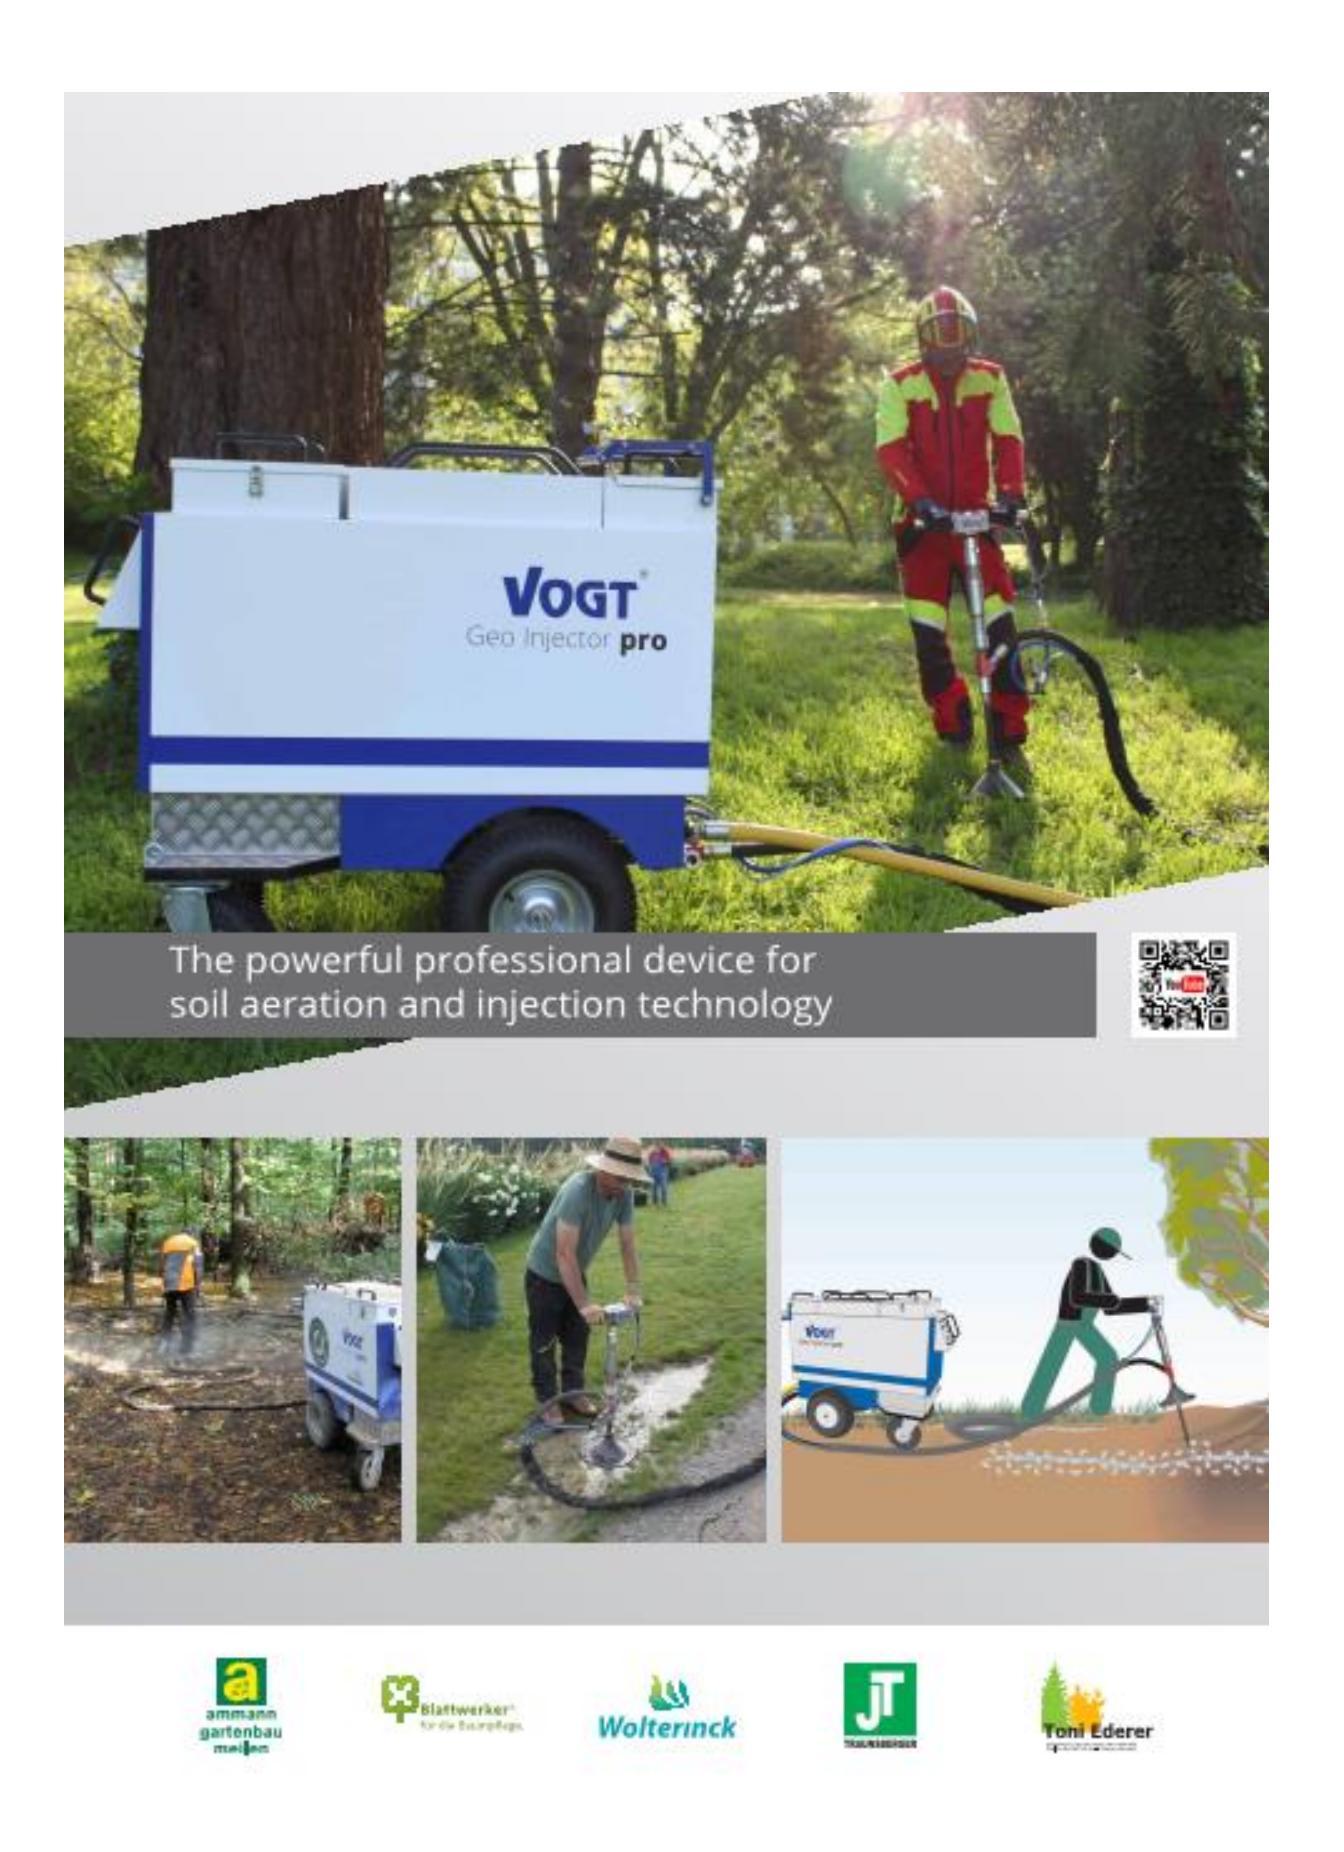
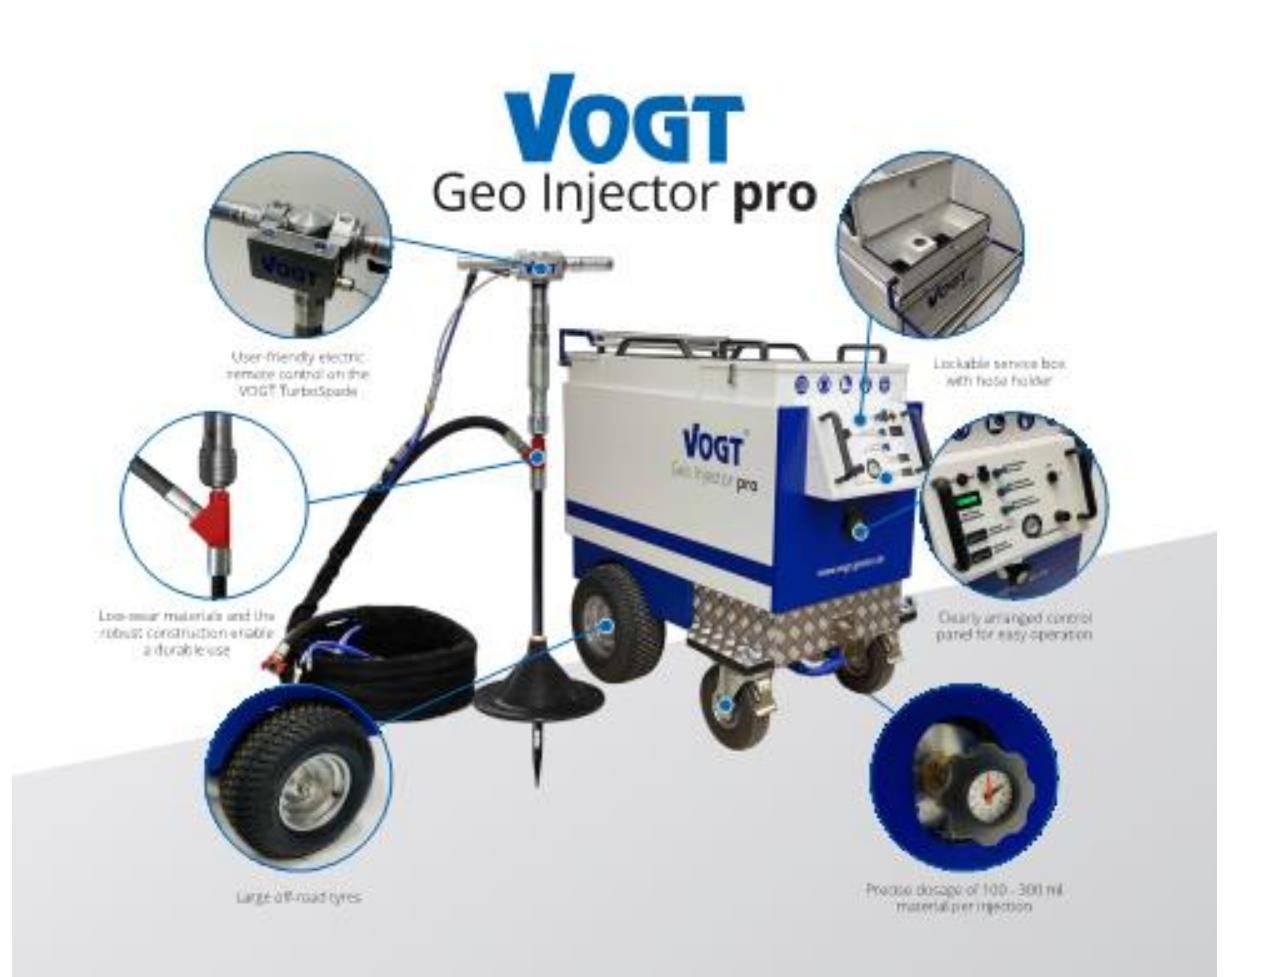
Constant injection volume through adjustable dosages and the best possible soil aeraton with large buffer storage capacity, for the processing of large order volumes.

The 40-liter material tank can be filled with granules up to 4mm grain size at any time without switching the mechanism pressureless. Flexible working is possible due to the 7 m (optional 10 m) long injection has around the supply unit. The quantity-adjustable dosing chamber in combination with the electrical trigger technique on the VOGT TurboSpaten enables fast and reliable work. This process can be done individually in diferent depths. The powerful filter technology deans the compressed air and removes moisture, which is particularly important at water storage granules. Two 25-liter buffer tanks are designed and tested according to the AD 2000 regulations

and ensure sufficient aeration and loosening power, which is especially in heavy soil needed. The clear control panel offers the option of a stepless injection pressure setting of 4-10 bar, the number of dosages as well as injections are counted digitally. The large, lawn-friendly pneumatic tires enable easy positioning in the field. Optionally, the VGI pro can also be equipped for liquid injection. For non-European countries, the buffer tanks are also available according to the ASME regulations. The device operating pressure is designed for 10 bar. The VOGT TurboSpade can also be used for digging- stem and compaction works.
