# Royal Academy of Dramatic Arts (RADA), London. Fire Precaution Works at RADA Studios, 16 Chenies Street, London WC1E 7EX

Dr. Folake Ekundayo. PhD Architecture Dip Surveying RIBA

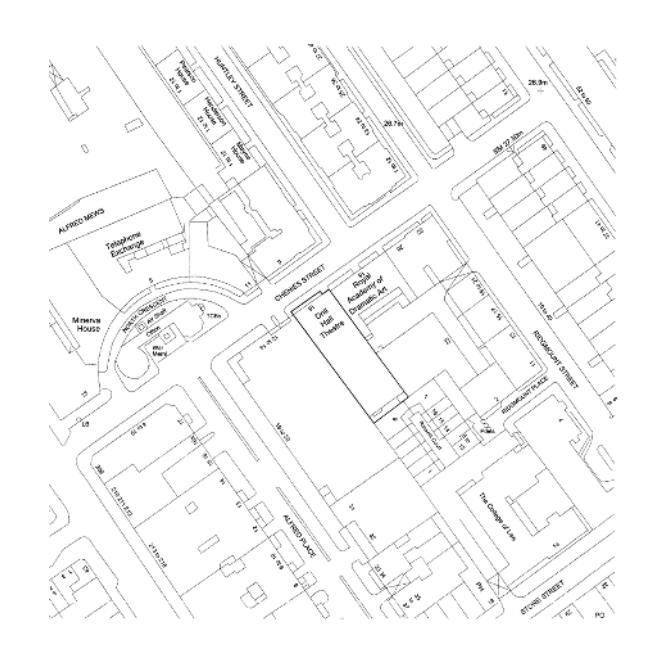
Fig 3 – Site / Block Plan of the Drill Hall Theatre next to the RADA building on Chenies Street.

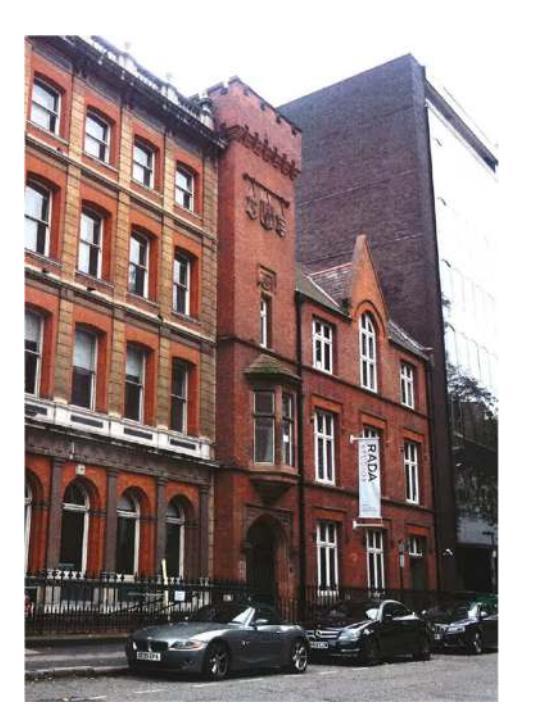
**Fig 6** – Street elevation of Drill Hall from the battlemented entrance tower side. A battlement is a notched parapet usually found on top of a fort or castle that has regularly spaced squared openings or embrasures for shooting through.

Fig 6 – Drill Hall, Chenies Street

**Exterior**: The building has 3 storeys visible at street level, with a basement. The front elevation is made up of 3-window symmetrical facade with a battlemented entrance tower to left.

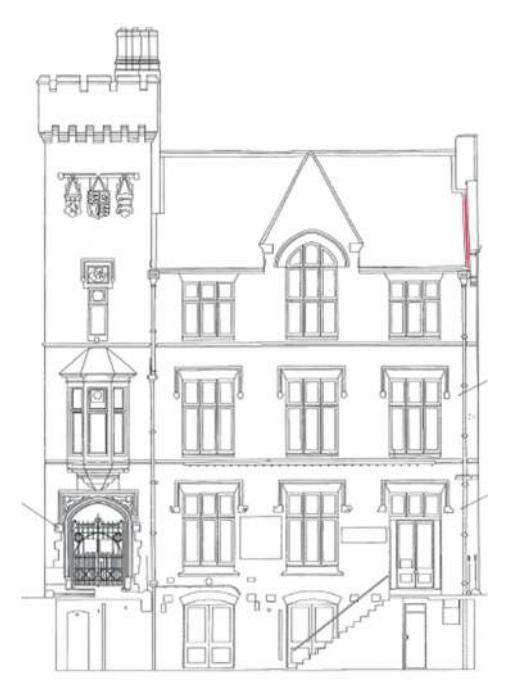
**Fig 7 below**: The entrance arch on the ground floor has a hood mould with carved Burgesion crowned lion-label stops and rose and riband spandrels.

Fig 7 – Drill Hall, Chenies Street

There is an oriel window right above the entrance door on the tower battlement on the first floor with 3-casement light and mullion windows.

On the second floor there is a narrower window with an over-panel depicting the hanging horn, the symbol of the Rifle Brigade to which the Bloomsbury Rifles was affiliated.

Above this window are three shields portraying, from left to right, the arms of the Duke of Bedford (the ground landlord), the royal arms and those of the county of Middlesex. To the right and on the second floor are 3-light transom and mullion windows with gauged brick flat-arch heads. The central second floor window has a pointed hood mould and gable in gauged brickwork.

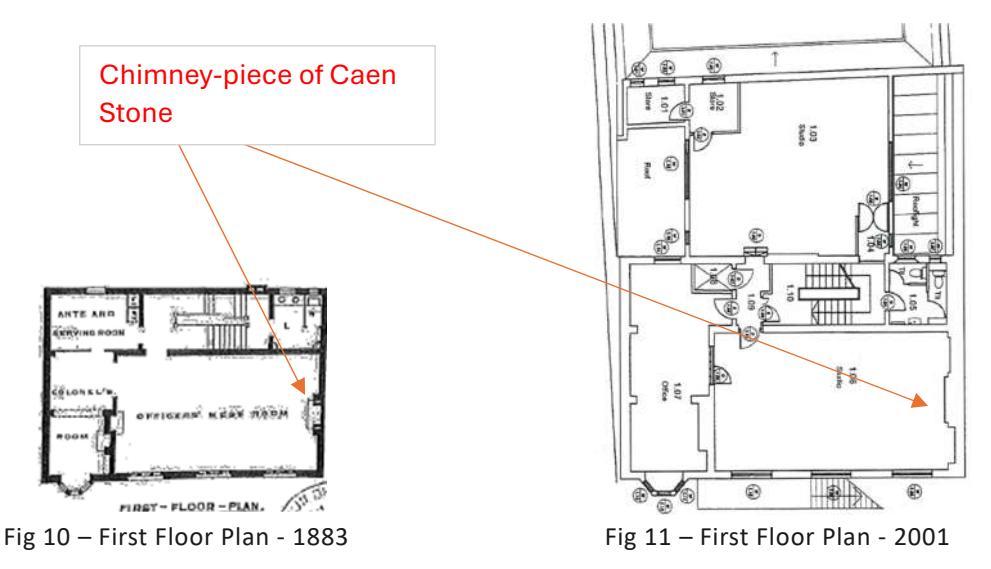
See Fig 10, 11 below showing the first-floor plans side by side.

Please note: The 1883 plan does not show the Studio and roof over the Ground Floor Drill Hall.

According to the Heritage Listing Citation, the floor officers' mess also has a good Gothic chimney-piece of Caen stone, enriched with a castellated canopy and the arms of commanding officers of the regiment. The ceiling and walls are panelled with diagonally-set deal planks. Adjoining the Officers' Mess is a small room with oriel window, which was the colonel's room. It also has a Gothic fireplace and panelling and more ornate fittings. The Officer's Mess has been converted to a Drama Studio, and the colonel's room is now an office. There is an opening formed off the landing which steps into another studio above the Drill Hall (see **Fig 11**).

It appears that all fireplaces and chimneys have been boarded over on all upper floors. As on the Ground Floor, our fire strategy will be to encapsulate them in Fireline boarding to provide fire compartmentation and protection to the structure without carrying out any invasive activities.

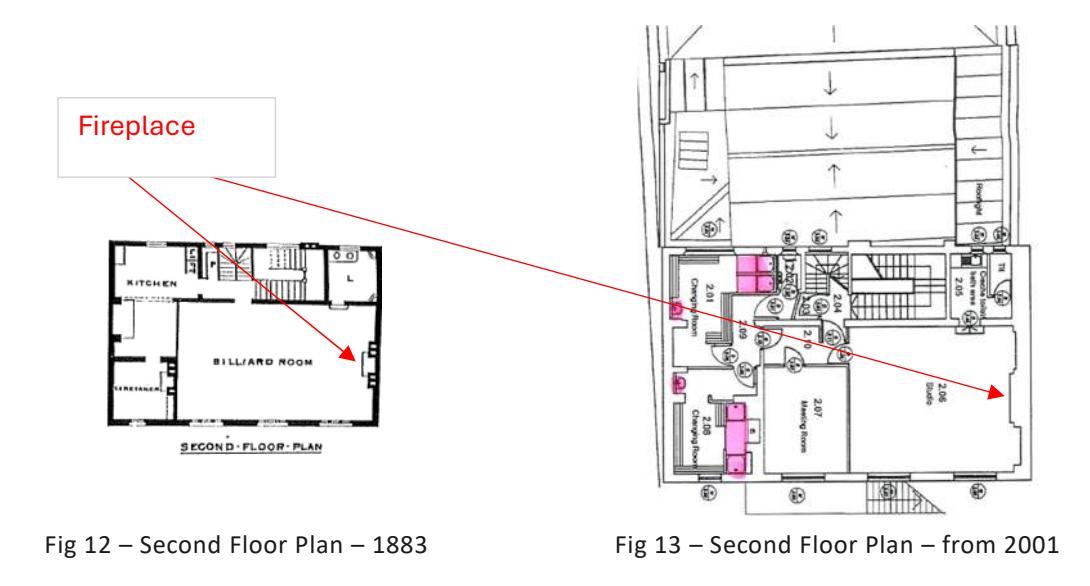
The 2001 floor plan shows that the 2<sup>nd</sup> floor 1883 Billiard Room has been partitioned to form a Rehearsal Studio and a Meeting Room. Showers and washbasins were installed in 2001 (see Fig 13 -highlighted in pink). It is proposed to strip out and remove these items.

On the 1883 plan on the second floor, there is a former billiard room, above the officers' mess, with a chimney-piece similar to that in the ground floor mess which will also be Fireline-boarded to provide fire compartmentation and protection.

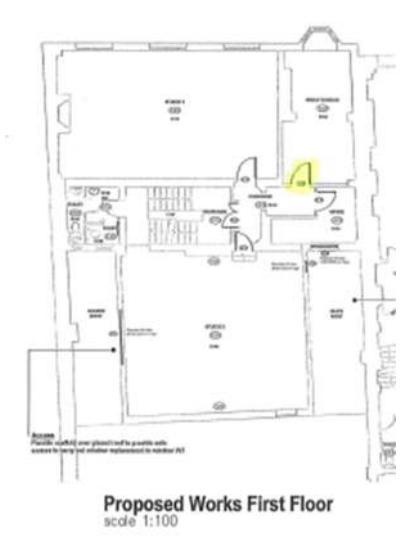
Fig 18 - First Floor Plan – Door D15

The door schedule showed that **16no** doors fell into this category (i.e. doors in fire compartment) and had to be replaced. One door **D15** to the Nancy Duguid Room on the first floor (i.e. former colonel's room with the oriel window on the front elevation) is being overhauled and made to be a fire door using the guidance document produced by the Institution of Fire Engineers Special Interest Group for Heritage Buildings. The document is entitled: *Guide to the fire resistance of Historic timber panel doors*.

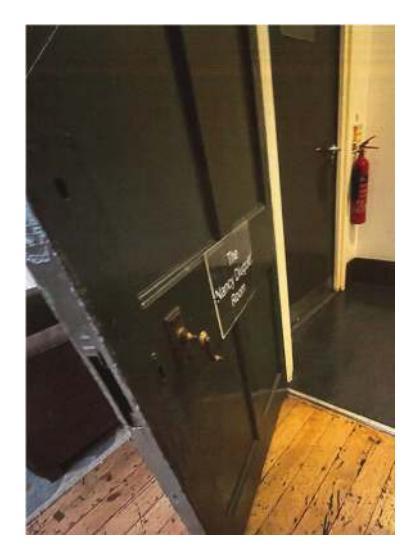
Fig 19 - D15 – Nancy Duguid Room

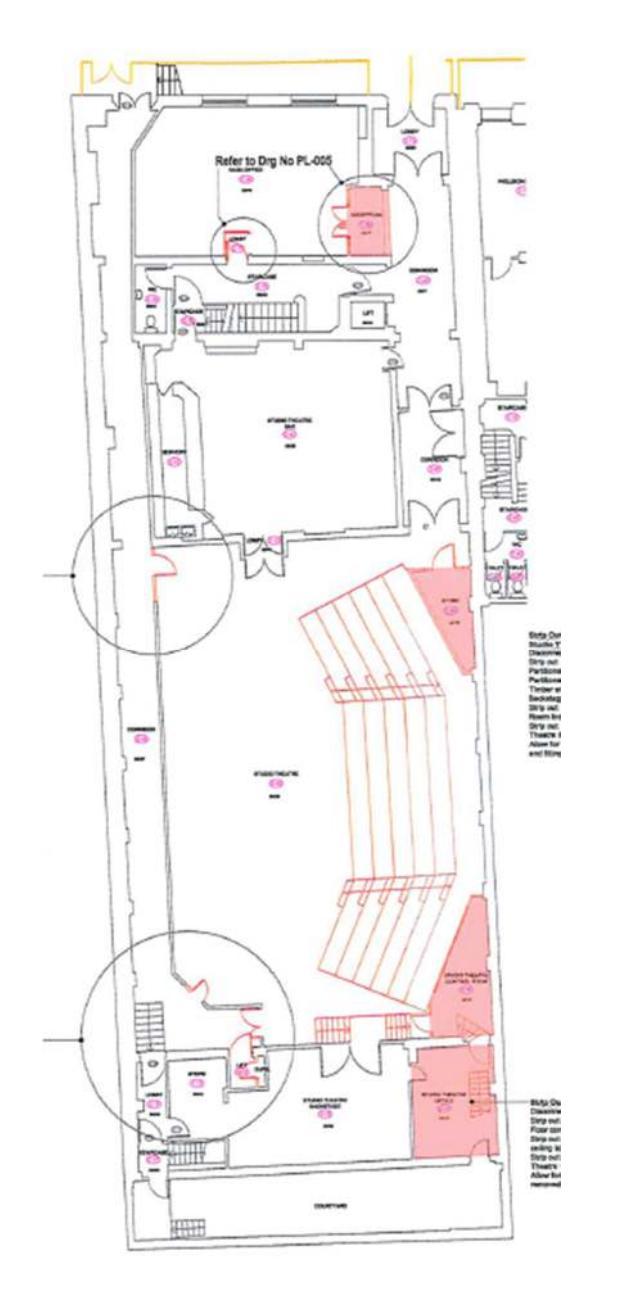
Fig 20 – Ground Floor – Strip Out Works

Fig 21 – Ground Floor – Proposed works

**3.6** <u>Academic Staircase Corridor</u>: An area of note was the academic staircase corridor on the ground floor, which is in the same compartment as the open stairwell. This was not clear on the plan, so was marked up as a 30min compartment instead of part of the 90min stairwell. Due to the large travel distance and presence of plasterboard walls that likely do not meet a 90min rating, it was recommend that the best solution was to add a new wall and doorset to enclose the staircase compartment. There is a void in the centre of the building that extends from the ground floor bar to the roof of the building. Little, if any, services enter this void but the glazing looking onto was only marked as having a 60-minute rating.</u>

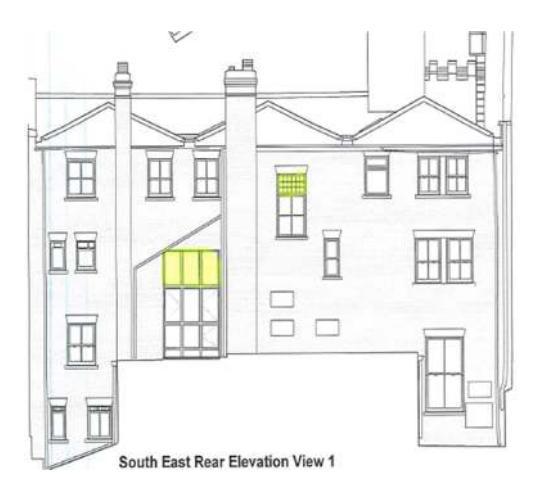
Fig 24 -Existing W5 and W11 to be replaced

Where smoke could be trapped in the single stairwell, smoke vents were to be provided to evacuate smoke in form of smoke louvres in existing windows and connected to and activated by the firealarm system. This is found in the South-East Rear Elevation of the building where two windows (W5 and W11) in the stairwell have had their transoms fitted with a natural ventilator product, Coltlite, which provides natural inlet and exhaust air as well as allowing natural daylight entry and can be used in the event of fire to provide natural smoke extract as a safety measure.

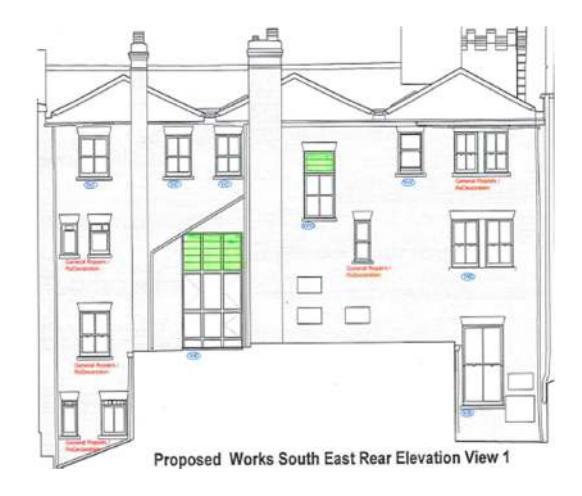
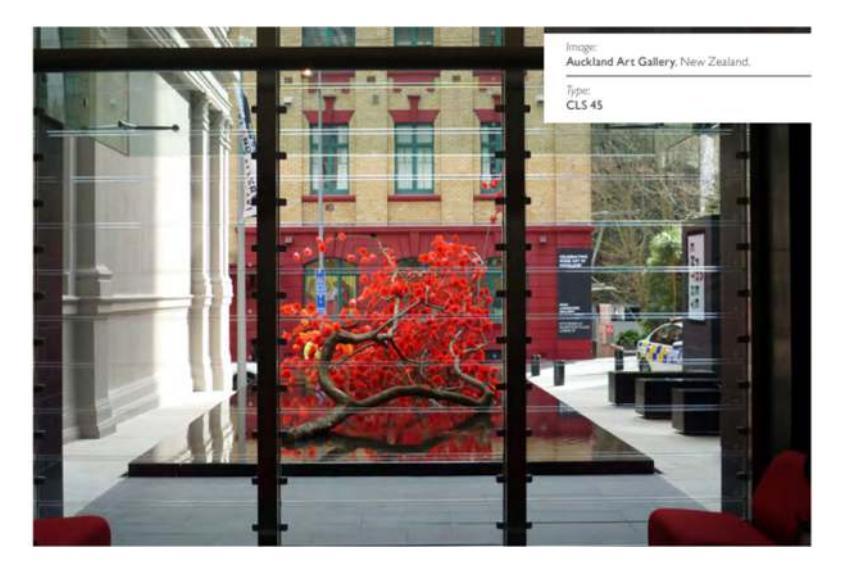
Fig 26 - Coltlite Louvre images

Fig 25 - W5 and W11 replaced with Coltlite louvres

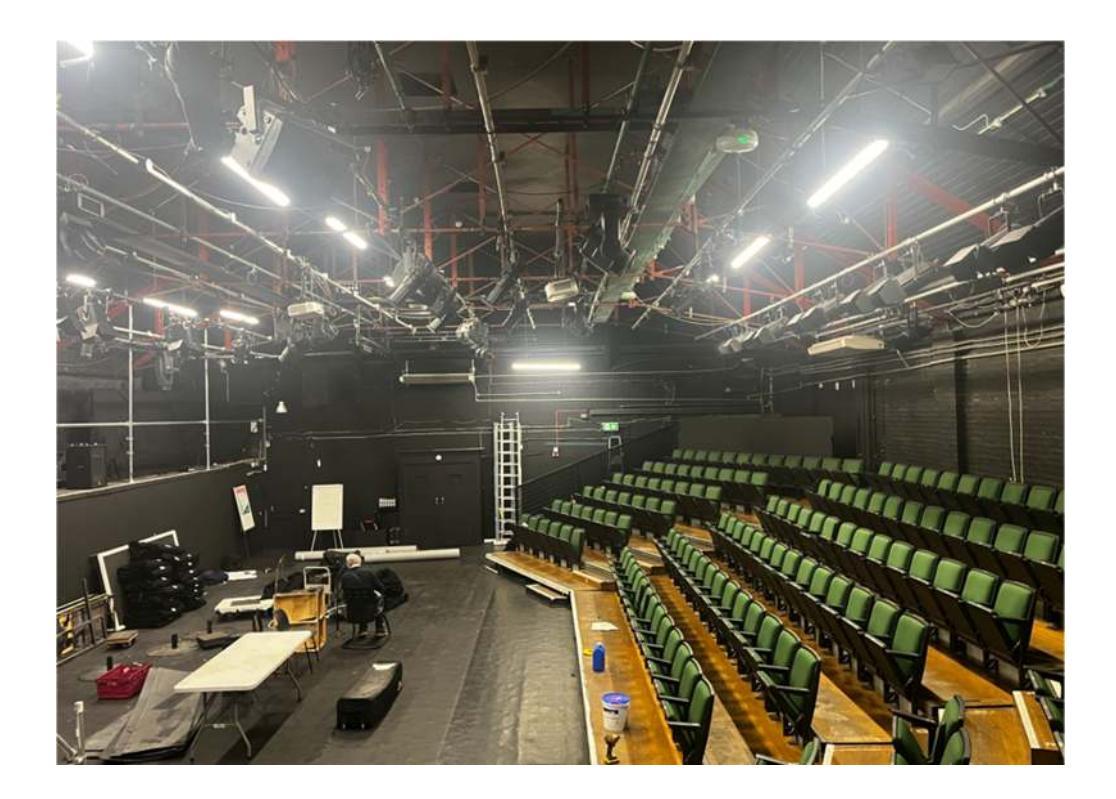
Fig 27 – The bleacher seating in the Drill Hall.

Part of the works is to convert the Ground Floor Drill Hall from the current performance hall to a rehearsal space. This takes the Hall back to the original Drill Hall layout in the 1883 building, where the Drill Hall was flat-floored and used for meetings, military instructions, indoor drills, band practices and gymnastic displays. The bleacher seating that was installed in 1984 will be removed (See Fig 27 below). As a result, the capacity of the Hall will be reduced to 60 persons, and because the exit doors open inwards to the Hall, this limits the number of people that can exit the space in an emergency to 60.
