Site Investigation Report

Auger Ref: 101134.3.BSI

Overview Auger were commissioned by Crawford & Co to undertake a site investigation within the area of concern (AOC) at the property. Findings Trial Hole 1 TH1 was completed in the desired location, we were able to expose the footings and collect soil and root samples to the requested depth. Trial Hole 2 Trial Hole Findings TH2 was completed in the desired location, we were able to expose the footings and collect soil and root

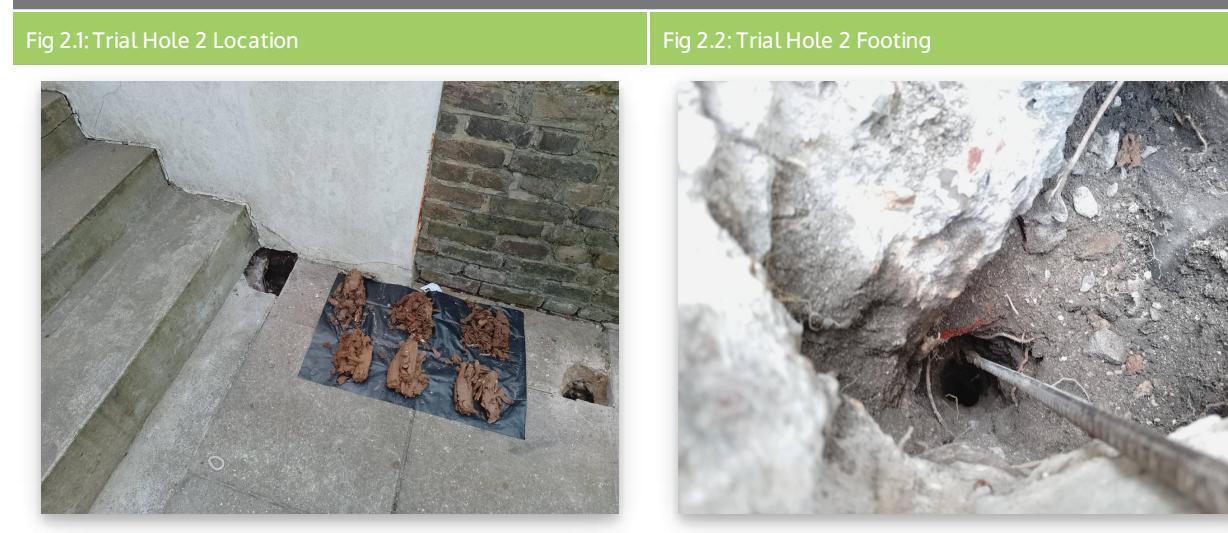
Trial Hole 2

samples to the requested depth.
