GROUND INVESTIGATION & BASEMENT IMPACT ASSESSMENT REPORT

24 BURGESS HILL LONDON NW2 2DA

Report Title:Ground Investigation & Basement Impact Assessment for 24 Burgess Hill, London, NW2 2DAReport Status:FinalJob No:P5943J3029/RAYDate:13/09/2024						
Version		Date	Issued By			
v2.0		24/04/25	SC			
Prepared by: JOMAS ASSOCIATES LTD For: VERVE CONCEPTS LIMITED Prepared by Ragul Yogarajah BEng (Hons), ICE Geotechnical Engineer R. Wummuh D.M. Cumu						
88 Di Me

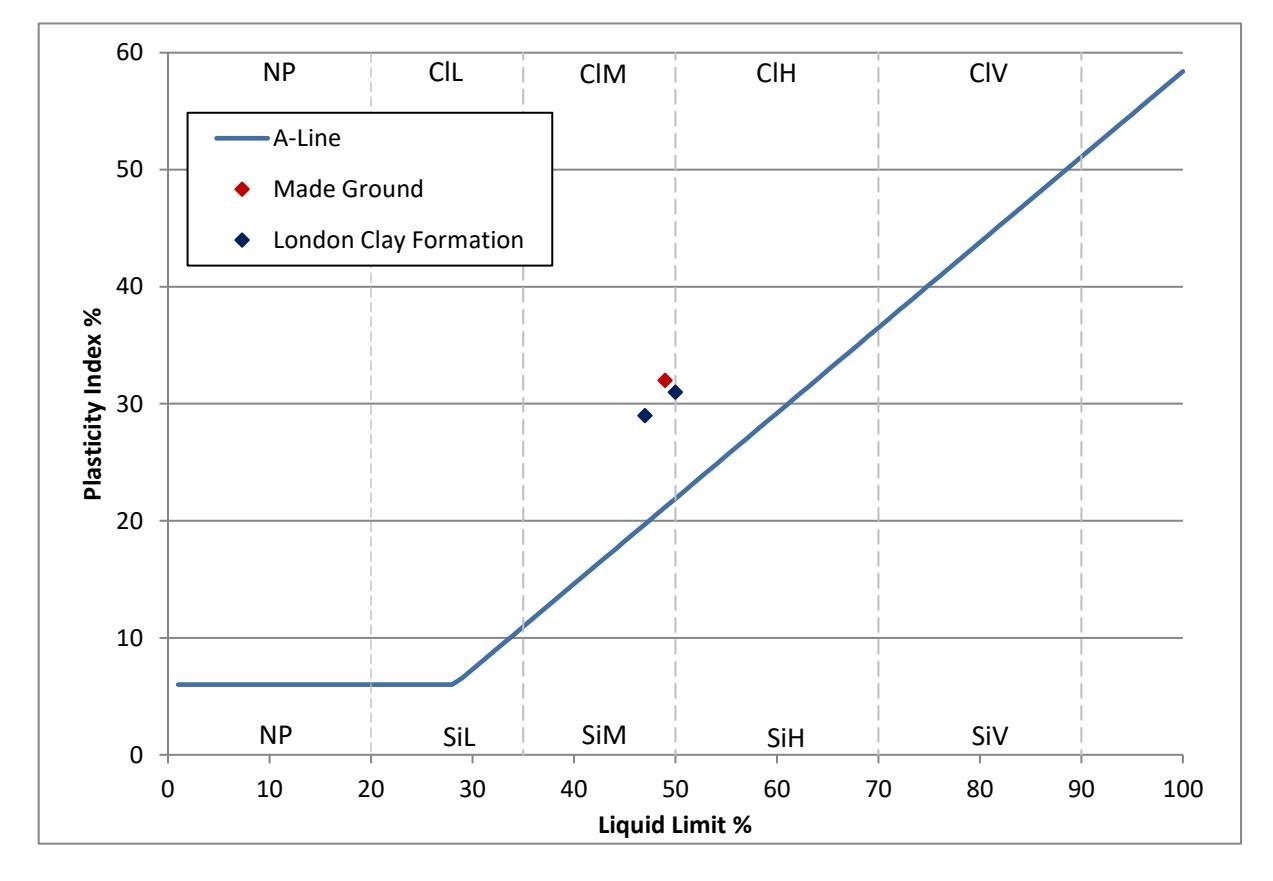
Figure 5.1: Plasticity Chart

- 5.2.1 Atterberg Limit determination was undertaken on 1No sample of the Made Ground at a depth of 0.5mbgl, and 2No samples of the London Clay Formation, at depths of 3.5m and 7.0m bgl.
- 5.2.2 A Plasticity Index value of 32% was recorded in the Made Ground, whilst values of 29% and 31% were recorded in the London Clay Formation, indicative of soils of intermediate plasticity, as illustrated in Figure 5.1 below.
- 5.2.3 Modified Plasticity Index values in these strata ranged from 28.16% to 31%, indicating soils with medium volume change potential.

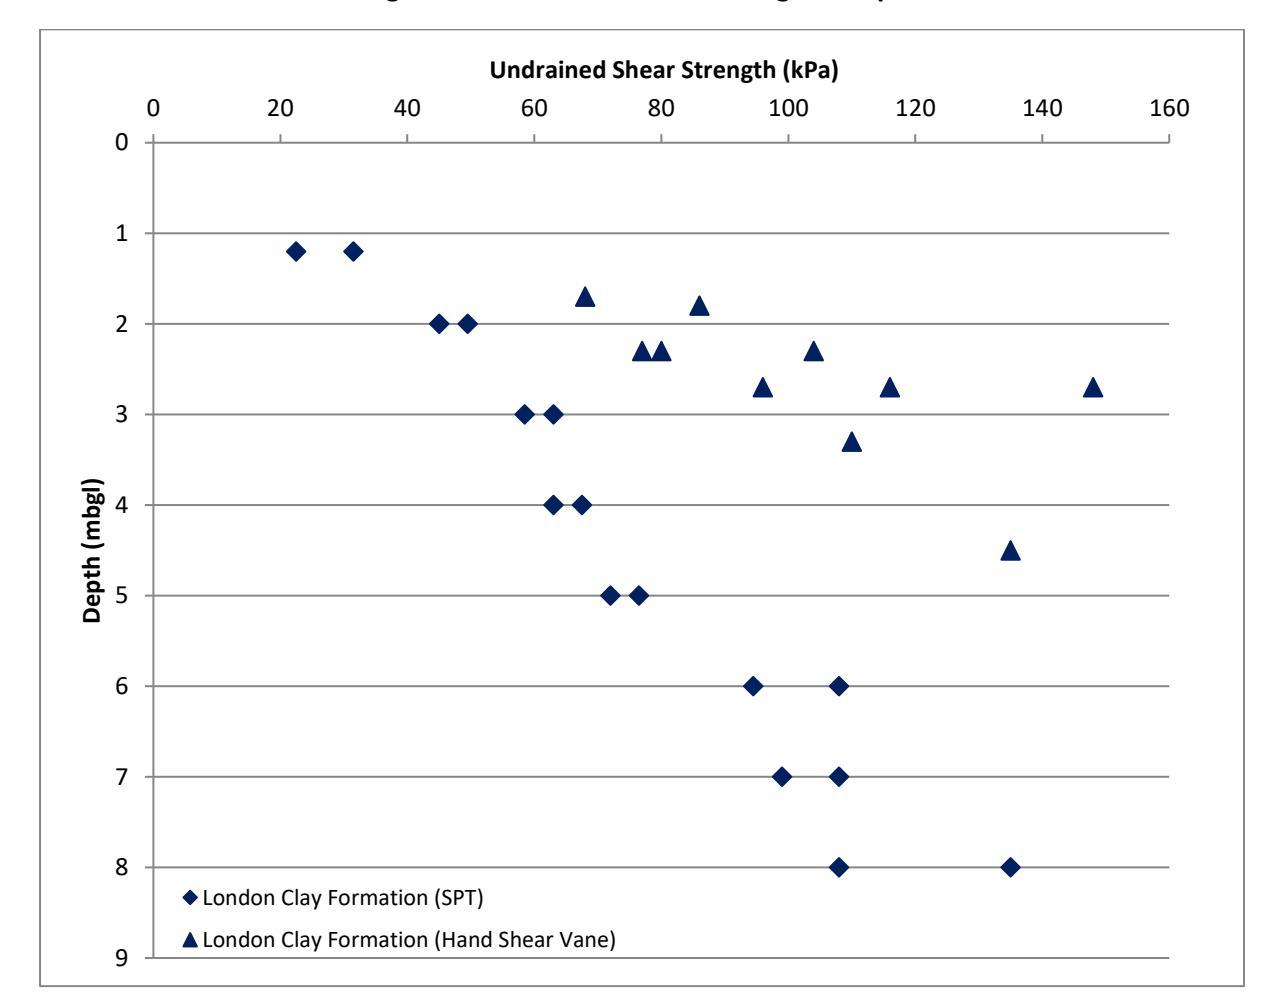
Figure 5.2: Undrained Shear Strength v Depth

- 5.4.6 As shown above, the shear strength of the London Clay Formation inferred from SPTs increases progressively with depth.
- 5.4.7 As expected the directly measured undrained shear strength values are slightly better than those inferred from SPTs.

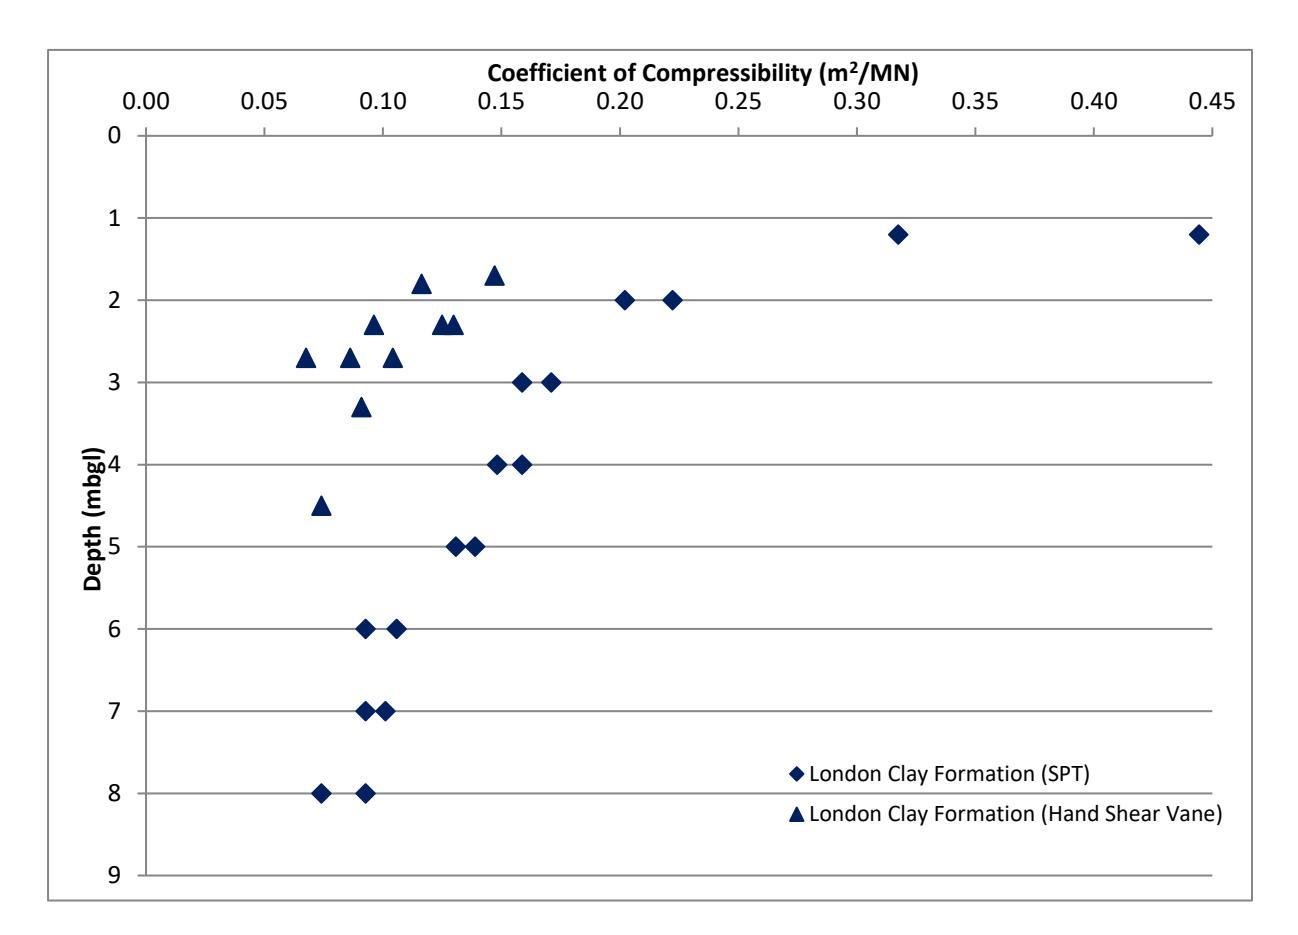
Figure 5.3: Coefficient of Volume Compressibility (mv) v Depth

- 5.5.2 Using the plasticity indices obtained and the graphs provided in Tomlinson (2001) a value of f_2 of 0.45 has been taken and used with the SPT N-values to infer coefficient of compressibility (m_v).
- 5.5.3 Where the undrained shear strength of the clays was measured by hand shear vane, the m_v value was calculated by rearranging the equations for f_1 and f_2 and substituting in the measured undrained shear strength.

- 5.5.4 As shown above, the values reduce with depth as the clay increases in strength and the over burden increases, reducing the potential for compressibility.
- 5.5.5 The shallow deposits of the London Clay Formation are generally of "medium compressibility". This is considered to be due to a combination of weathering and softening of the upper horizon of the London Clay, and the lack of overburden pressure at shallow depth allowing the clays to relax and so compress slightly when loaded.
