## Arboricultural Survey, Impact Assessment & Arboricultural Method Statement (BS5837:2012)

12 Pilgrims Lane London NW3 1SN

AIA/MF/0195/24/revA

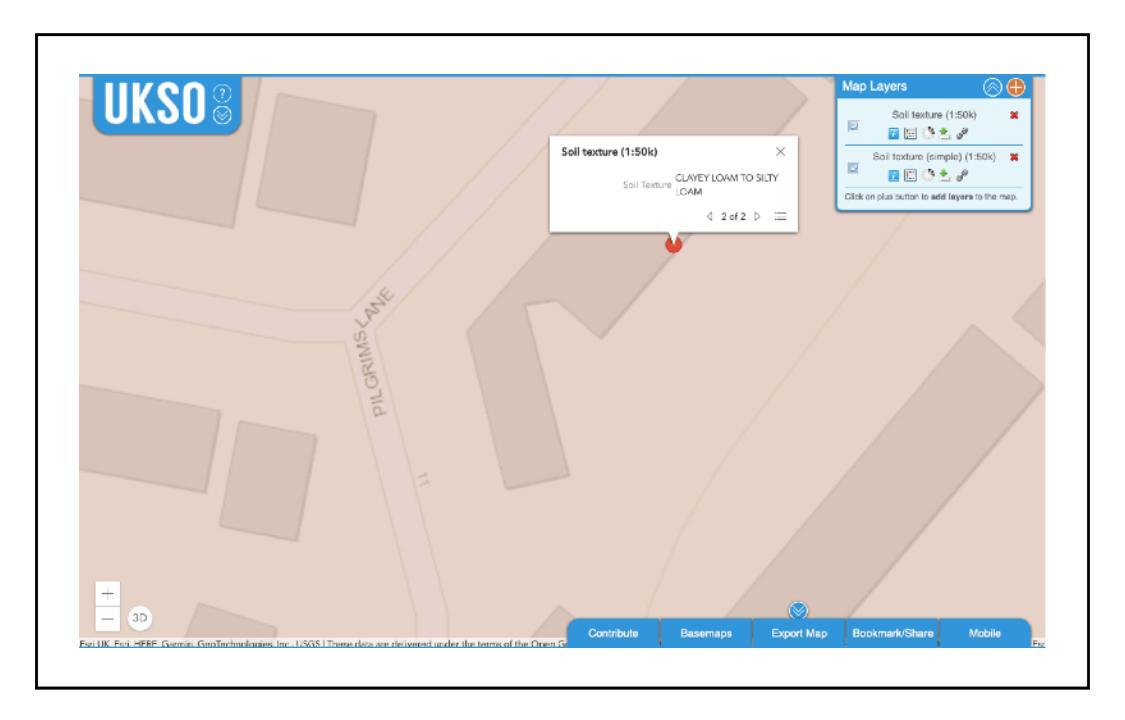
5.4 The underlying soil to this area is classified as 'clayey loam to silty loam' within the UK Soil Observatory - <u>www.ukso.org</u> - a medium to heavy soil mix as confirmed below:

5.5 The presence of a clay element within the soil is significant in terms of both tree protection and foundation design. Clay soils can experience substantial volume changes when vegetation extracts moisture from the ground and they are also prone to compaction when wet; the soil is deemed as being of medium heavy texture. Any foundations should also be designed in accordance with the recommendations contained within NHBC Chapter 4.2 (National House Building Council, 2010) and should account for the possibility of both subsidence and heave.

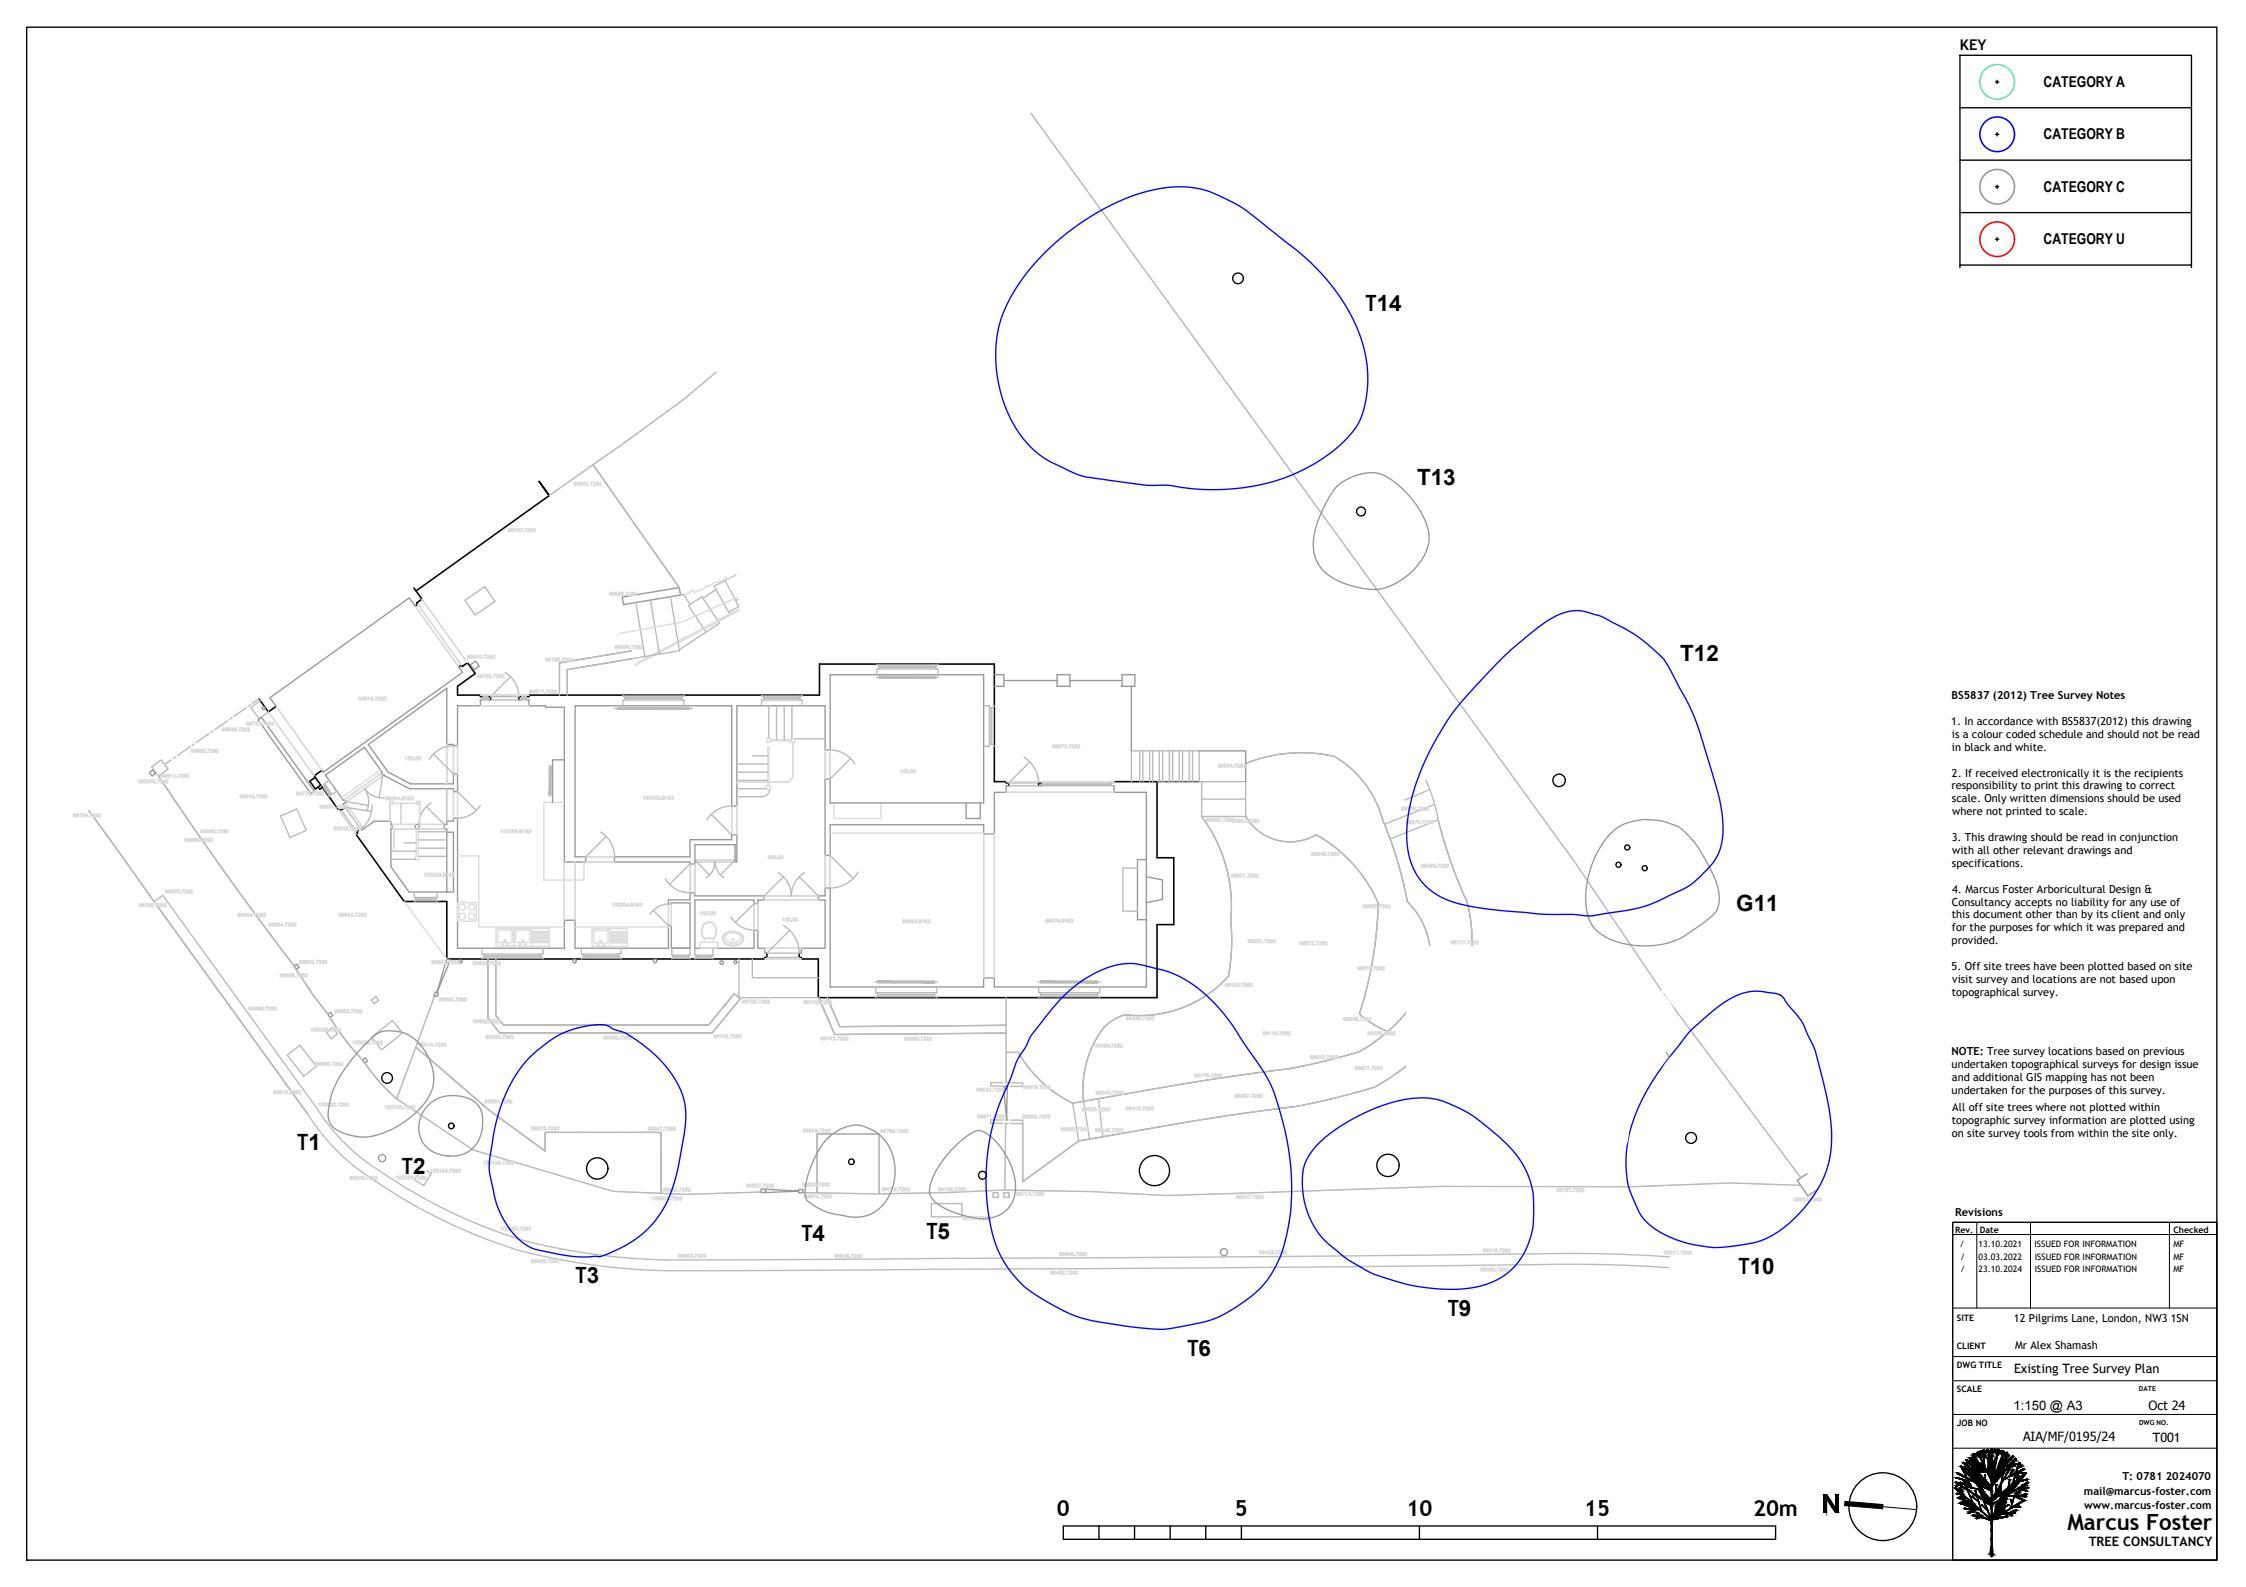
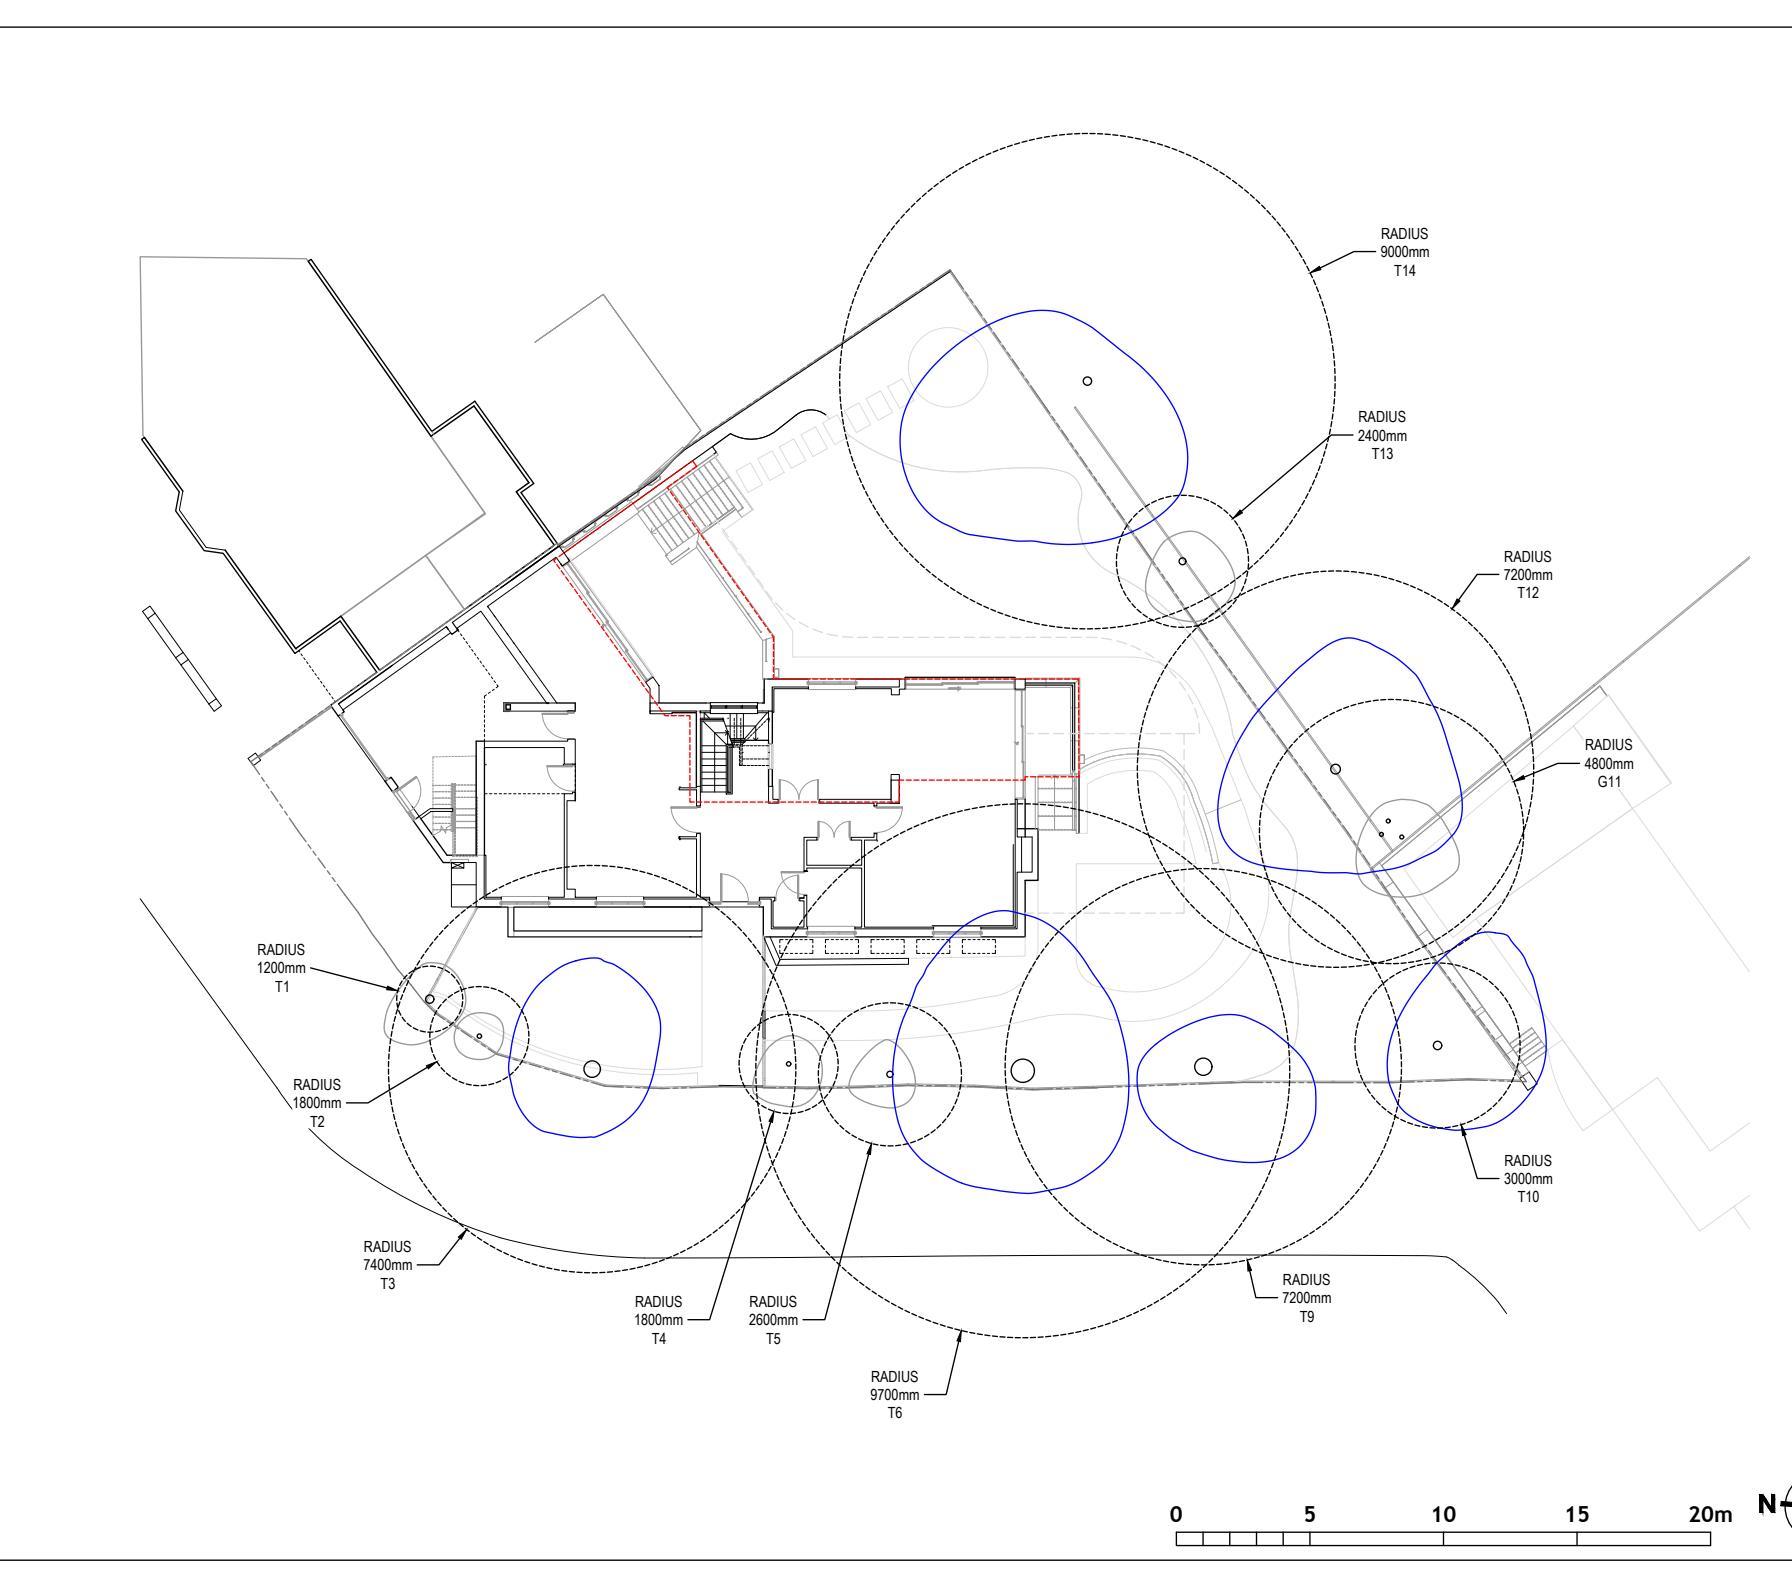
2.5 Findings as shown within *Appendix A* and assessed within *Section 5* are also highlighted within *Appendix B* which incorporates the Existing Tree Survey (T001), Tree Constraints Plan (TCP) - drawing T002 addressing areas where arboricultural solutions are required. The Tree Protection Plan (TPP) - drawing T003 provides outline tree protection measures.

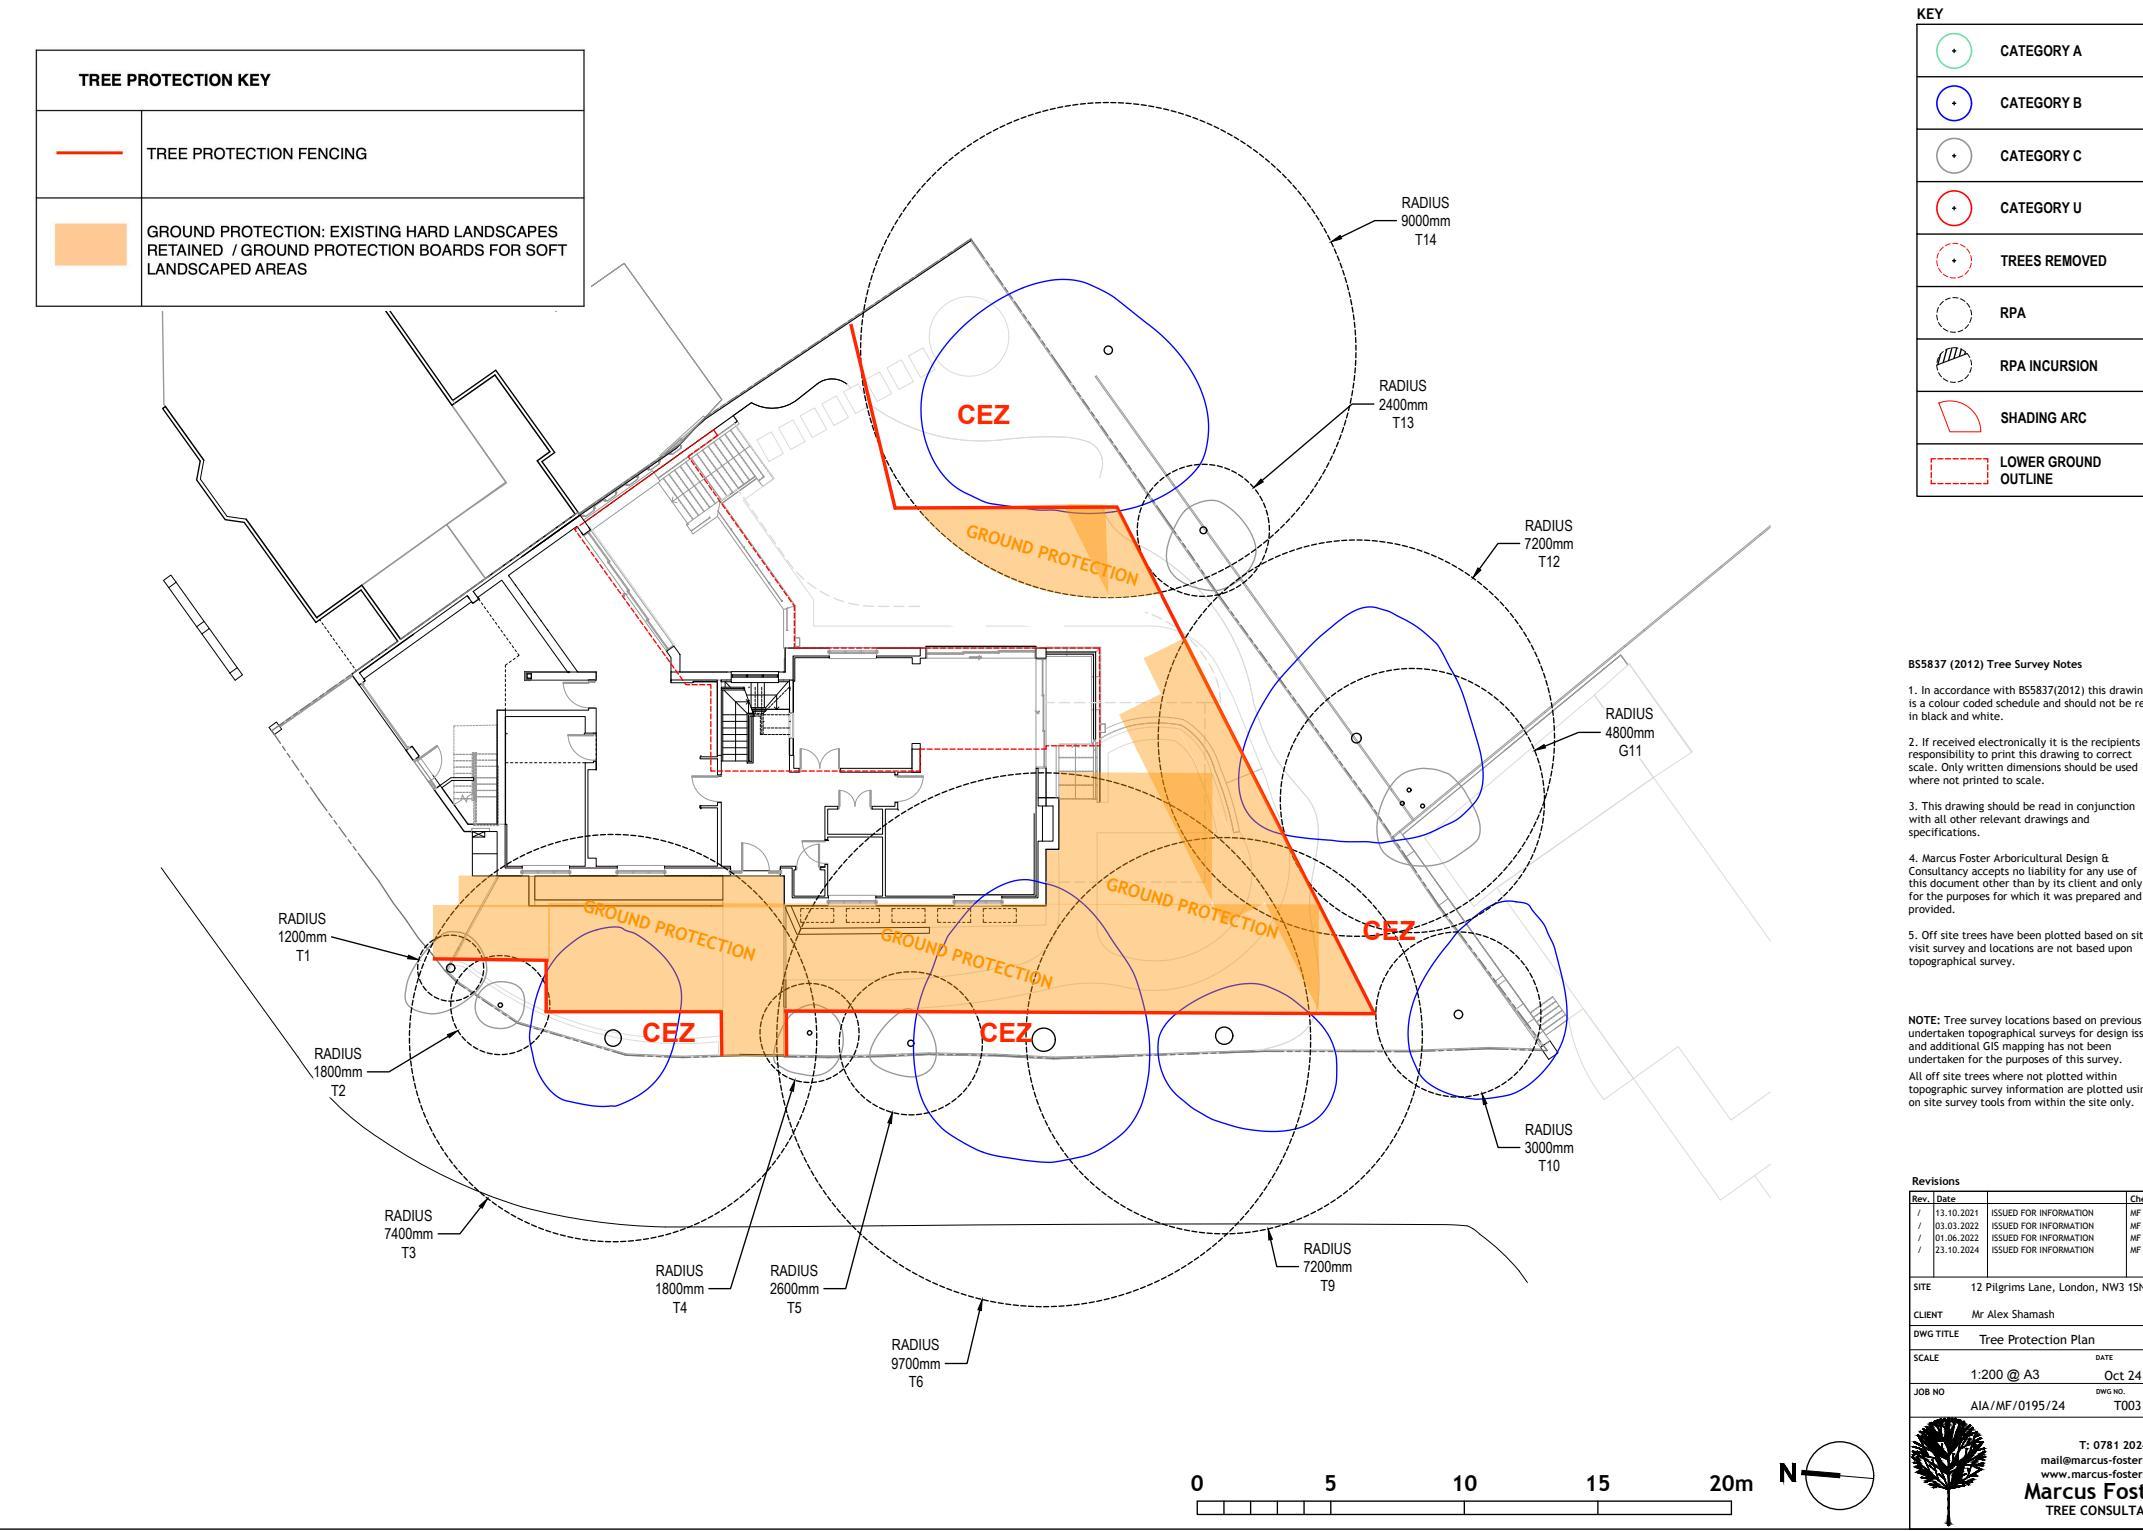
A full Arboricultural Method Statement (AMS) shall be prepared and agreed at pre-commencement stage to fully corroborate with the construction methodology. The following tree protection measures require close adherence AT ALL TIMES with full supervision from the consulting arboriculturist. The measures are outlined within Tree Protection Plan (TPP) - drawing T003.

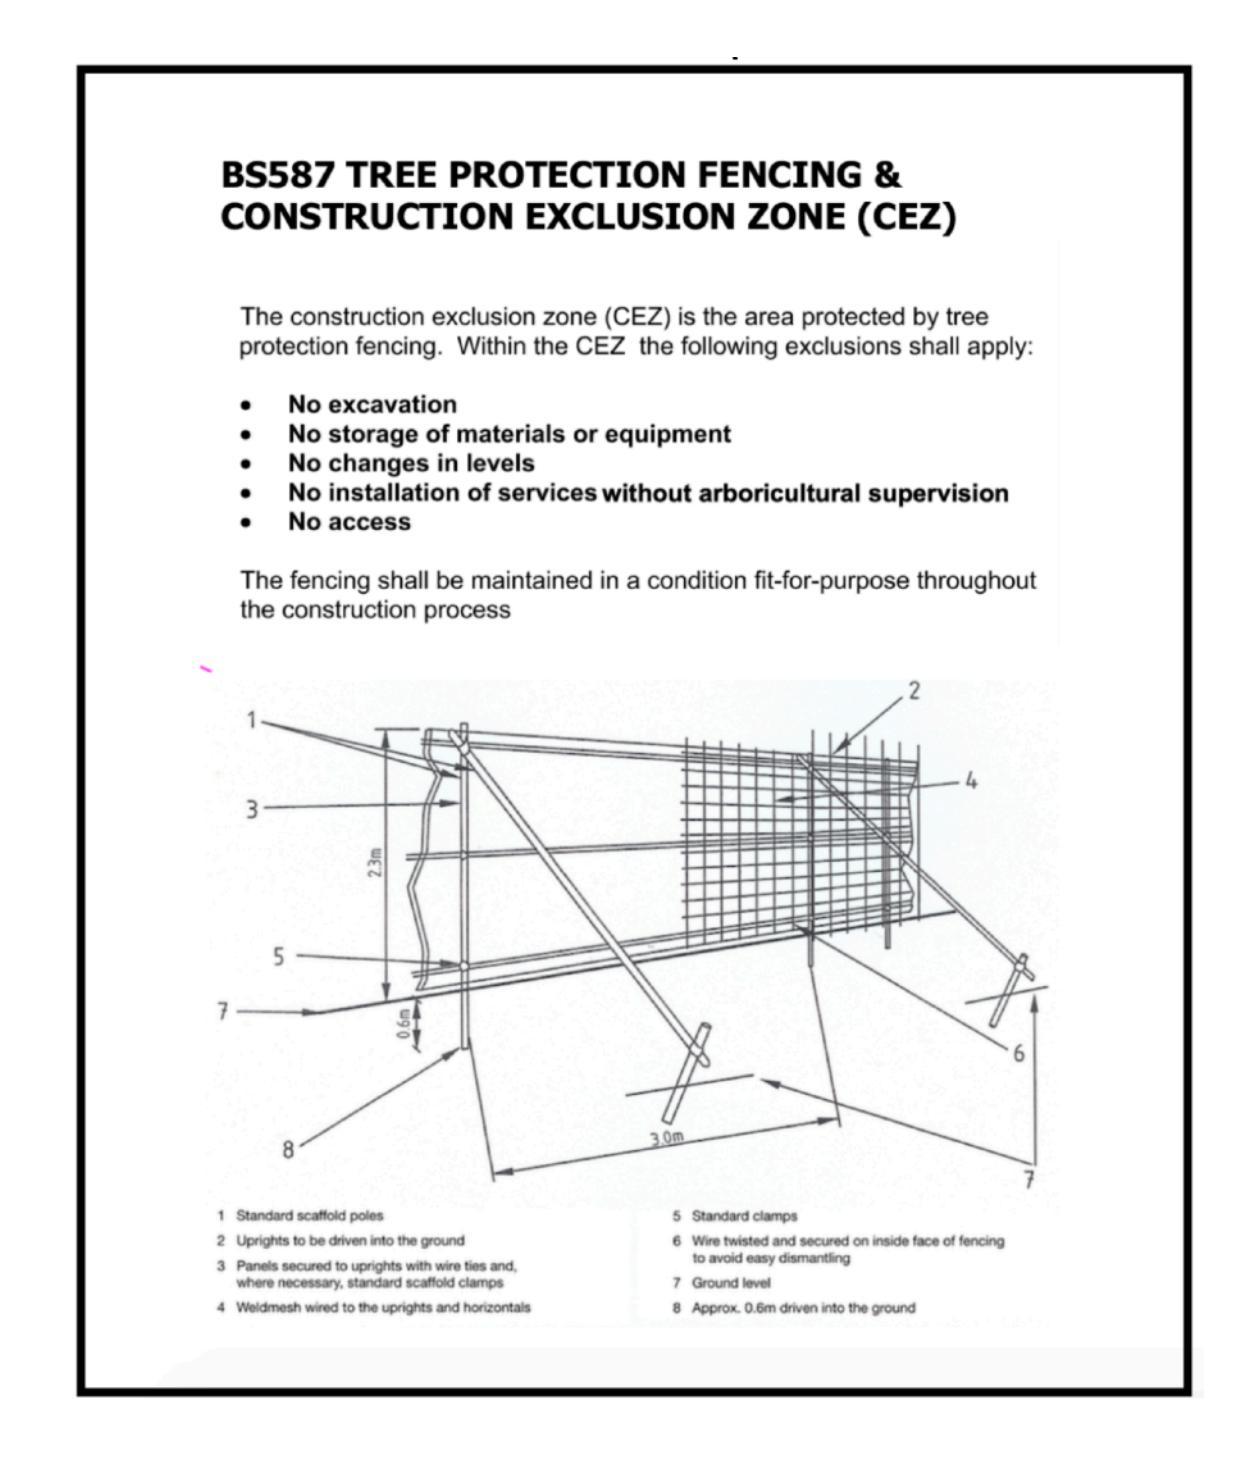
Figure 2: BS5837:2012

## <u>Appendix D:</u> <u>Tree Protection Fencing Specifications</u>

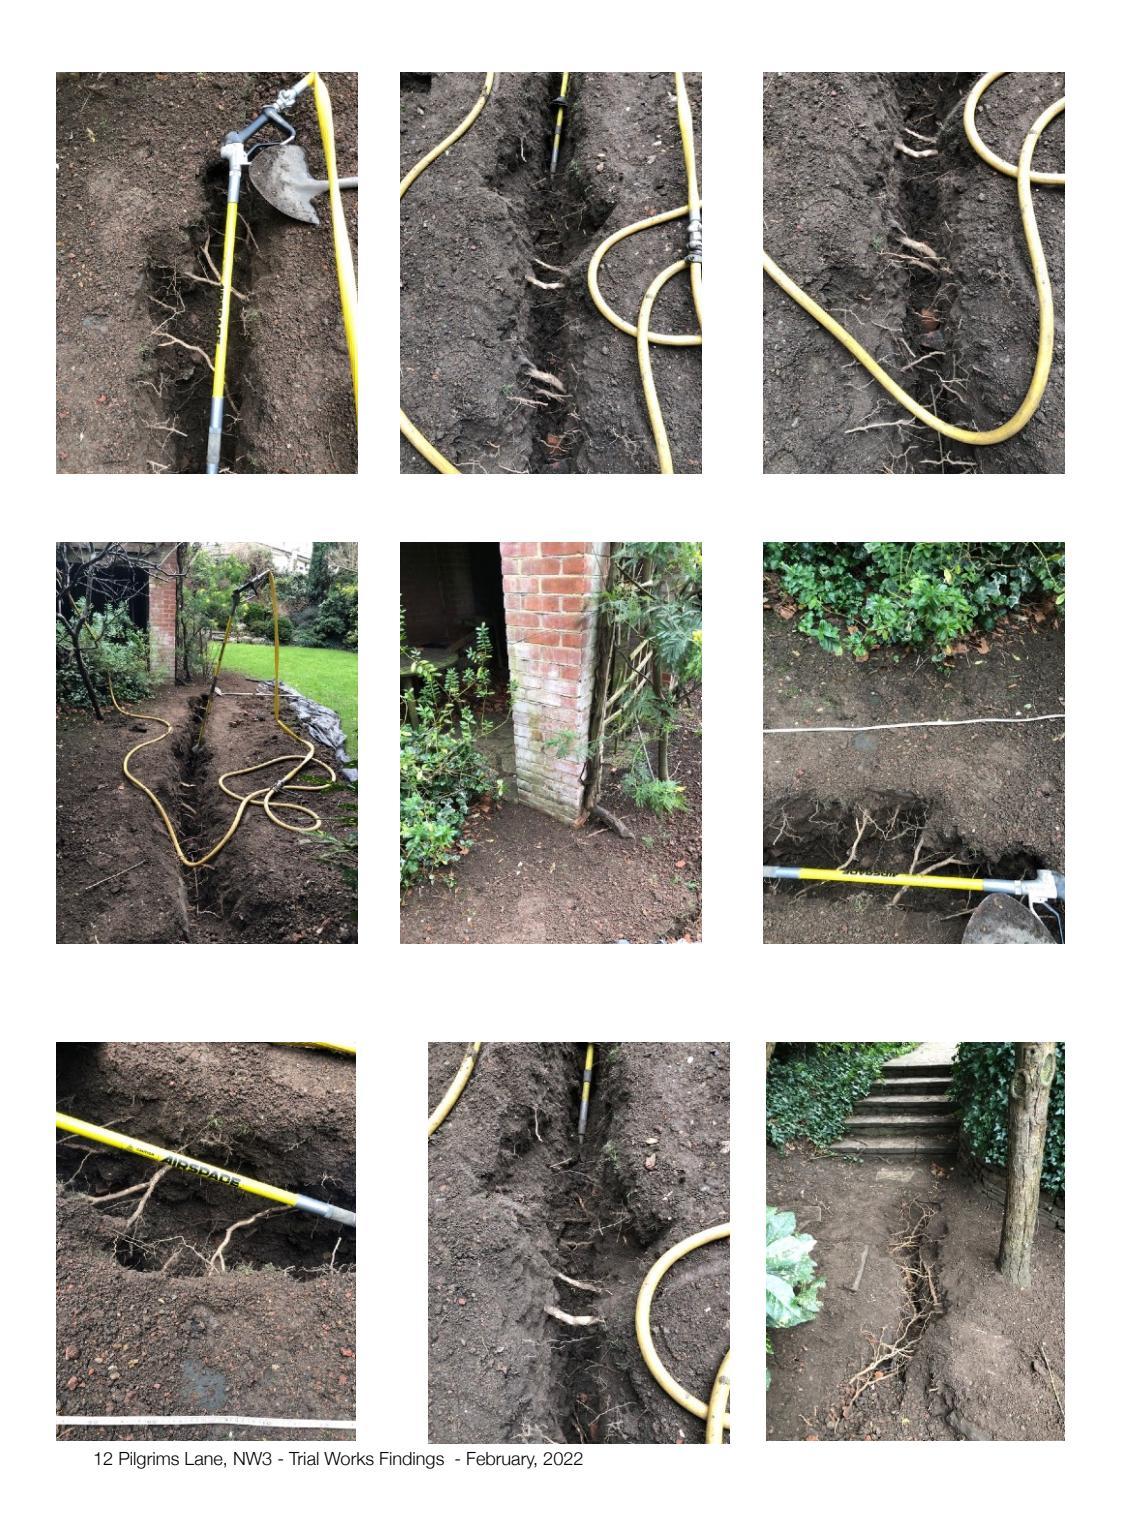
### TRENCH 1

#### TRENCH 1 FINDINGS

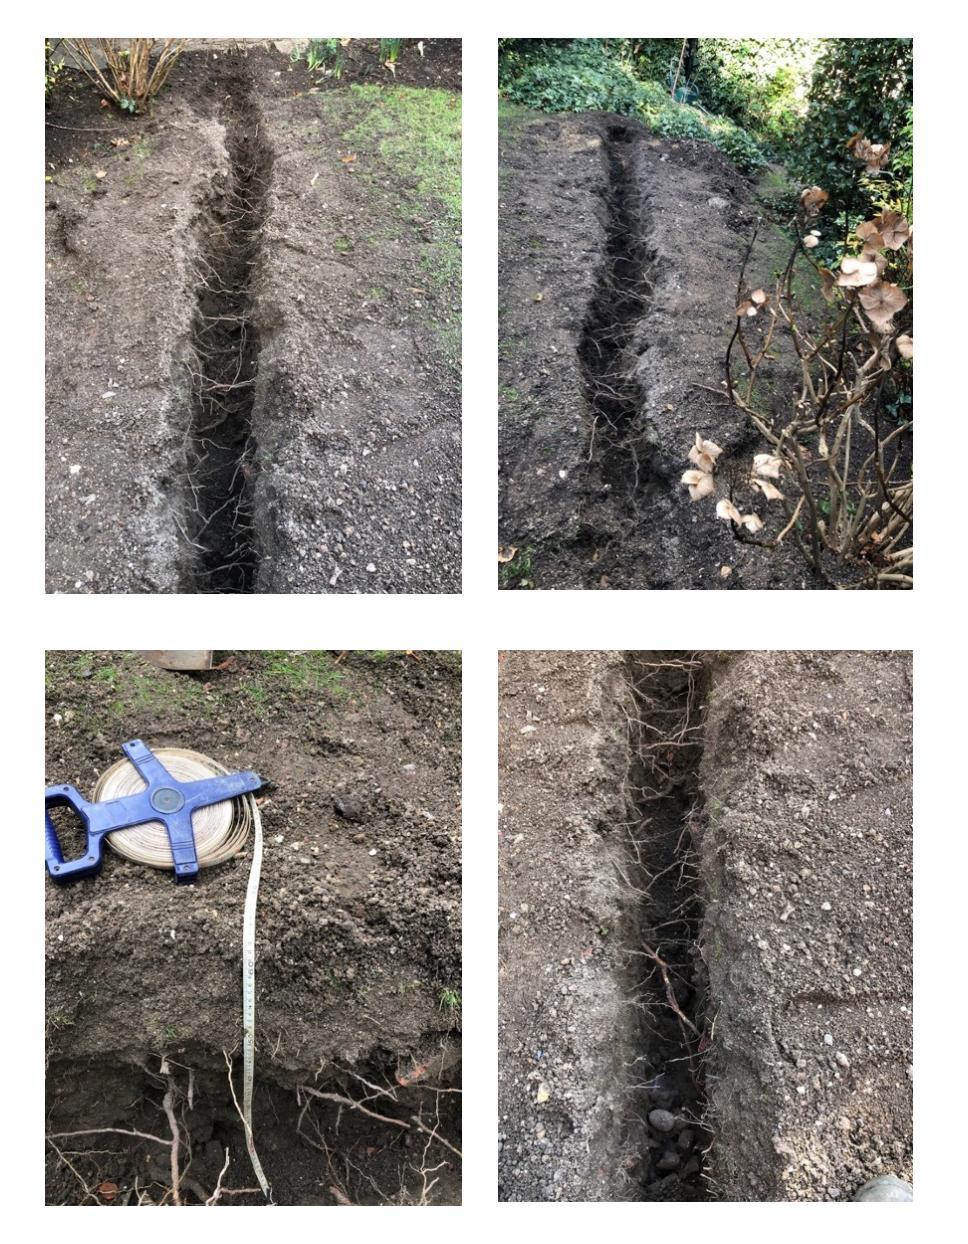
#### TRENCH 3

- Roots sub 10mm diameter
  No roots encountered above 10mm diameter 0-600mm depth
  Soil based profile

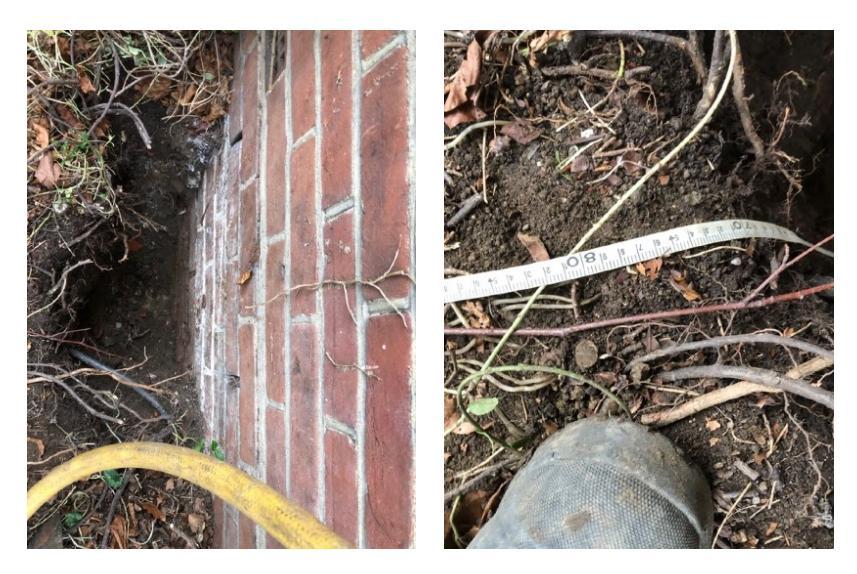
#### TRIAL PIT 1 (south west corner of property

TRIAL PIT 1 - Findings

- 700mm depth
- No tree roots
- Foundations to unknown depth beyond 700mm

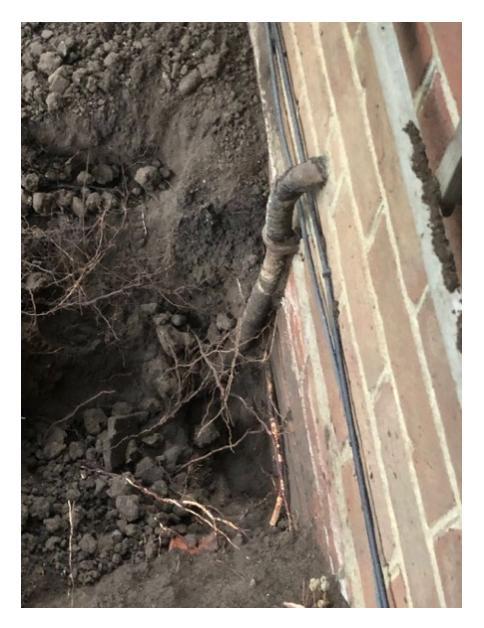
TRIAL PIT 2 (next to front door)

TRIAL PIT 2 - Findings

- 700mm depth
- No tree roots
- Foundations to unknown depth beyond 700mm
