#### **ARBORICULTURAL SURVEY**

# BOURNE ESTATE CAMDEN

A Report to CampbellReith Hill LLP

Report Number: RT-MME-111475A-02 Rev 1

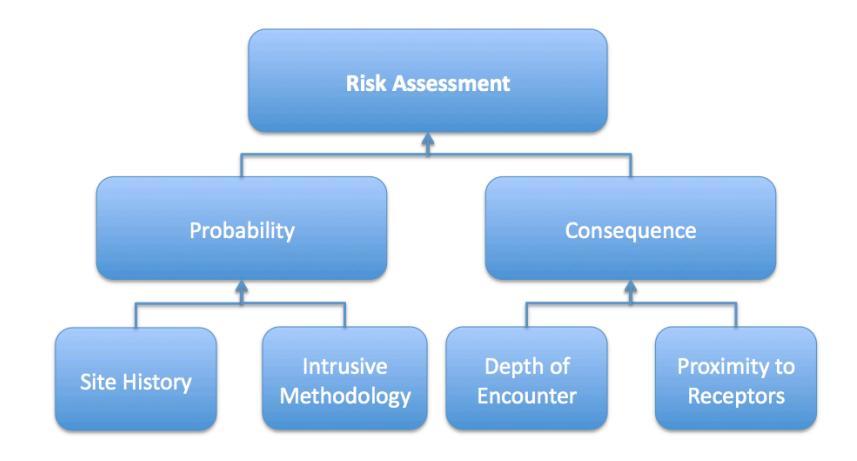
Figure 1 – Risk Assessment Relationships

Risk (R) is calculated as a function of Probability (P) and Consequence (C), thus (P  $\times$  C = R). In UXO terms these components can themselves be shown to be dependent on a number of additional sub-factors. The relationships are depicted in *Figure 1*.

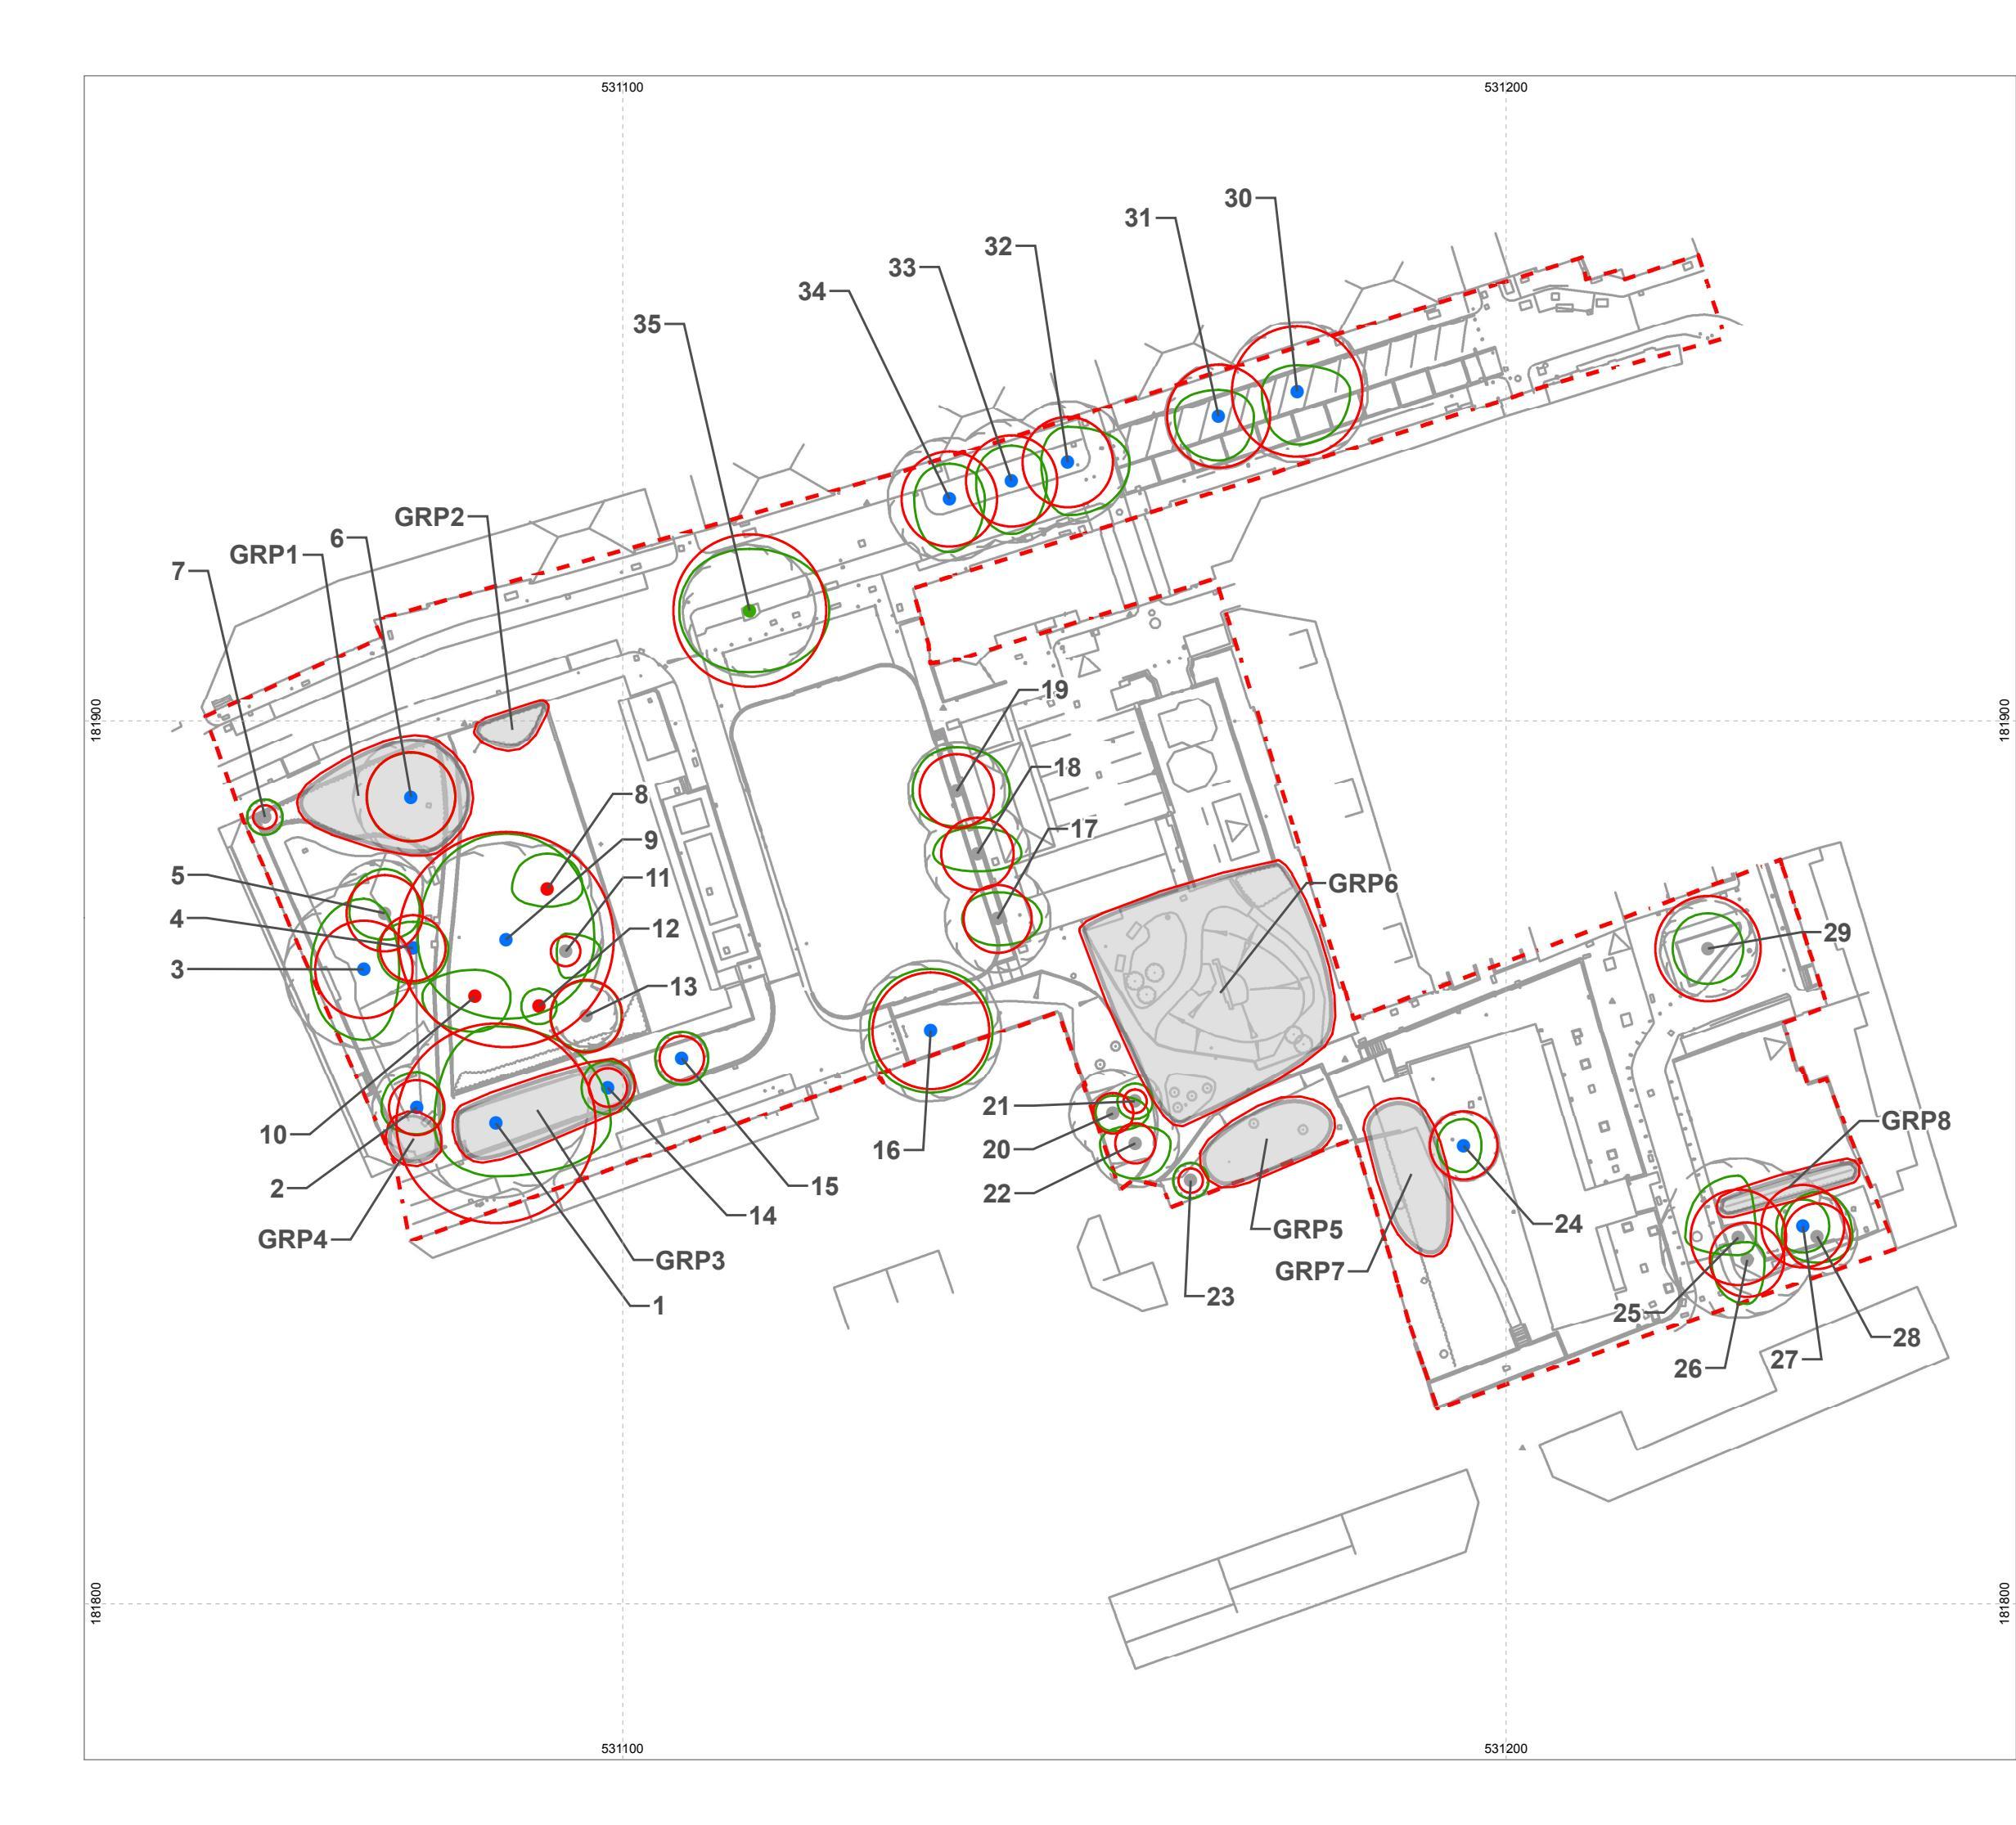
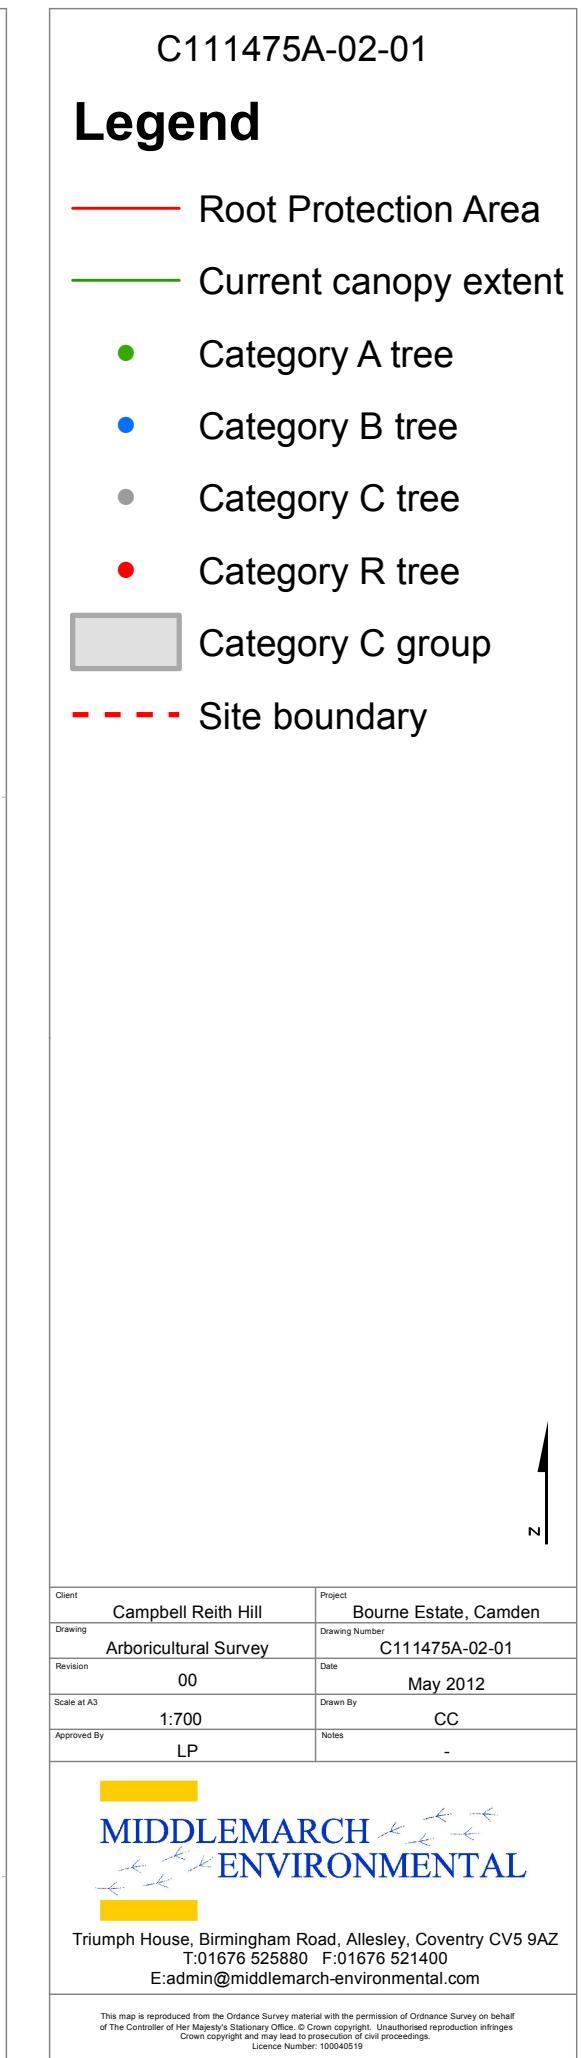
Middlemarch Environmental Ltd Drawing C111475A-02-01 - Location of Trees Surveyed.

The location of the trees surveyed can be found on Middlemarch Environmental Ltd Drawing Number C111475A-02-01.
