BOURNE ESTATE (SOUTH)

REGENERATION

ARBORICULTURAL IMPACT

ARBORICULTURAL IMPACT ASSESSMENT

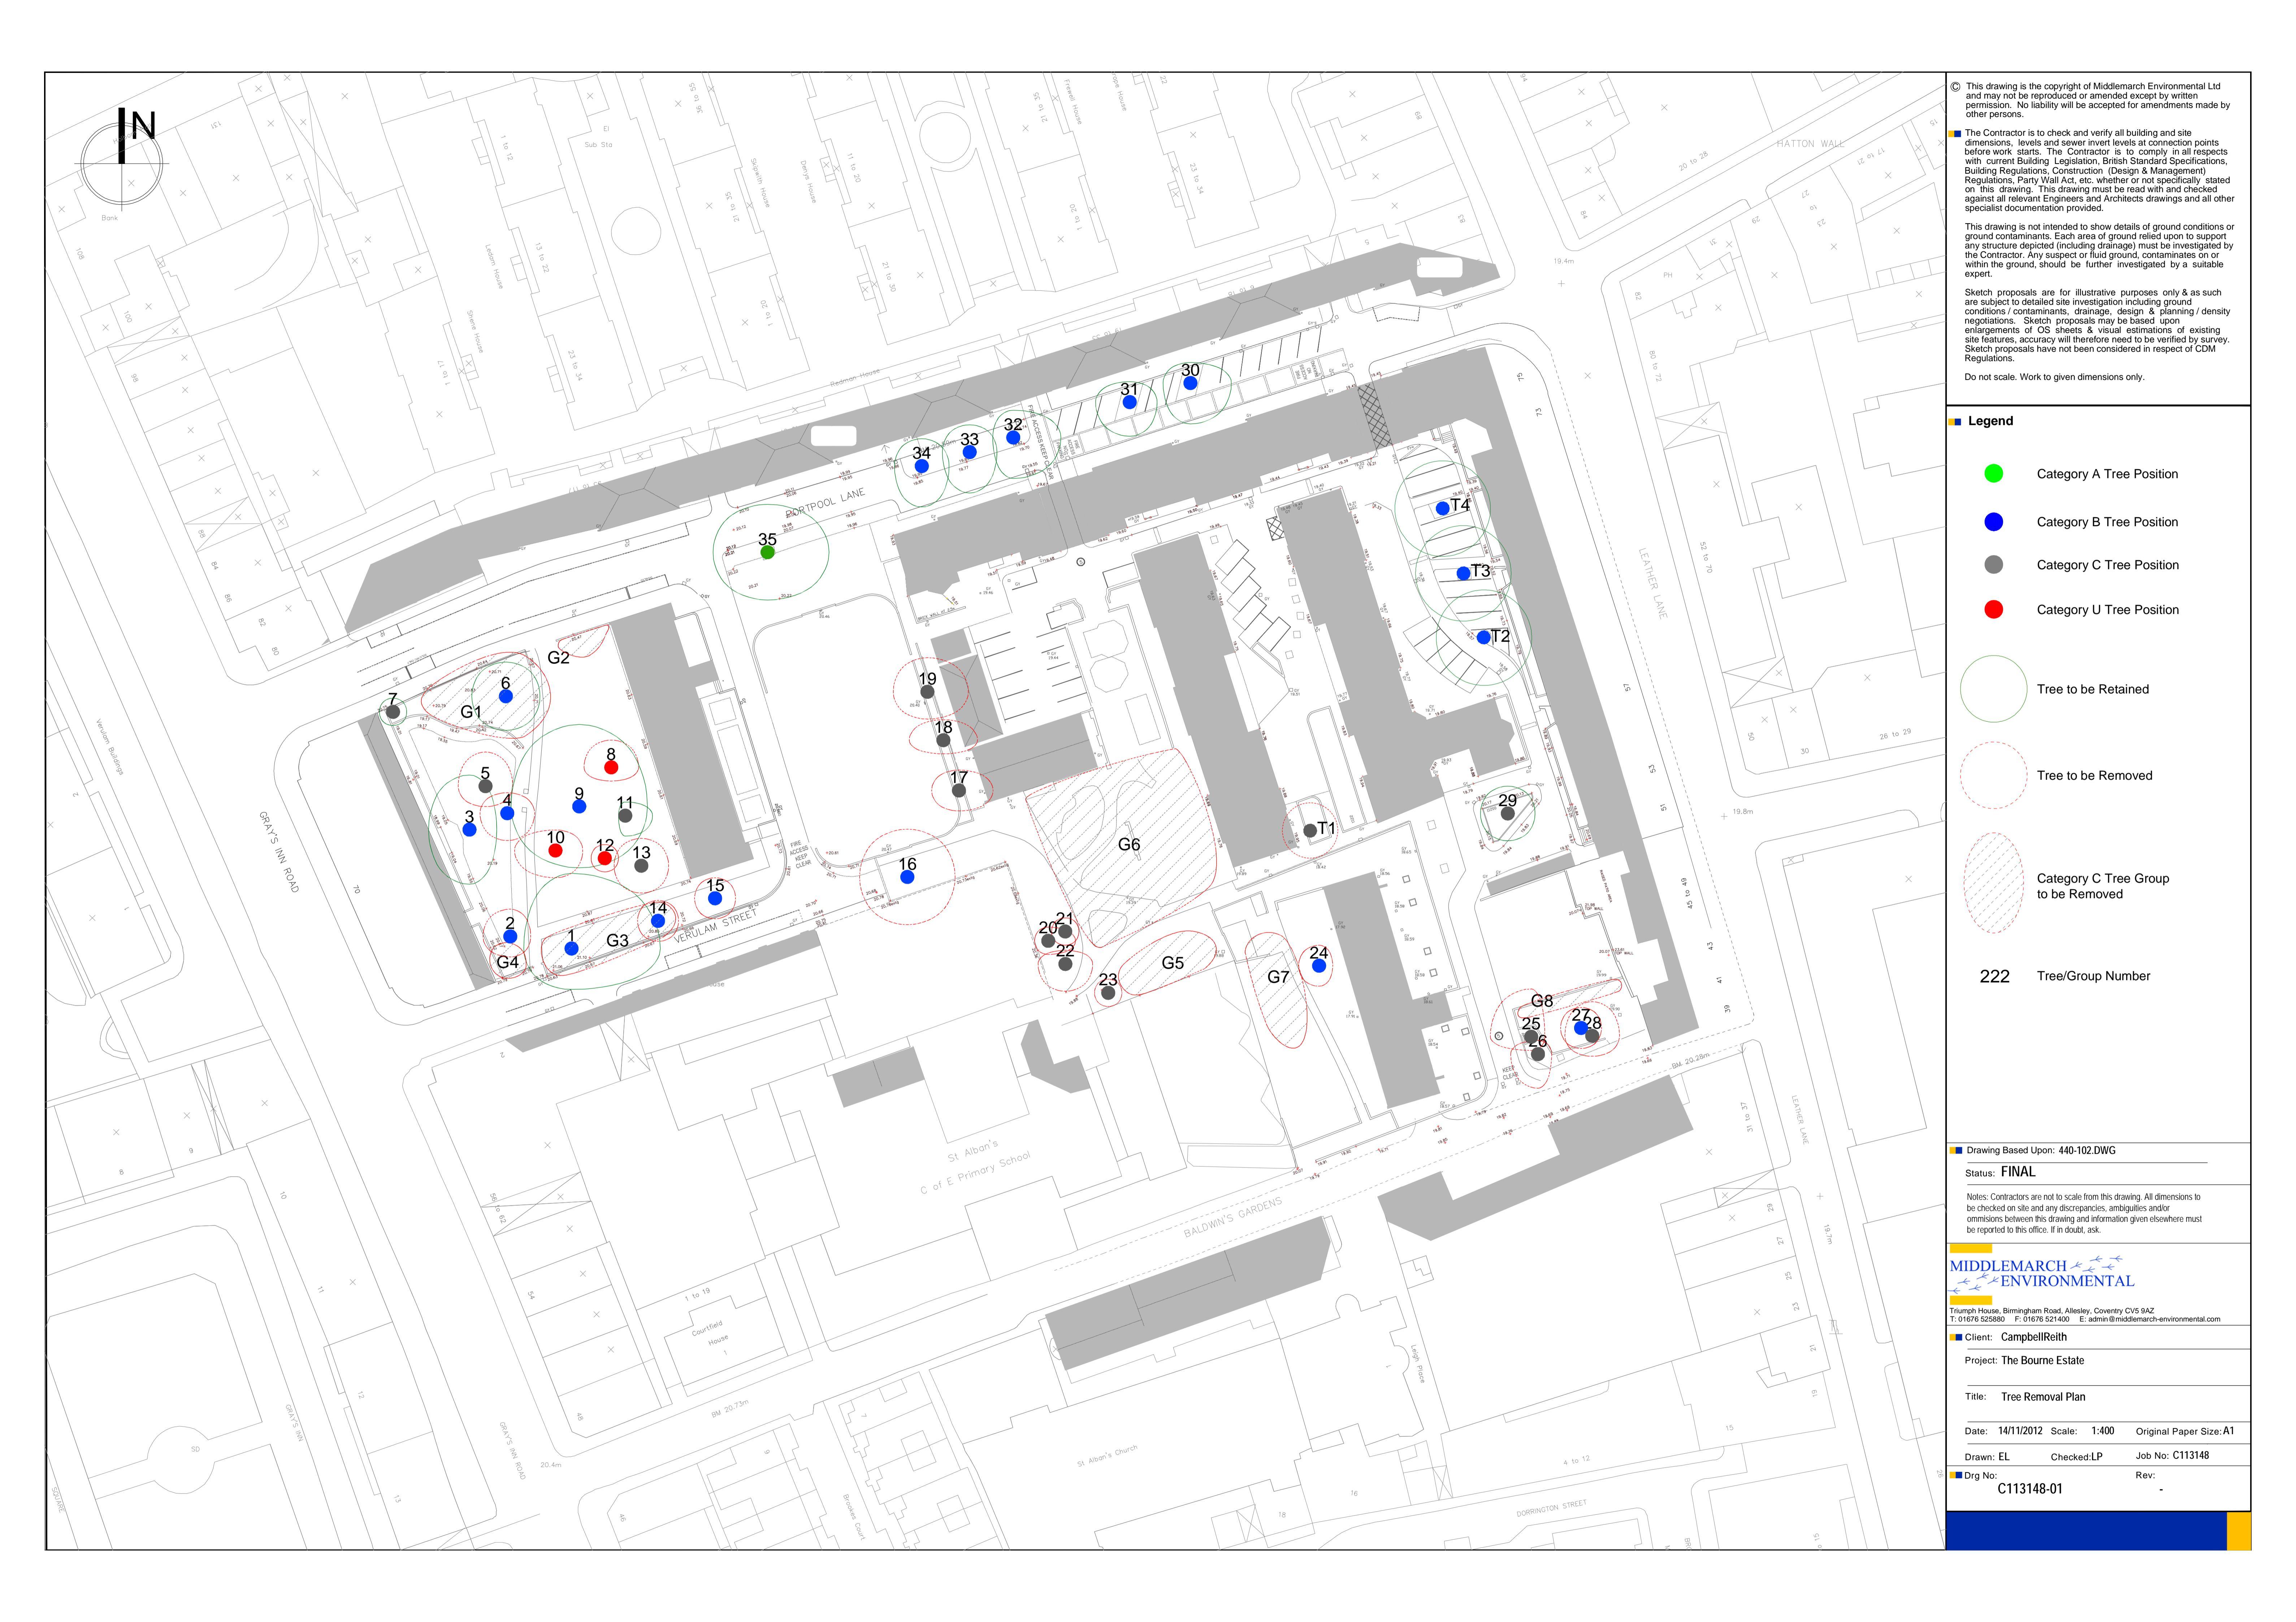
Drawing Number C113148-01 - Tree Removal Plan

All trees within and closely surrounding the site have been surveyed and each has been identified with a unique number. The location of the trees can be found on Drawing Number C113148-01. A schedule of the trees surveyed can be found within Appendix 1.

The location of the trees within the site can be found on Middlemarch Environmental Ltd Drawing Number C113148-01.

- **Tree Condition:** Three of the trees to be removed (numbers 8, 10 and 12) are Category U specimens which are in a poor condition. The removal of these trees would be required in the short-term irrespective of the proposed development and as such their removal should not be a material consideration in the planning process.
- Bourne Estate Gardens Enhancement: The proposed development includes works to enhance the usability of Bourne Estate Gardens to provide new community facilities and opportunities. As part of the landscape strategy for this it has been identified that the removal of the lower value trees within this area is desirable.

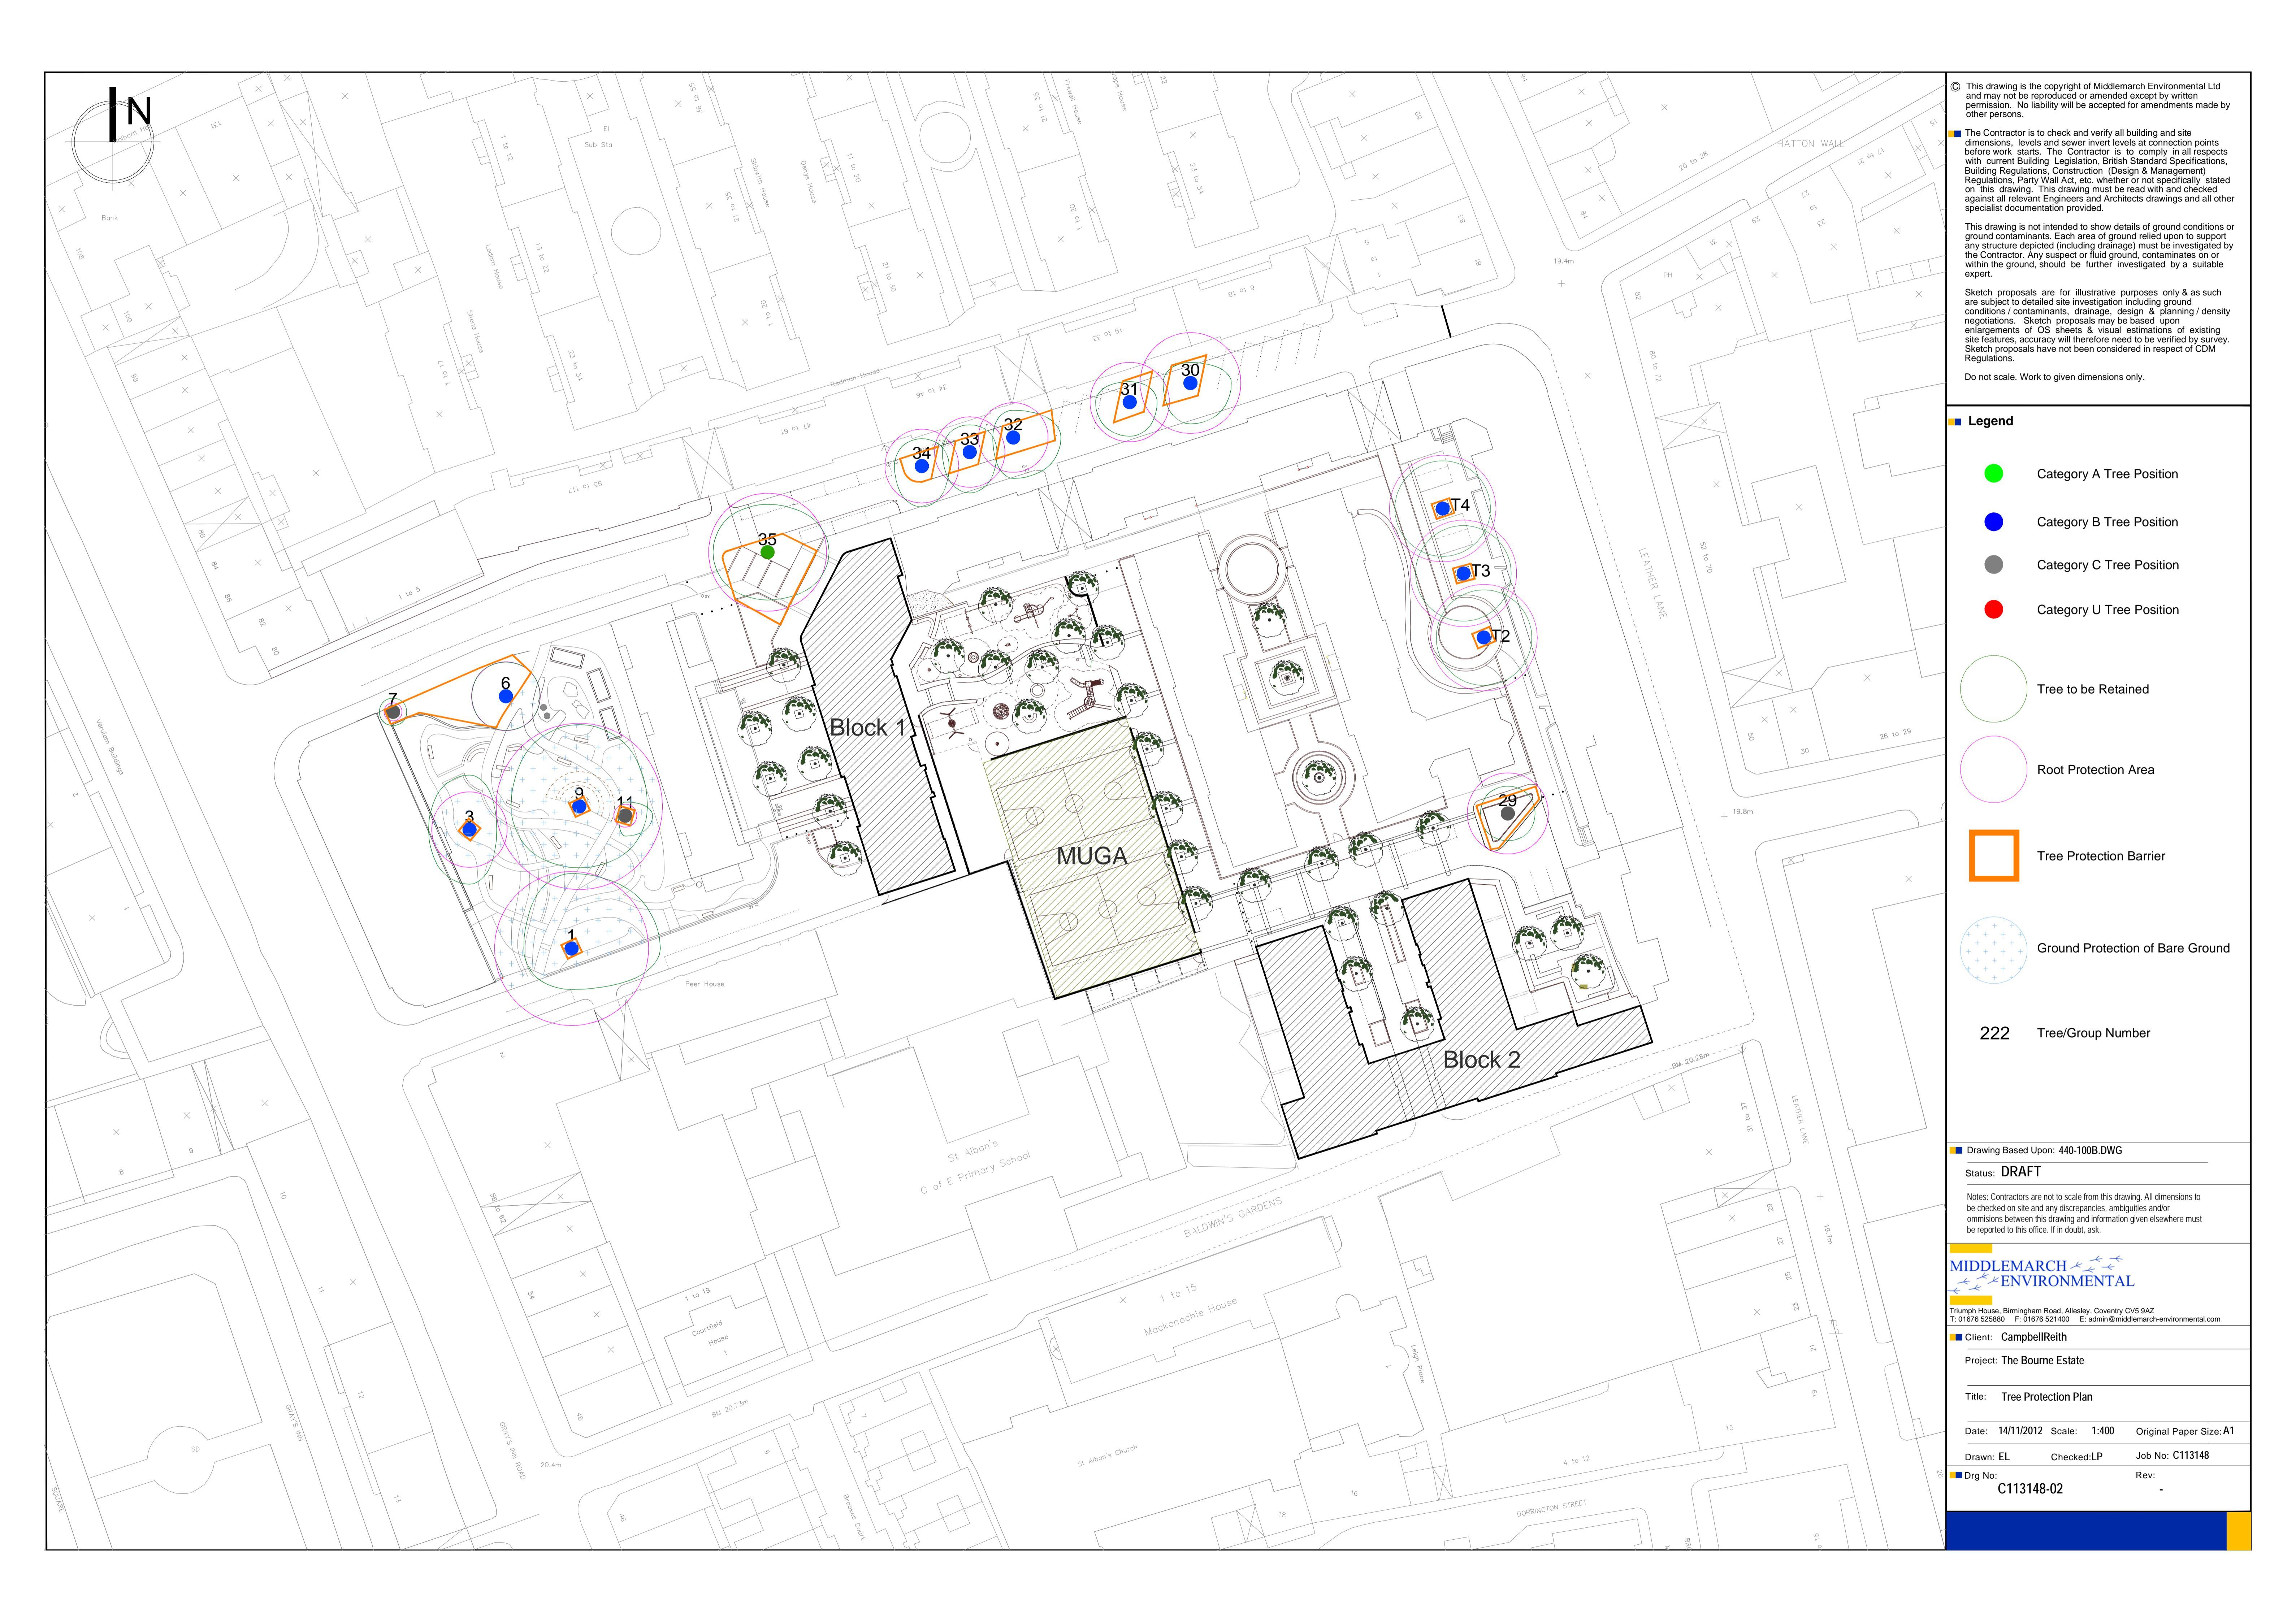
Drawing Number C113148-02 - Draft Tree Protection Plan

It is recommended that the exclusion zones are to be afforded protection at all times through the use of tree protection barriers and/or ground protection (specified in accordance with BS5837:2012).

Protective barriers should be installed to prevent vehicles accidentally encroaching into areas of unprotected ground within the RPAs of retained trees and to minimise the potential for collision damage to trees stems occurring.

All trees surrounding the access routes should be adequately fenced and ground protection installed (where required) to ensure that no damage to these specimens occurs during construction.
