# Trees and Proposed Development at: Former Adelaide Public House, Elsworthy Rise, London NW3

# **Arboricultural Implications Assessment Report**

Site: Adelaide P H (former), Elsworthy Rise W3

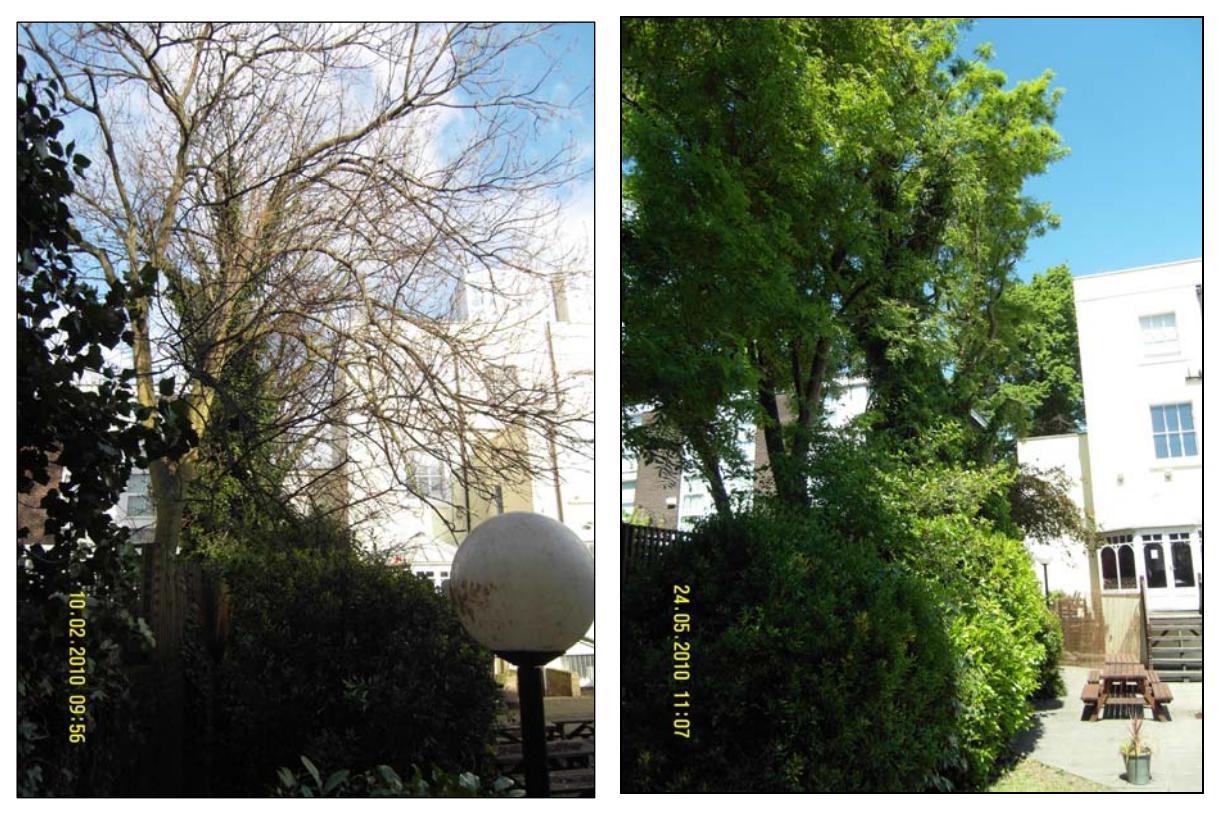
P1 Boundary Trees over-hanging the site have been pruned back.

The under-storey Laurel shrubs are to be removed as part of the proposals but which will have no impact upon the general character of the area.

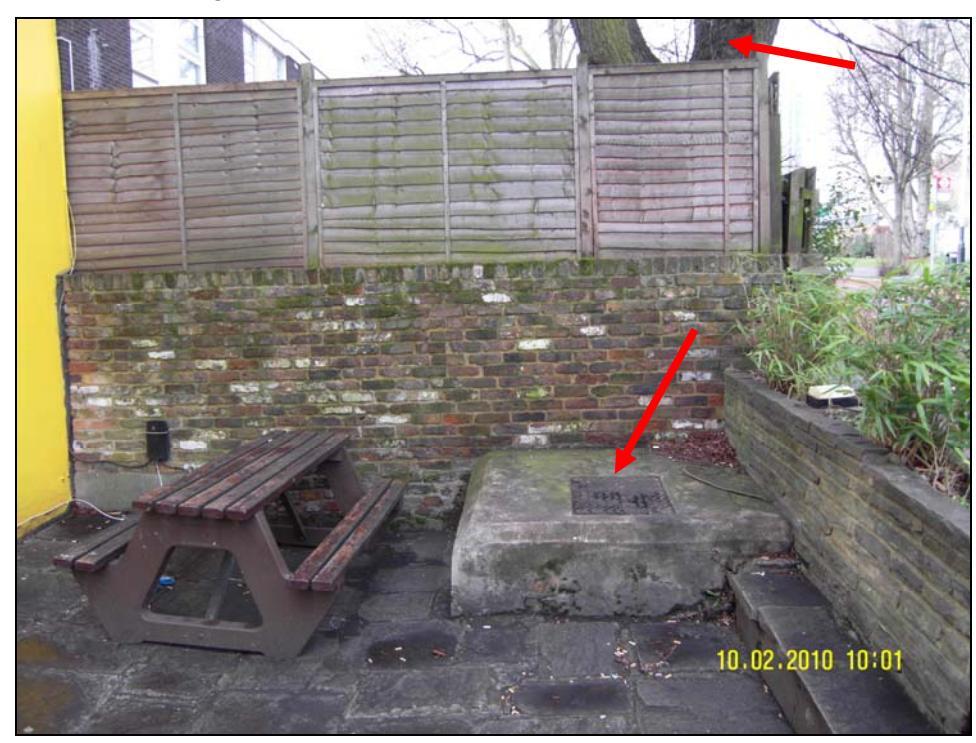
2.3 The roots of these trees, including T1 at the front of the site adjacent to Adelaide Road, have been restricted from growing in a westerly direction by the presence of the retaining wall. Excavations within the site therefore are unlikely to present risks to the trees, but I recommend undertaking some precautionary, preliminary manual excavations in order to assess any rooting that may be present. Assessing the extent of rooting in the areas shown on the Tree Protection Plan (TPP) at **Appendix 1** can assist in advising the tree owners about tree condition and safety.

P2 Retaining structures at the base of T1 (Lime)

The concrete surround (arrowed) for the inspection chamber is certain to prevent, yet further any lateral root spread from T1 (arrowed) into the site.

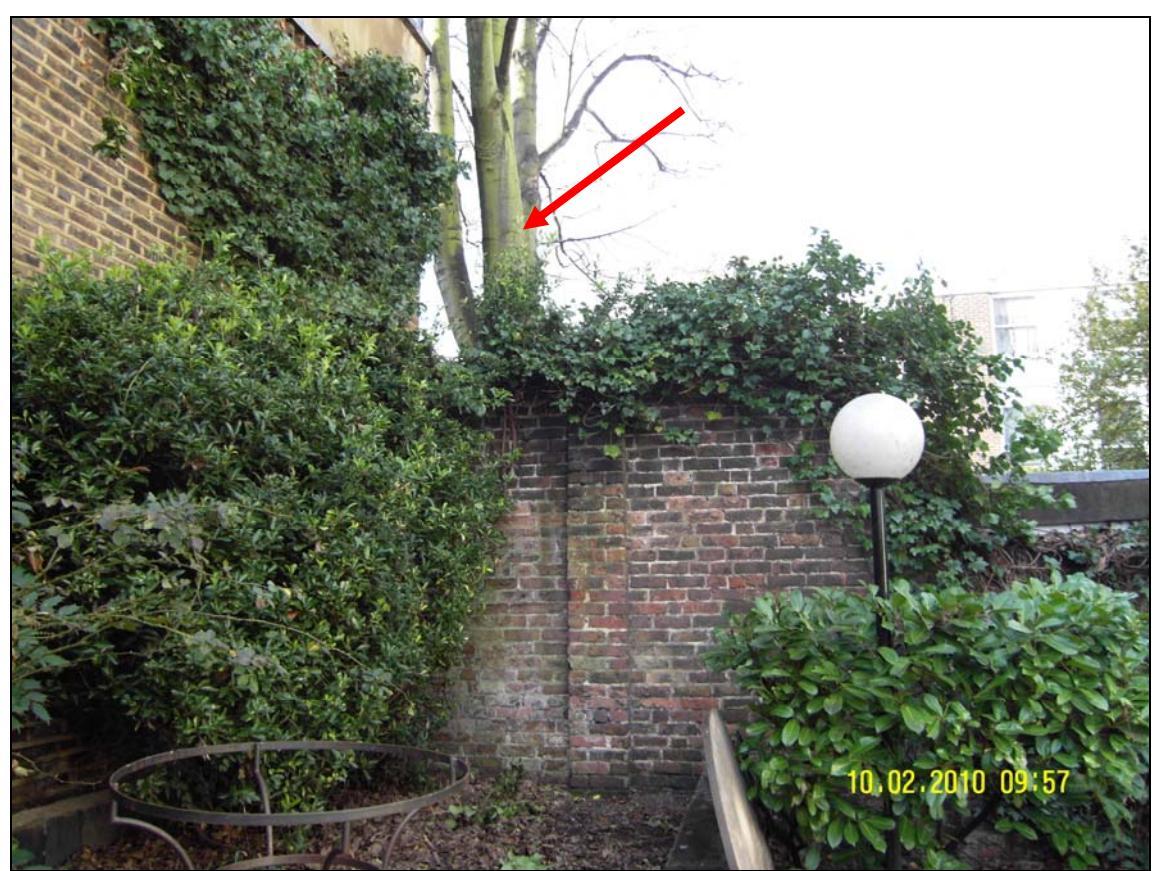
2.4 A mature Sycamore T5 is also growing off-site and no access was available to inspect this tree thoroughly but from available vantage points this tree is adequately protected from construction by its separation to the site and the position of the boundary structures, whose foundations will have acted as a root barrier.

P3 Boundary Wall, whose foundations act as a root barrier for T5 (arrowed)

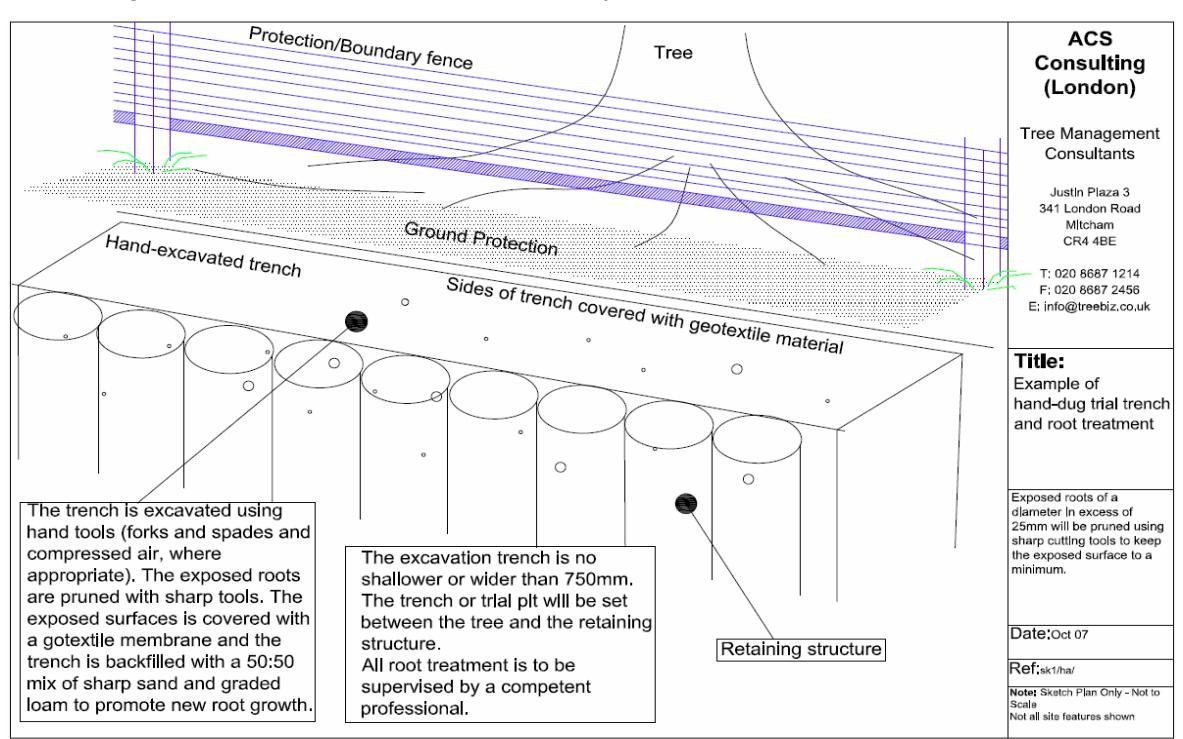
- 4.3 An example of the root excavations and retaining structures is provided below.
- 4.4 In this case, no tree protection fencing nor ground protection will be required to afford effective protection to off-site trees.

# 4.6 Fig 1 Hand Excavations near boundary tree

- 4.2 i) Break out concrete or any hard standing areas.
  - ii) Under specialist supervision, hand excavate soil, retaining all significant, roots in line with location of proposed foundations and any subterranean walls.

- ii) Professionally undertake root pruning (in accordance with guidance in BS 3998:1989 'Tree Work' and amendments).
  - iii) Cover exposed soil/roots with material (preferably water-absorbent) to prevent undue desiccation of soil and exposed roots.

- iv) Subsequent to wall construction, back fill space between exposed soil and wall with a mix of graded top soil and sharp sand (not builder's sand) ratio of 50:50.

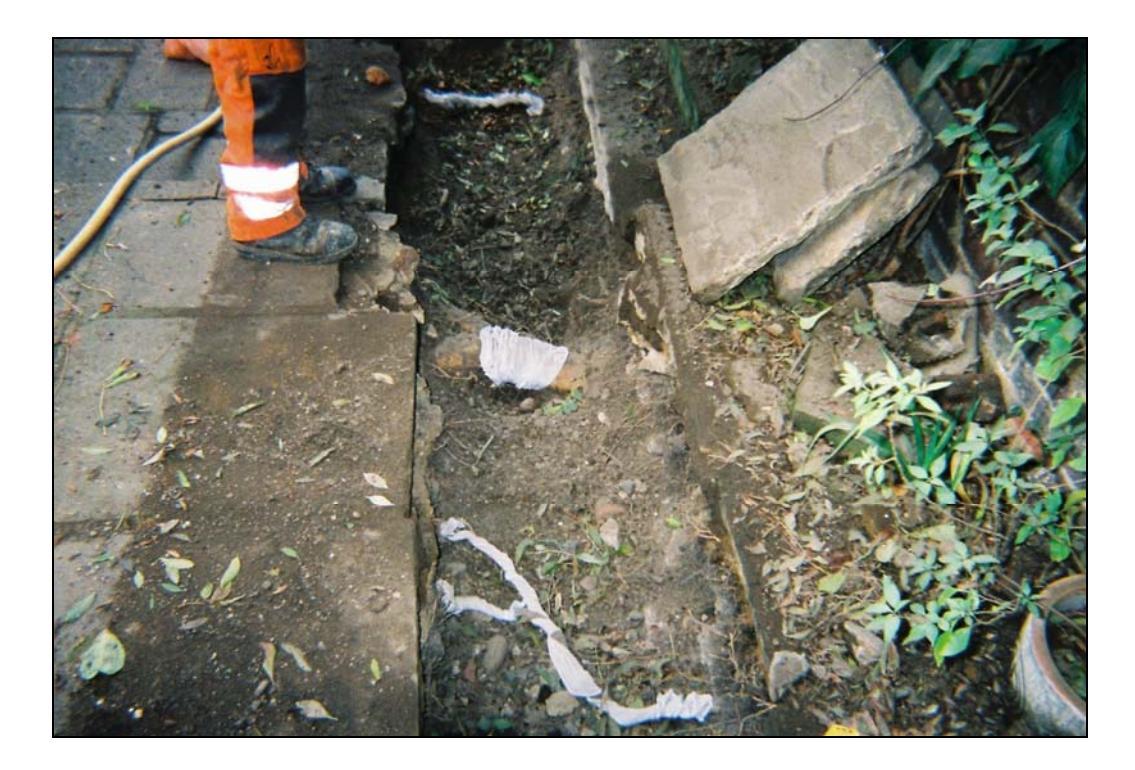
Example of Root exposure and root identification

- 6. With the use of hand tools, dig out the soil to expose roots to the agreed depth. Roots in excess in excess of **20mm** are to be retained.
- 7. Use hand brush (or compressed air) or similar to clear soil away from encountered roots before proceeding to use spades or forks to remove further soil. Hand excavations must limit so far as reasonably practicable, damage to the root bark or root wood.
- 8. Exposed roots are to be wrapped for identification with material. To prevent desiccation (drying out) of all roots, the sides of the trial pit should be covered with a damp material e.g. hessian or similar. No roots are to be left exposed for more than four hours. All exposed trial pits must be covered overnight.
