ARBORICULTURAL IMPLICATIONS REPORT

for : 37 Queens Grove London NW8

Produced for: SHH Architects

Date: 3rd March 2010

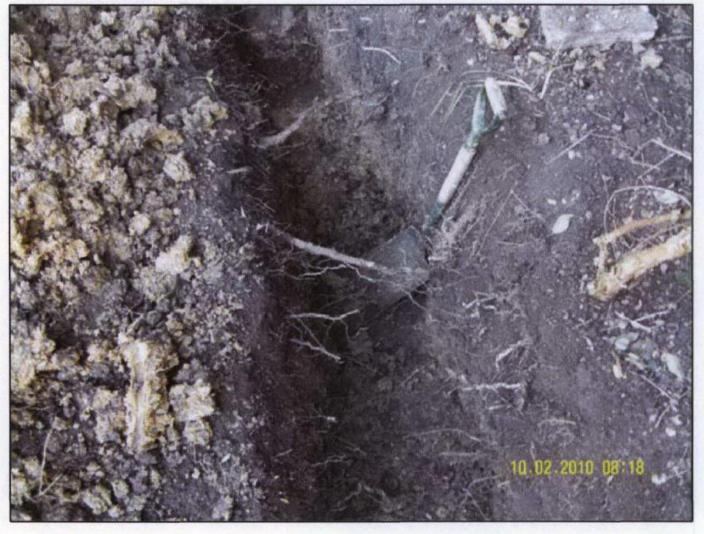
P1 - Trench 1

Roots from shrubby plant growth in the upper soil horizons. The two roots can be pruned professionally. Most roots are inhibited from growing across the boundary by the boundary wall foundations.

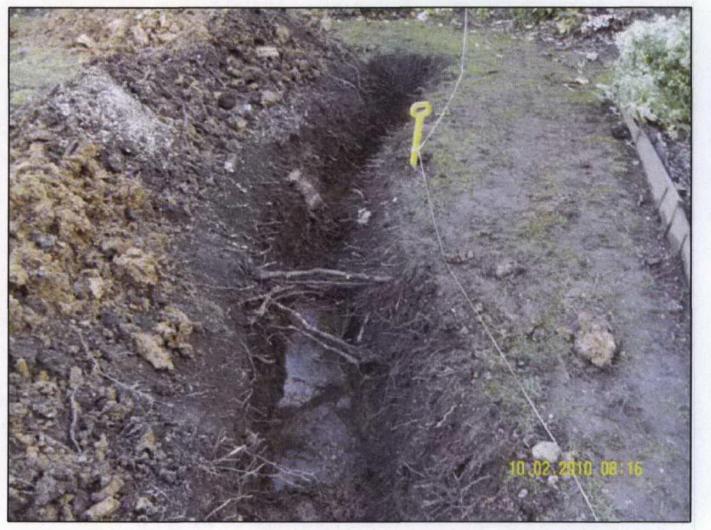
P2 – Trench 2

Profuse small-diameter roots and larger roots exploit the upper soil profile. There is no wall foundation barrier and roots can spread laterally in a northern direction.

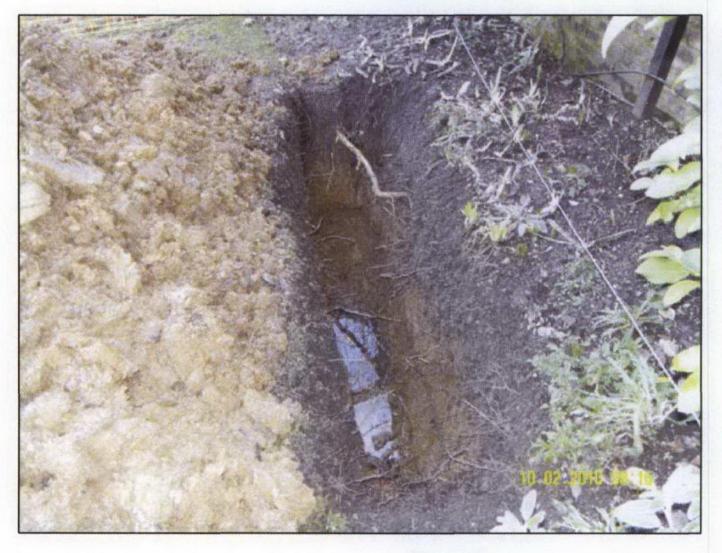
P3 Trench 3

One root of a significant size has been found. Professional treatment of this root will avoid any impacts upon the long term retention of the neighbouring tree.
