# Tree Survey,

Arboricultural Implications Assessment And Arboricultural Method Statement

La Sainte Union School, Highgate Road, London NW5 1RP

> Date: 20<sup>th</sup> May 2009

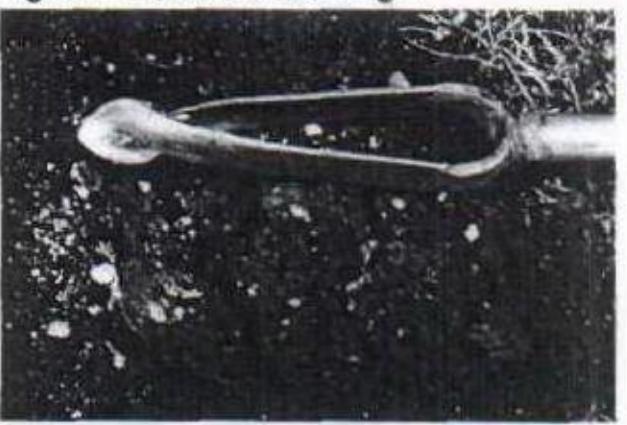
# Figure 1 - Results of Soil Auger

- 5.1 The site is within the administrative jurisdiction of the London Borough of Camden.
- 5.2 No enquiries have been made regarding the legal protection status of the trees.
- 5.3 The site slopes downwards to the north/north-east.
- 5.4 The soil type is London Clay with reference to Geological Survey Sheet no. 256. Use of a hand auger on site revealed a dark, made-up soil to 400mm depth. Clay is likely to lie beneath this and the soil will be relatively vulnerable to compaction.

- 6.1 The site and trees were inspected on 19<sup>th</sup> May 2009.
- 6.2 The trees were inspected from ground level and no climbing inspections were undertaken.
- 6.3 Heights of the trees were estimated by eye and crown spreads were estimated by pacing.
- 6.4 Photographs were taken on site using a digital camera.
- 6.5 A hand auger was used to assess the soil type.

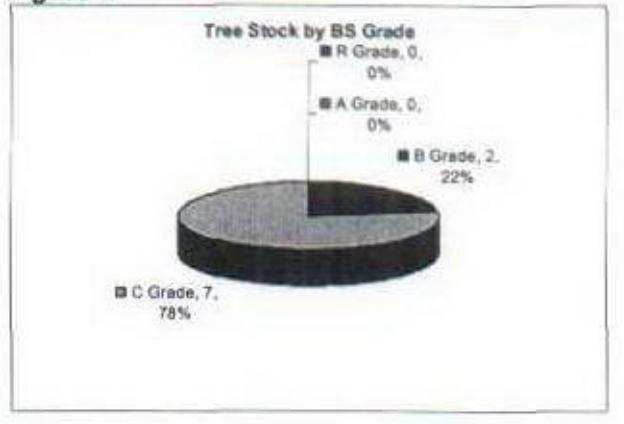
# Figure 2

- 7.2 The tree details and proposed works are presented in the Tree Survey Schedule and Recommended Tree Works at **Appendix 2** and tree positions are shown on the Tree Protection Plan at **Appendix 3**.
- 7.3 The quality and value of the individual tree stock has been broken down by BS quality grade in **Table 2** and **Figure 2** below. The grading system can be summarised as follows:

Total No. Individual Trees (9)	A Grade	B Grade	C Grade	R Grade
No. of Trees	N/a	2	7	N/a
% of Total	N/a	22%	78%	N/a

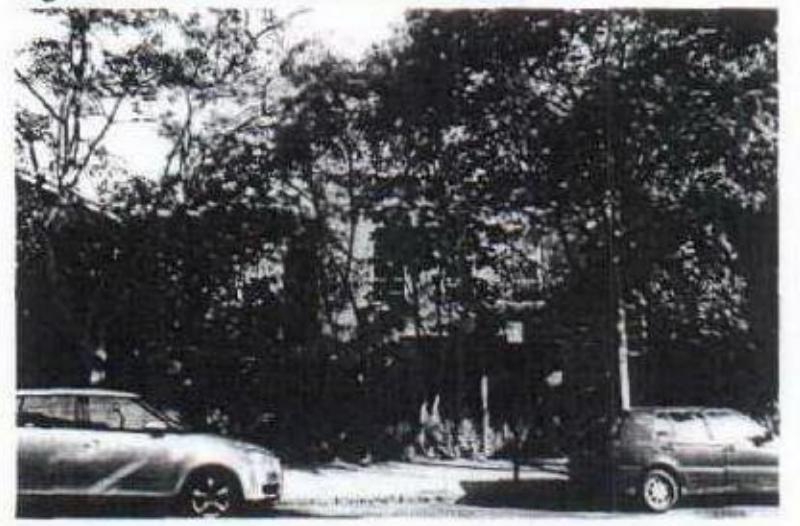
### Figure 3 - View of G10 between T6 and T7

9.1 Trees T9 and G10 are to be removed. These comprise poor quality trees of up to 12m in height, situated at the eastern end of the proposed new section of walling. The existing chain-link fence has become embedded in the stems of many of these trees (including T9) and it would not be possible to construct a new boundary wall and retain the trees. The trees are of modest landscape significance and removal will have minimal impact on the character and amenities of the locality.

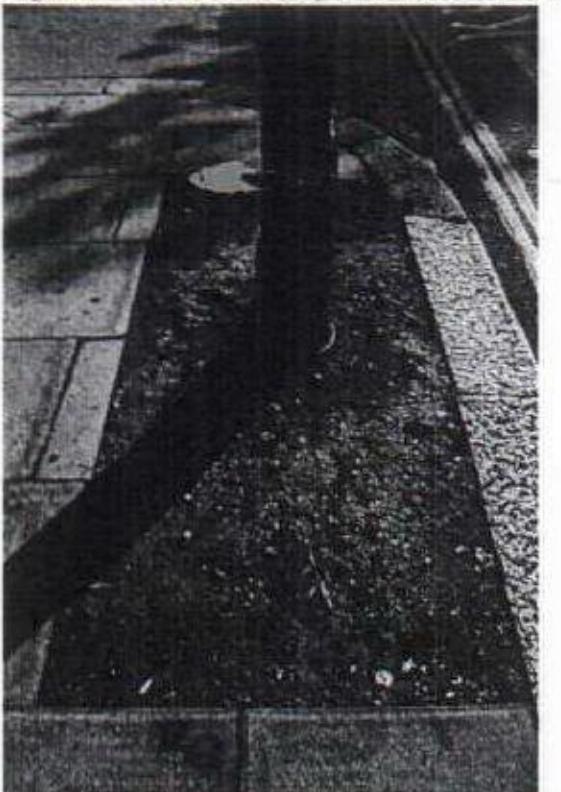
# Figure 5 - Soft Landscaped Area around Tree Growing within Pavement

- 14.1 Tree protective fencing and ground protection are used to ensure that the RPAs of retained trees are safeguarded. These measures may also be employed to protect areas of ground for new landscaping.
- 14.2 The positioning and specification of the fencing are shown in **Appendix 3** and **Appendix 4**. Hoarding will be most suitable for the trees growing within the pavement outside the site. These trees are surrounded by hard surfacing which will serve as effective ground protection during the works. Hoarding has been specified around the trees to protect the trunks from damage. Either Heras fencing or hoarding will be suitable for G11.
- 14.3 To properly safeguard the RPAs of the trees growing within the pavement outside the site, the hoarding will be adjusted for each tree such that it covers the soft landscaped area around the tree (the sizes of these vary).

- 14.4 The protective fencing will remain in position for the duration of the development, including the removal of any existing structures. Clear signs will be attached to the fencing once erected suggested wording will be 'Protected Trees No Access'.
- 14.5 Site security fencing will also be erected by the contractors carrying out the works. The exact location of this fencing can be agreed upon at the precommencement meeting.

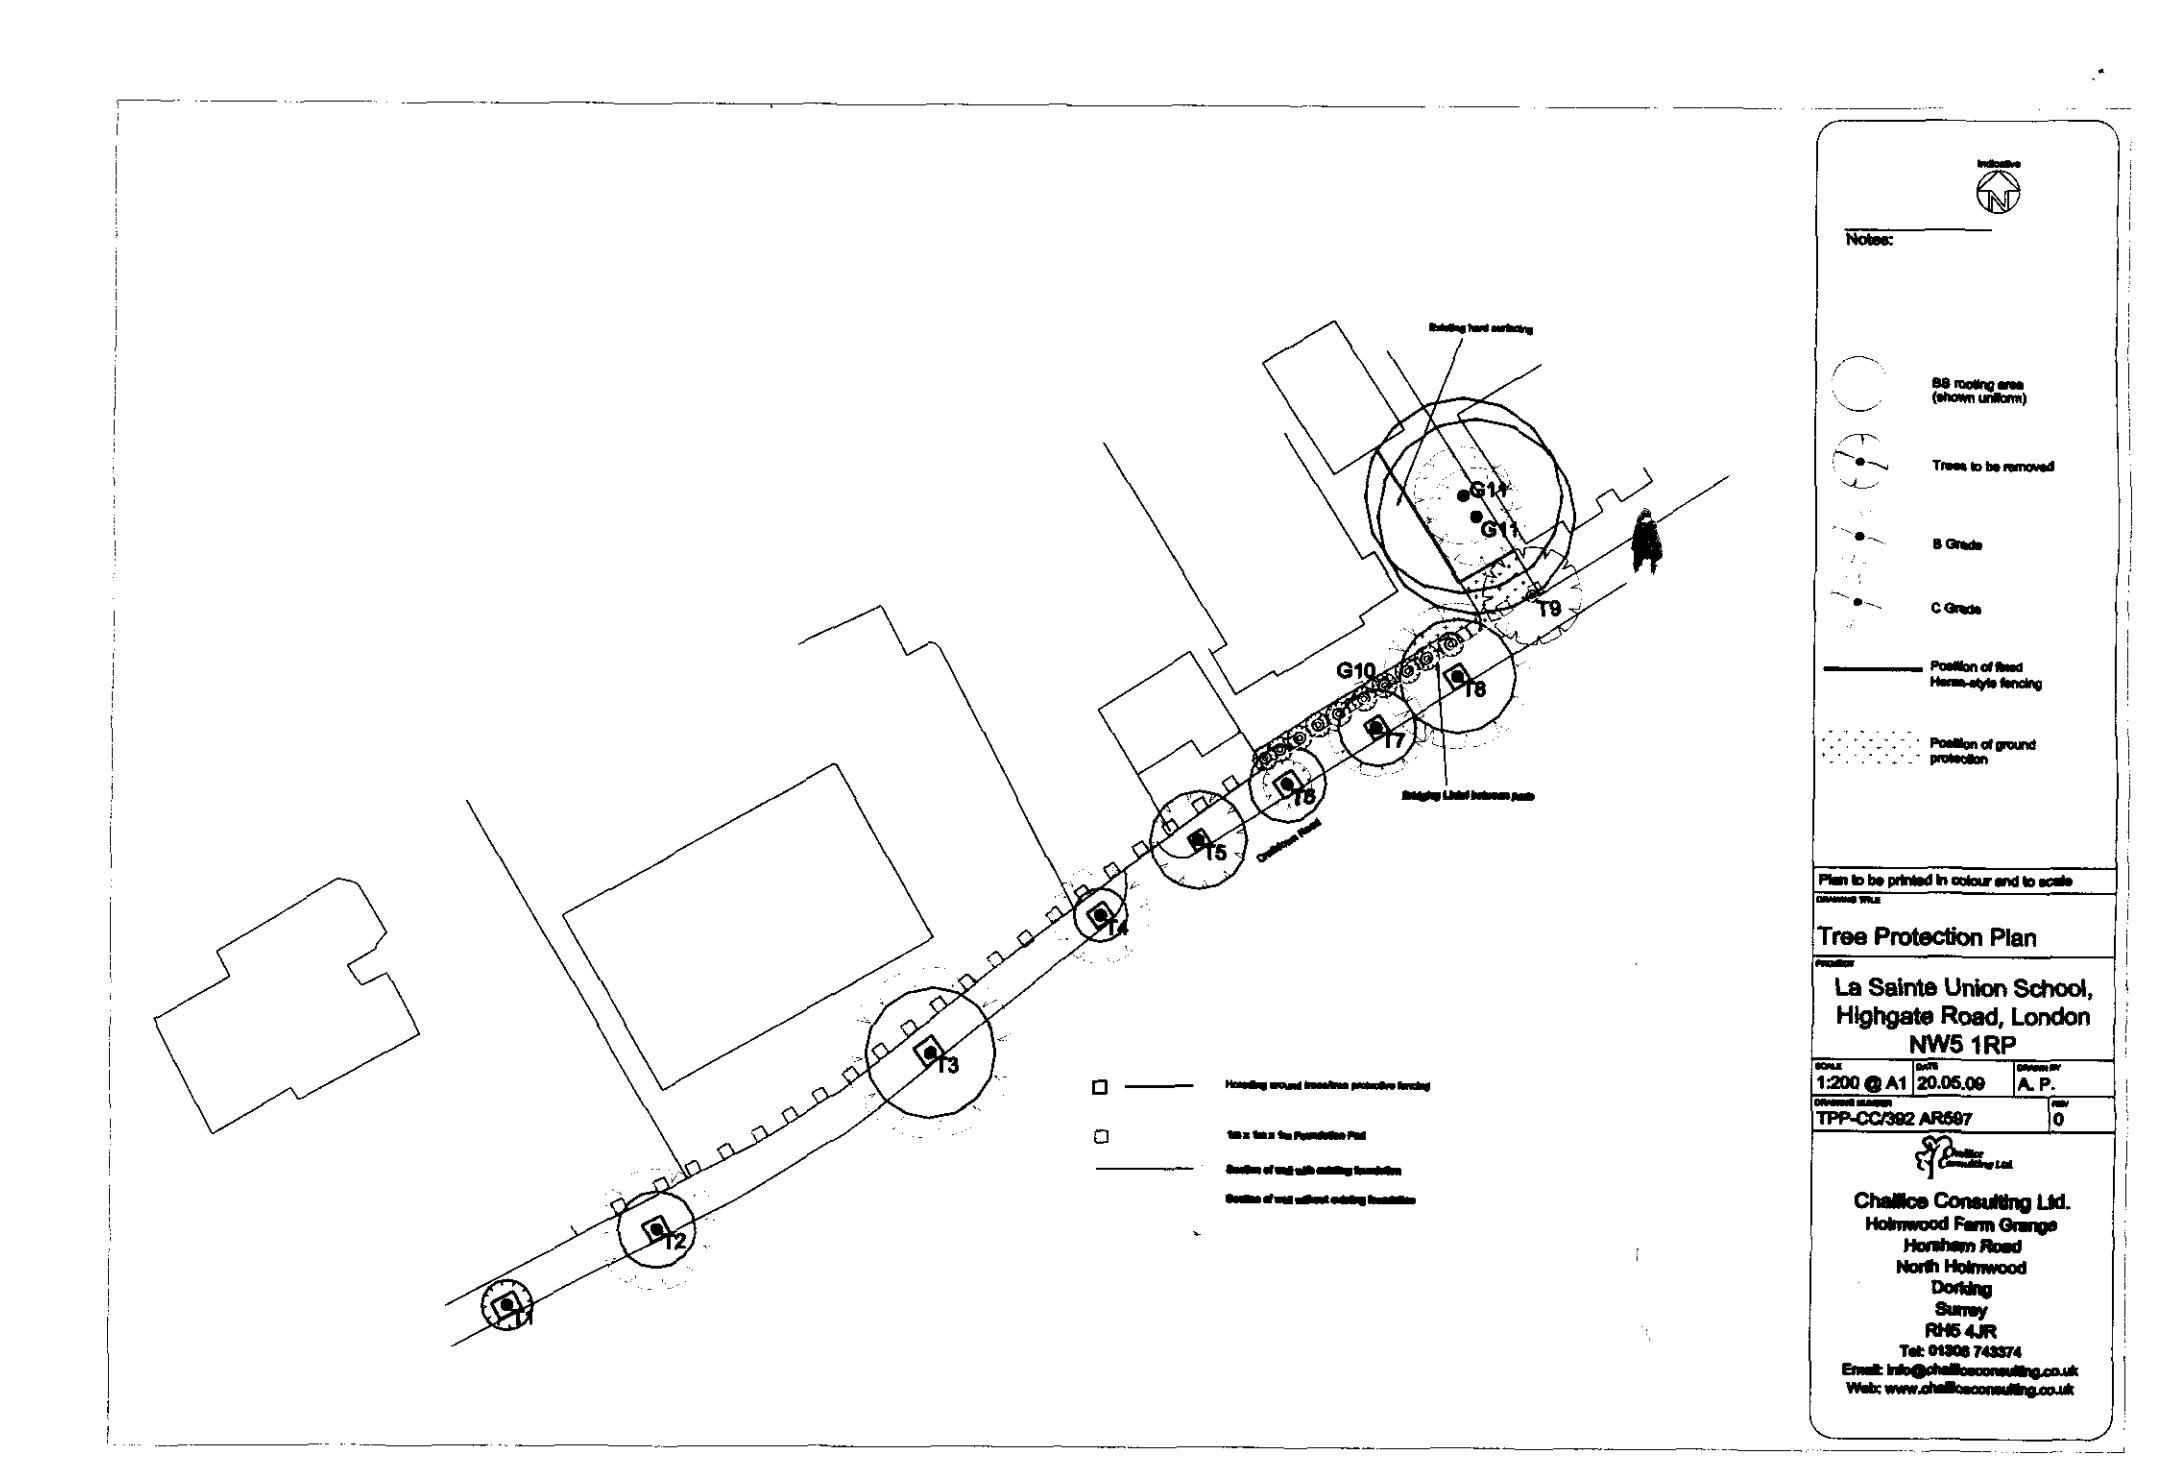
Appendix 3

- 9.3 There are incursitions of the new wall and associated back-stays within the \_ RPAs of T2, T3, T4, T5, T6, T7, T8 and G11.
- 9.4 Part of the new wall is to be built on the foundation of an existing wall. This section of the wall is highlighted in red on the Tree Protection Plan at Appendix

3. The 1m<sup>3</sup> concrete pad foundations for the back-stays are within the nominal RPAs of adjacent trees (T2, T3, T4, T5 and T6), but the presence of the existing wall foundation means that limited root damage will occur.

- 9.5 A section of the new wall is to be constructed along the line of an existing chain link fence (highlighted in yellow on the Tree Protection Plan at Appendix 3). This will entail excavating a 1m deep foundation, 0.45m in width. Excavations will also be required for the concrete back-stay foundations. The trees affected are T6, T7, T8 and G11. With regard to T6, T7 and G11, the incursions into the RPAs are relatively minor. There is a more significant incursion into the RPA of T8. This tree is a mature Robinia which is not of the highest vigour. To reduce the potential impact on this tree, additional tree protection measures are to be adopted as detailed in the Arboricultural Method Statement (AMS).

- 17.1 Part of the wall is to be constructed on an existing wall foundation (shown in red on the Tree Protection Plan at Appendix 3). This will minimise root damage to T2, T3, T4, T5 and T6. Excavations on the school side of the wall will be necessary for the 1m<sup>3</sup> concrete pad foundations which support the back-stays for the railings. Excavations within the nominal circular RPAs of the trees will be carried out by hand under direct arboricultural supervison, with any exposed roots being cut cleanly in accordance with Section 11.3.5 of the BS. Heavy gauge polythene sheeting/damp proof membrane will be used to line the foundation pad holes to protect the rooting environment of the trees from the potentially toxic effects of leaching concrete.

- 17.2 A section of the wall is to be constructed along the line of an existing chain-link fence (shown in yellow on the Tree Protection Plan at **Appendix 3**). A 1m deep by 0.45m wide foundation trench is to be excavated, along with excavations for the back-stay foundation pads. Excavations are to occur within the RPAs of T6, T7, T8 and G11. All excavations within the nominal circular RPAs of the trees will be carried out by hand under direct arboricultural supervison, with any exposed roots being cut cleanly in accordance with Section 11.3.5 of the BS. Heavy gauge polythene sheeting/damp proof membrane will be used to line the foundation pad holes to protect the rooting environment of the trees from the potentially toxic effects of leaching concrete.

- 17.3 The most significant incursion is into the RPA of T8 (a mature Robinia). To minimise damage to the roots of this tree, it is proposed that a lintel/ground beam be used in the location indicated on the Tree Protection Plan at **Appendix 3**. The lintel would need to be above existing ground level and would rest on concrete pads either side. The full details of the method of construction can be discussed and clarified at the pre-commencement meeting.

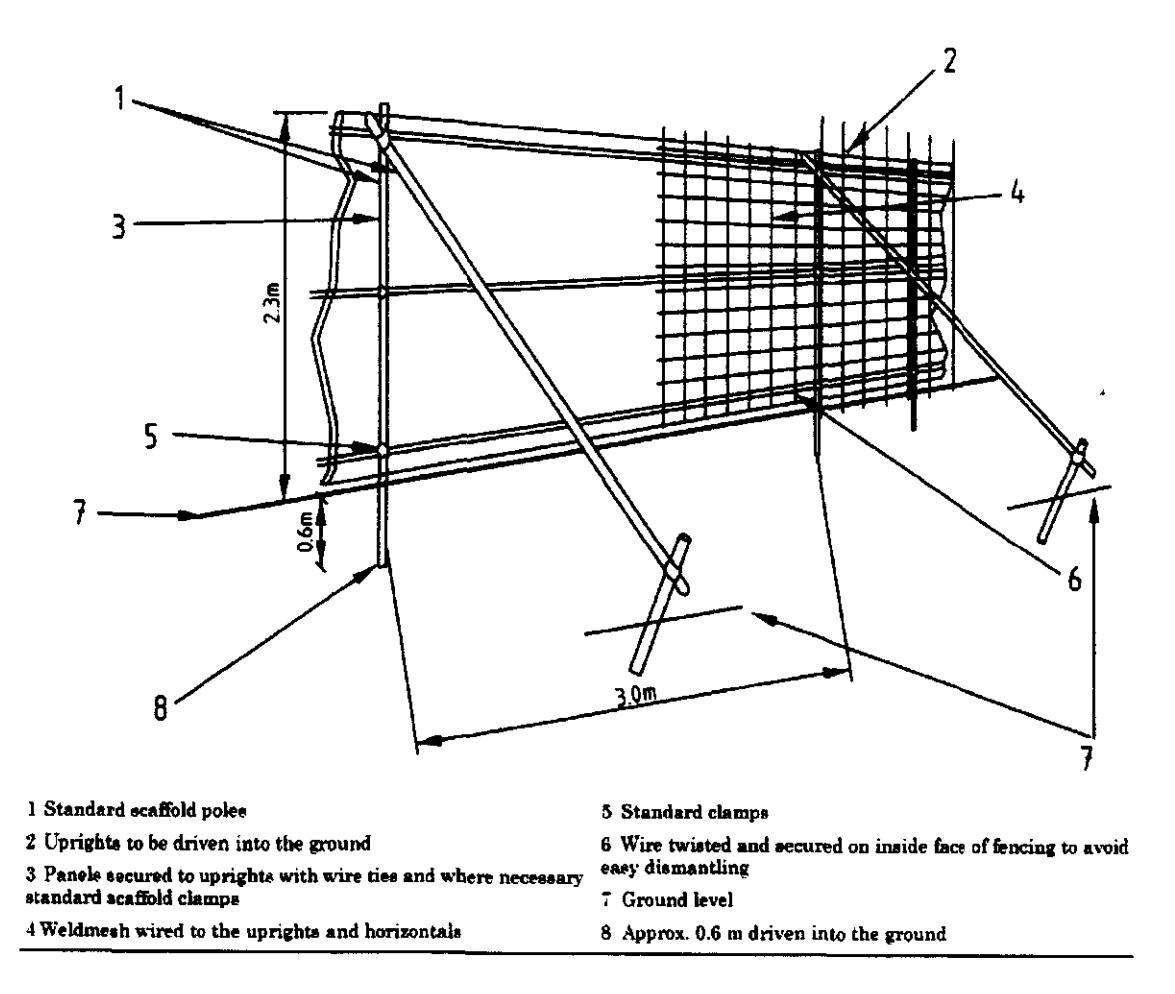
Example of Protective Barrier from British Standard 5837:2005

Heras fencing describes the 2.4m galvanised steel mesh panelled fencing with pre-cast bases.

For extra stability, scaffold poles are to be attached at a 45-degree angle on the 'tree side' of the fencing and fixed into the ground by further scaffold poles firmed into the soil.

The quantity of extra support scaffolds will be no less than two per panel.

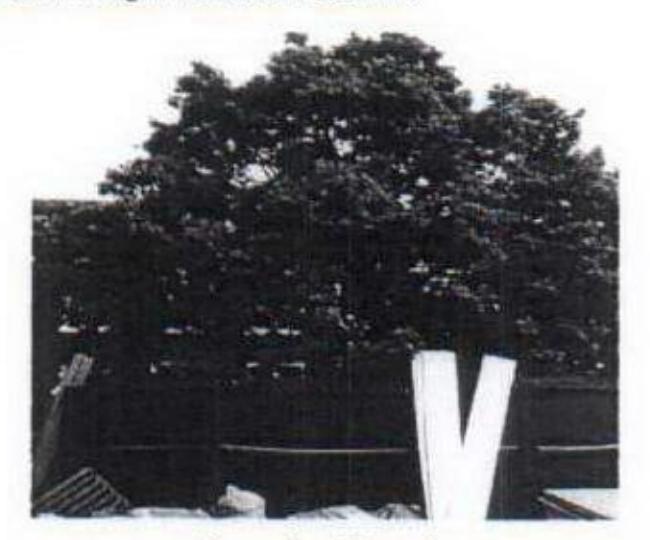
Example of Hoarding

- 3.0m 100 x 100mm square wooden posts.
- 3 x 38 x 87mm wooden rails affixed to posts.
- 2.4m x 1200 outside board panels (12-15mm) affixed to rails.
- 50 x 100mm angled supporting struts affixed internally (quantity as required).

Supporting posts fixed into position using concrete.

All post holes to be hand excavated.

Post holes to be no larger than 300 x 300mm.
