DEVELOPMENT SITE TREE REPORT

DATE: 28th April 2009

<u>SITE</u> ADDRESS: Magnolia House 2a Redington Road Hampstead London NW3

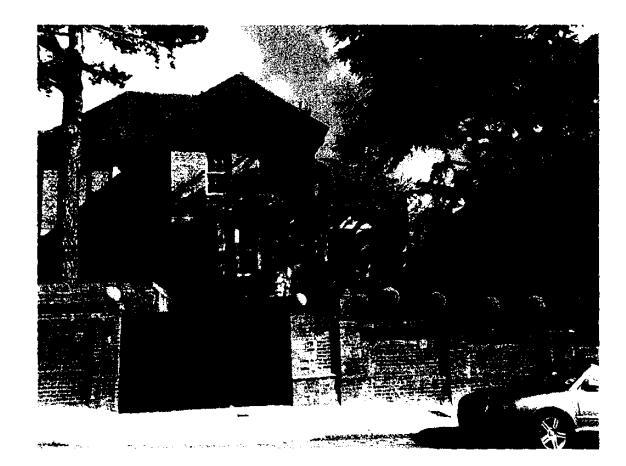
T1 & T2 & locations of gate parking works

Any works in root protection areas <u>must</u> be carried out with great care as described below. The enlargement of the parking area on its east side, by aprox 1m (including the width of the retaining wall) will infringe the tree T2's root protection area by $2m^2$ or approximately 5% of the whole RPA. As the garden area within the side of 2a and 71 Frognall are permeable surfaces, this small incursion will not be detrimental to T2. The excavations will need to be by hand only and any roots found within the excavation must be cut back cleanly with a sharp hand-saw or secateurs. Once the excavation is complete the new retaining wall should be erected as quickly as possible. To prevent drying of the exposed soil face and its interspersed root area the face must be covered with a plastic sheet to create shade and prevent evaporation of soil water.

On completion of the new retaining wall the small void between the wall rear and soil face should be filled with pea shingle to aid drainage and provide a benign environment for any cut root ends.

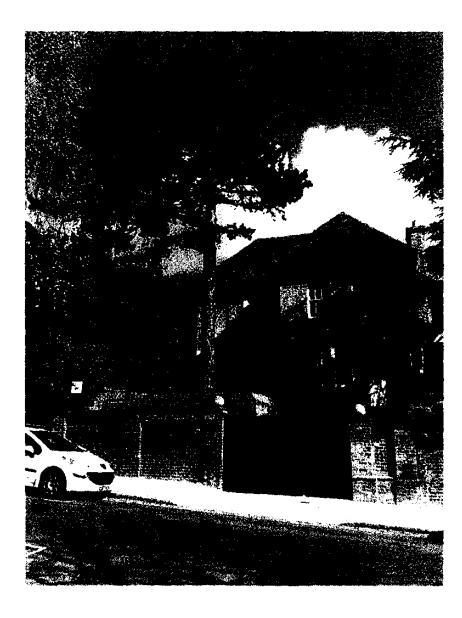
T1 Corsican Pine & hedge TH3 far left

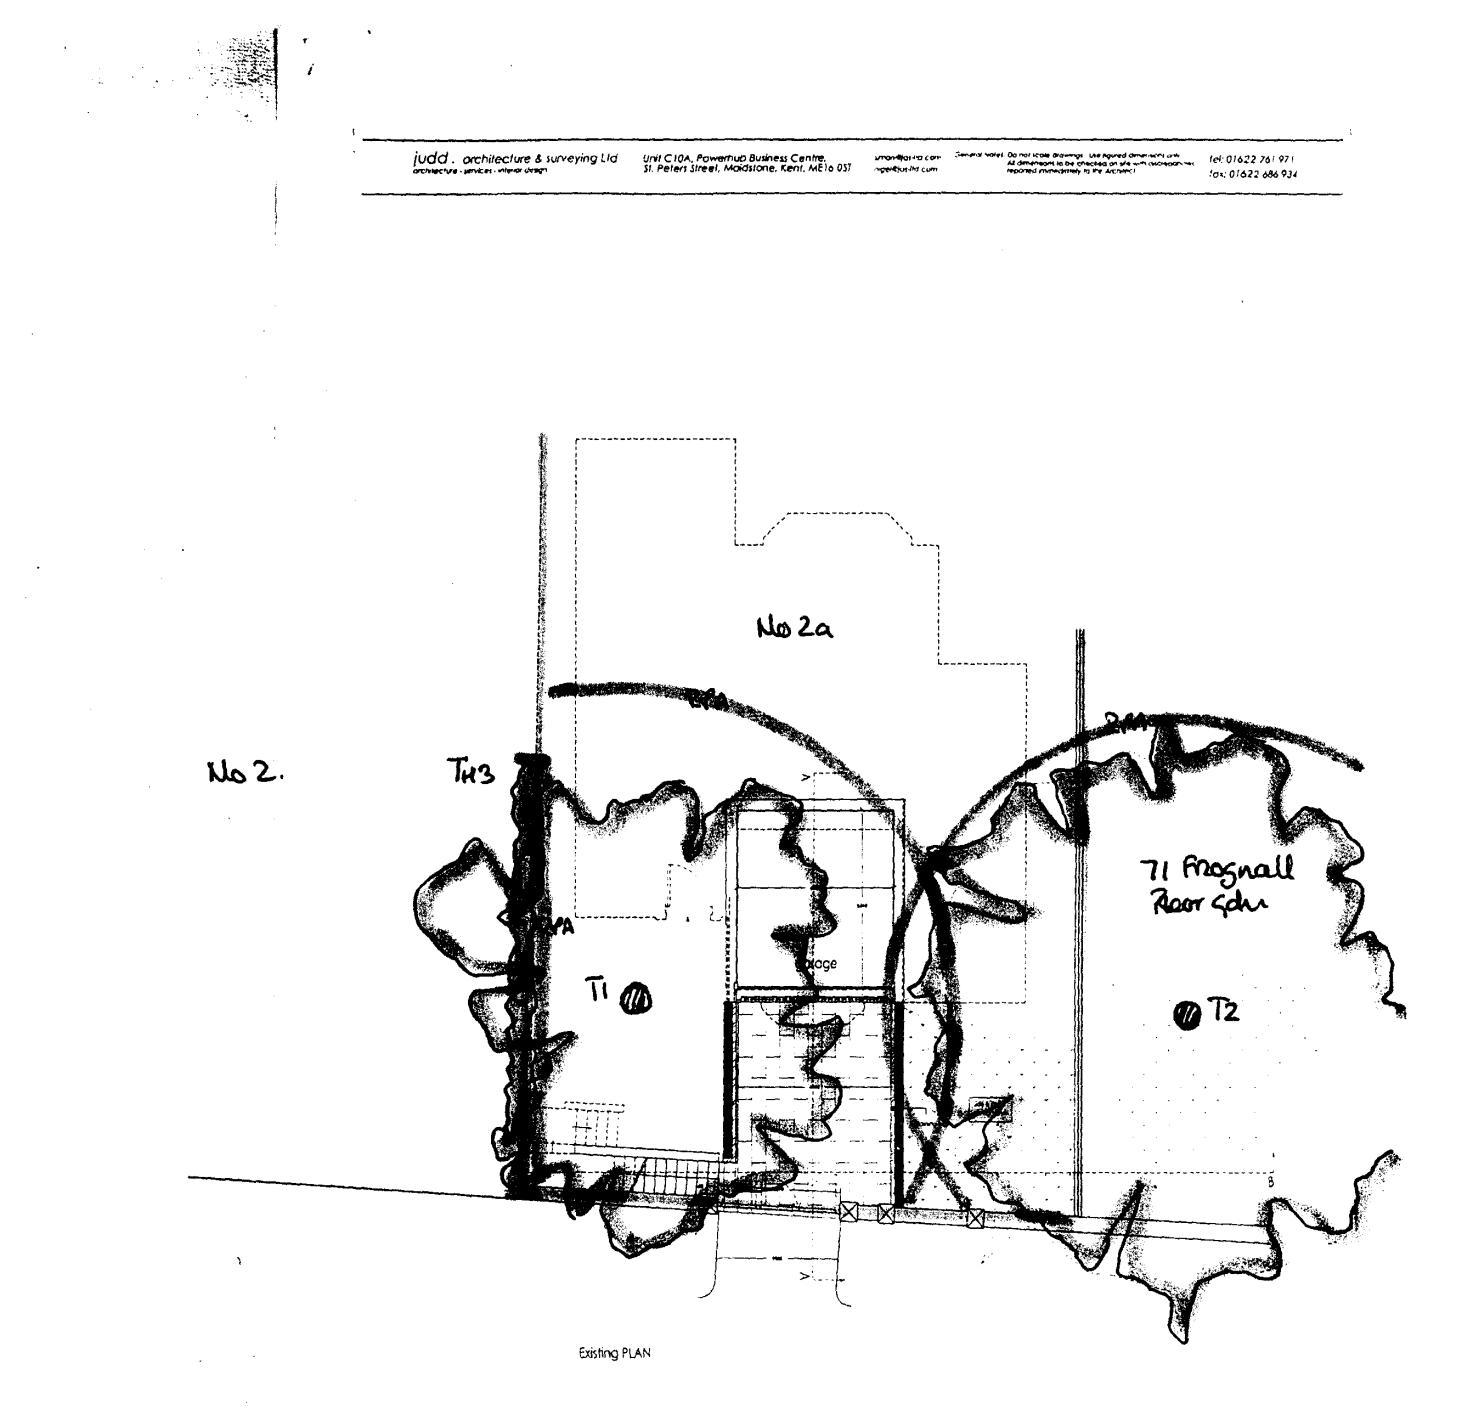
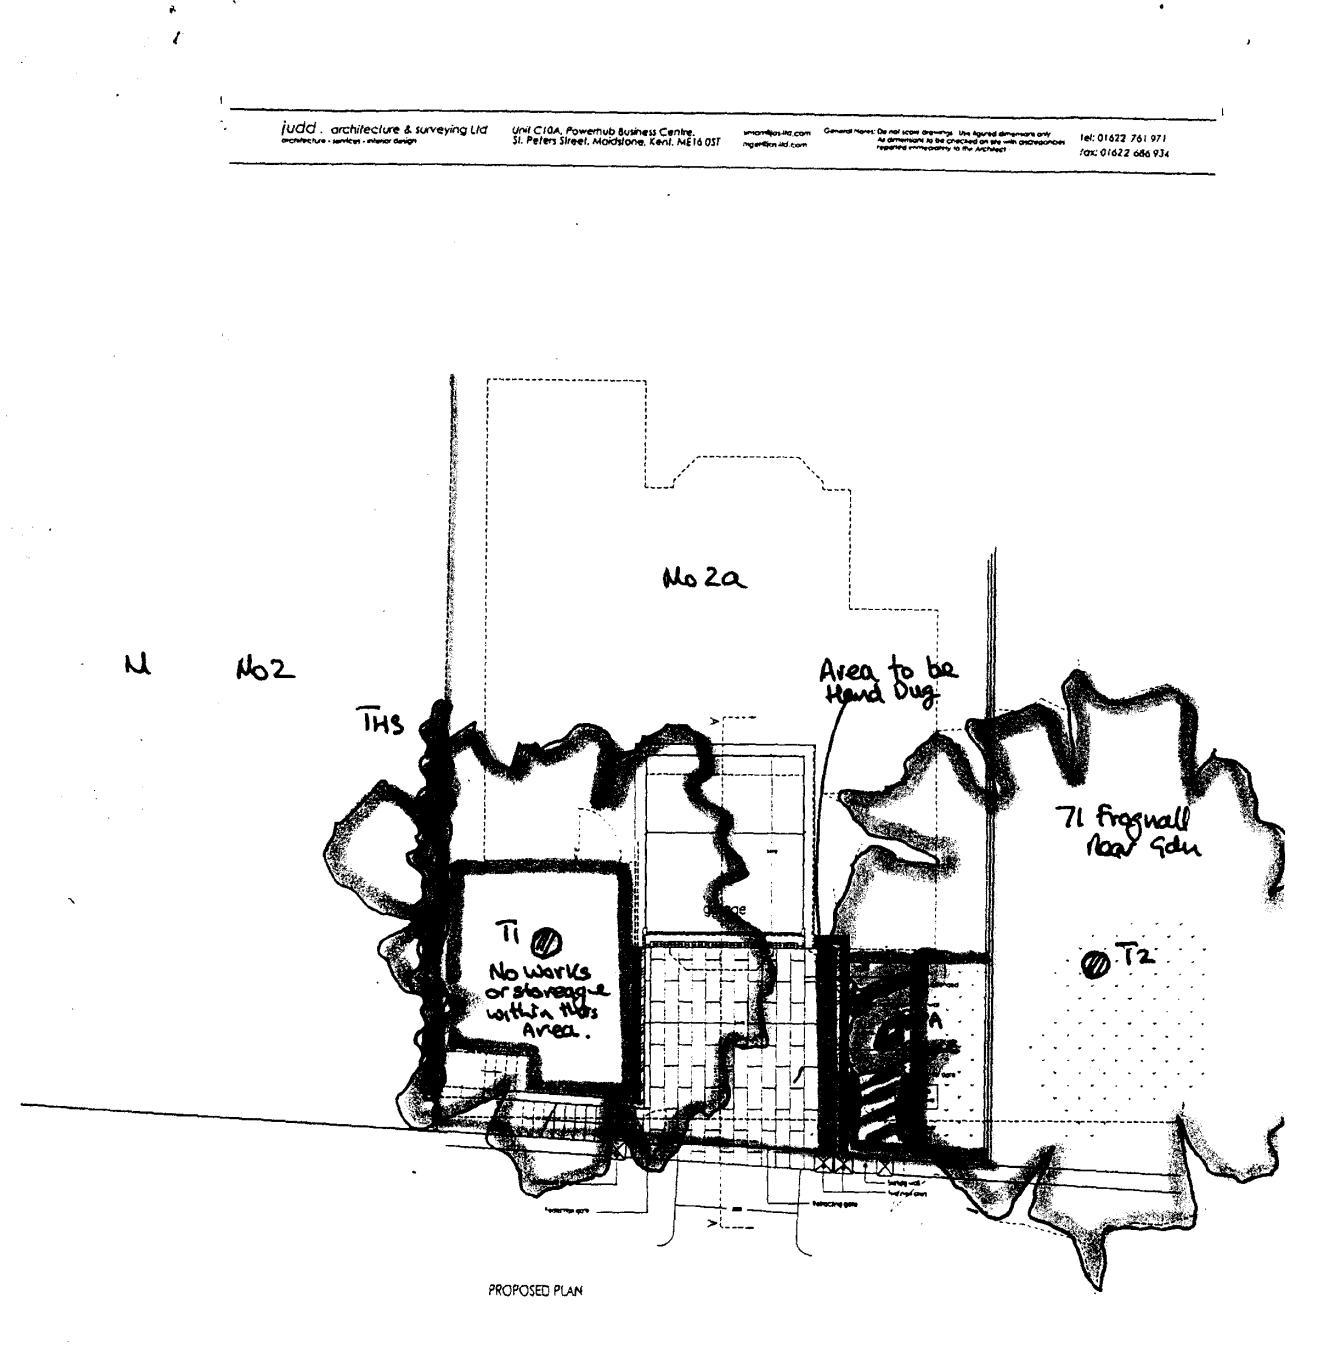
The location of the permanent and any temporary barriers, and the tree root protection areas they protect is shown on the tree protection plan. The precise location of the barriers and the sequence of their installation and removal <u>must</u> be agreed with the council before any construction or demolition starts. A small box of fencing to protect as much of T2's root area within No. 2a should be erected on the lawn area and a boarded work platform, from this out to the desired extent of the proposed excavation will need to be laid to provide some "tree safe" access to the work area. The hedge TH3 is beyond the works area and needs no protection, to reassure neighbours a lightweight fence could be fixed alongside the hedge face, if desired.

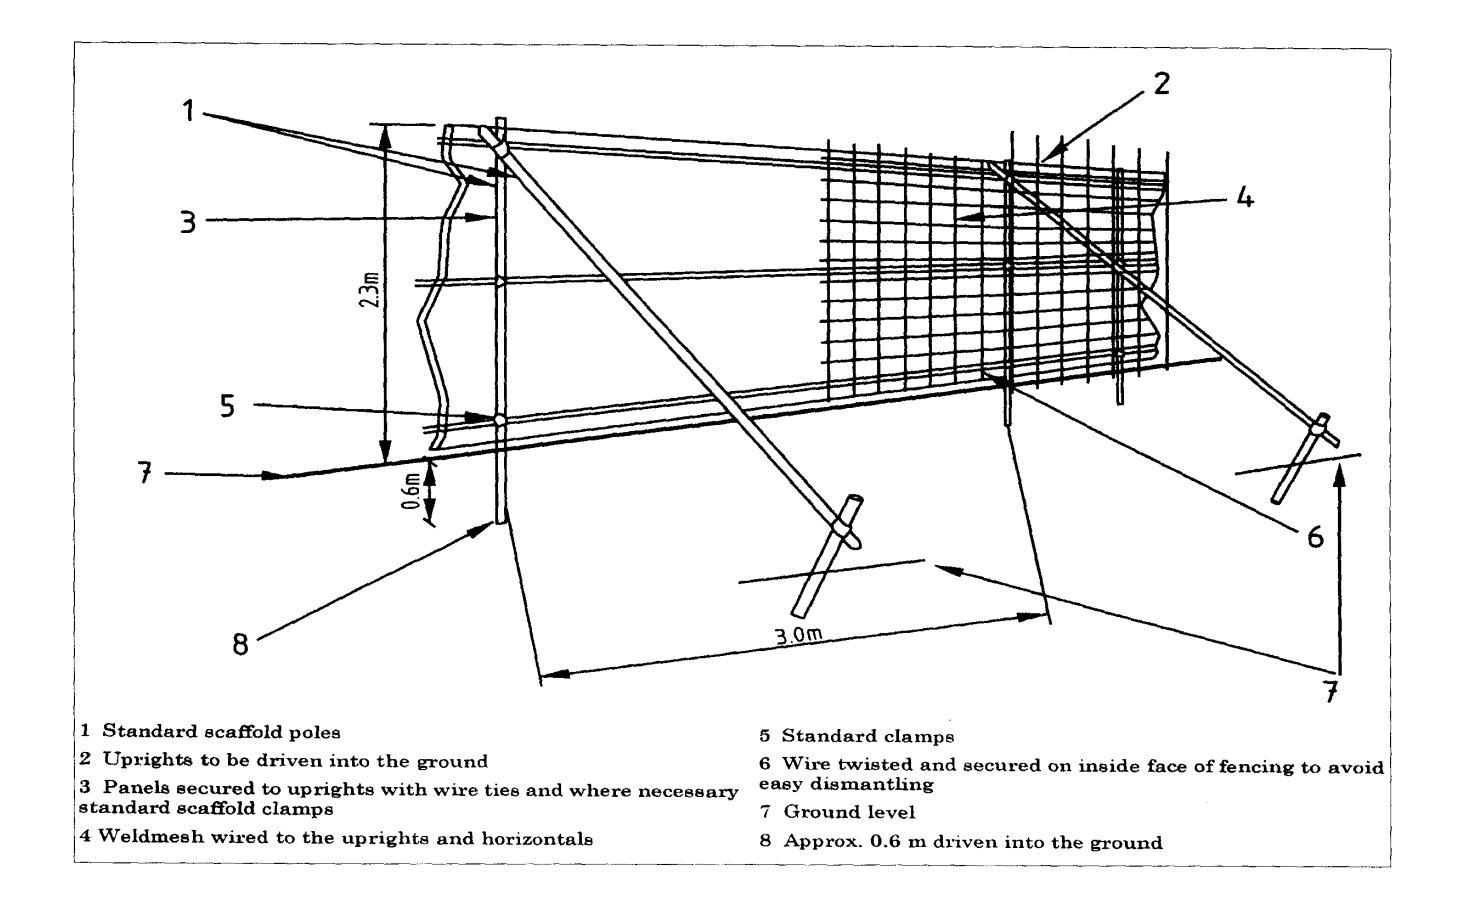
METHOD STATEMENT 1 FENCING – TREE ROOT PROTECTION AREAS

The fencing to tree protection areas should be constructed of scaffold tube uprights (set at 3m intervals with diagonal braces driven securely into the ground). Faced with 'herras' type fencing attached to uprights with steel strapping or scaffold clamps sited along the protection zone perimeters as per attached site plans.

The fencing shall completely exclude access during the demolition and construction process. The protected areas shall not be used either for the storage of materials or spoil nor for the mixing of substances or the disposal of any residues nor shall be allowed to be contaminated by run off from activities beyond the protection zones. Thus fencing for the root protection zone shall comply to the requirements of British Standard 5837:2005 'Trees in Relation to Construction': 9.1-2 and Figure 2.

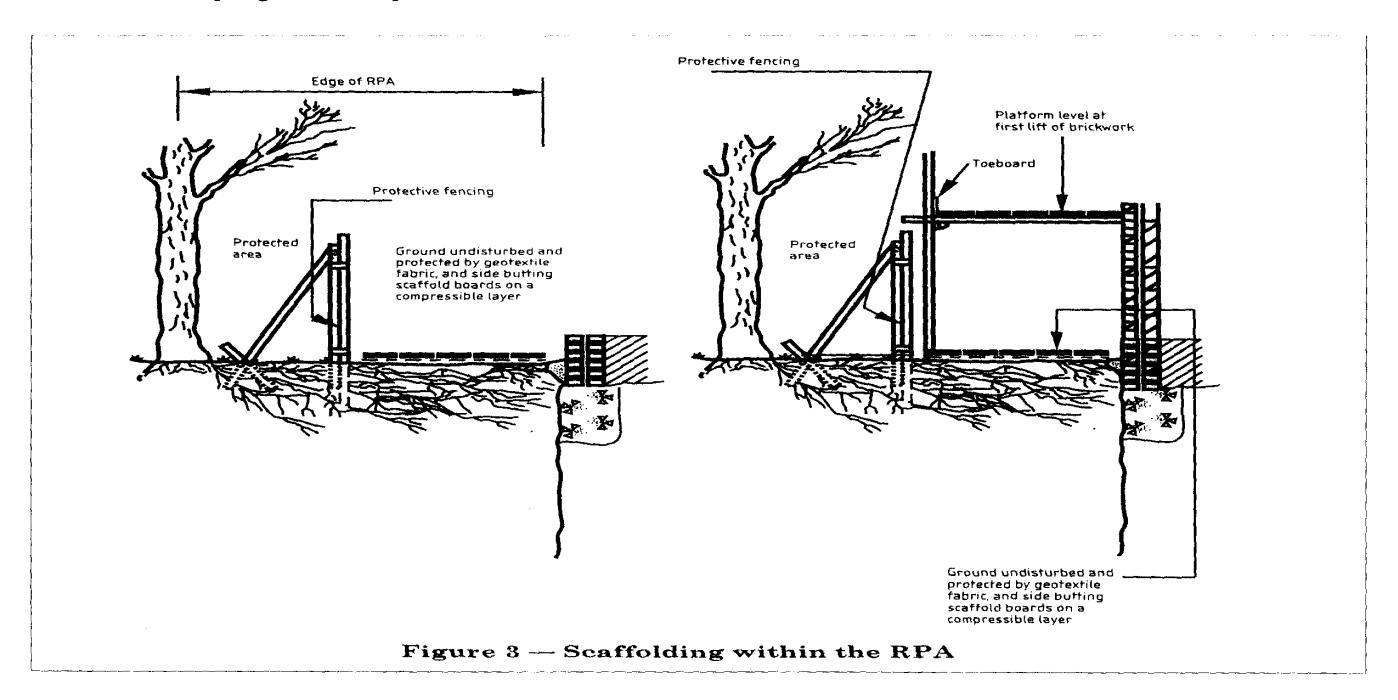
METHOD STATEMENT 2

For lightweight (pedestrian access) on sloping sites or over retained ground features an impervious membrane shall be laid over the existing surface, over this, supported on a scaffold low level framework shall be constructed a planked boardwalk, as per Fig 3 part 9.3 of the British Standard 5837:2005 'Trees in Relation to Construction'. [diagram below]
