### Arboricultural Report Planning & Development

British Standard 5837:2012 'Trees in relation to Construction & Demolition – Recommendations'

44 Queens Grove London NW8 6HH

22<sup>nd</sup> December 2014

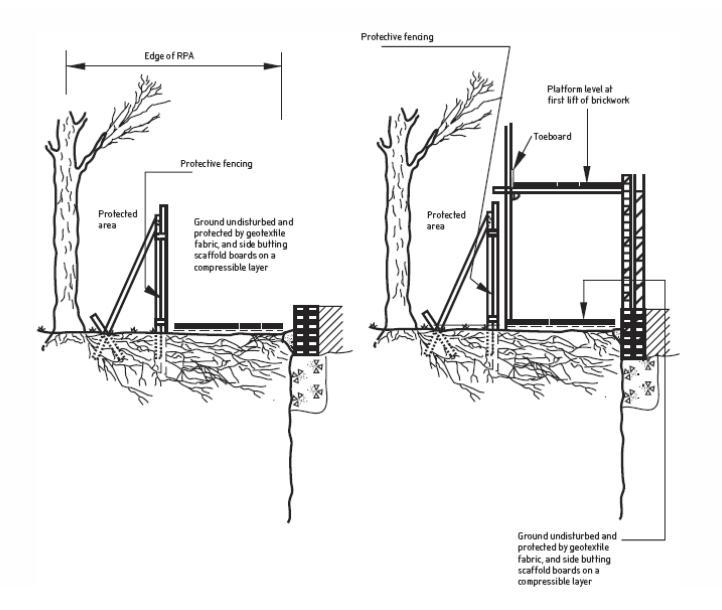
#### 3.9 Scaffolding within the RPA

Scaffolding which is to be erected within the RPA shall be done in accordance with the Standard as detailed below.

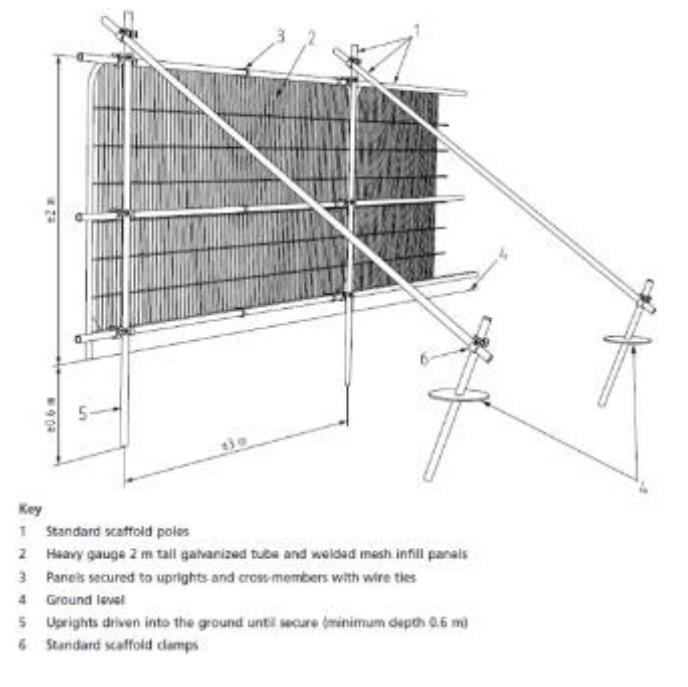
#### 4.3 Fencing diagram

Tree protection fencing. This should consist of a scaffold framework comprising a vertical and horizontal framework, well braced to resist impacts, with vertical tubes spaced at maximum intervals of 3.5m. Onto this welded mesh panels should be securely fixed with wire or scaffold clamps, as shown in figure 2 BS 5836: 2012, section 6.2. As illustrated in 4.3 of this report.

4.2 Construction exclusion zones (CEZs) will be formed by erecting protective fencing around the RPAs of retained trees within the development area, linking up with the existing site boundary fences (see TPP appendix 1). The protective fencing shall be erected to a specification recommended in BS5837: 2012, section 6.2 prior to the commencement of construction. This should consist of a scaffold framework comprising a vertical and horizontal framework, well braced to resist impacts, with vertical tubes spaced at maximum intervals of 3.5m. Onto this welded mesh panels should be securely fixed with wire or scaffold clamps, as illustrated below. The protective fencing shall remain in place until completion of the project. The position of protective fencing is shown on the tree protection plan. "TREE PROTECTION ZONE - KEEP OUT" or similar notices should be attached. (See appendix 5)

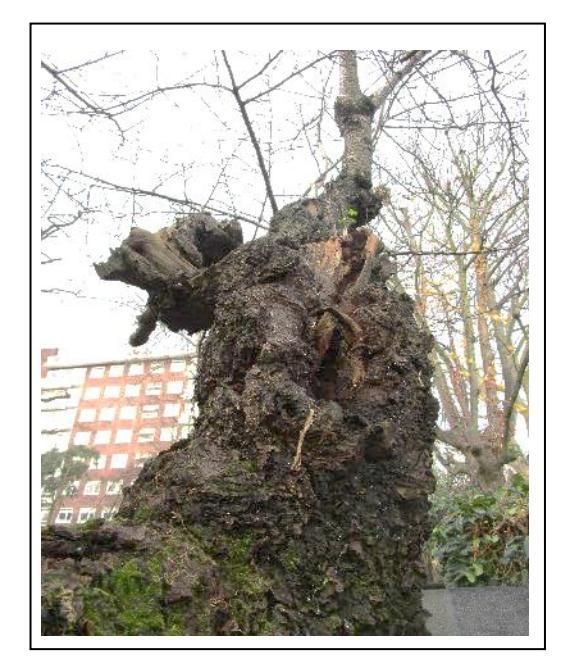
View of decay on T15 Cherry

It is proposed that T4, T3 and T15 are removed to facilitate the development of the proposed extension and landscaping works as the proposal encroaches into the RPAs of these trees. It is considered that these trees are of low value and as such their retention and protection would impose unnecessary constraints to the development.

4.7 It is proposed that T3, T4 & T15 are felled in order to facilitate the proposed development.

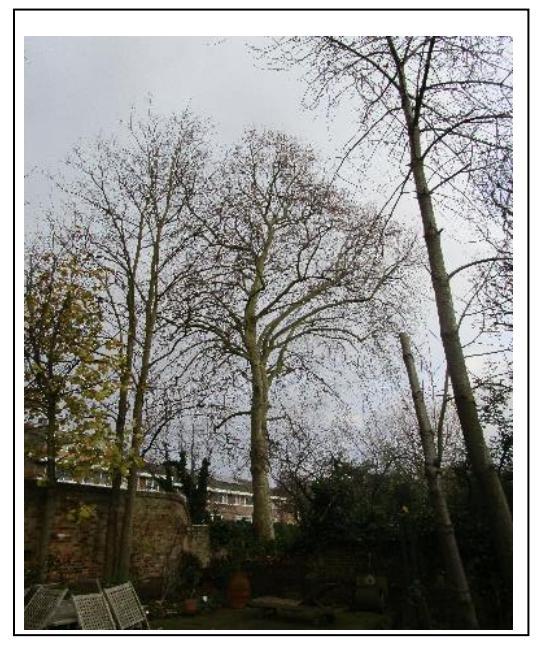
View of T16 London plane

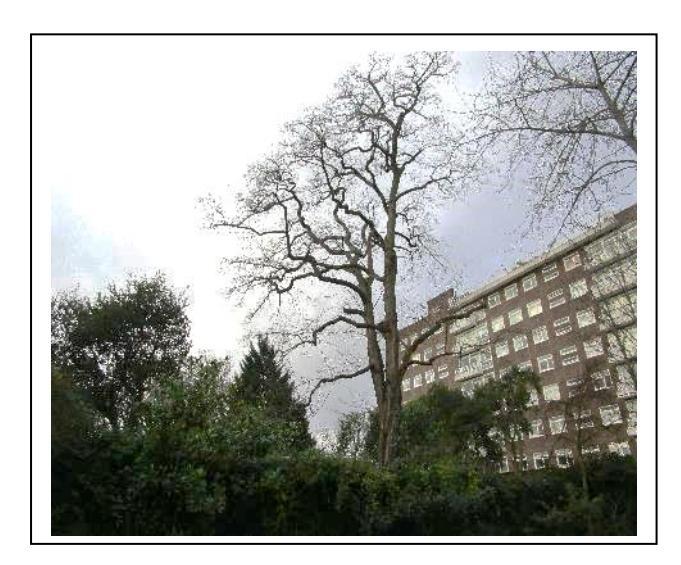
View of T5 False acacia

Construction exclusion zones (CEZs) will be formed by erecting protective fencing around the RPAs of T5, T11, T12 & T14 and linking up with the existing site boundary fences. This will also act as protection for the reaming trees to be retained towards the rear of the back garden. The fencing should consist of a scaffold framework comprising a vertical and horizontal framework, well braced to resist impacts, with vertical tubes spaced at maximum intervals of 3.5m. Onto this welded mesh panels should be securely fixed with wire or scaffold clamps, as shown in figure 2 of BS 5837: 2012. The protective fencing shall be in place before any on site development works commence and should remain in place until completion of the project.
