Arboricultural Development Report

LAND REAR OF 20 GORDON SQUARE LONDON

Produced for: UCL Estates

December 2015

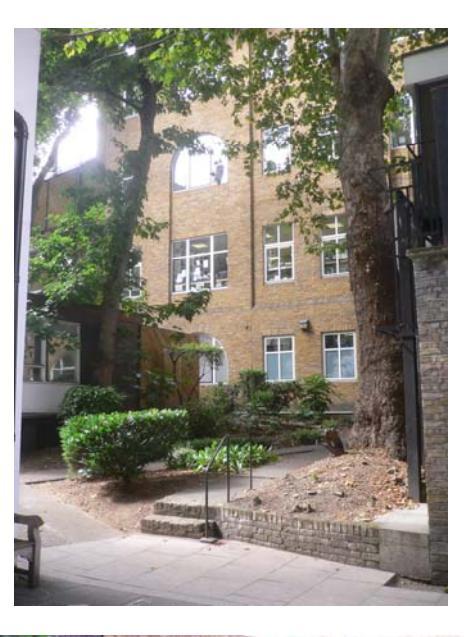
General view of existing amenity area with London Plane (T1) located to the right of the photo and Sycamore (T2) located to the left of the photo.

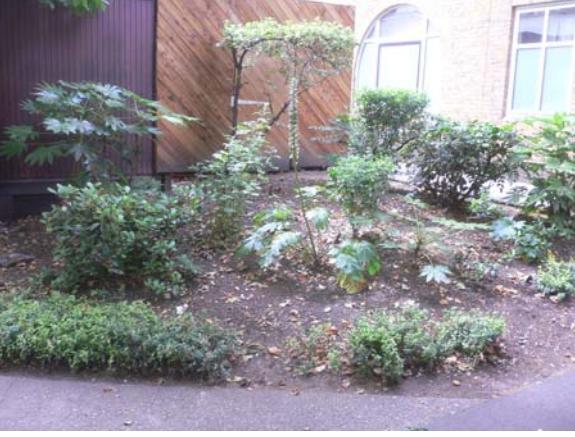
2. General view of existing vegetation including Bay, Euonymus, Japanese Arailia, Laurel, Mallow, Oregon Grape, Periwinkle, Viburnum. with open soil between.

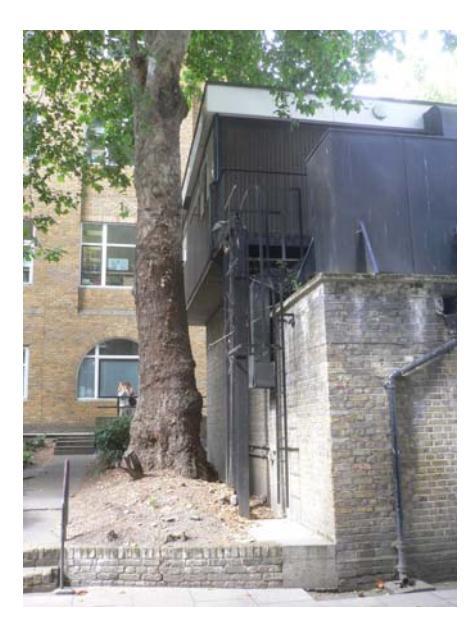
3. General view of London Plane (T1) located at raised level and adjacent existing building.

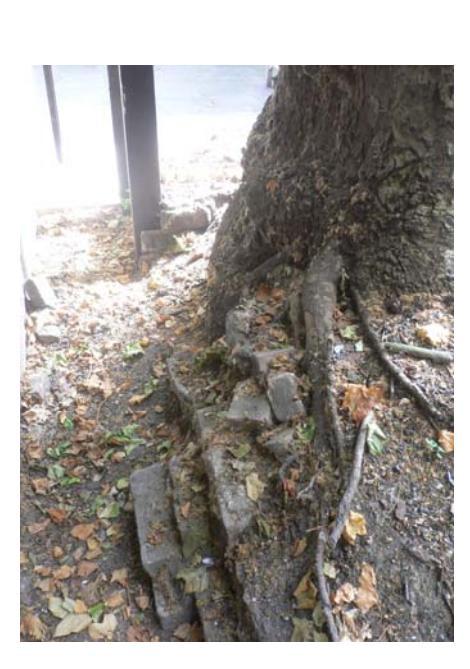
- 5.2.1 Two mature trees are located within the open space, a mature London Plane (T1) located to the northwest boundary and a Sycamore (T2) located to the southeast boundary.
- 5.2.2 The London Plane (T1) is set within a soft ground area and located approximately 1m from an adjacent building and a retaining wall 3.3m to the northeast. A remnant wall foundation remains between the tree and the building. This remnant wall has influenced the trunk (flattening) with the visible rooting pattern bias to the soft ground. This is

typically characteristic of a previous structure in close proximity. The existing building displays vertical cracking and appears to be subject to level monitoring.

4. Detail view of London Plane (T1) with remnant wall between tree and existing building. Basal area and surface roots typically characteristic of previous structure.

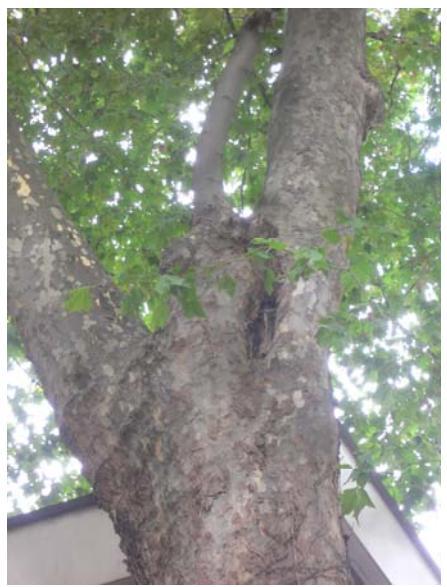
- 5.2.3 Outwardly, the London Plane displays previous tree works and appears to be of fair health and vigour. At approximately 8m above ground level, the trunk forks forming two spires supporting a full crown. Below this fork, a cavity is located approximately 7.5m above ground level on the northeast profile. The cavity displays dysfunctional wood with good wound wood and occlusion. The upper crown of the London Plane displays previous crown reduction at approximately 15m and has now regrown a full crown. Given the position of the cavity below a structural fork, previous major branch removal and the adjacent target risk, it is recommended that an ariel H&S inspection is carried out and any recommendation for works implemented.

5. Detail view of cavity/wound below fork of London Plane (T1) at approximately 7.5m a.g.l

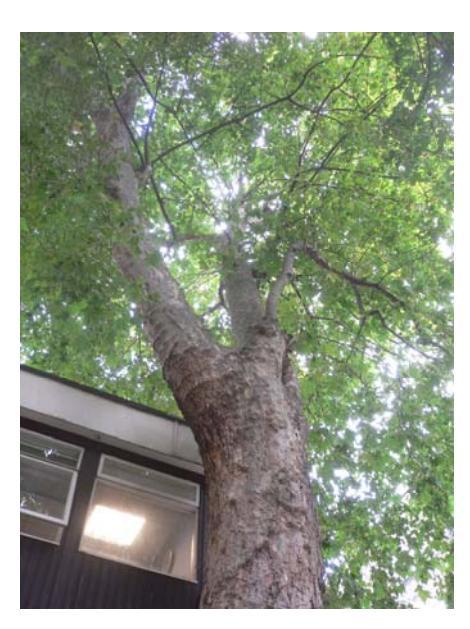
6. General view of London Plane (T1) adjacent existing building and displaying previous pollarding within upper crown.

- 6.7.2 It is the intention of UCL to reduce the crown of the London Plane (T1) to its previous reduction points. Whilst the works would have a temporary impact on visual amenity the tree works would be reasonably considered as part of tree management within an urban area regardless of the proposal. Further, whilst not directly required to facilitate installation of the temporary building, the removal of the Sycamore is currently being considered as part of good arboricultural management. The Sycamore is of poor quality and subservient to the London Plane and in early discussion with Camden Council's Tree Officer, Nick Bell, the principal of removal was considered acceptable, subject to an adequate replacement elsewhere within the campus. A separate tree works notification, according with BS3998 (2010) has therefore been submitted in respect of the proposed tree works with the intention of carrying out these works prior to installation of the temporary building. This will minimise risk of future failure and maintain the London Plane within the local and wider landscape.

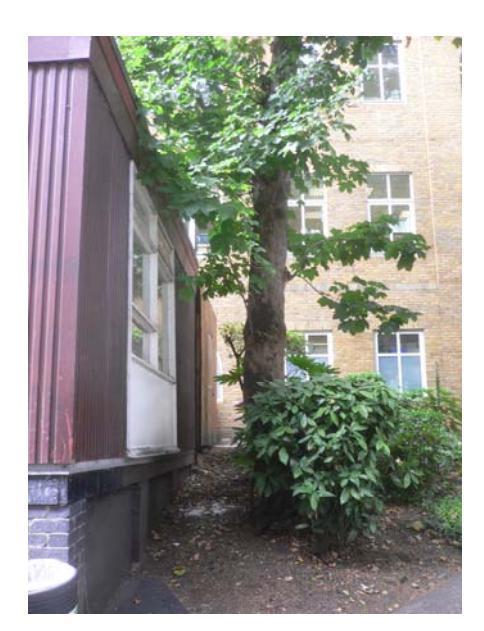
- 5.2.4 To the northeast of the site, a Sycamore (T2) is located 1m from an existing temporary building. This building is located on brick piers with soft ground retained beneath. The void beneath the building is excluded by metal grills. The tree appears to be of fair health and is subservient to the adjacent dominant London Plane (T1). The lower trunk is slightly swept with surface roots biased to the west and flattening of the trunk on the northeast profile. The tree has been previously crown lifted to accommodate the adjacent building with the upper crown displaying a poor crown architecture.

7. General view of Sycamore (T2) located adjacent temporary building. Foundation type appears to be on piers with void enclosed by metal panels.

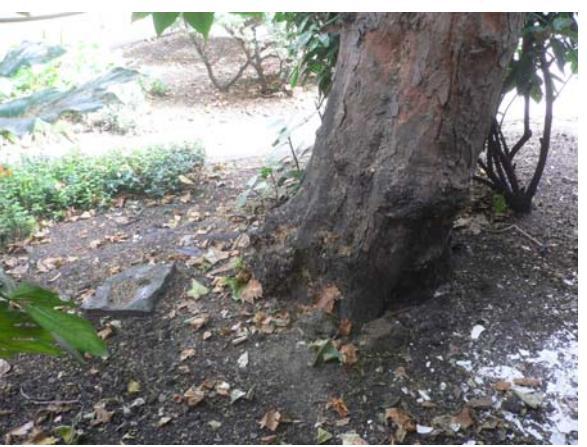
Detail view of swept lower trunk of Sycamore (T2) with flattening on SE side possibly indication previous structure in close proximity.

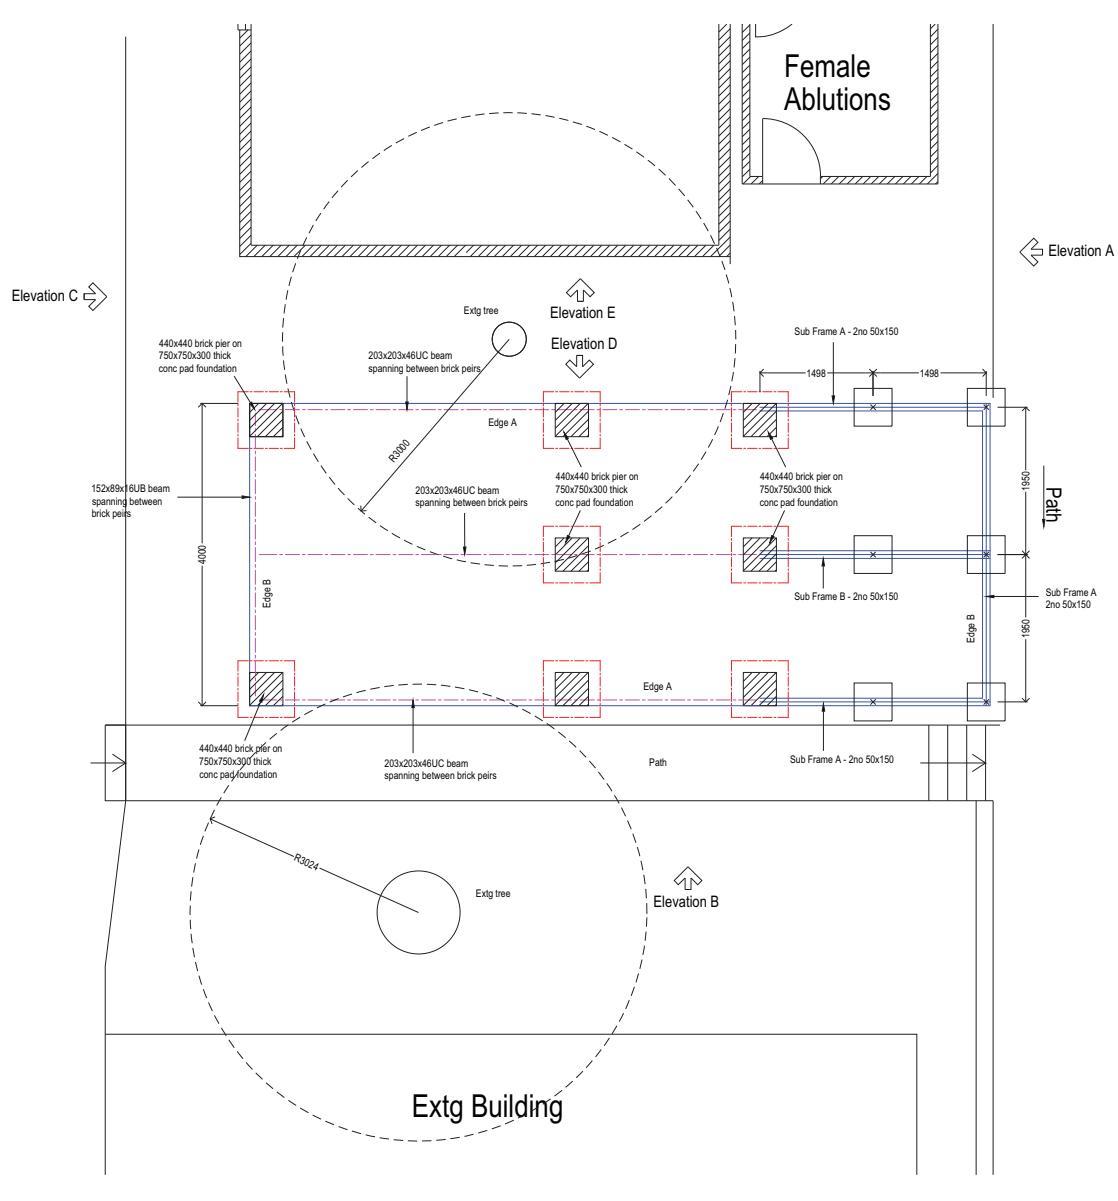
New 'Qube' STRUCTURE

FOUNDATION & SUB-FRAME NOTES

Loading onto foundation pads: (See Loading Data for Sub Frame Calc) Floor Loads (Live) 3.0kN/m2 (from BS 6399-1:1996/ Table 1/ Category C1/ Classrooms)

Floor Loads (Dead) 0.45kN/m2 (Self weight of SIPS panels)

Swift Foundations pads capable of bearing 2.5 tonnes (24.5 kN) - refer to LABC type approval. Area of base is 0.36m2

Assumed worst case ground bearing capacity 75 kN/m2 (from BS 8004:1986 - 'firm clays')

Therefore the maximum allowable loading onto an individual pad for this soil type is 75 kN * 0.36 m2 = 27.00 kN, but limiting factor is capacity of Swift Pads at 24.5kN

Maximum loadings conditions of pads shown opposite - all less than 24.5kN.

Foundation pads at the centres shown are therefore adequate for the assumed soil type - to be established by trial hole. Obtain instructions if conditions vary.

Sub Frame sizing: EDGE A - 2 no. 50 x 150 C24 EDGE B - 2 no. 50 x 150 C24 INTERMEDIATE - 2 no. 50 x 150 C24

Joists bolted with M12 bolts at 600mm centres.

- 6.4 Foundation design – The proposed foundations are to be formed of brick piers built on a 750mmx750mmx300mm thick concrete pad foundations with a suspended sub frame above ground level (see Appendix 3: New Qube Structure Foundation & Sub-Frame Notes). This design minimises the footprint of excavation required and reconciles the changes in land levels within the site whilst maintaining the soil environment and allowing gaseous exchange. Whilst localised excavation will be required to install the foundation pads, the excavation is limited to 300mm depth. Given that the existing ground cover is cultivated soil with scattered shrub cover, it is not anticipated that structural roots (>25mm diameter) would be encountered. However, in the unlikely event that structural roots are encountered, the design allows flexibility to re-position the piers outlined in red (see Appendix 3). Where re-positioning is found necessary, the hole will be backfilled and a new hole excavated in consultation with the engineer. Prior to pouring of concrete pads, the hole will be lined with a non porous textile to minimise leaching of wet concrete into the surrounding soil. Care will be taken to avoid splashing during the pouting process. All excavation will be made using hand tools, under supervision of the Project Arbroculturist.

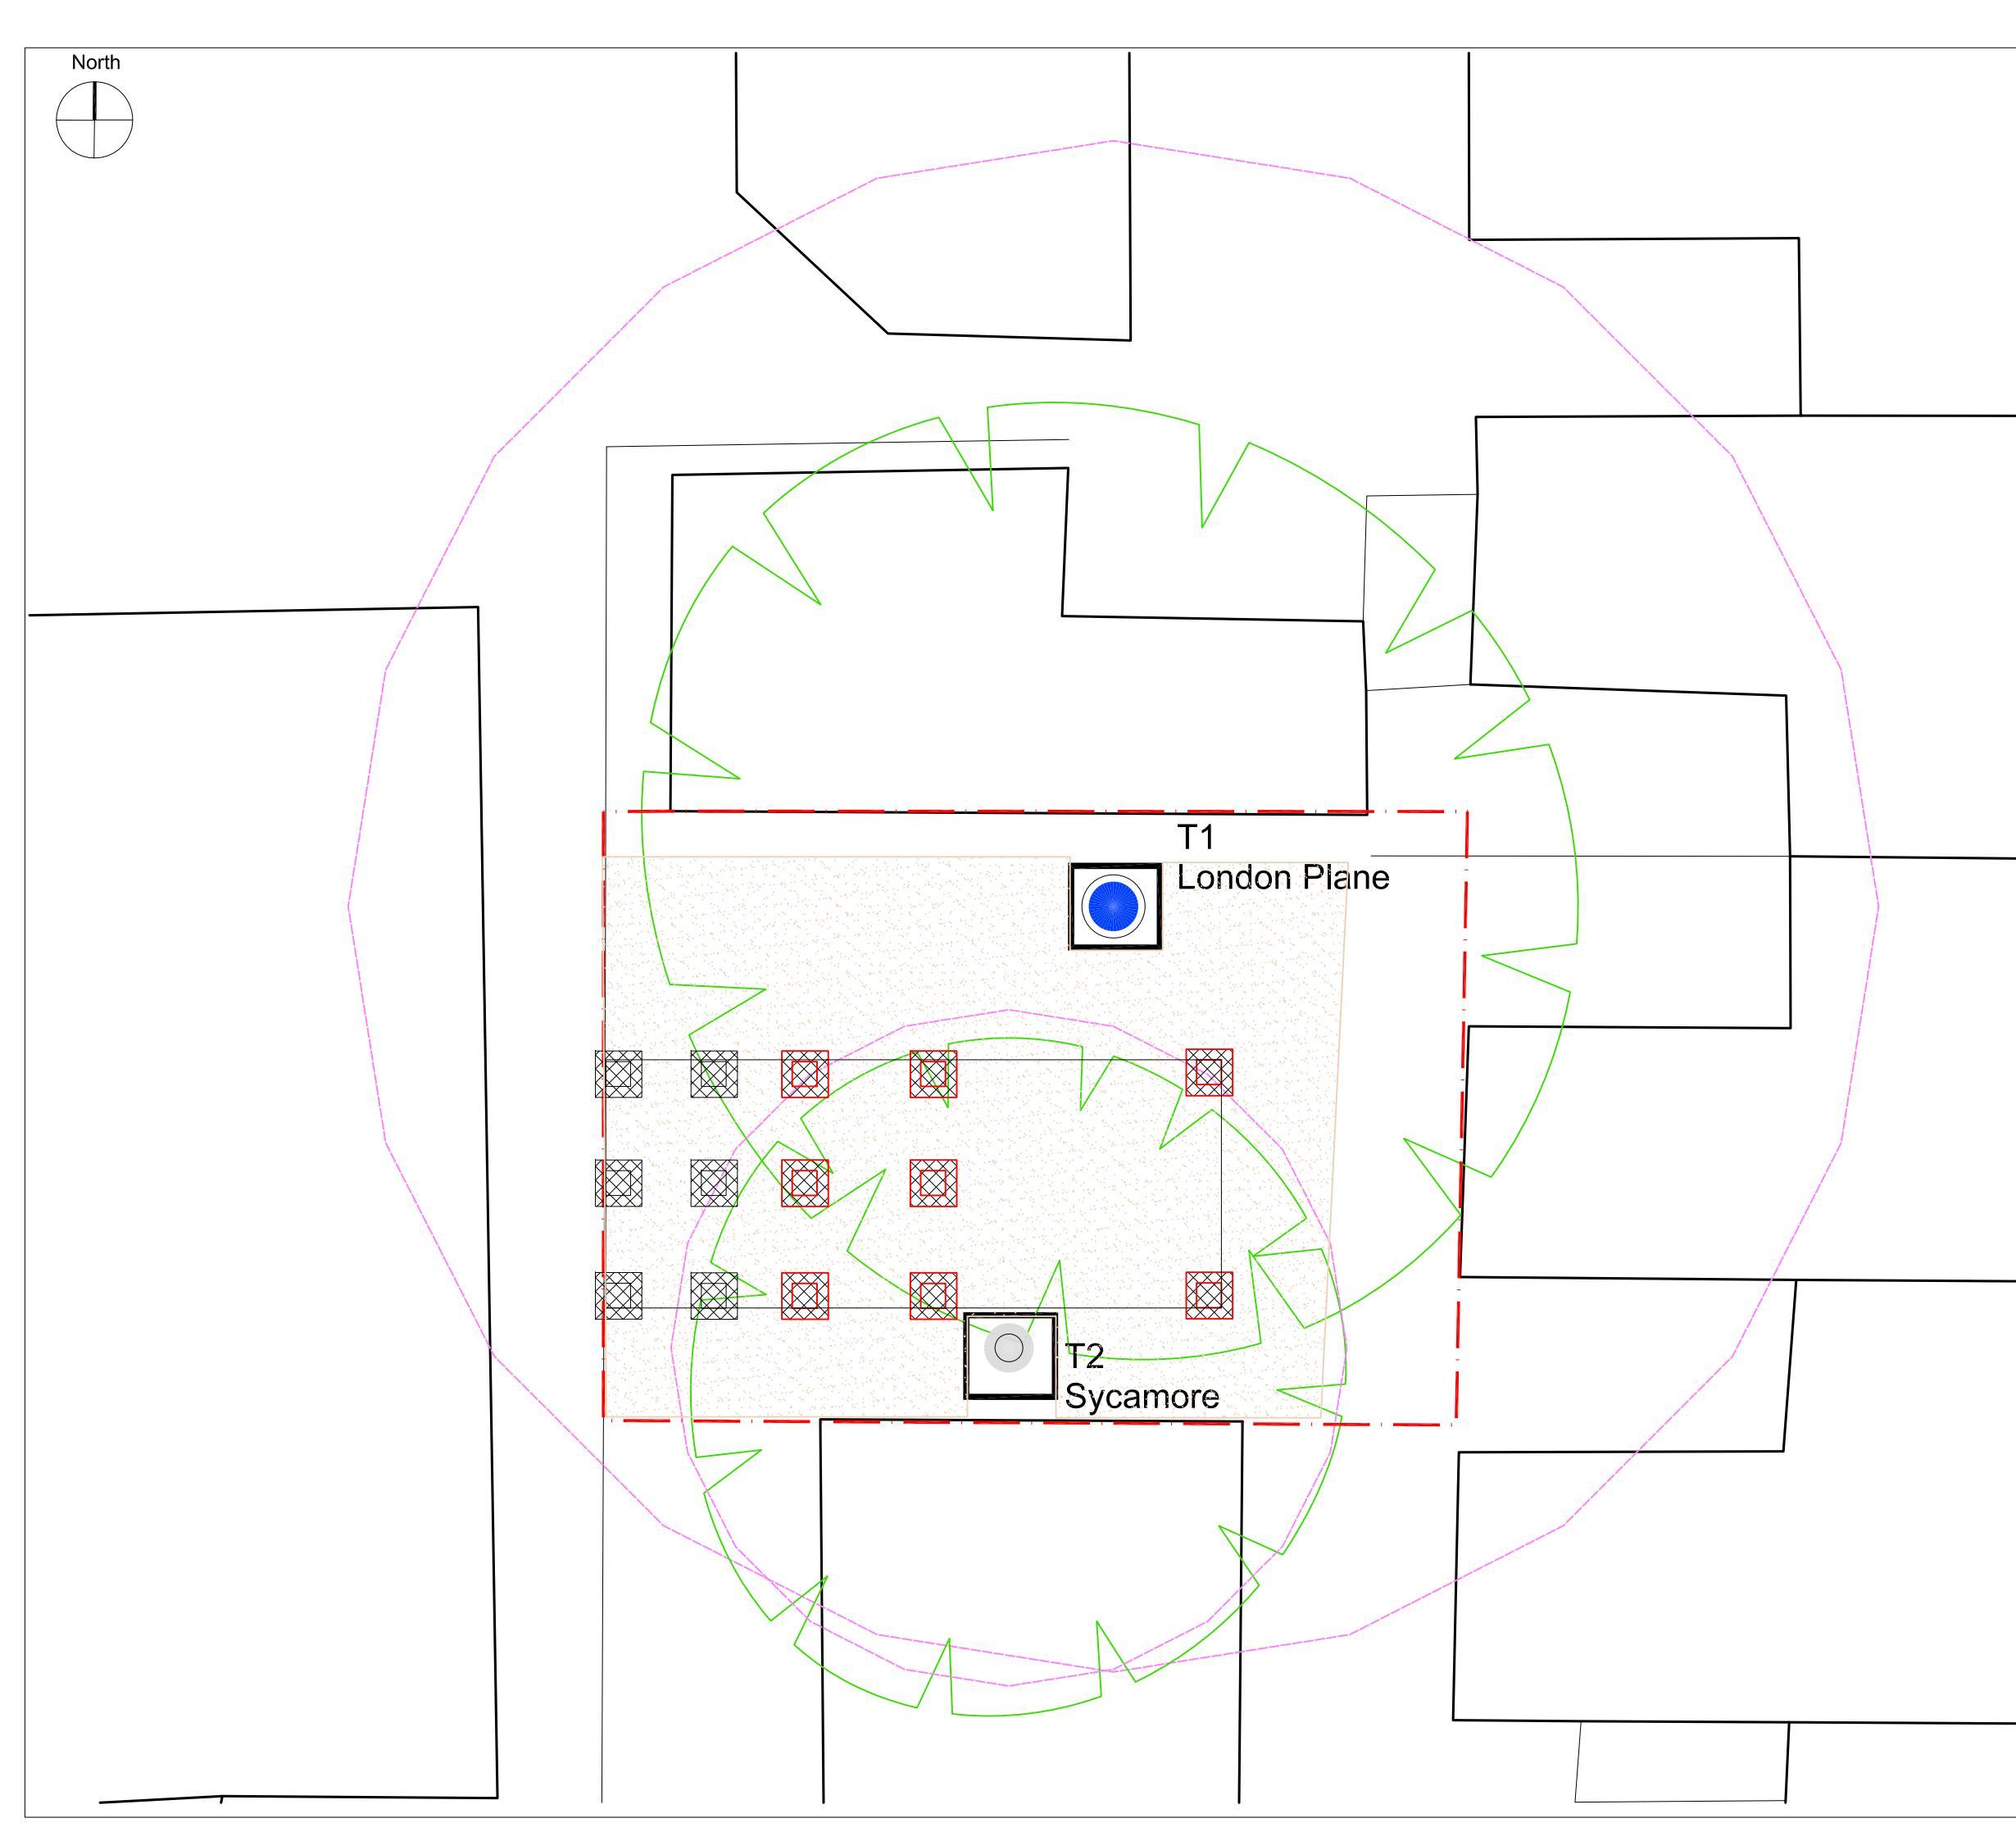
- 6.8.1 The adjacent trees can be adequately protected in accordance with BS 5837 (2012) as discussed within this report and demonstrated within Appendix 4: Tree Removal and Preliminary Tree Protection Plan [TF1017/TPP/200].
- 6.8.2 Prior to commencement of construction, physical protection to the tree trunks will be erected and formed of a robust box to exclude the trunk from accidental damage during installation. The box will be 2.1m high formed of marine grade ply and be free standing ie. not attached to the tree. In addition, ground protection will be installed to minimise compaction of the soil from pedestrian use during installation. This will be formed of 100mm depth of woodchip laid directly onto the soil surface.
- 6.8.3 Following construction the ply box will be removed and woodchip retained to provide a compost mulch.
