## St Giles - Zone 3 : 9 Denmark Street Listed Building Application

September 2017

The existing building is located on Denmark Street, London WC2H 8LS. The building is undergoing a full refurbishment in accordance with Listed Building Consent - 2012/6867/L. Ian Chalk Architects have been appointed as the architects deliver the building on site and Cord Contracting as the Contractor.

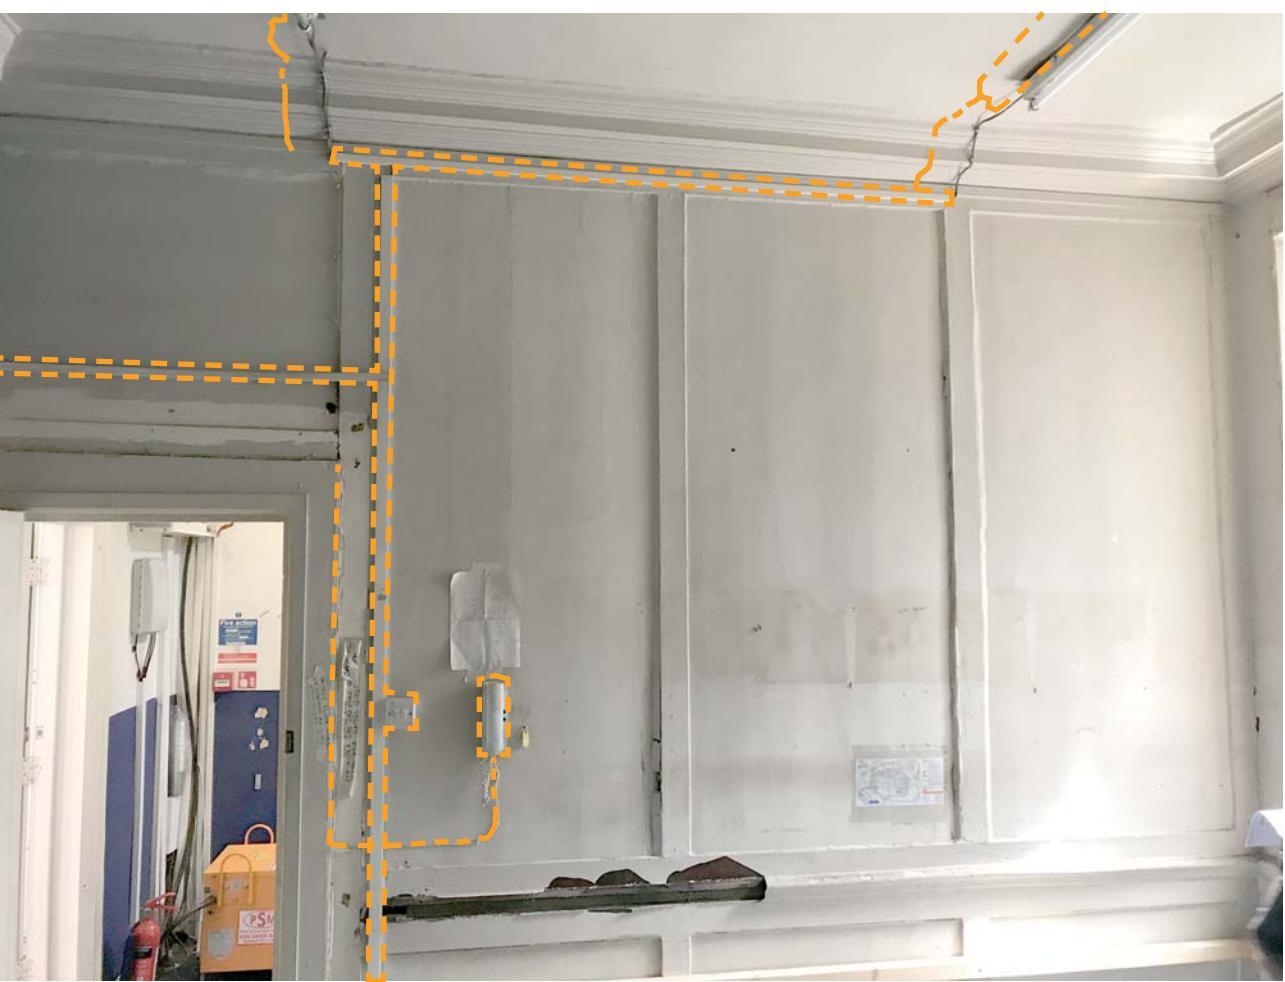
First floor back room, August 2017, following possession showing with surface mounted containment and strip lighting

The existing building is generally in a poor condition and the services provision throughout is inadequate and piecemeal. This is typical of old buildings where later services have been added at varying stages. The photographs to the right show various services installations across the building.

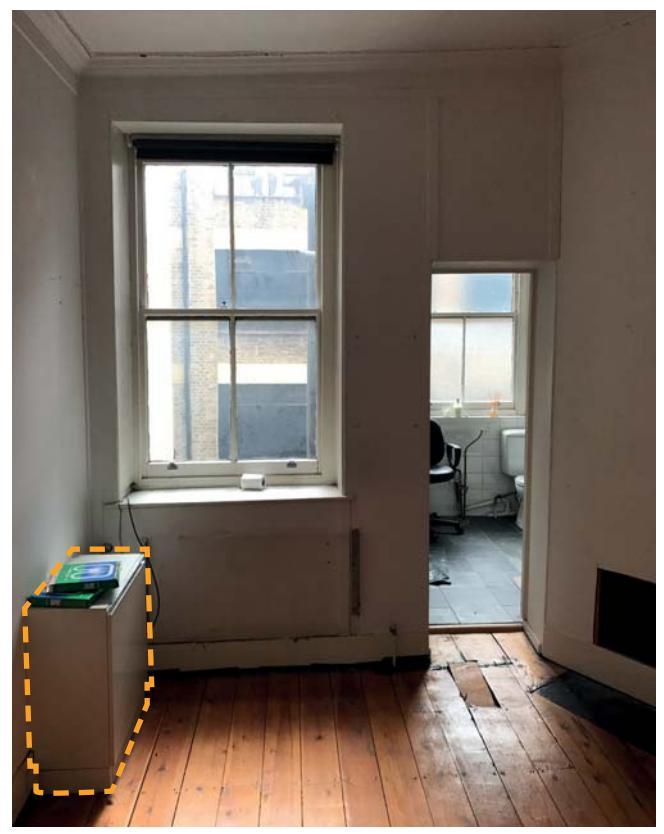
Second Floor back room, August 2017, with mains gas meter in cupboard

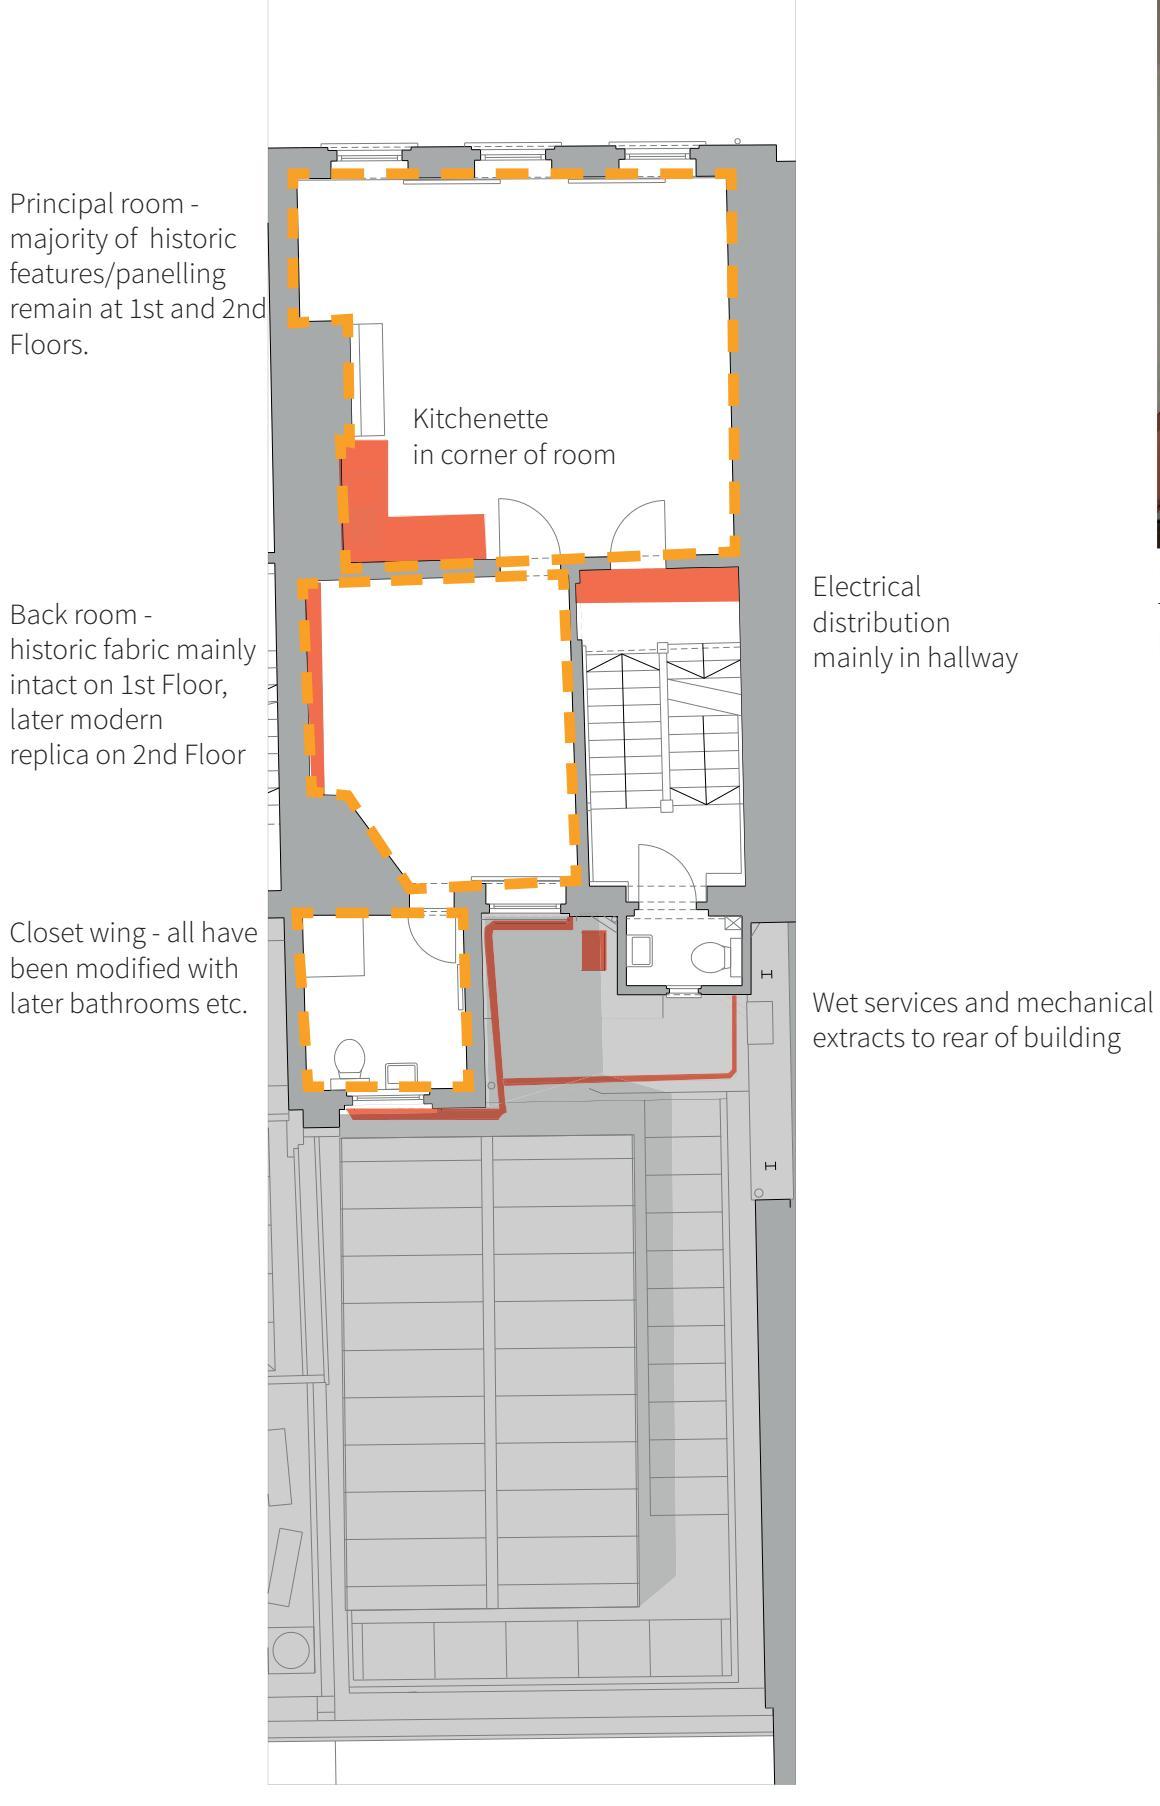
Boxing-out in back room to conceal drainage from kitchenette

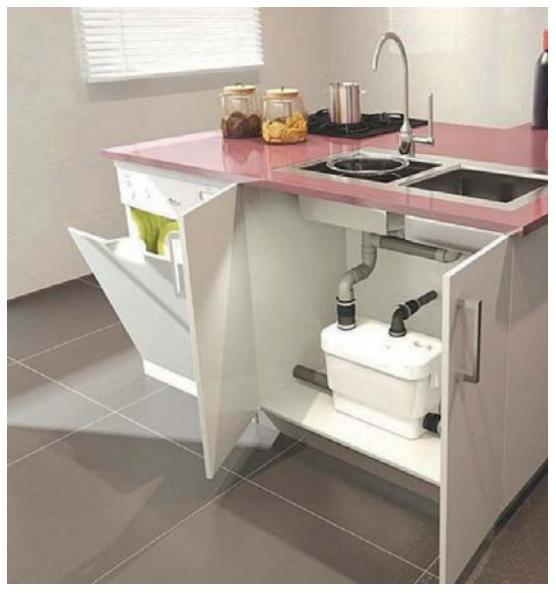
Pumped drainage unit located beneath kitchen sink

These units, whilst having some benefits, are noisy and can become blocked - this is a particular risk in this building as the pumps will be serving kitchen sinks and food waste and grease can easily block the pumping mechanism.

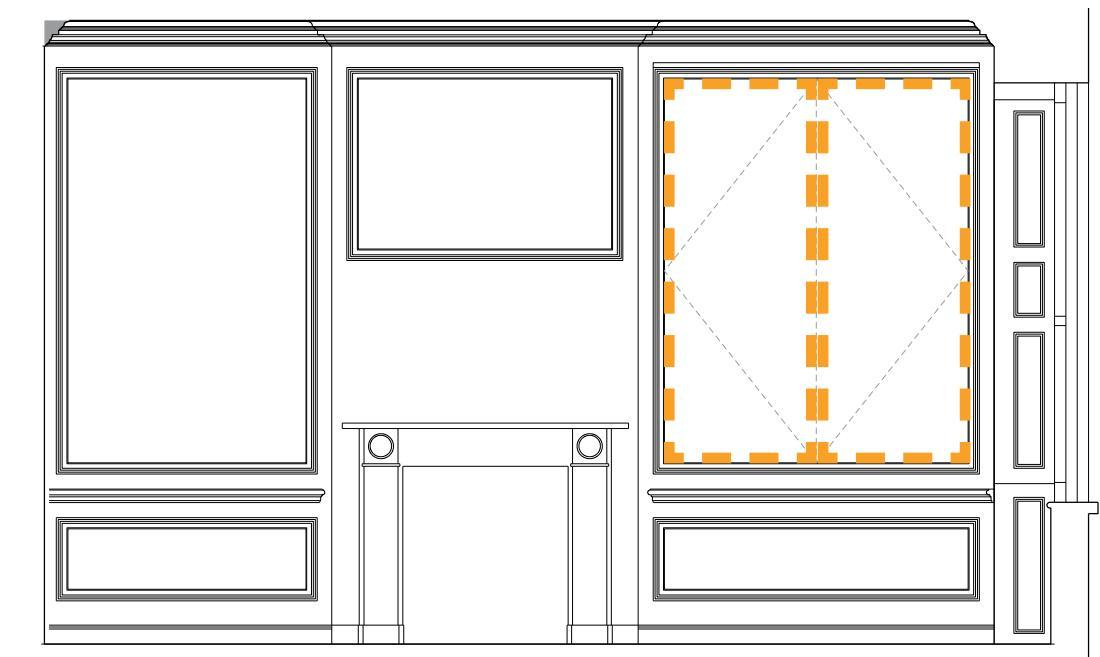
Proposed elevation showing bolection detailing retained, with opening panels on concealed hinges. Extract could be provided by a slot concealed behind the bolection detail

There is also an opportunity to incorporate extract ventilation to the kitchen which could be concealed as a slot hidden at the head of the opening panels, behind the bolection detailing. Ductwork can then rise to roof level and terminate at in-line slate roof vents located on the valley side of the roof facing away from the street.

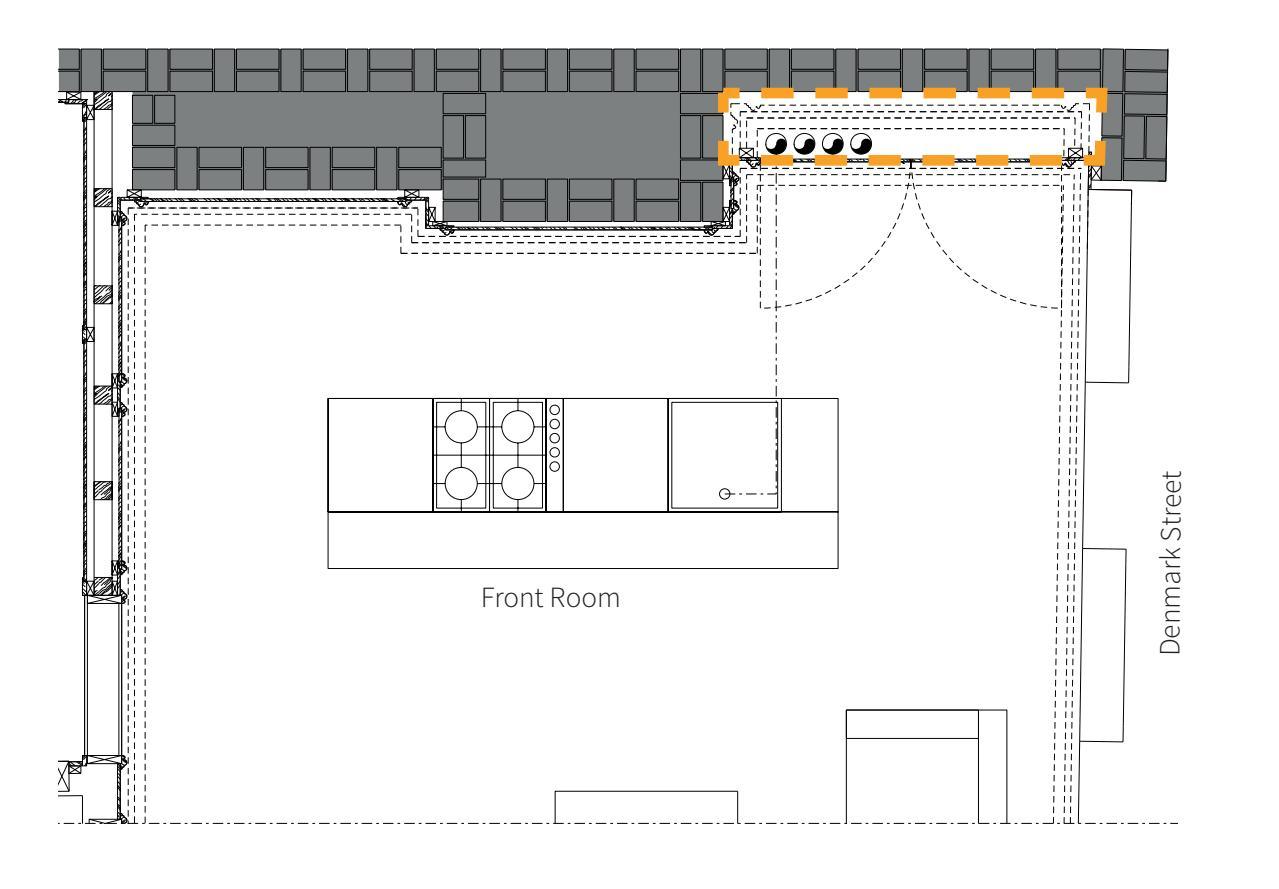
Closet detail showing panelling either adapted or retained with new panelling in front. Vertical distribution can occur through the building

The introduction of a concealed closet allows for simplified vertical distribution across all floors and, if the kitchen island unit is relocated, does away with the need for pumped drainage.

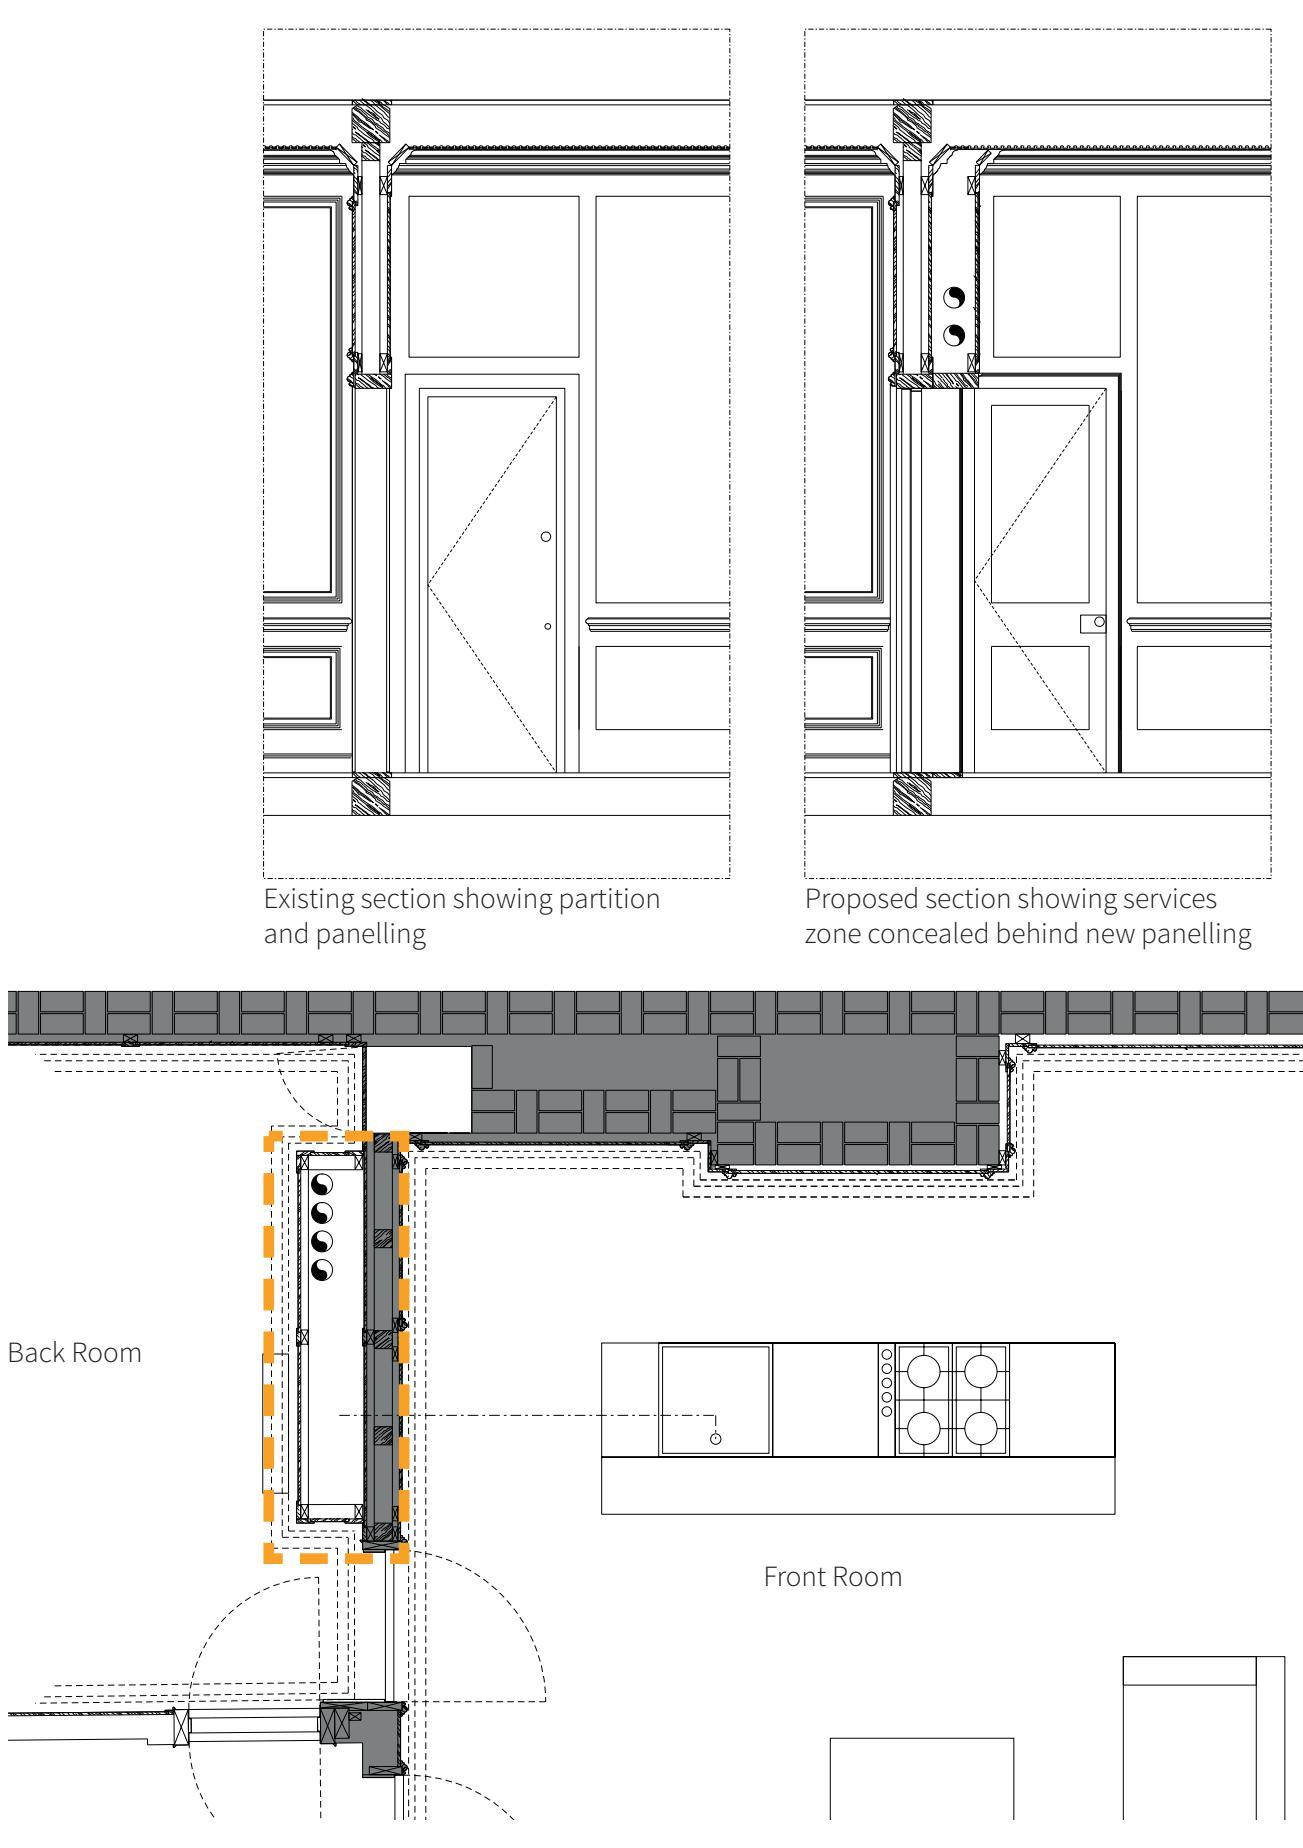
Proposed plan showing services zone concealed behind existing panelling with doors and architraves reinstated

Our preferred solution is Option 3 - creating a false spine wall. Whilst there is a small amount of harm by passing vertical pipework through existing floorboards and lath and plaster ceilings, this is kept to a minimum and allows both front and rear rooms to be serviced from a single riser. The false wall will be panelling to match existing, with a new plaster cornice. All existing panelling will be retained in-situ and any new works will be scribed into the existing, ensuring that the false wall can be removed in future and the original panelling revealed.

The structural works required to arrest the sinking of the spine wall (see accompanying Engenuiti Report) also offer an opportunity to integrate the services route in this location with minimal further intrusion to the existing building.

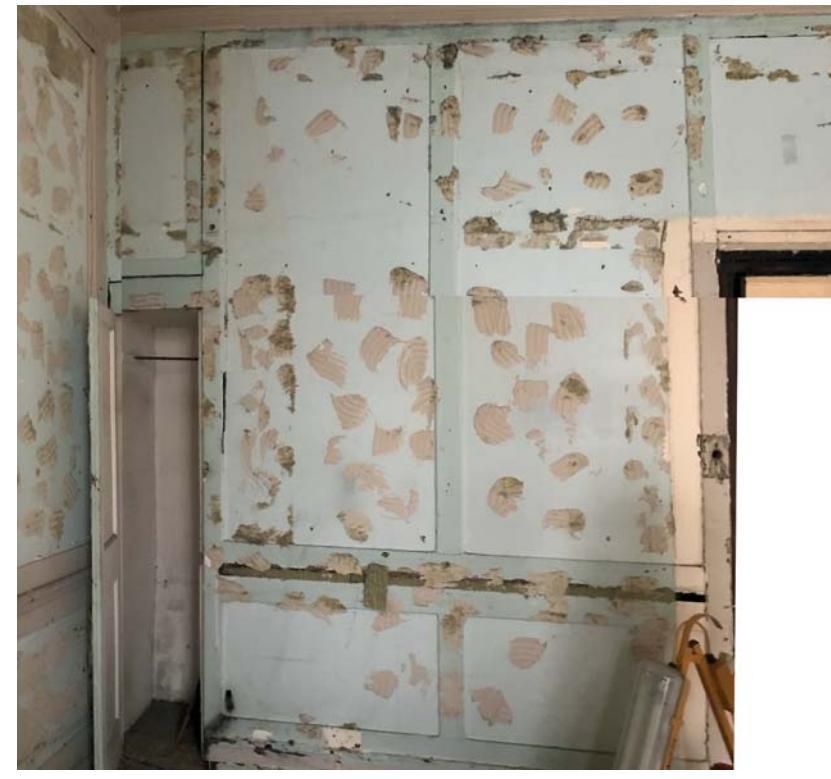
First Floor back room - existing spine wall, showing corner cupboard to left and door to front room right

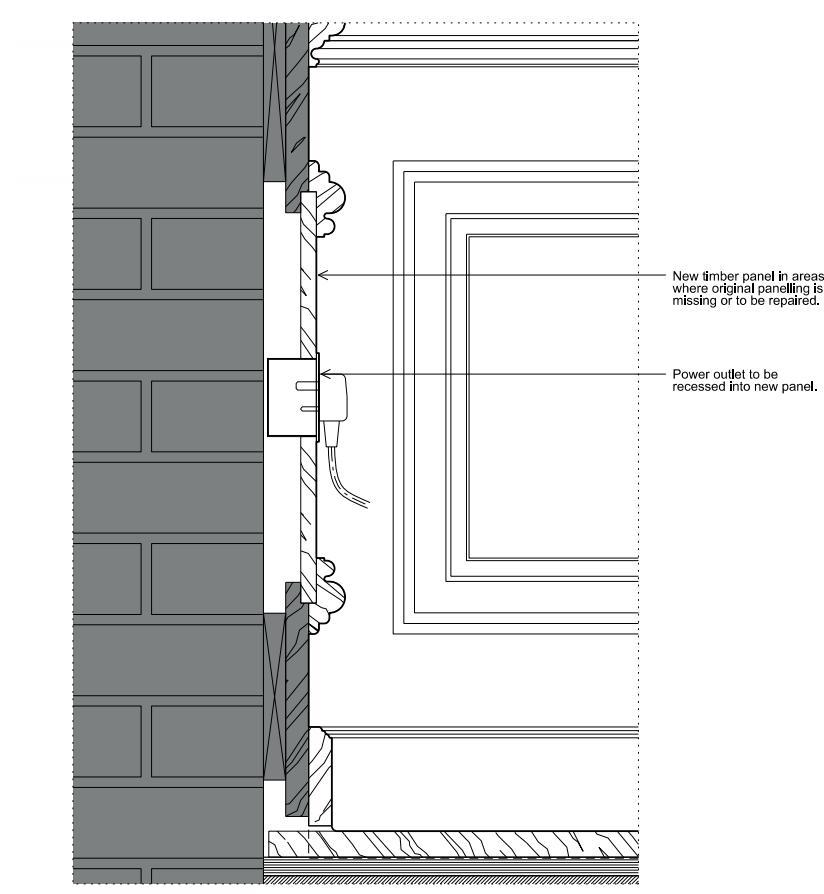
Recessed back-box and flush-mounted switch plate

Where panelling has been damaged/lost and needs replacing, we will incorporate recessed back-boxes with flush plates into new panelling.

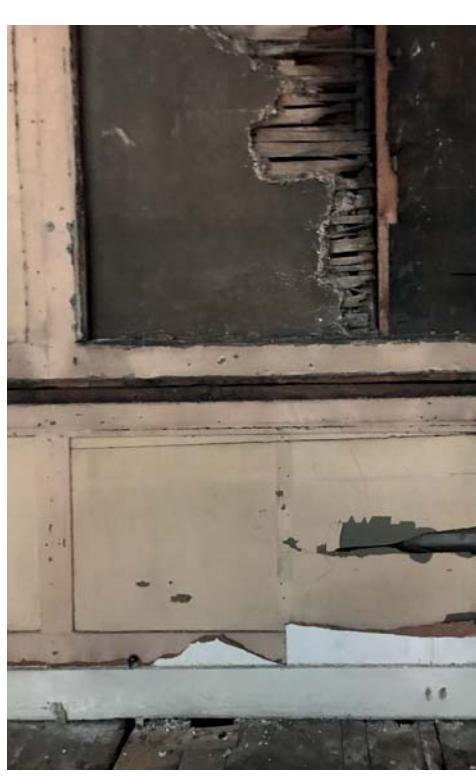
Example of damaged panelling in no. 9 Denmark Street. This panel will require replacement and offers the opportunity to incorporate flush-mounted switch plates

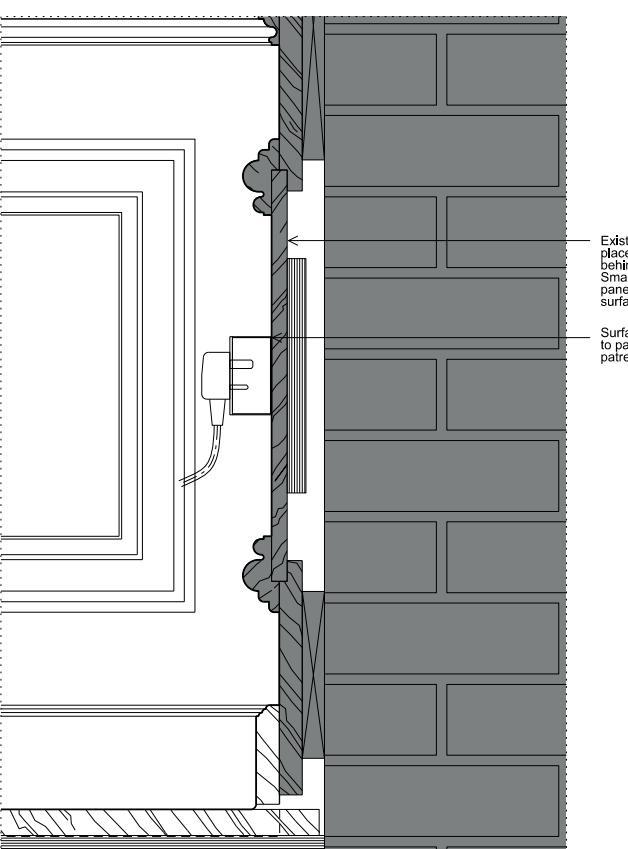
Surface-mounted back-box and switch plate

Existing panelling retained in place with wiring passing behind. Small opening to be made in panel to pass through to surface mounted socket.

Surface-mounted socket fixed to panel through to plywood patress panel affixed behind

Where existing panelling remains, we will either reuse locations where back-boxes have already been cut-out, or we will surface-mount units.

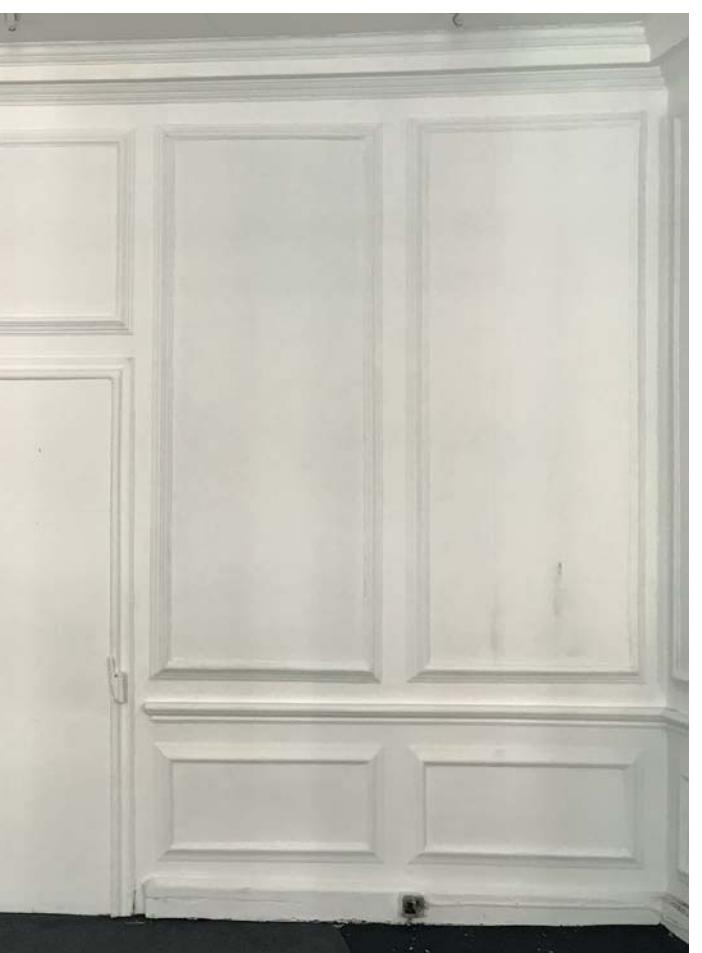
Example of fully intact panelling - surface-mounted back-box and switch plate will be

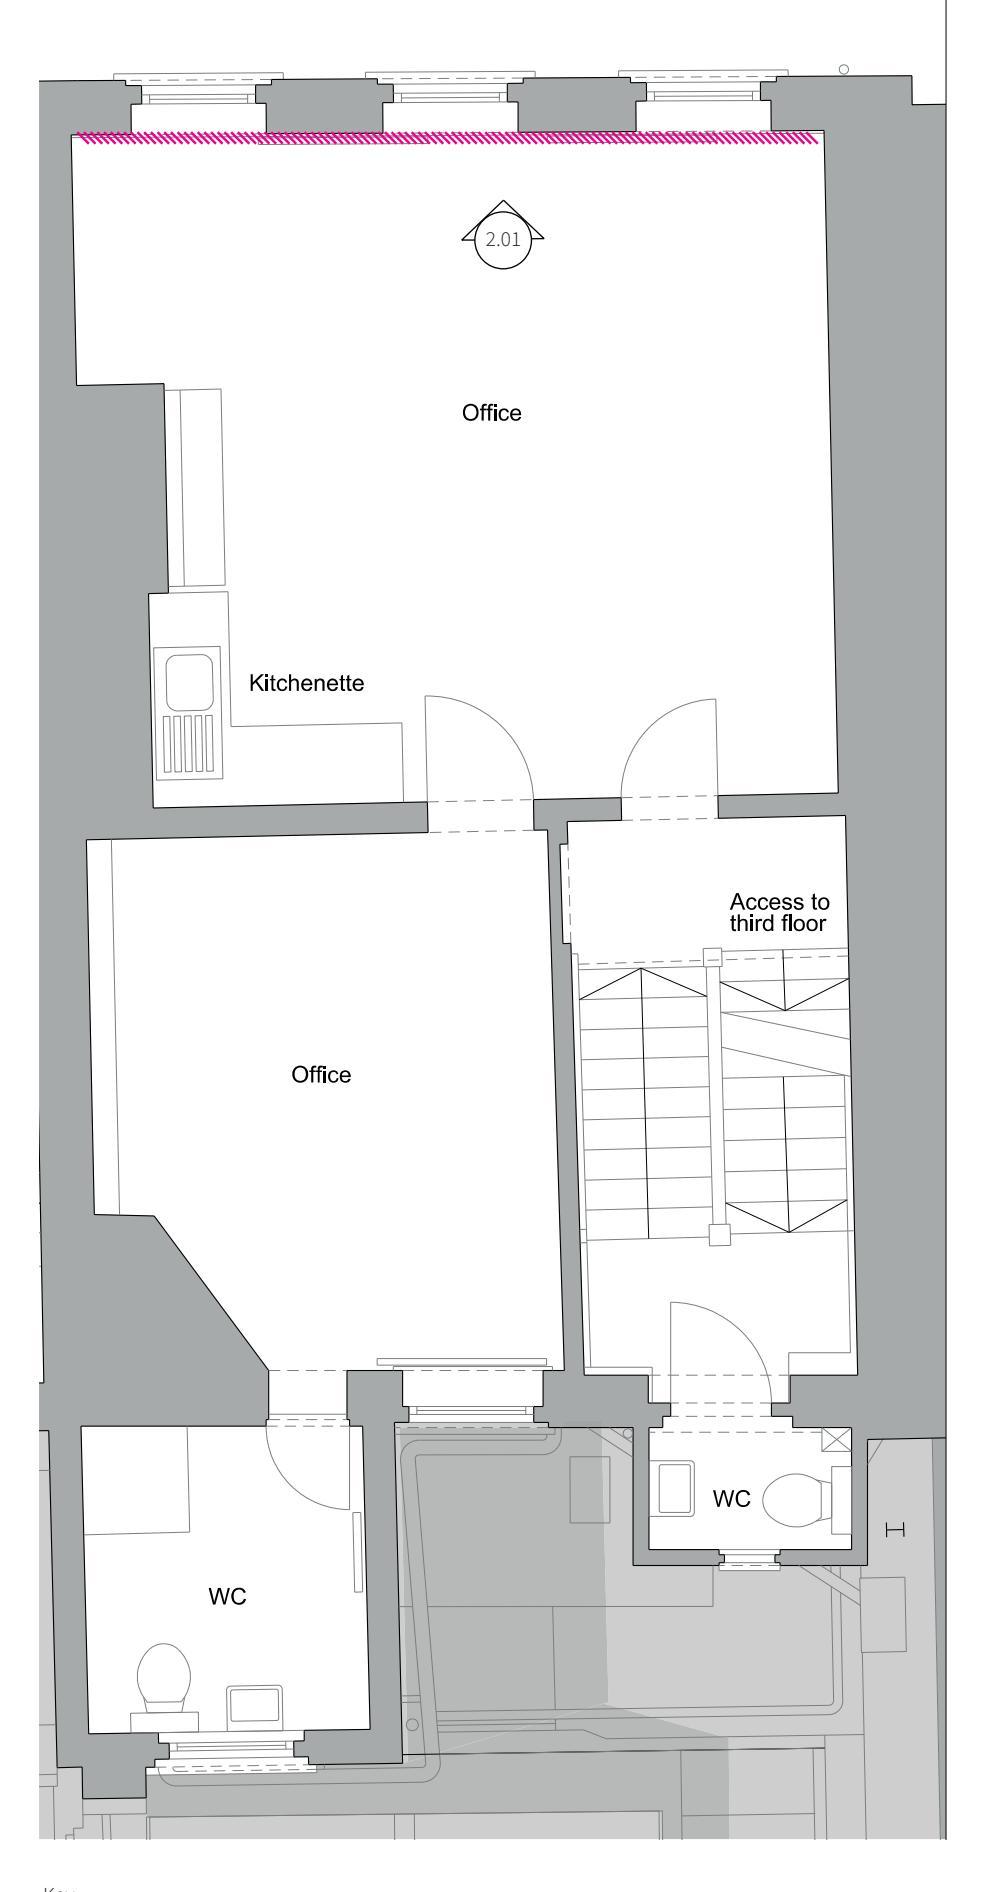
Cornice line to be recorded, and subsequently cut out in sections carefully and taken down. To be stored ready for reinstatement following repairs to concealed box gutter above - all works to be carried out by plaster specialist

The existing cornice line to the internal front elevation has suffered from long-term damage and is at risk of collapse. This is the result of water damage from a blocked gutter on the floor above.

This application seeks to carefully cut out the cornice and take it down carefully to ensure that it does not fall and damage further. The cornice will be carefully recorded and photographed prior to removal. It will then be cut out in sections and stored to allow the masonry and timber structure behind to be assessed and repaired. Upon completion of structural and waterproofing repairs, the cornice will be reinstated and repaired.

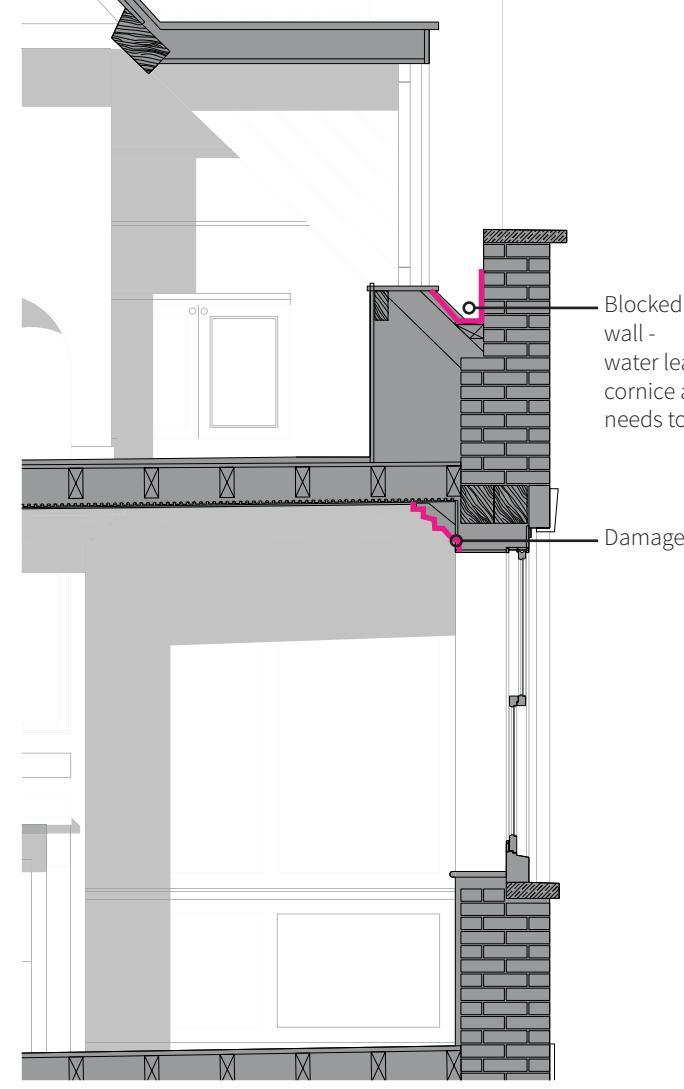
Section detail showing relationship between gutter and cornice

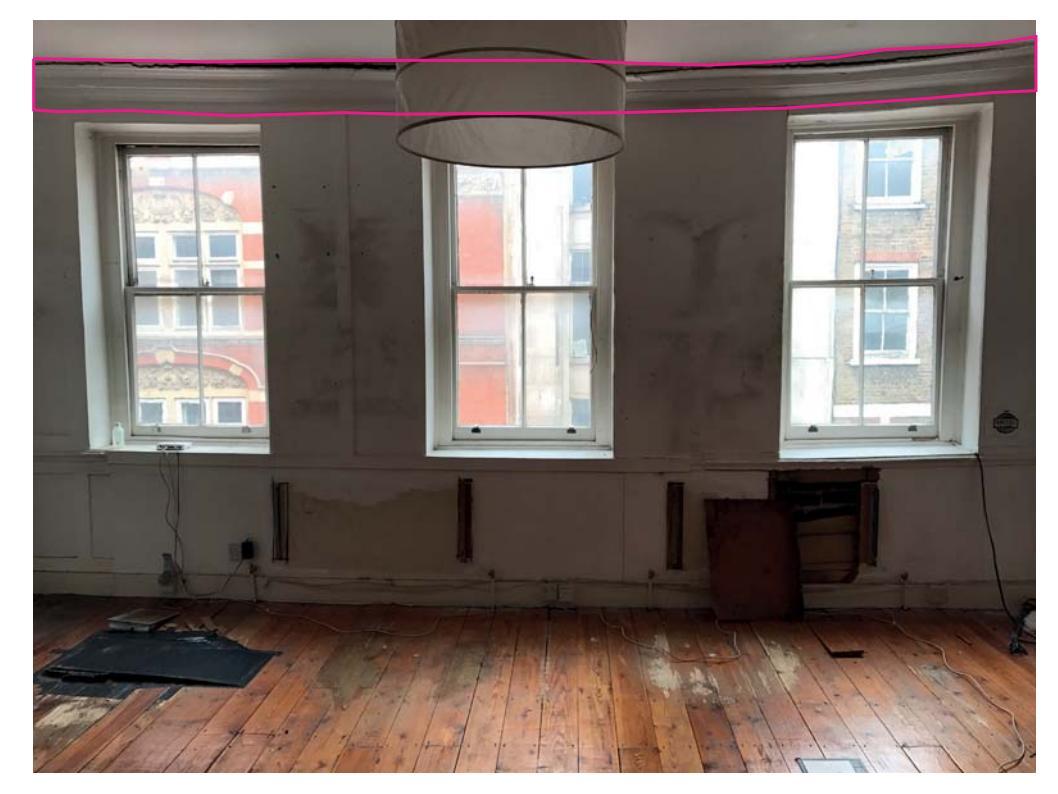
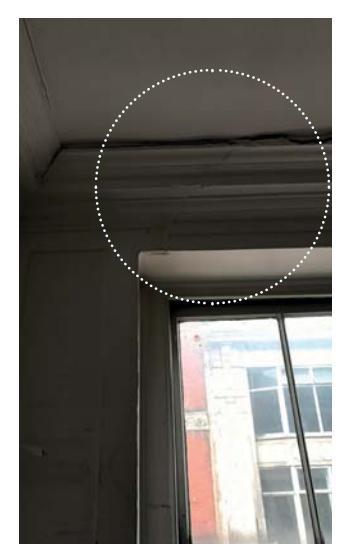
Damaged cornice shown to be coming away from soffit. This is assumed to be the result of a blocked box gutter directly above. The cornice is at risk of failure and requires repair. Under the proposals the gutter is to be unblocked and the cornice to be carefully taken down to allow a full inspection of the gutter and masonry behind. The cornice will be retained and carefully reinstated by a trained professional, with interfaces to panelling to be made good

Detail of damaged cornice showing risk of collapse

Blocked box gutter at 3rd Floor parapet

water leakage to below has damaged cornice and masonry/timber structure needs to be assessed.

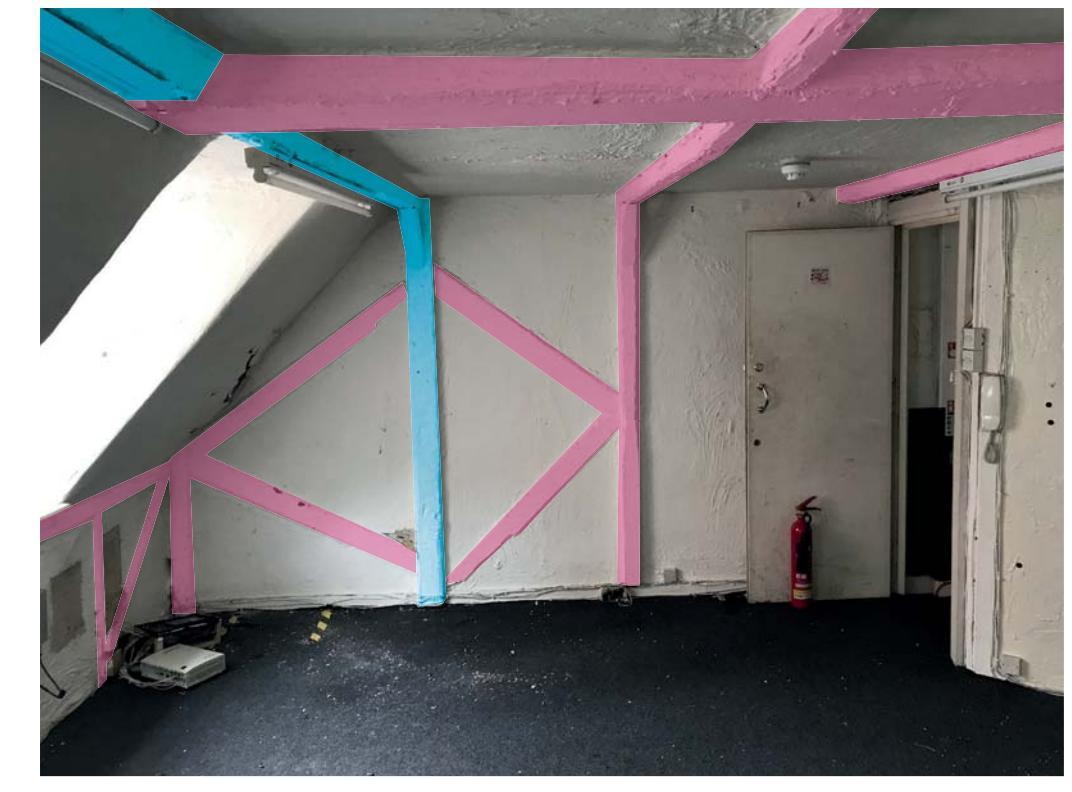
Non-original non-structural elements to be removed

Interior prior to removal of later coverings - non-original non-structural elements highlighted in pink

On initial inspection, it was thought that the framing within the third floor front room was original to the house and was providing structural support to the roof However, following the removal of later coverings including artex coatings, it became apparent that the majority of the framing was later 20th Century 'mock' framing.

This application seeks to remove this non-original framing - highlighted. Within the supporting Engineer's Report the framing is assessed and has been found to be non-structural. The only element believed to be original is the purlin above the dormer windows and the timber posts supporting it at either end. These will be retained and repaired as recommended by Engenuiti

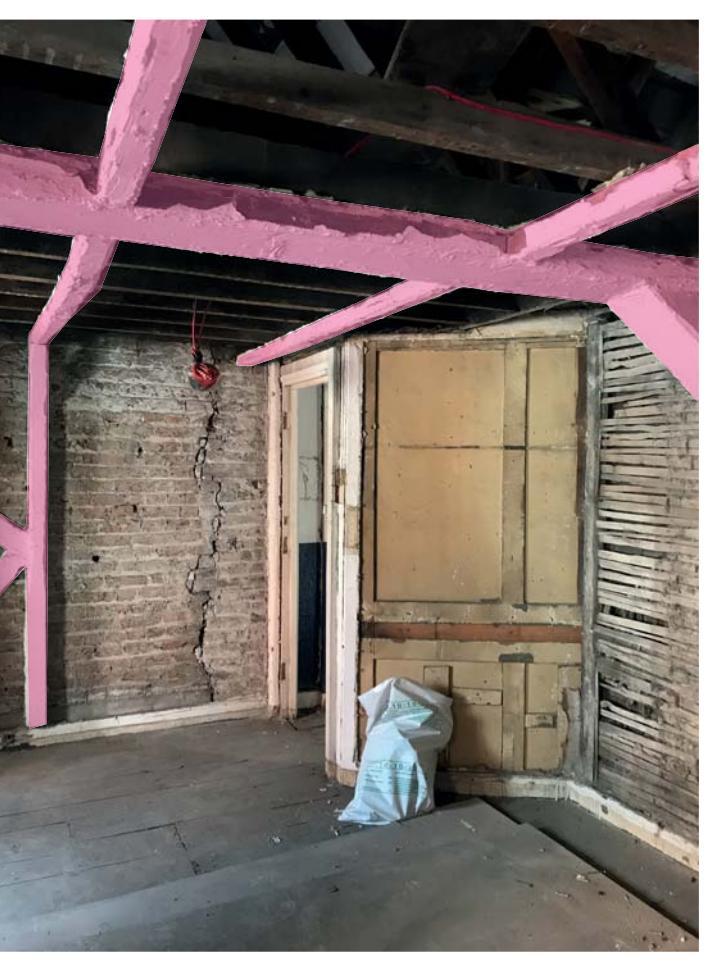
Interior prior to post soft-strip, revealing timber frame as non-structural

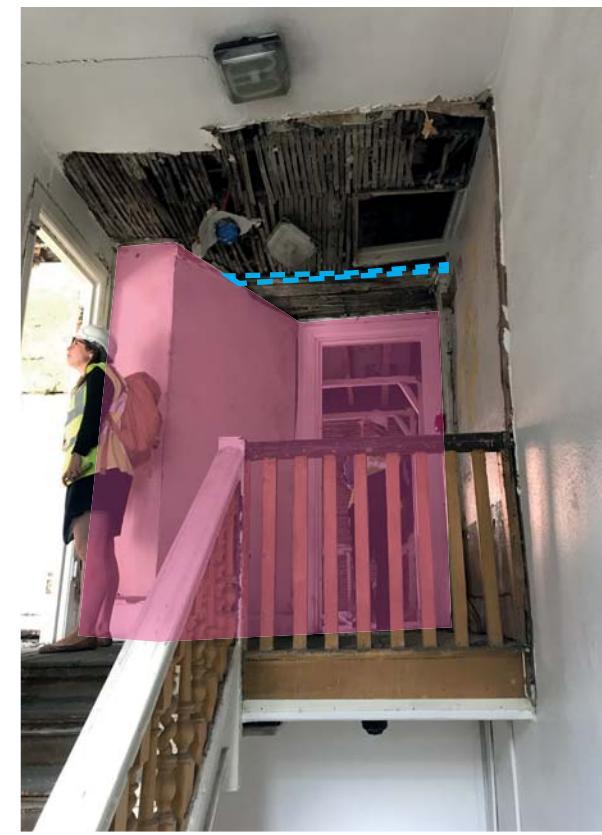
Angled partition, August 2017, prior to removal of non-original linings. Presumed location of original partition shown in blue - where timber ceiling laths change direction

Angled wall to be removed - panelling to be retained and reinstated in hallway where original panelling is missing

Of the four townhouses on the southside of Denmark Street, no. 9 is the only property at third floor to have an angled wall and inset door leading into the front room. Following the opening-up and removal of non-original fabric, it has become apparent that the angle is formed from adapted panelling, presumed to have come from elsewhere in the house. The unfinished frame end to one side and lack of deep base rail suggest that the panel is not in its original location. The plan form adaptation is supported by the change in direction of the laths in the landing area, suggesting the original partition line. A fullheight partition and corner shelving were introduced during the 20th Century on the landing area and the wall was most likely realigned at the same time to allow sufficient width to access the front room. With the shelving and partitions removed, this application now seeks to reinstate the plan form to match the other townhouses.

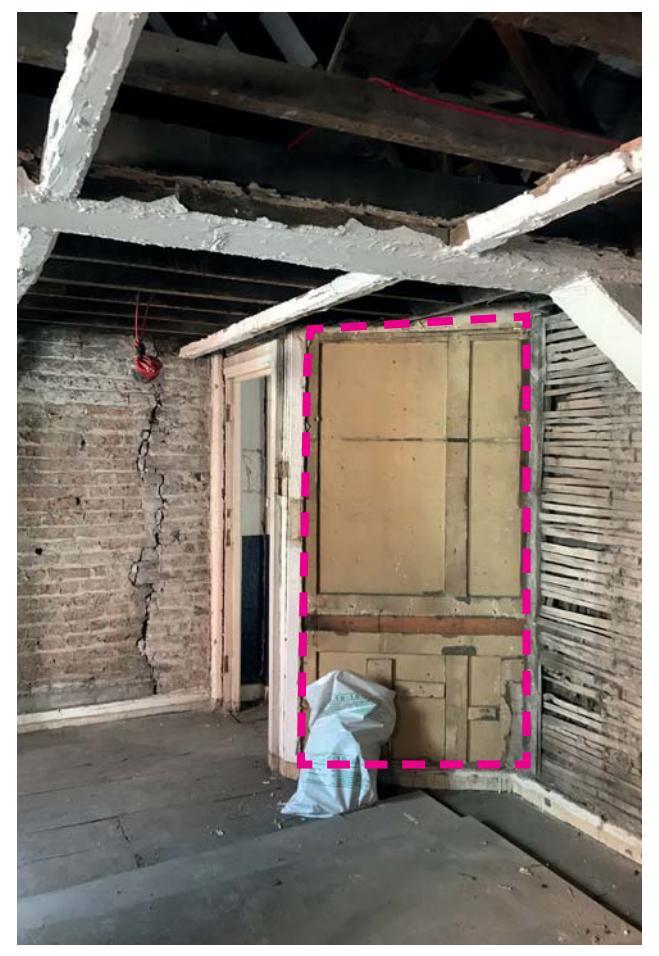
Angled partition, late August 2017, after removal of non-original linings. Panelling is not evenly jointed and is not properly terminated where it meets the existing lath partition. The base rail has been cut short and the deep mid-rail and dado line suggest it has come from a floor of greater importance than the attic space

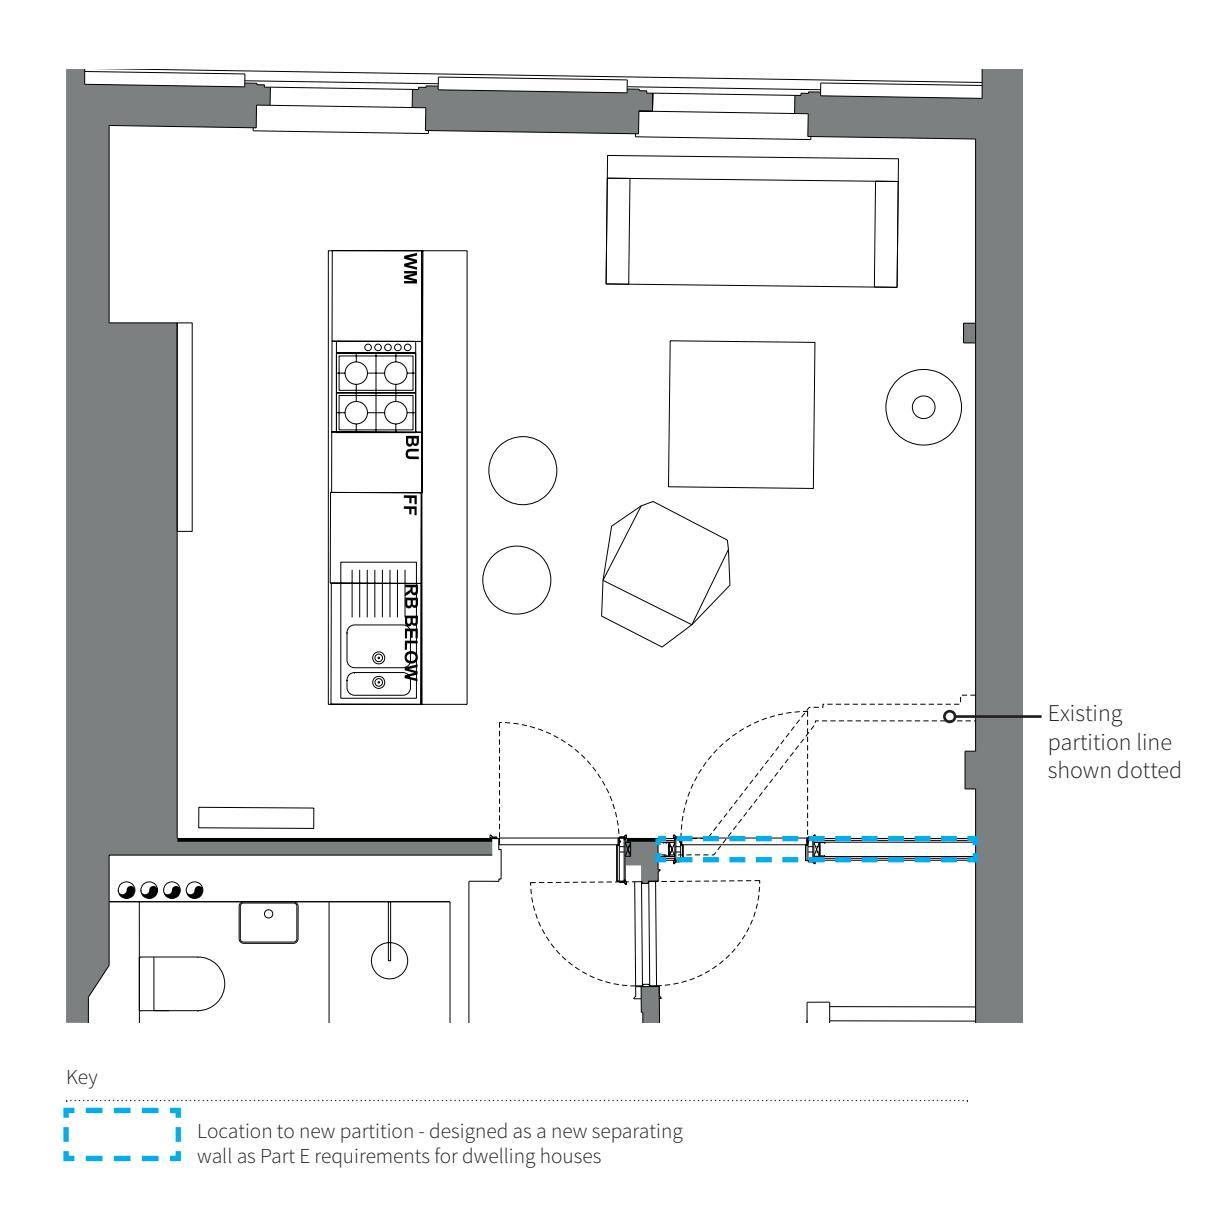
1:50

Part plan - Third Floor showing new partition location

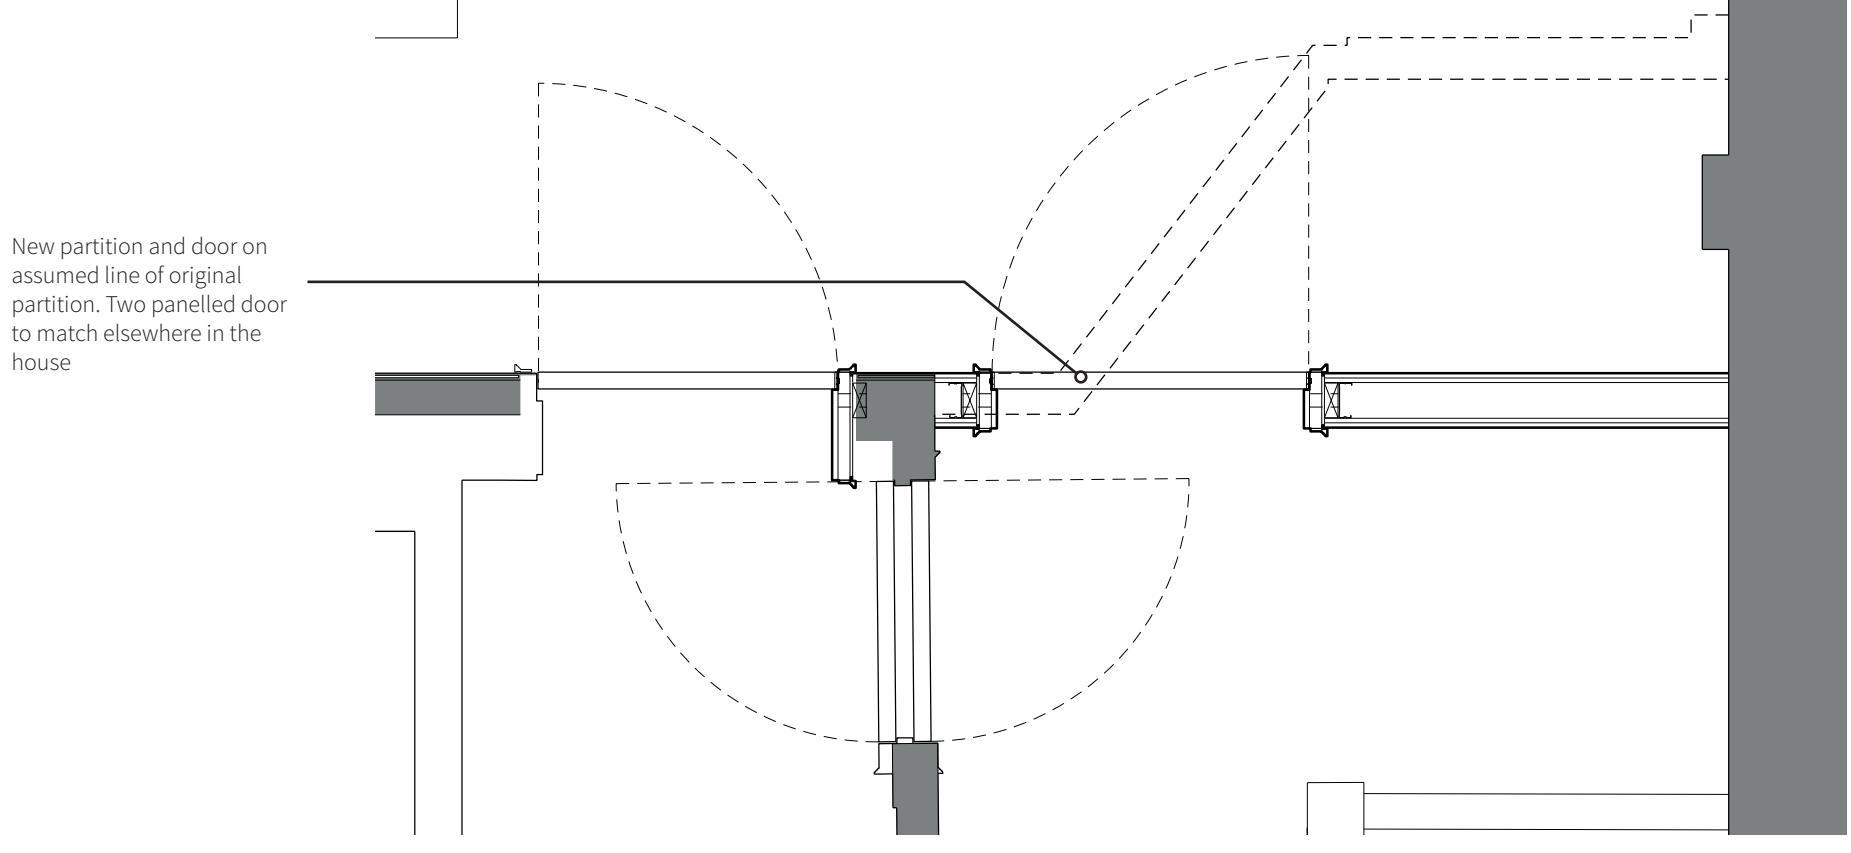
Detail plan - Third Floor showing new partition and relationship to existing
