## St Giles - Zone 3 : 9 Denmark Street Listed Building Application

September 2017

The existing building is located on Denmark Street, London WC2H 8LS. The building is undergoing a full refurbishment in accordance with Listed Building Consent - 2012/6867/L. Ian Chalk Architects have been appointed as the architects deliver the building on site and Cord Contracting as the Contractor.

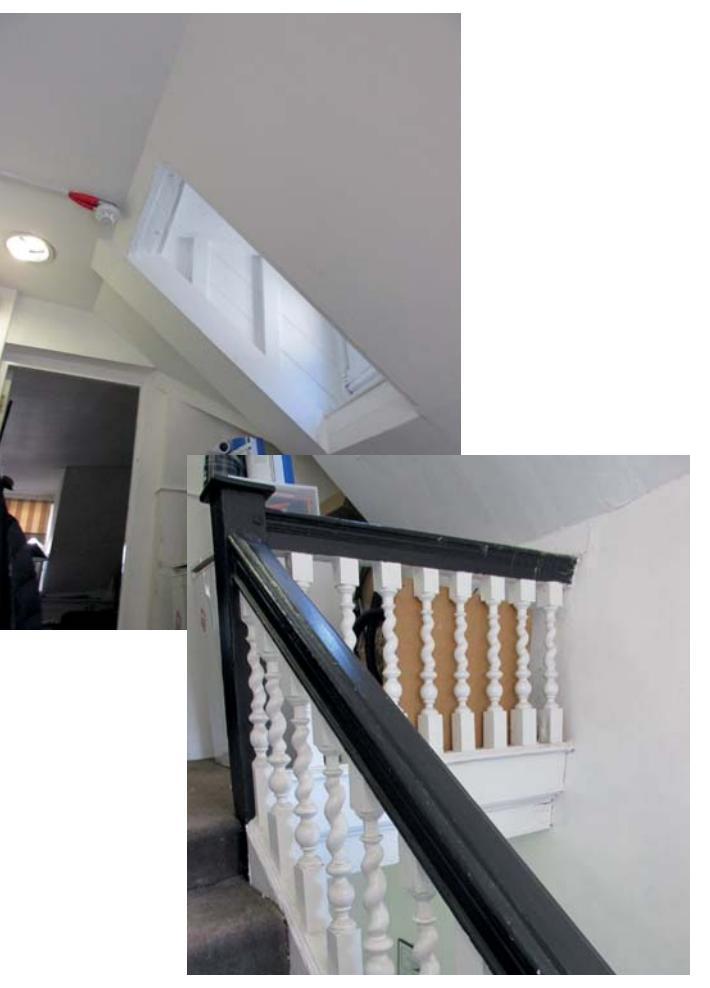
Internal photo montage from no.. 7 Denmark Street showing door to left with landing area behind balustrade. This has informed the assumed layout of no. 9 Denmark street

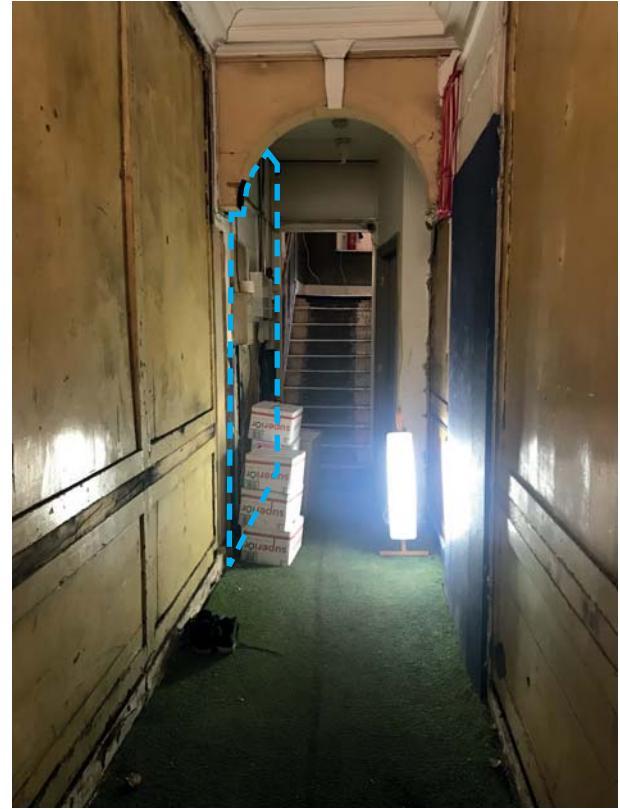
Hallway, late August 2017, after removal of non-original fabric, with original panelling revealed. Section highlighted where panelling has been lost

Hallway, late August 2017, Close-up of lost panelling - presumed to have been removed when meters and distribution boards were introduced

We have reviewed the panelling elsewhere in the house to establish where the panel from the attic may have originally been installed. Having opened up the hallway, we have revealed the original timber panelling and have identified a section adjacent to the archway where panelling is missing - in the location of the later services meters and distribution boards. This application seeks to reinstate the panelling in this location, assumed to be where it has come from - this is supported by the paint colour and the deep mid-rail joint between the upper/lower panels, as well as the ghosting of the former dado line. The panel will be reinstated, and the interfaces made good with timber panelling to match.

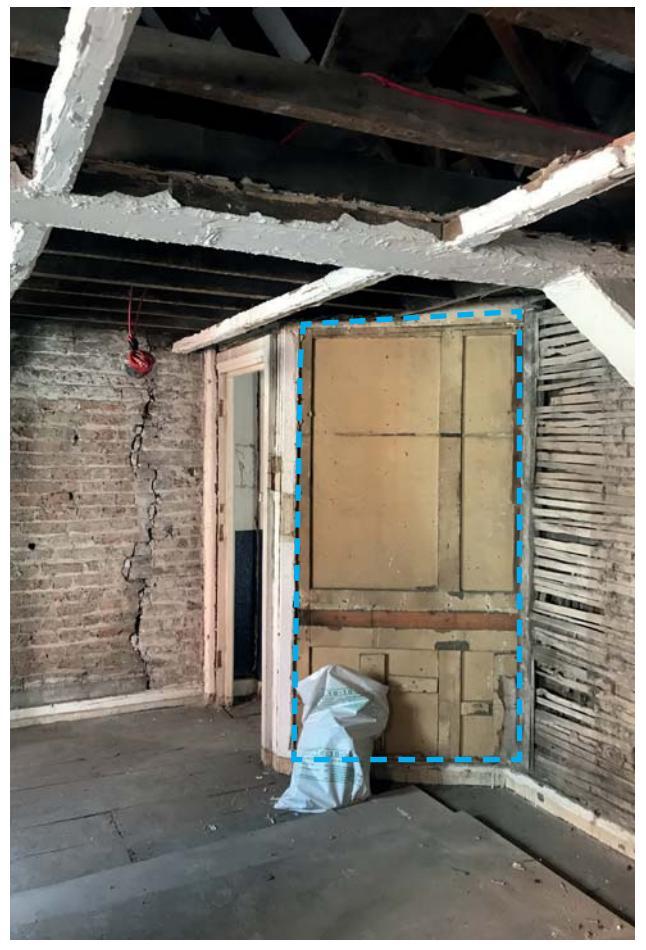
Panel from attic space - paint colour, profile size and dado positioning match the Ground Floor Hallway

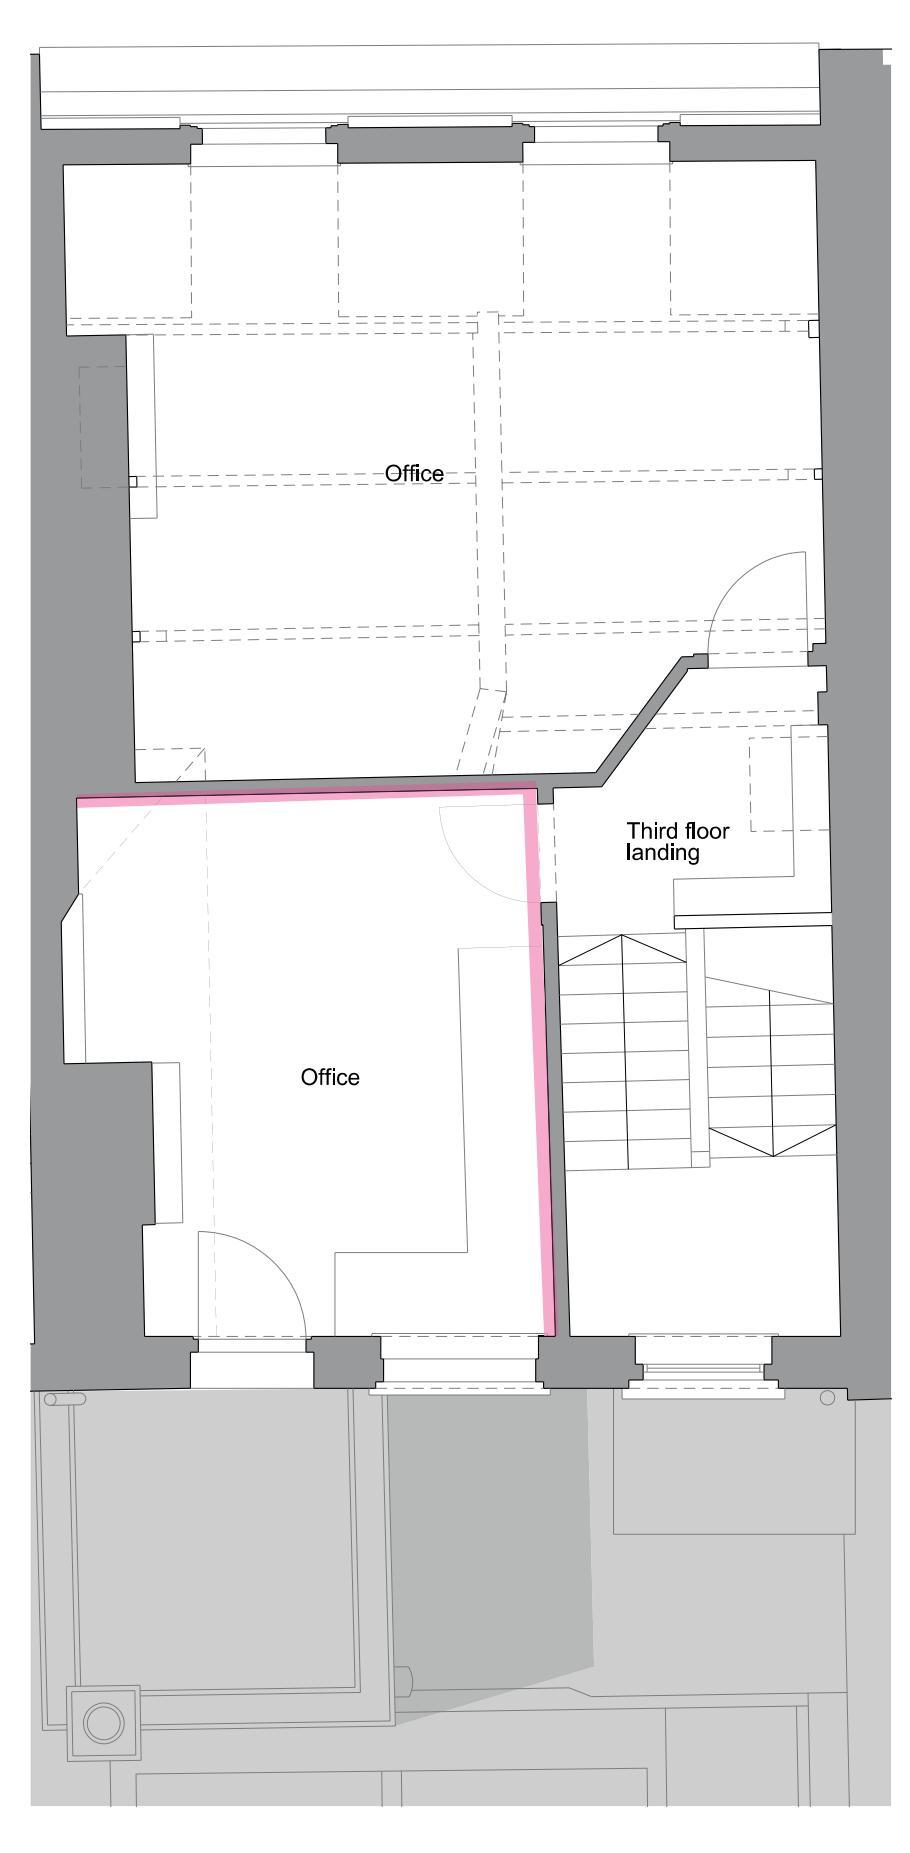
Location of match-board timber cladding to be carefully removed, stored and reinstated

Upon removal of later linings in the back room at Third Floor, timber match-boarding was uncovered. This appears to be 19th Century; behind the matchboarding are walls papered in wallpaper dated by Alan Baxter Associates to circa 1840. This application seeks permission to carefully remove the matchboarding to reveal the papered walls behind and allow for better investigation of the original fabric.

The match-boarding will be retained, ready for reinstatement during the refurbishment works.

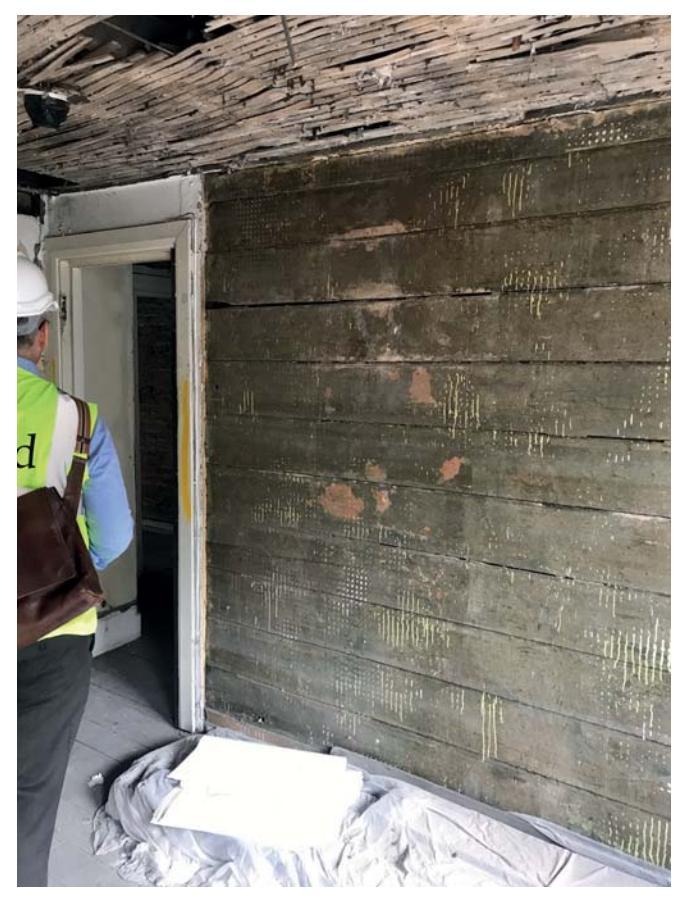
Match-boarding to rear room, late August 2017 - to be carefully removed to reveal plastered partition behind

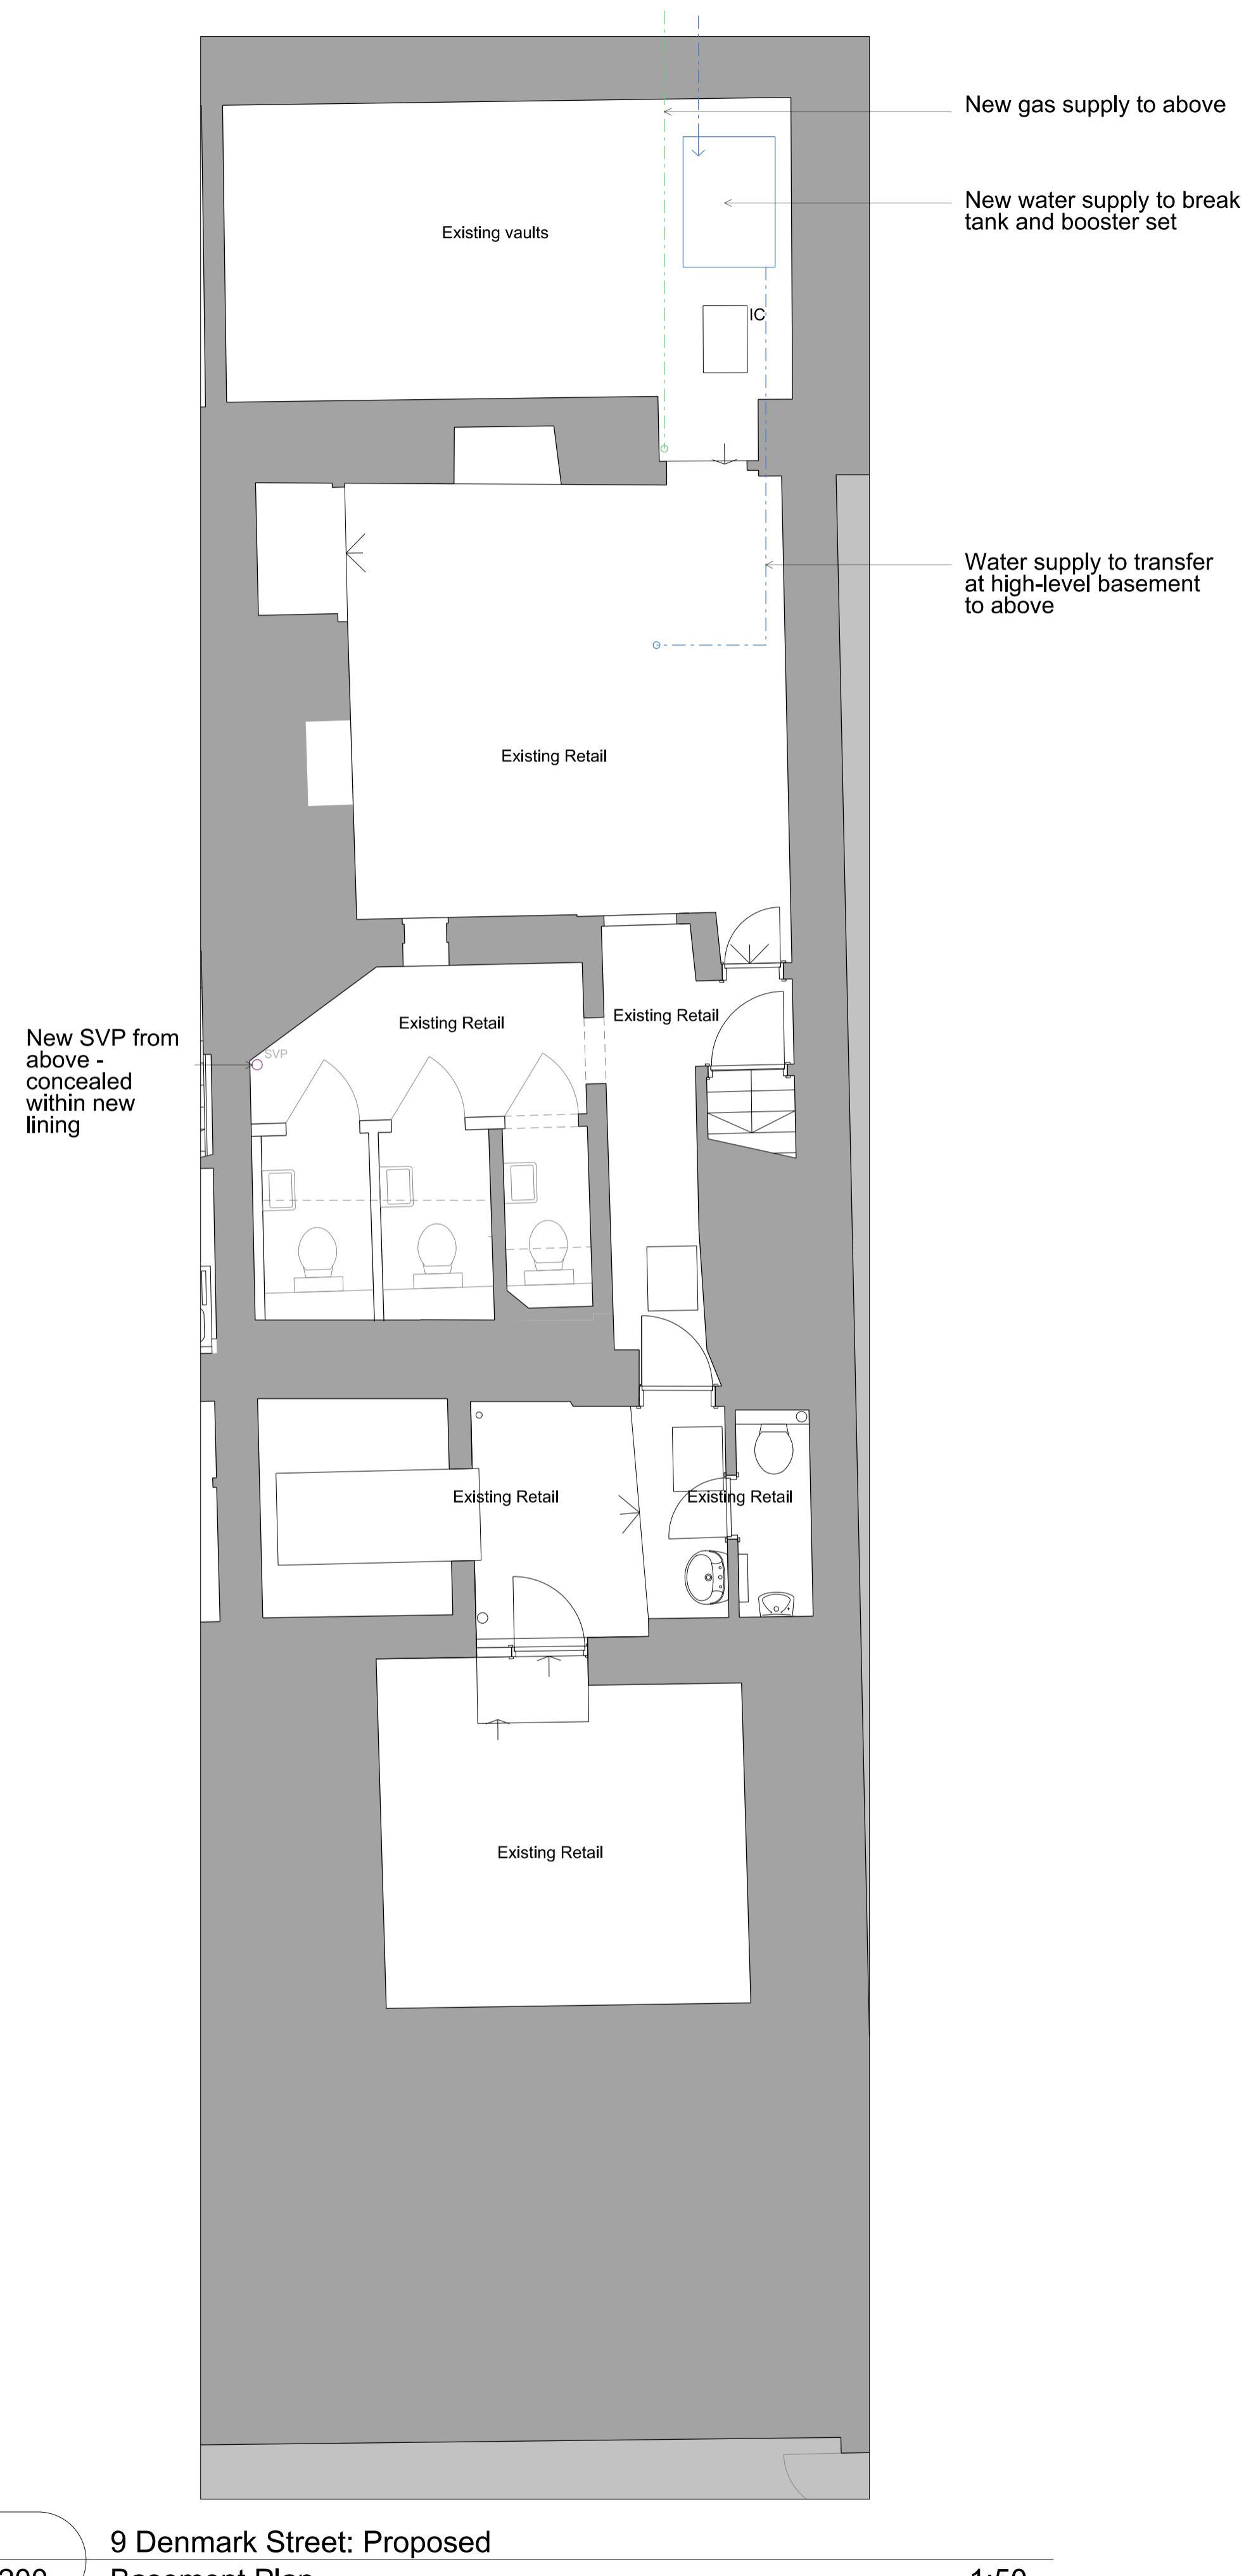
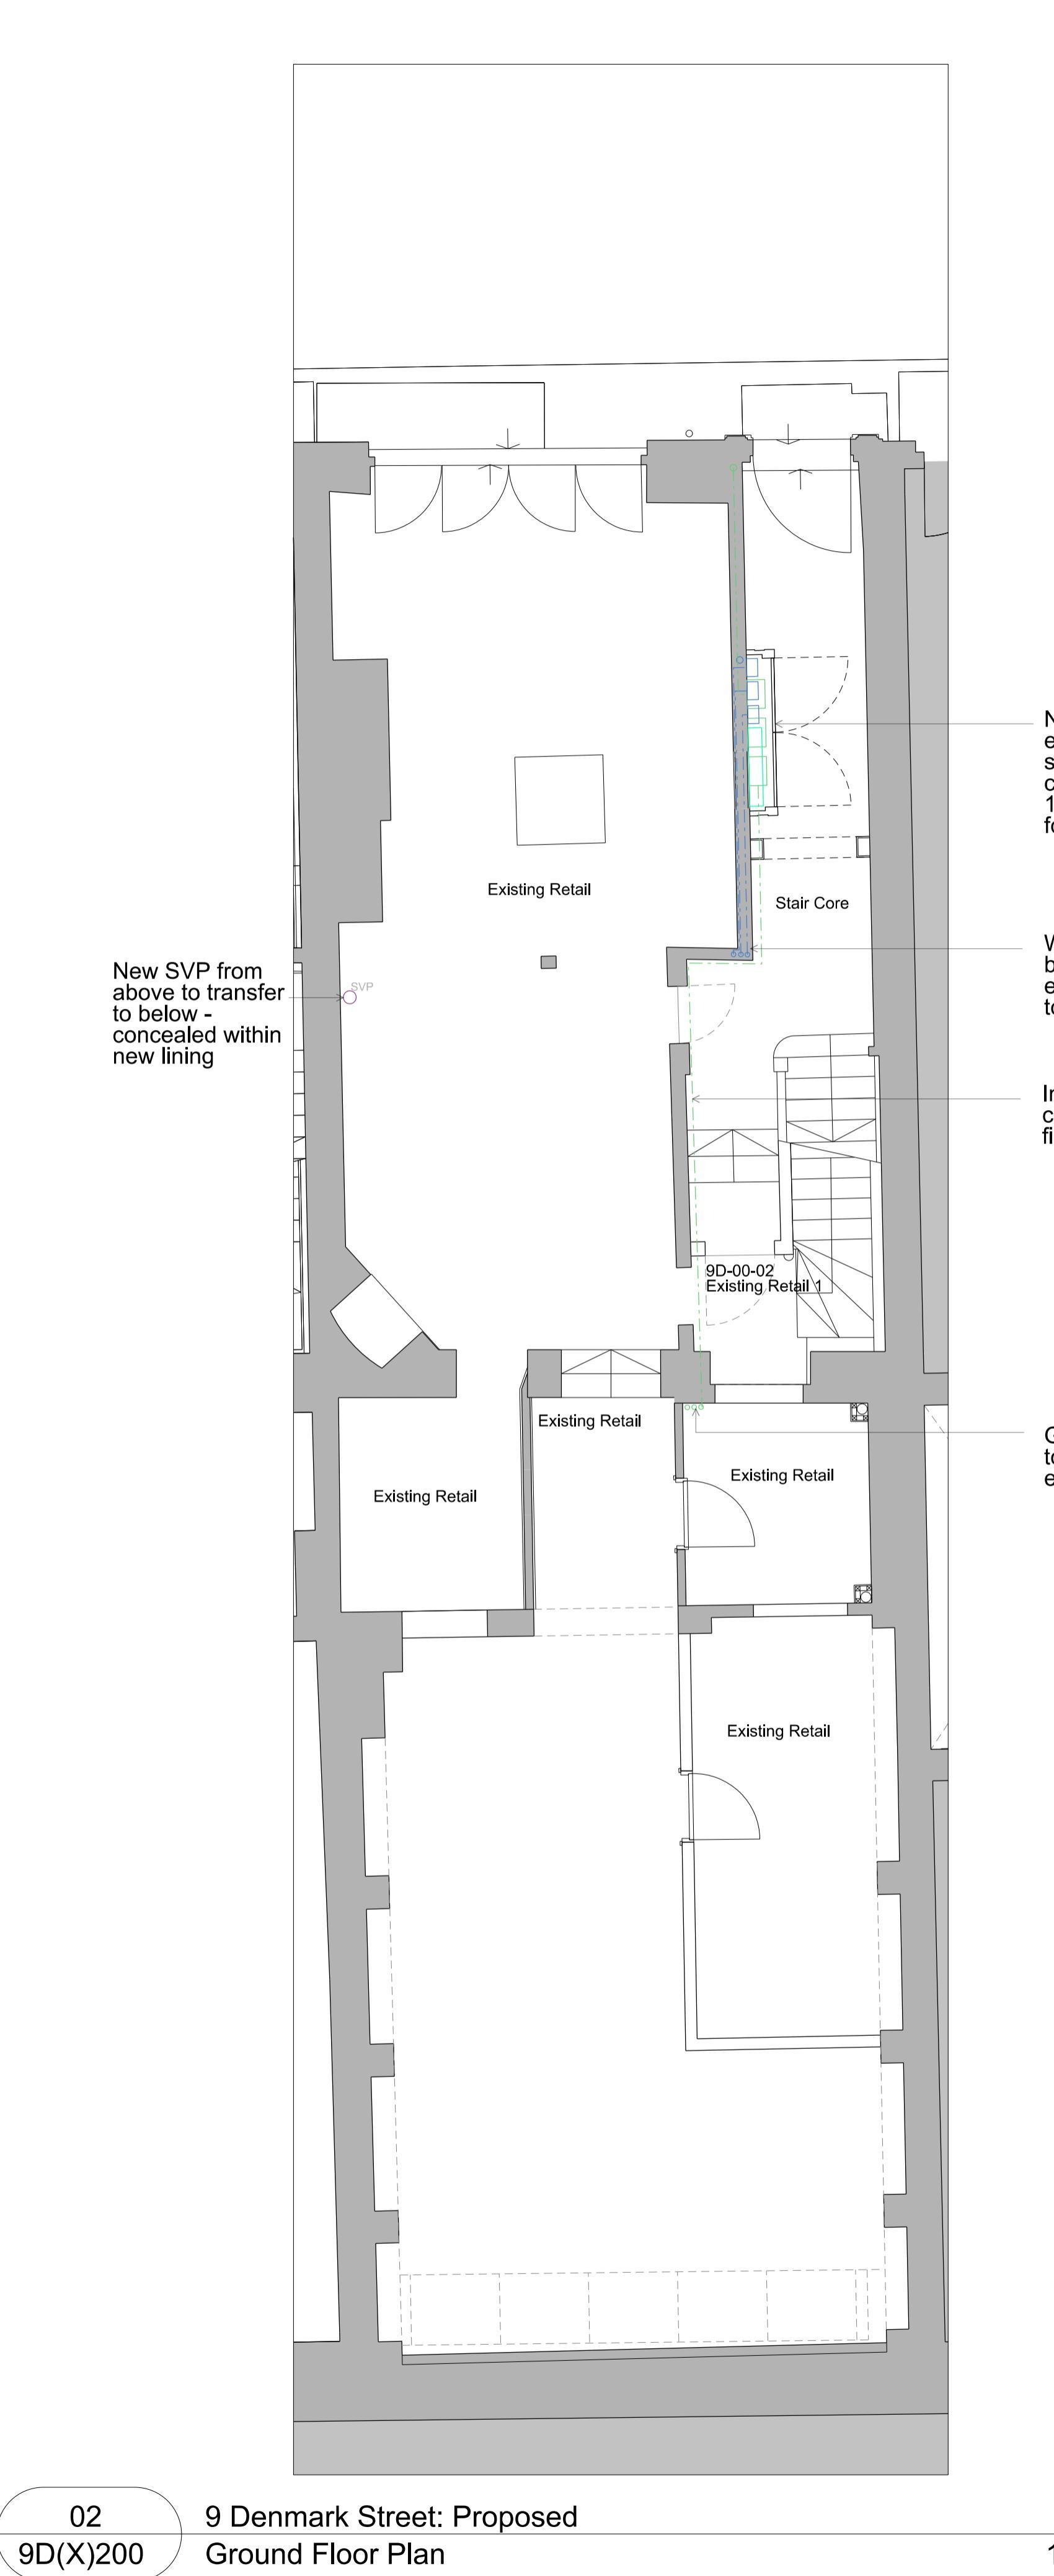
01 9D(X)200

## Services Routes:

Electric distribution
Wet services distribution
Gas distribution
Drainage
Ventilation

# New gas, water and electricity meters in common space, located within utilities cupboard - see drawing 1401\_9D(X)507 for details

# Water and electric supply to be carefully installed behind existing linings and distribute to high level

## Incoming gas supply to be concealed below floor finishes

Gas supply to transfer to levels above on external wall as existing

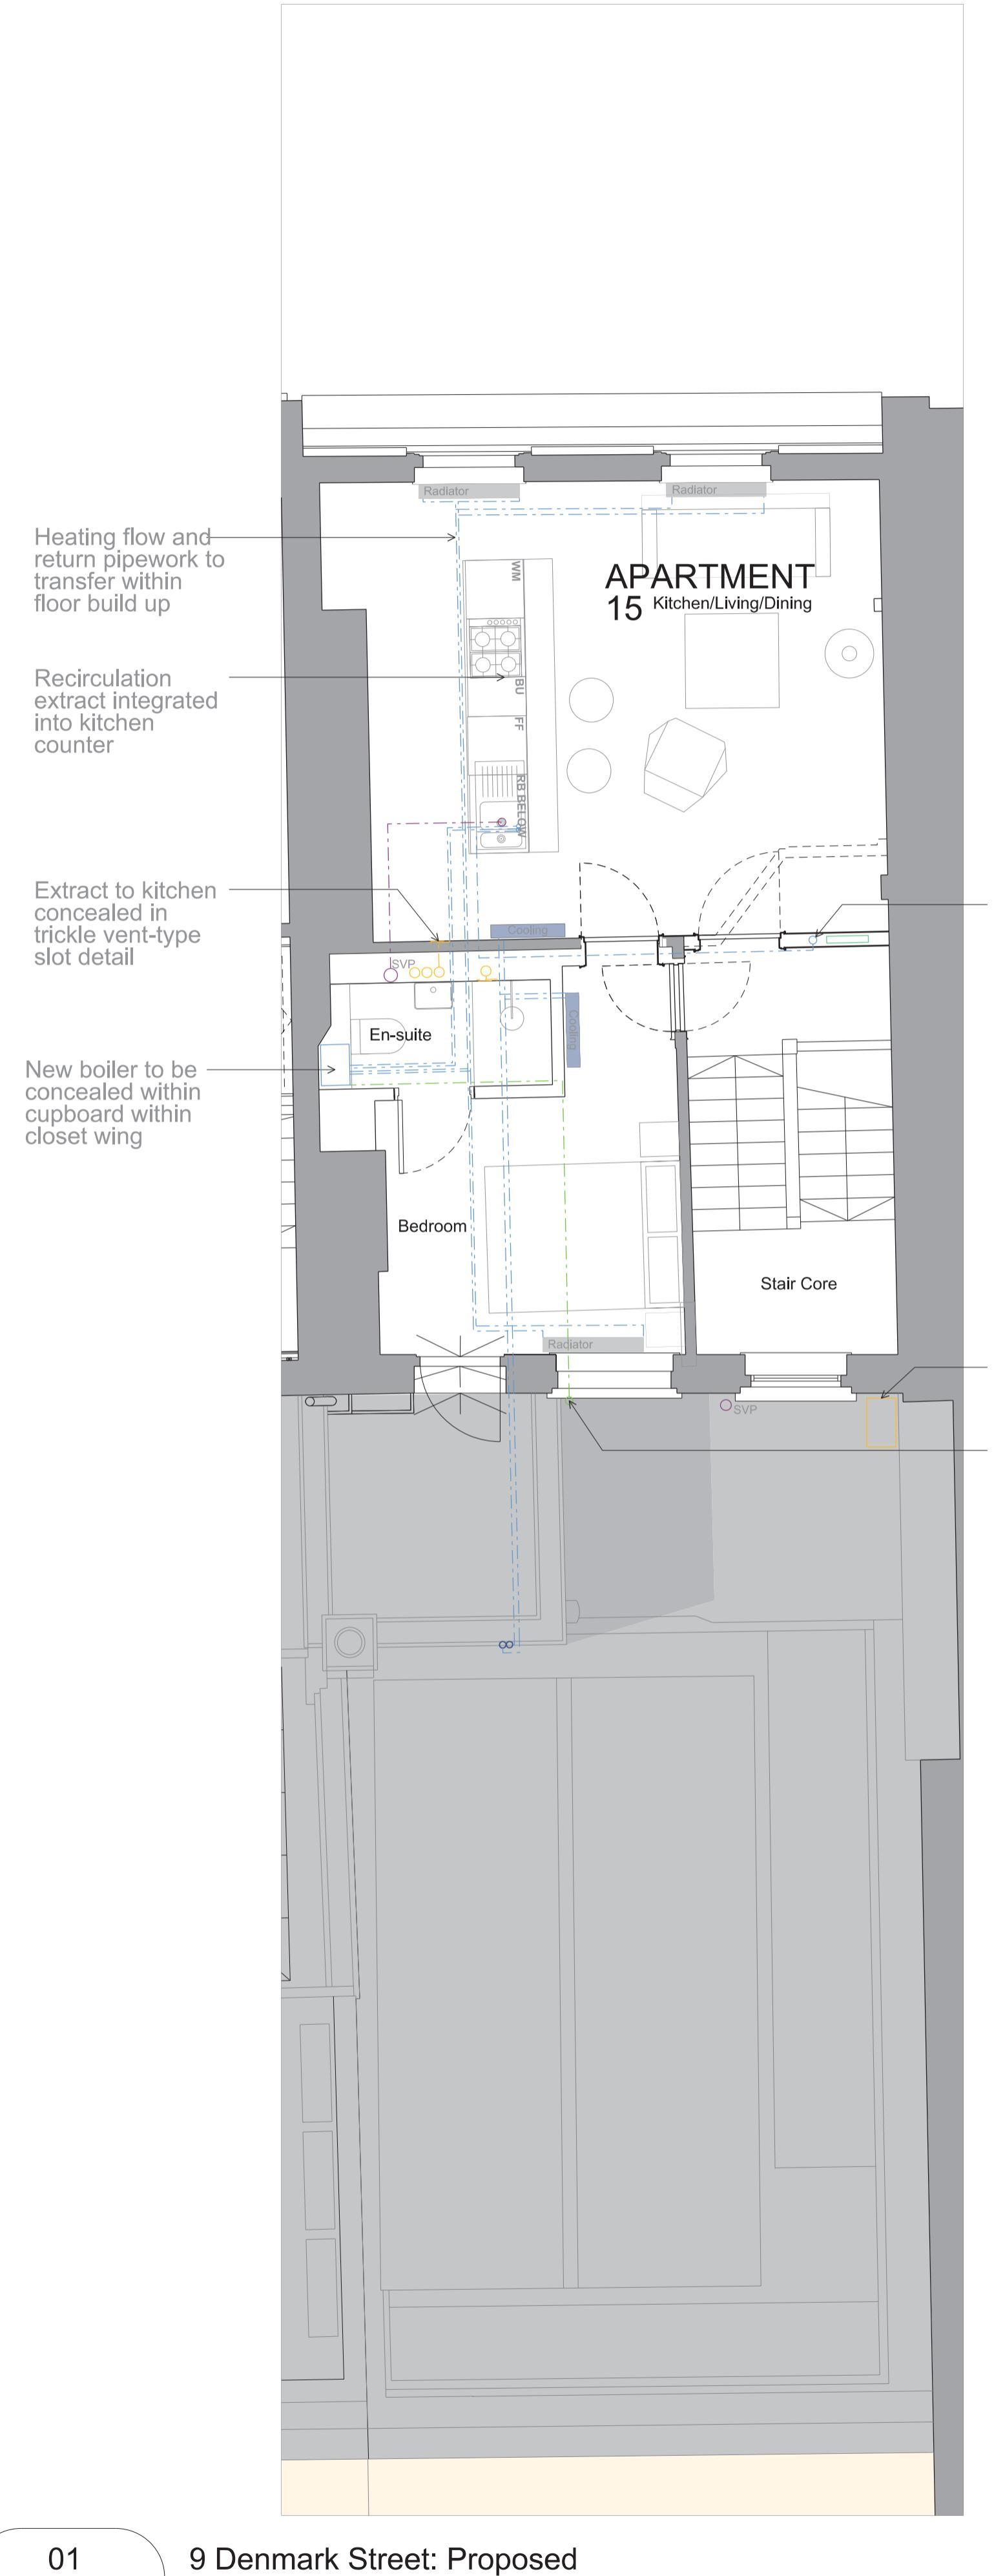
Water and electric supply to be carefully concealed within existing partition -panelling to be carefully lifted to allow for installation of services and subsequently reinstated

1 no. gas pipes from below, transfer at low-level within floor -to be concealed in cast metal rainwater pipework - painted

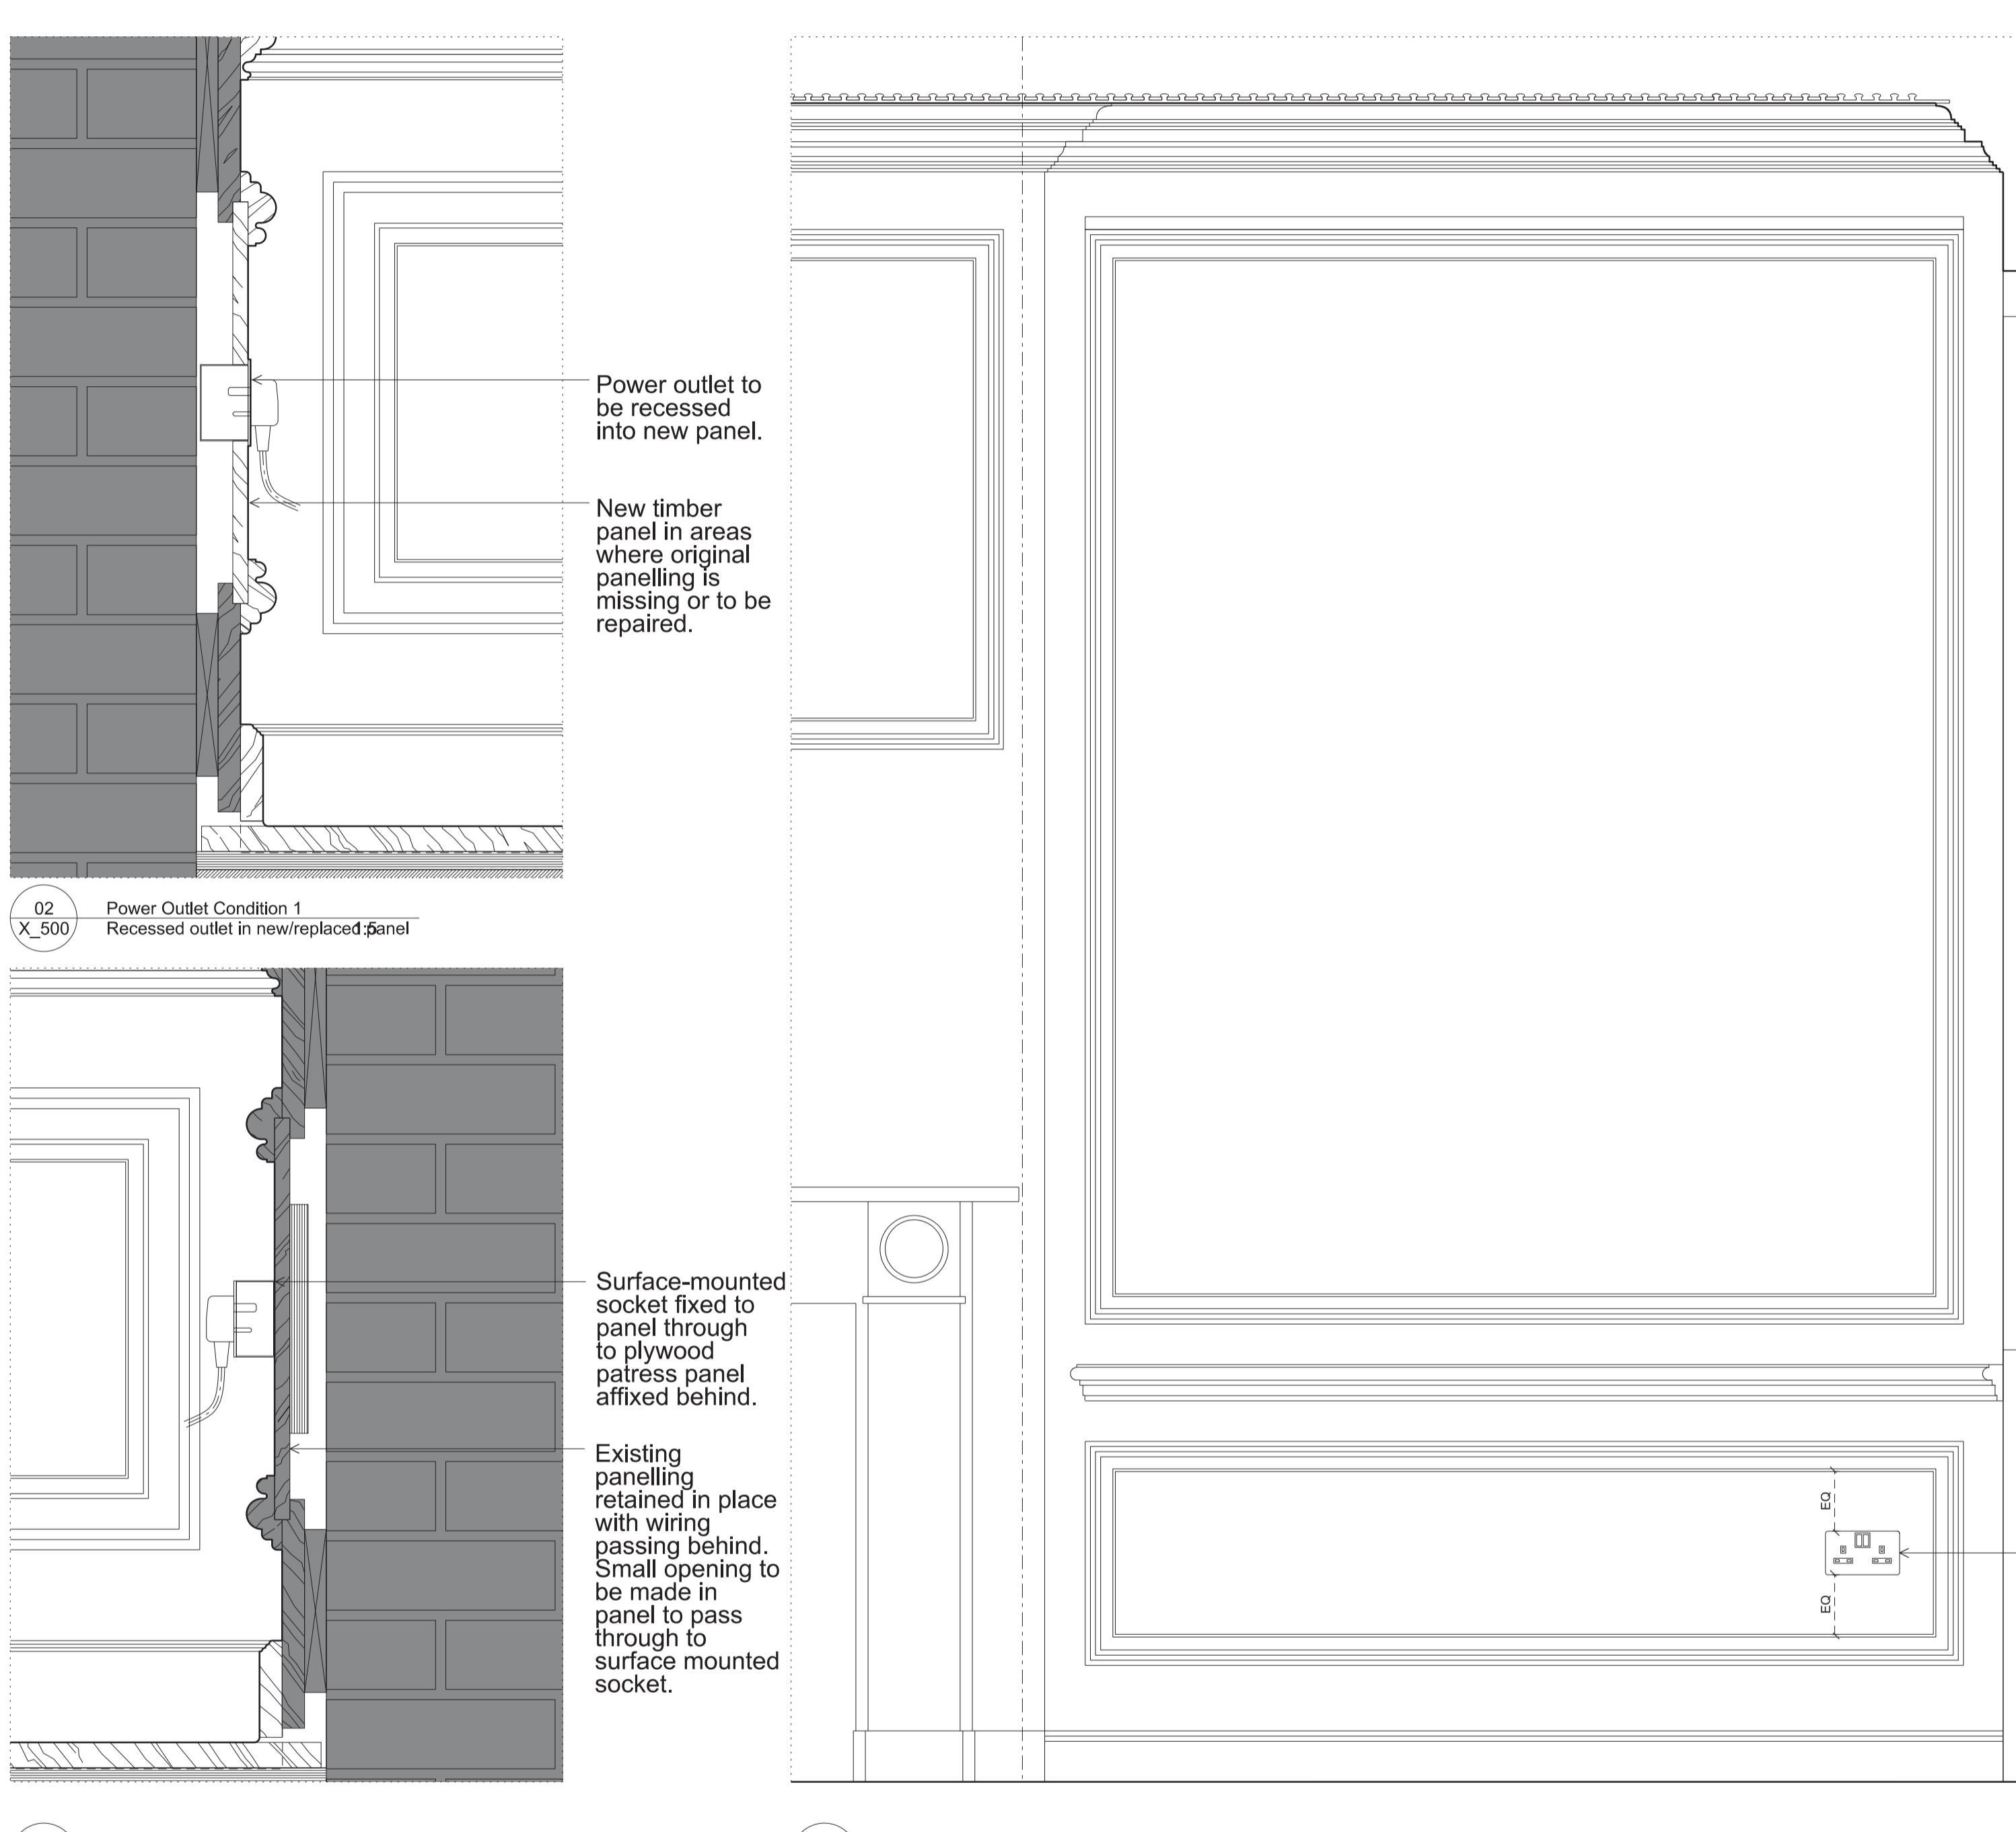
04Power Outlet Condition 2X\_500Elevation1:10

Note- Where existing— power outlets are provided at low level on skirting, outlet to be removed and skirting repaired.

Power Outlet Condition 2 Surface mounted power outlet t**d:**Existing panelling

Socket to align centrally in existing lower panel.

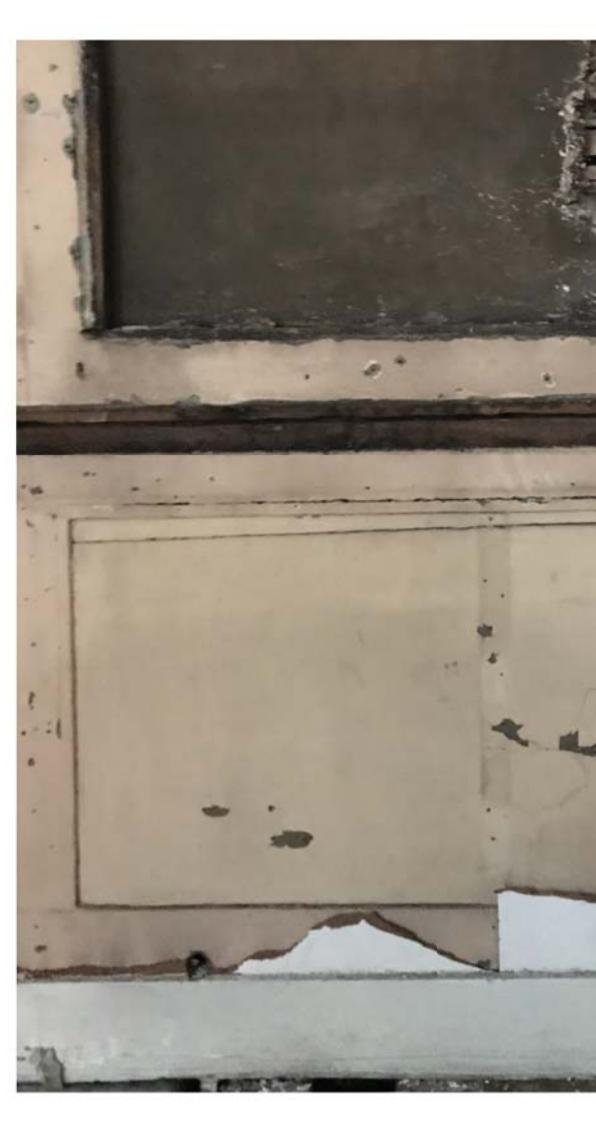
02 Existing Condition First Floor X\_501 Original Panelling and dado removed - to be reinstated

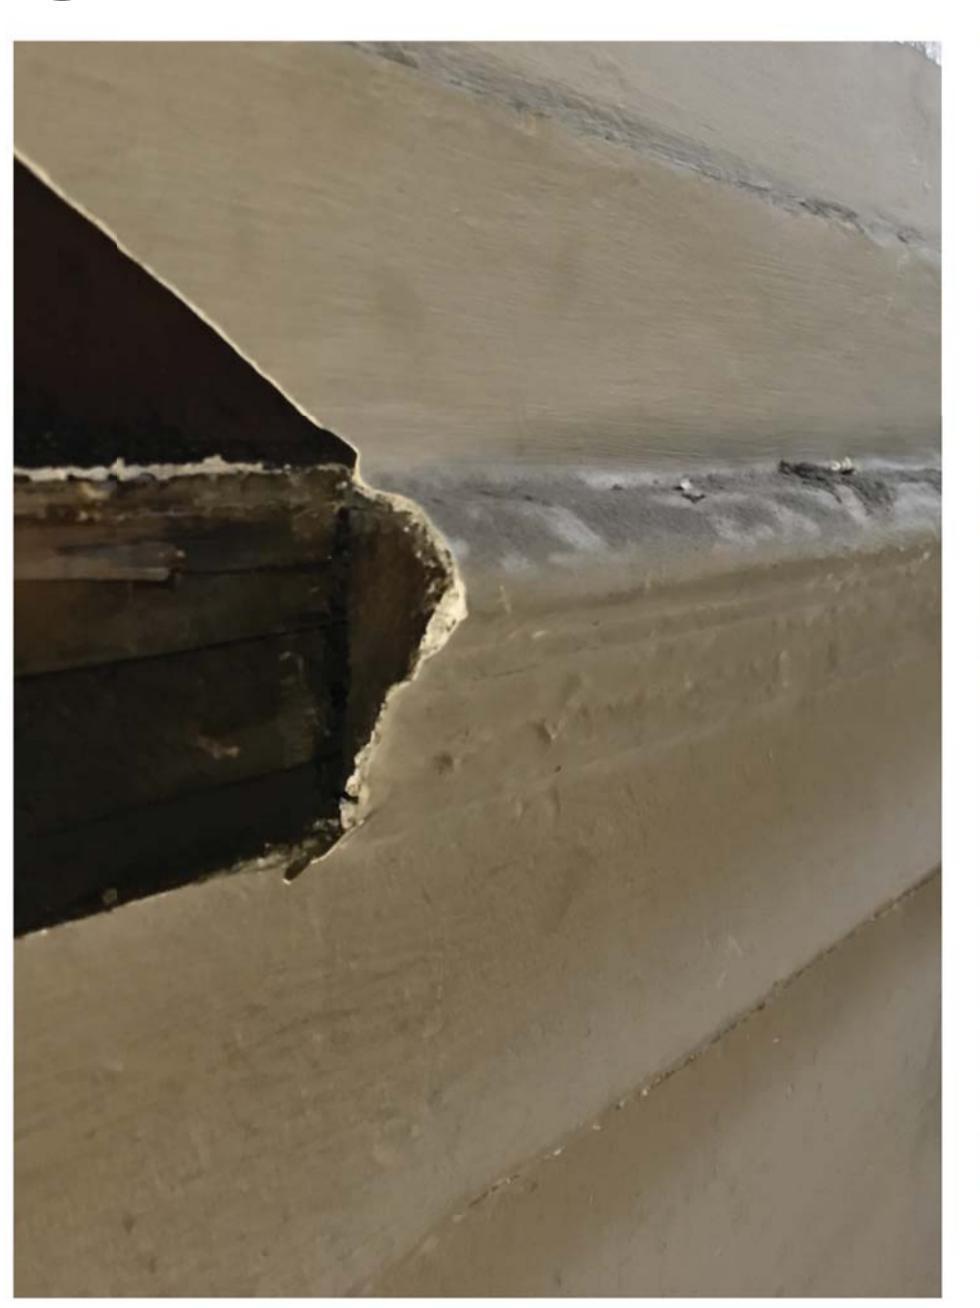
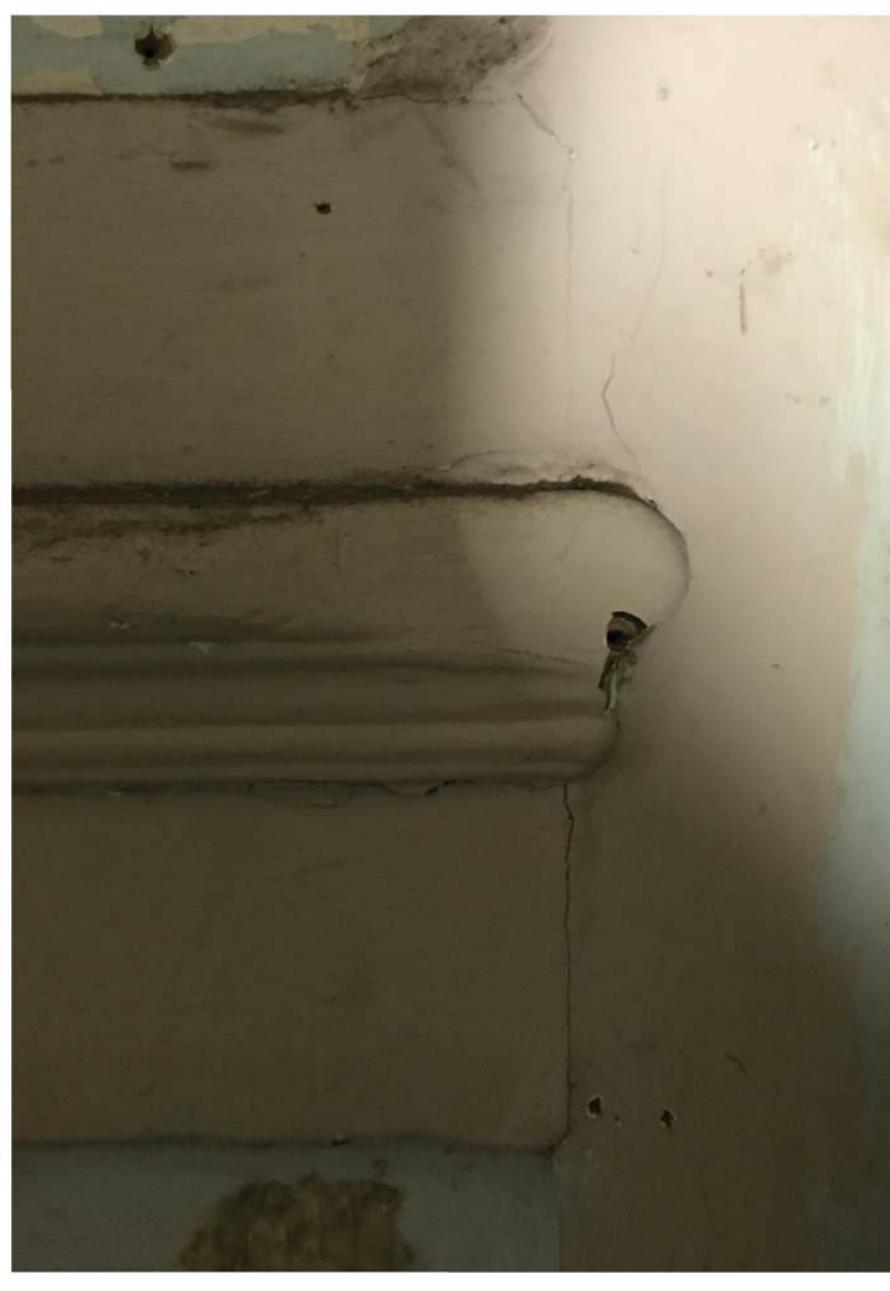
Existing Dado Images Condition 2 - Rear Room

do profile
01 Existing Dado profile to be used for repair and replacement	 	           	
			Dado profile

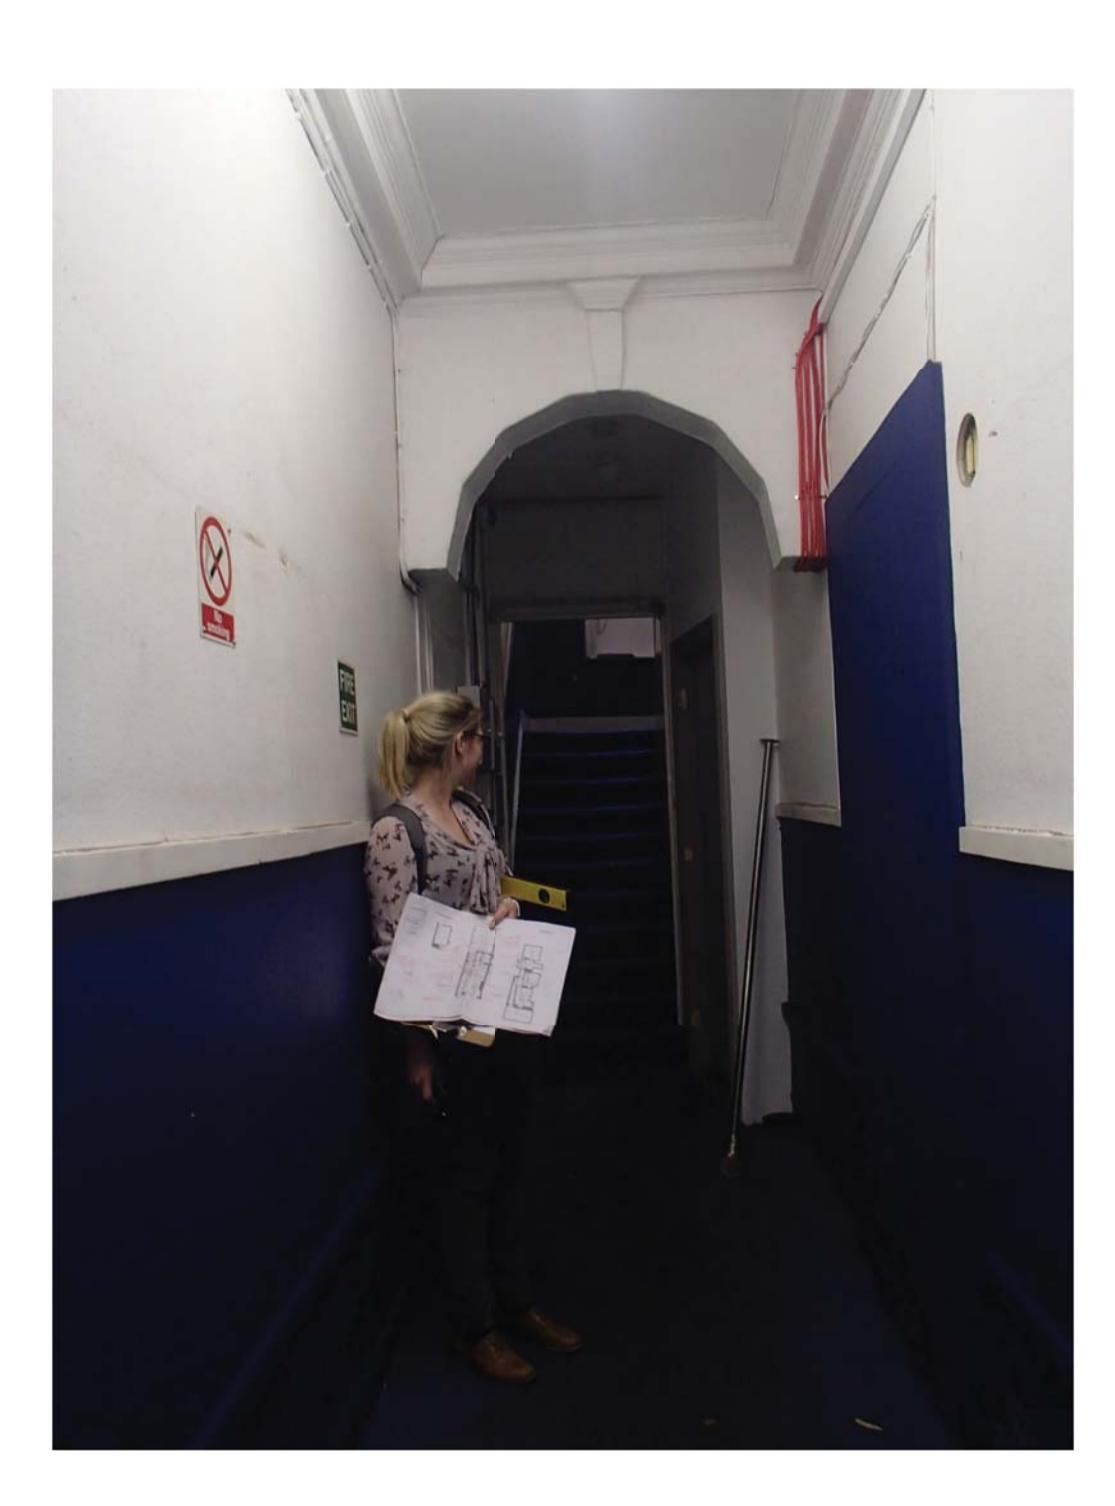
01 Existing Condition X\_501 Splayed wall built out to base of stair
