Geo-Environmental Assessment and Basement Impact Assessment 42 ELSWORTHY ROAD, LONDON, NW3 3DL – Volume 1 of 9

42 ELSWORTHY ROAD, LONDON, NW3 3DL Basement Impact Assessment

Client:	Daniel Austin		
Engineer:	Create Consulting Engineers Limited 109-112 Temple Chambers 3-7 Temple Avenue London EC4Y 0HP		
	Tel:020 7822 2300Email:enquiries@createconsultingengineers.co.ukWeb:www.createconsultingengineers.co.uk		
Report By:	Andrew Warren BSc (Hons), MSc, FGS		
Checked By:	Robert Griffiths BSc (Hons), MSc, FGS, CGeol Pete Gasparatos BSc MSc DIC Eng MIStructE Eur Ing		
Approved By:	Colin Buchanan BSc (Hons), FGS		
Reference:	CB/CS/P17-1308/01		
Date:	August 2018

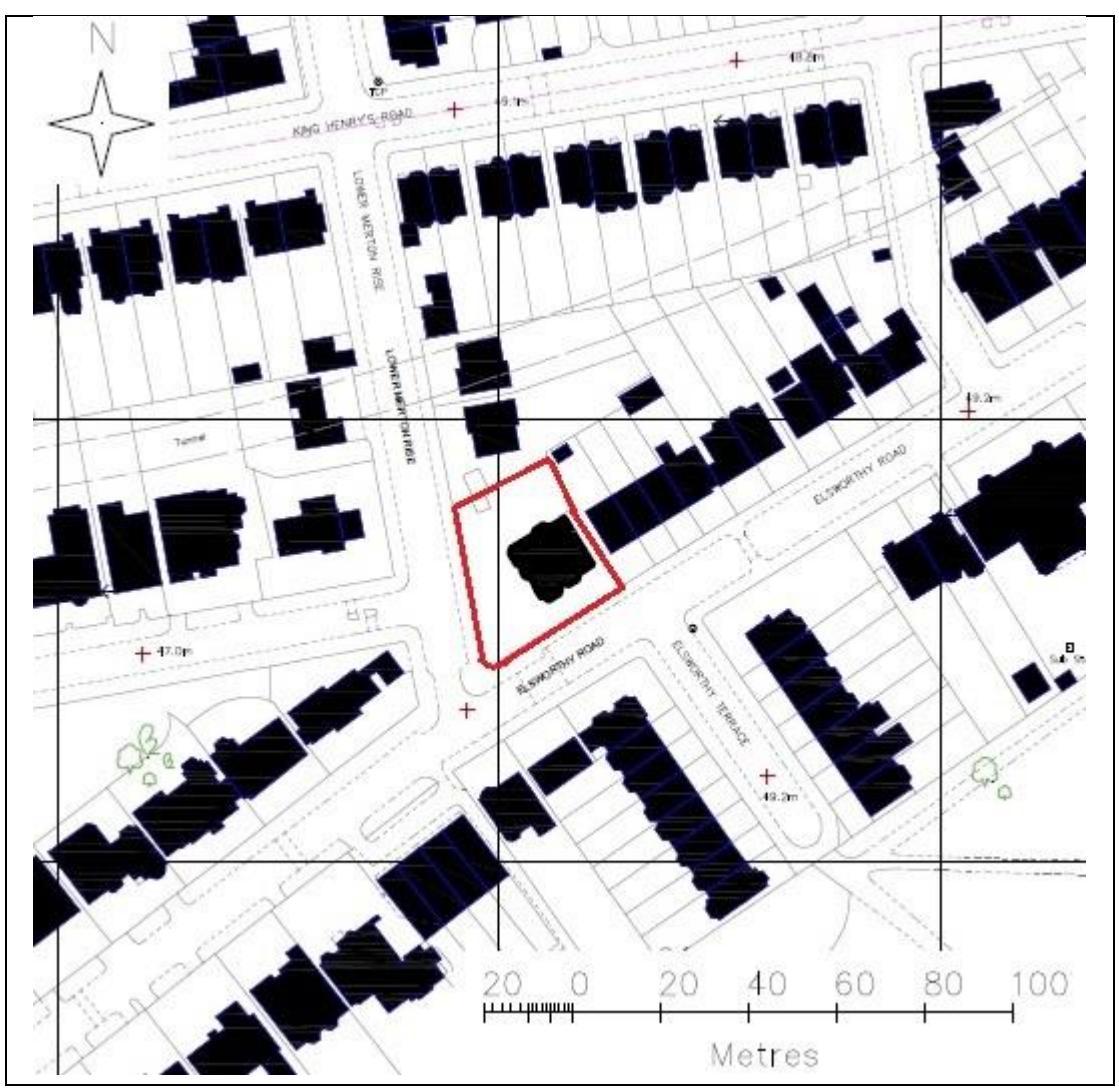
Figure 1.2: Existing Site Plan

1.2 The Site currently comprises a detached property in a residential setting as presented in Figure 1.2 overleaf.

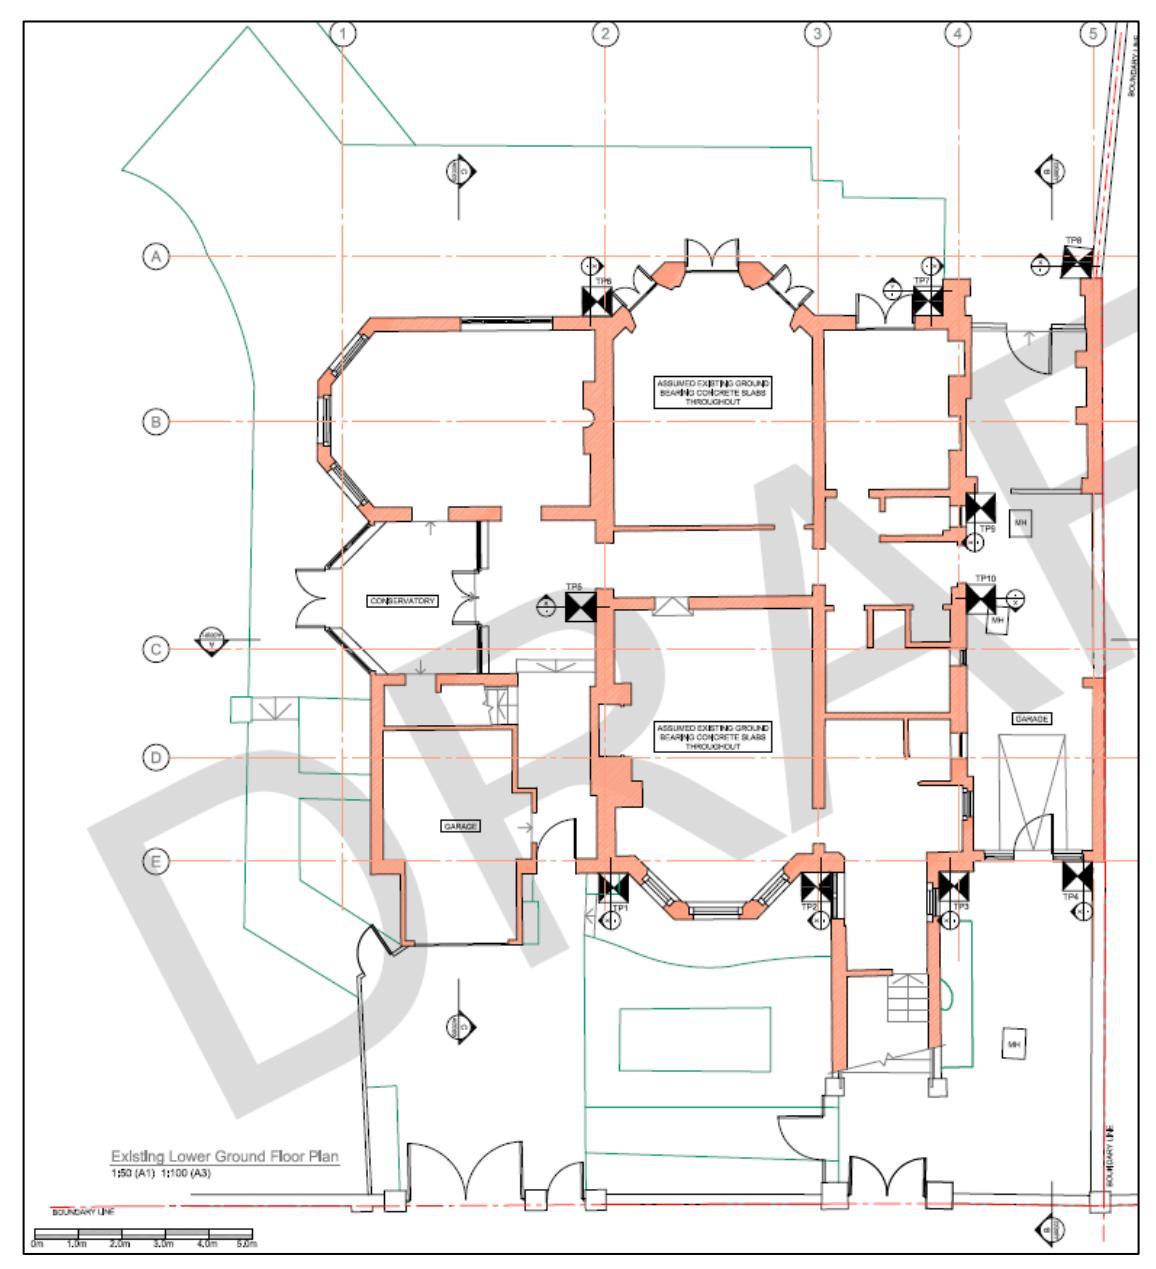
Figure 3.1: Existing Layout of the development site (Source: FormSD Drawing: L(00)01 P1)

A plan of the existing Site layout is presented in Figure 3.1 below.

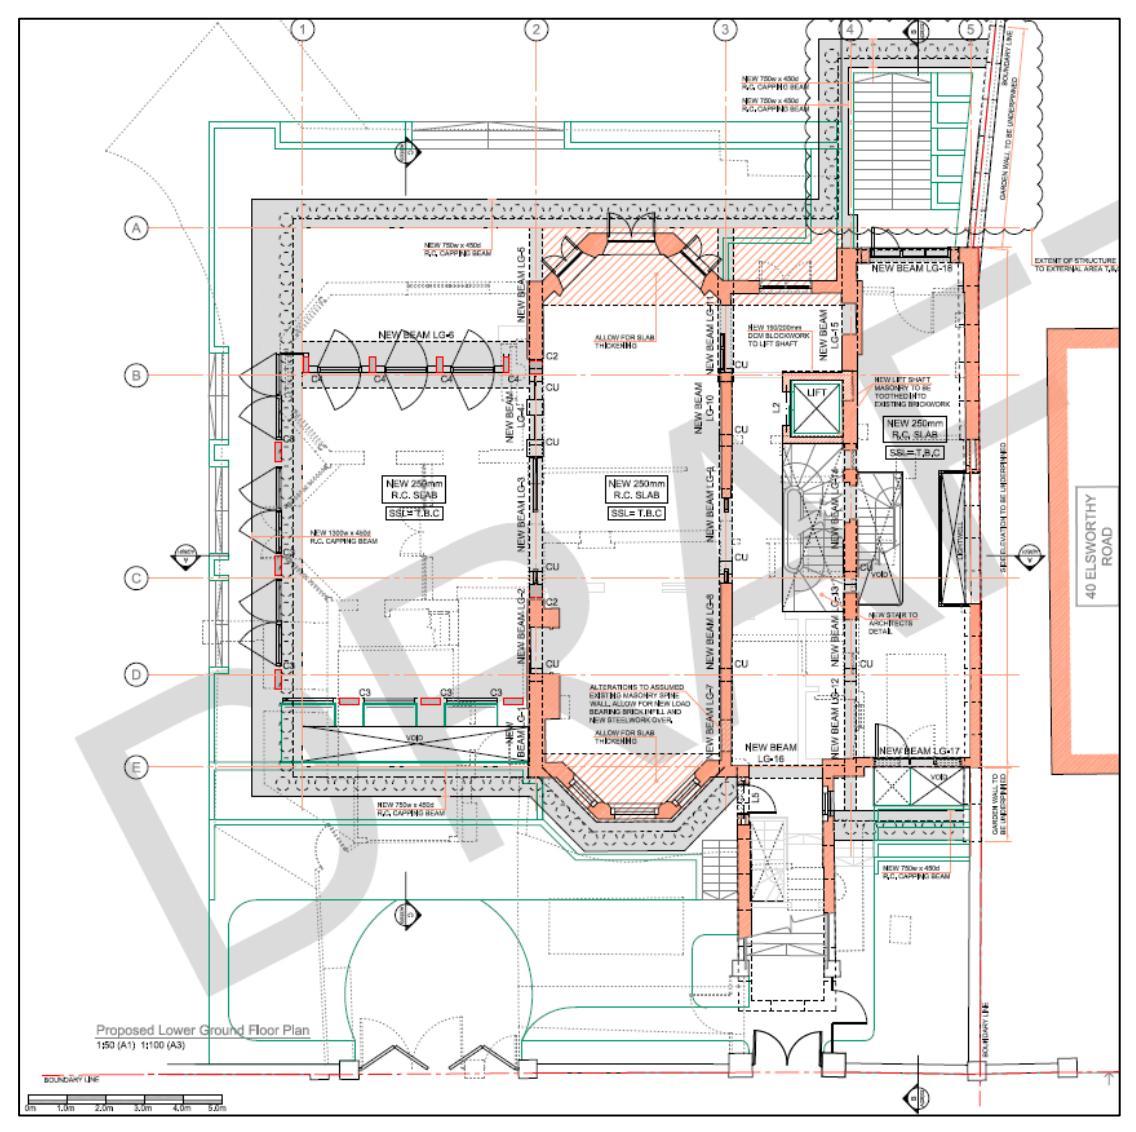
Figure 3.2: Proposed development (Source: FormSD Drawing L(23)01 P1)

The proposed development is to provide an extension to the existing upper and lower ground floor areas of the main residential unit to accommodate further reception areas and amenities. The basement will provide additional living space and space for leisure facilities (swimming pool).

A plan of the proposed development in relation to the existing Site layout is presented in Figure 3.2 below.

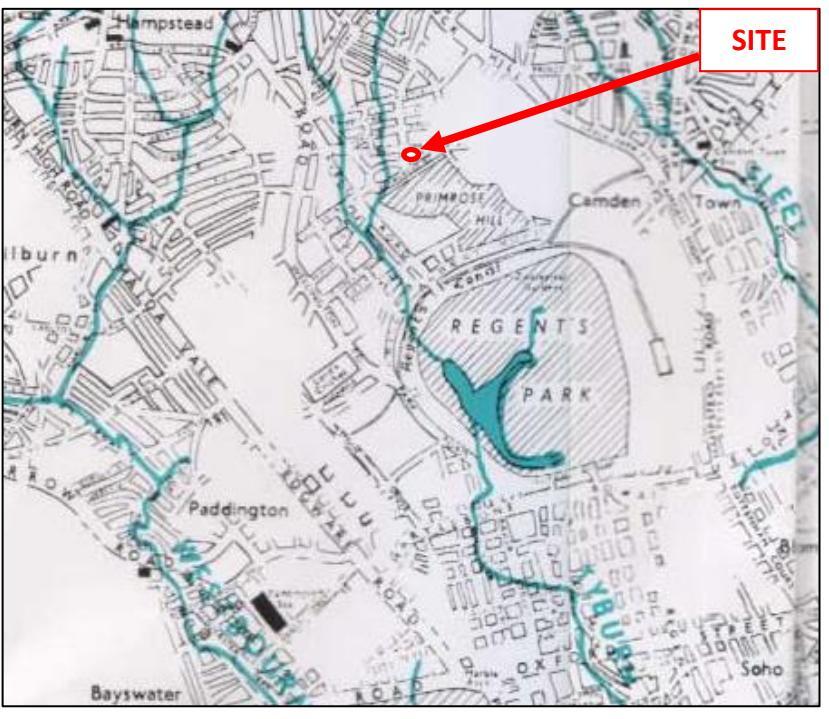
Figure 4.1: Lost Rivers of London, Barton 1992

4.10 There are no primary, secondary or tertiary rivers identified within the site boundary or within 500m of the site boundary. There is a culvert identified trending north – south approximately 150m to the west. This is believed to be associated with the lost river Tyburn, as identified in Figure 4.1, below.

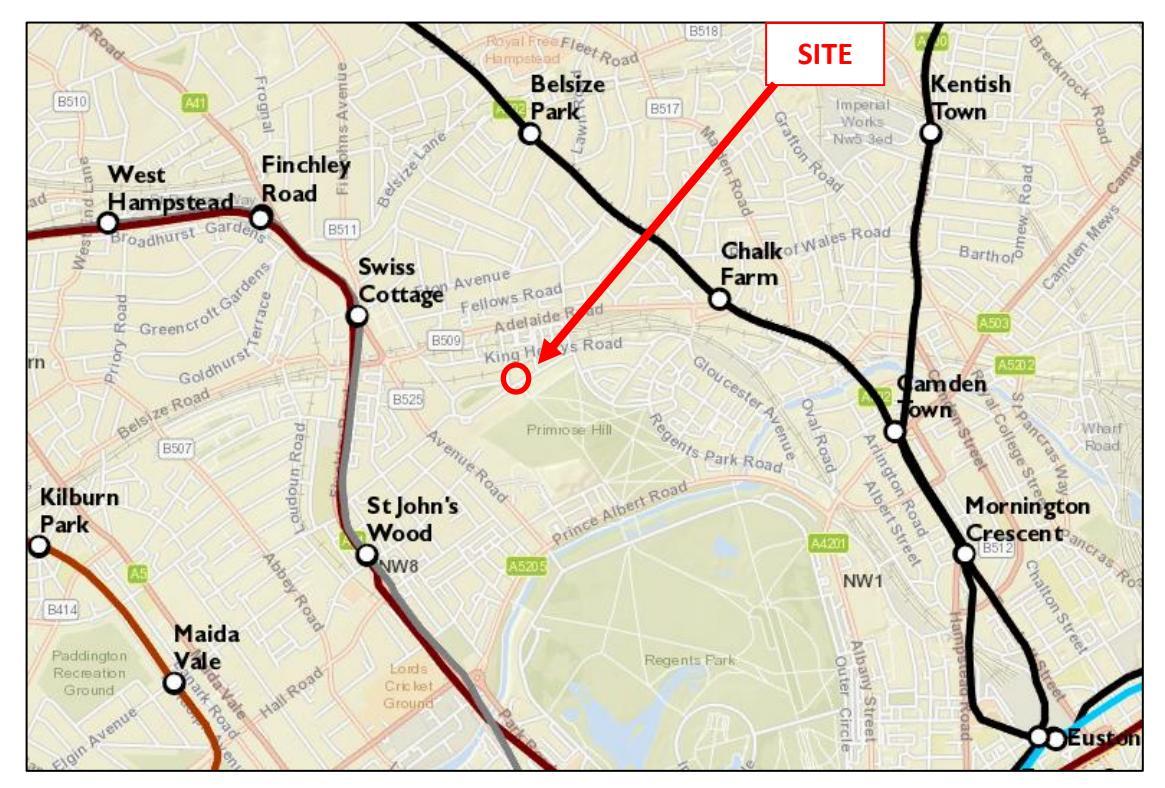
Figure 4.3 London Underground network

4.18 The location of the London underground lines were confirmed using the ARCGIS online information providing a true representation of the London underground network in relation to the site, as provided in Figure 4.3.

4.19 The London Underground Infrastructure team were contacted to confirm assets will not be affected by the proposed works on this site. It was confirmed that no London Underground assets will be affected by the works at this site and the correspondence is provided in Appendix D.

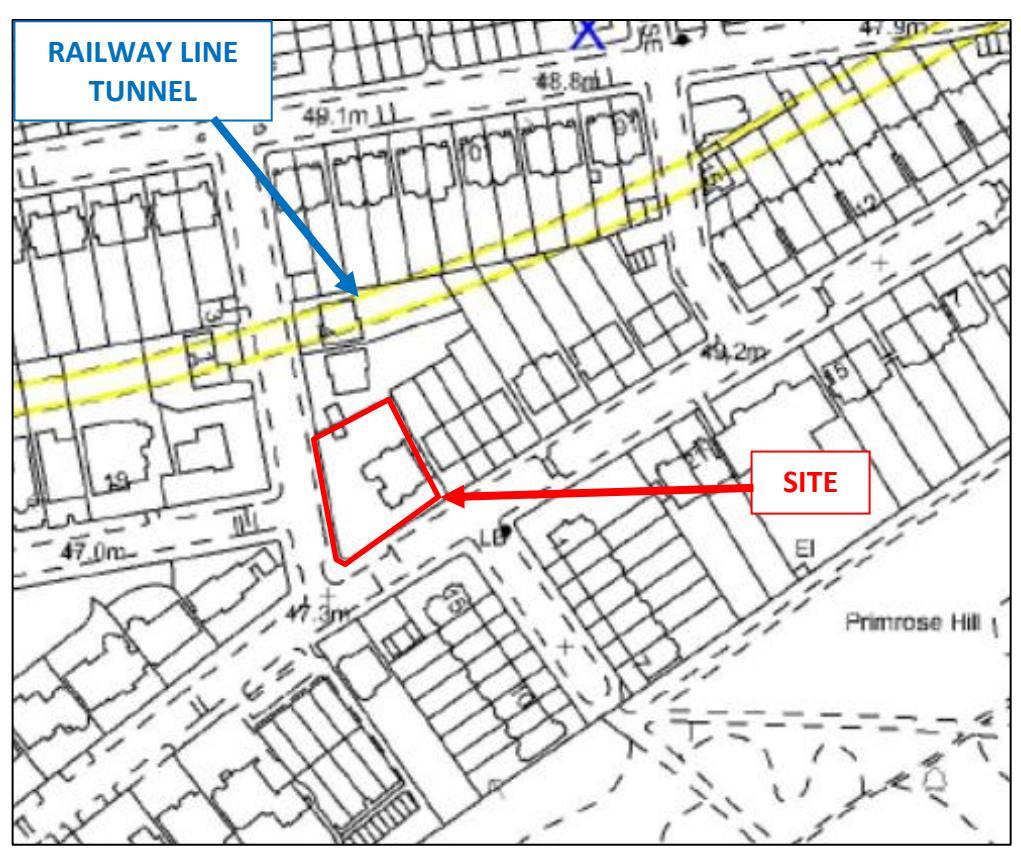
Figure 4.4: Overground Railway Network

4.20 The location of the London over ground lines were confirmed using available historical Ordnance Survey mapping and through information provided by the Network Rail Asset Protection team as illustrated in Figure 4.4 below.

4.21 Network Rail confirmed the location of their asset (Appendix E).

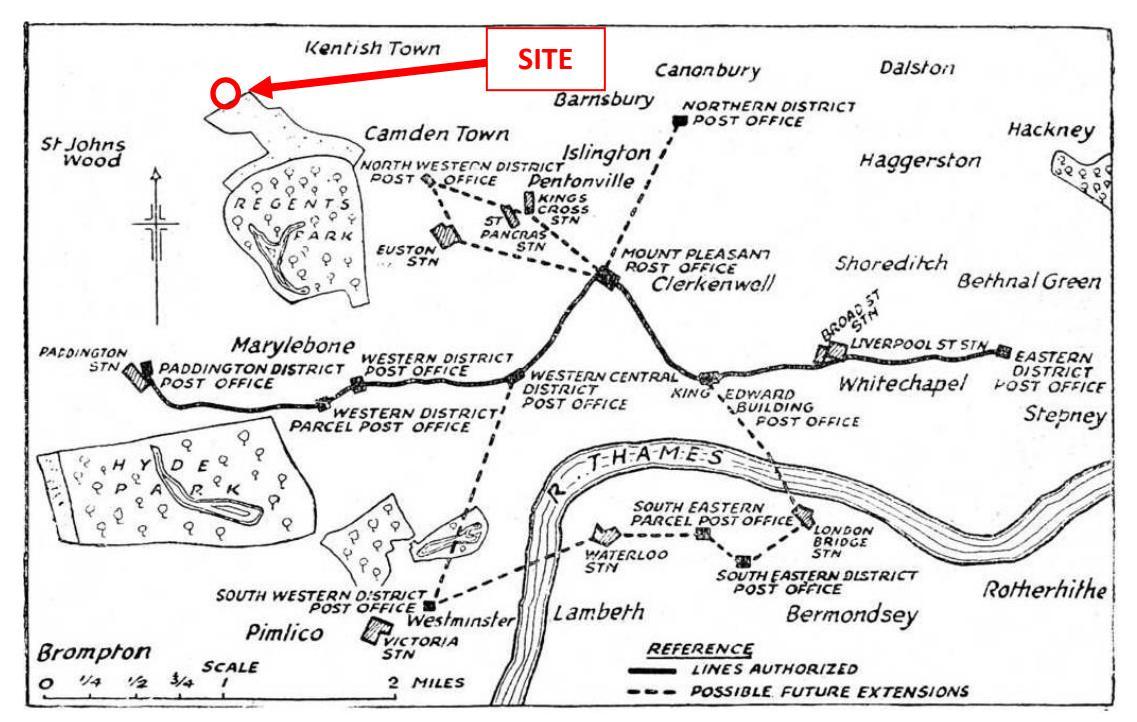
Figure 4.5: Post Office Tube Railway Route, London

4.22 The location of the post office tunnels were confirmed using online information and provided as Figure 4.5 overleaf.

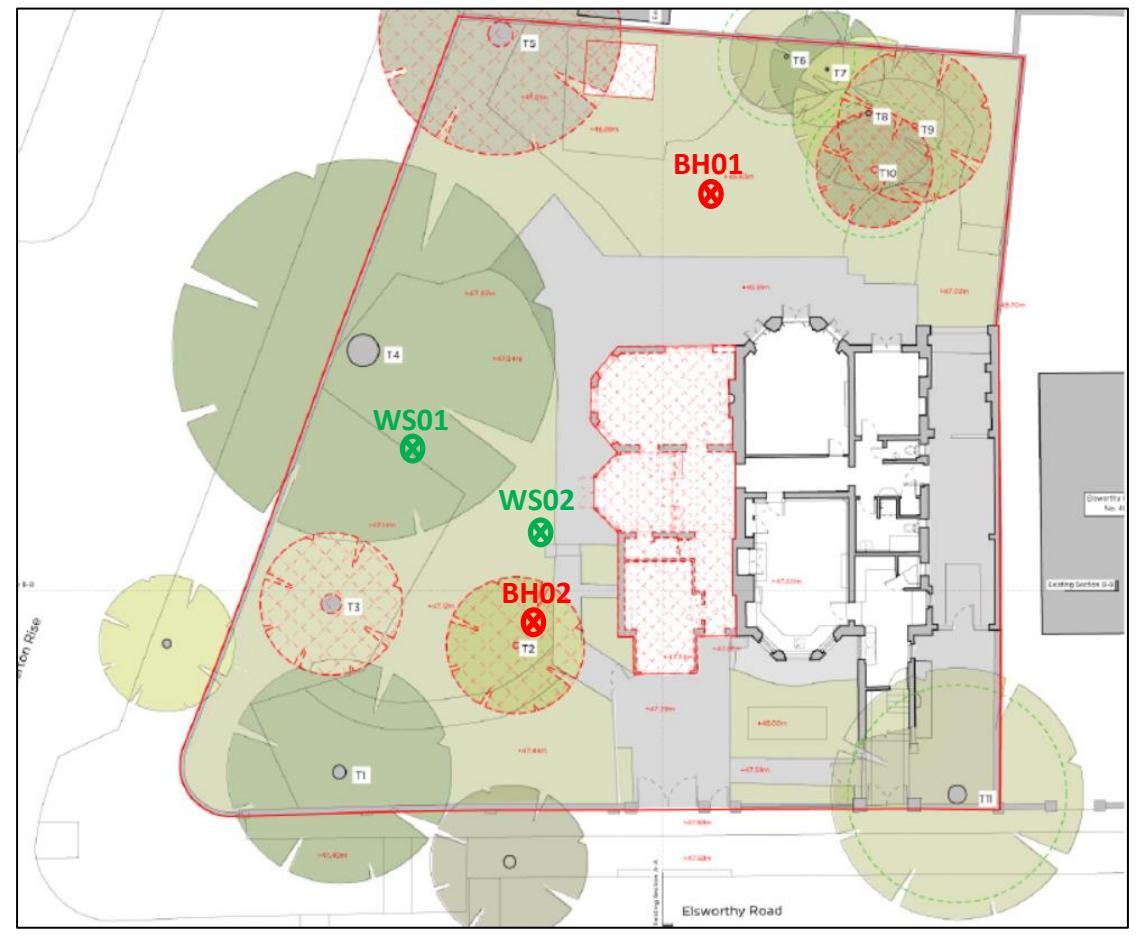
Figure 7.1: Exploratory Hole Locations

- 7.1 A ground Investigation was carried out on the subject site between 3 and 5 July 2017 to support the basement assessment and design solution for the proposed development.
- 7.2 The investigation comprised the drilling of 2No. cable percussion (BH01 and BH02) boreholes to a maximum depth of 15 metres and 2No. windowless sampler boreholes (WS01 and WS02) to a maximum depth of 5 metres. The purpose of the investigation was to confirm ground conditions at the location of the proposed basement and extension including the groundwater table.
- 7.3 The location of the exploratory holes is illustrated in Figure 7.1 below.

7.4 The soil arisings from each borehole were logged by a suitably qualified Engineer, in line with the relevant British Standard (BS 5930 and Eurocode 7). The borehole logs are provided in Appendix F.
