### Arboricultural impact analysis

Trees at and adjacent to

Proposed development site 29-33 Arkwright Road London NW3 6BJ

for

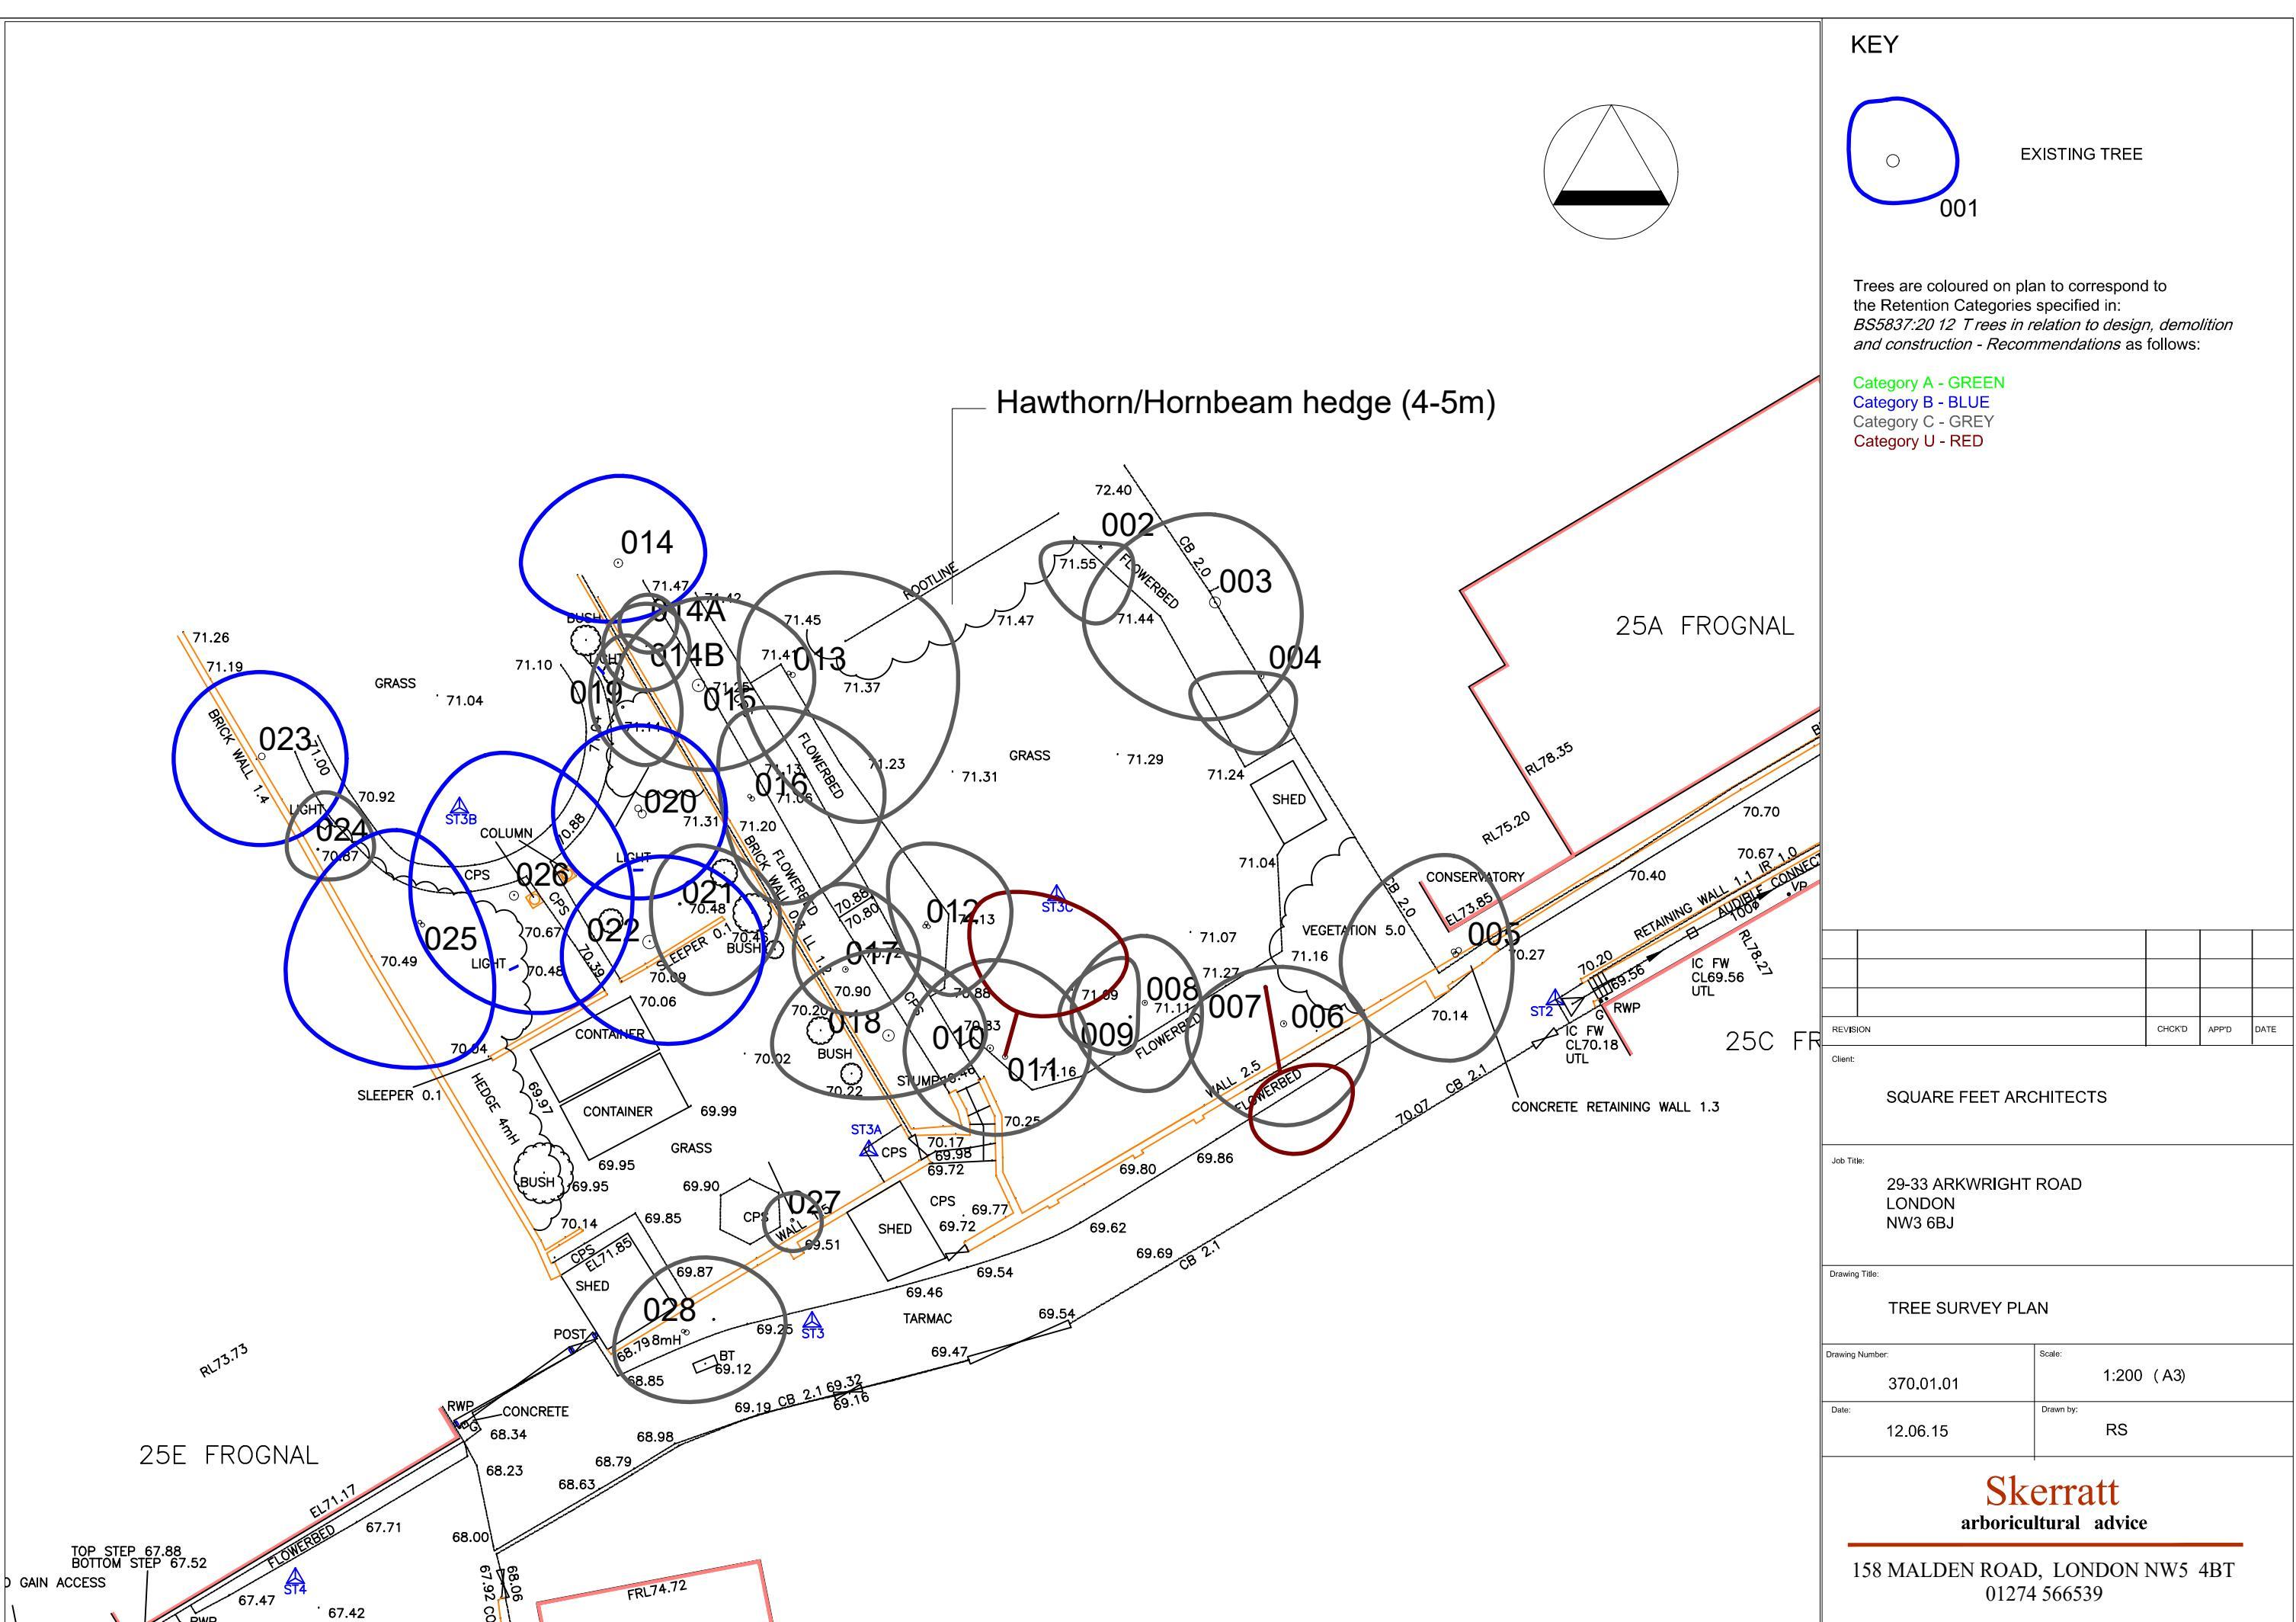
- 2.1.3 The **Tree survey plan** in **Appendix a**, which is based upon EDI Surveys' topographic survey of the site (Drawing No. 14988/T/01-01) shows details of the layouts of the different parcels of land with spot levels, giving a clear indication of level changes within the site as a whole.

All trees have been numbered in the survey text to correspond to the location numbers shown on the accompanying Tree survey plan. No trees have been marked on site.

**Crown spread** - radial crown spreads in metres have been recorded at four points on the circumference of the crown (north, east, south and west). The accompanying Tree survey plan shows approximate crown shapes based on these measurements

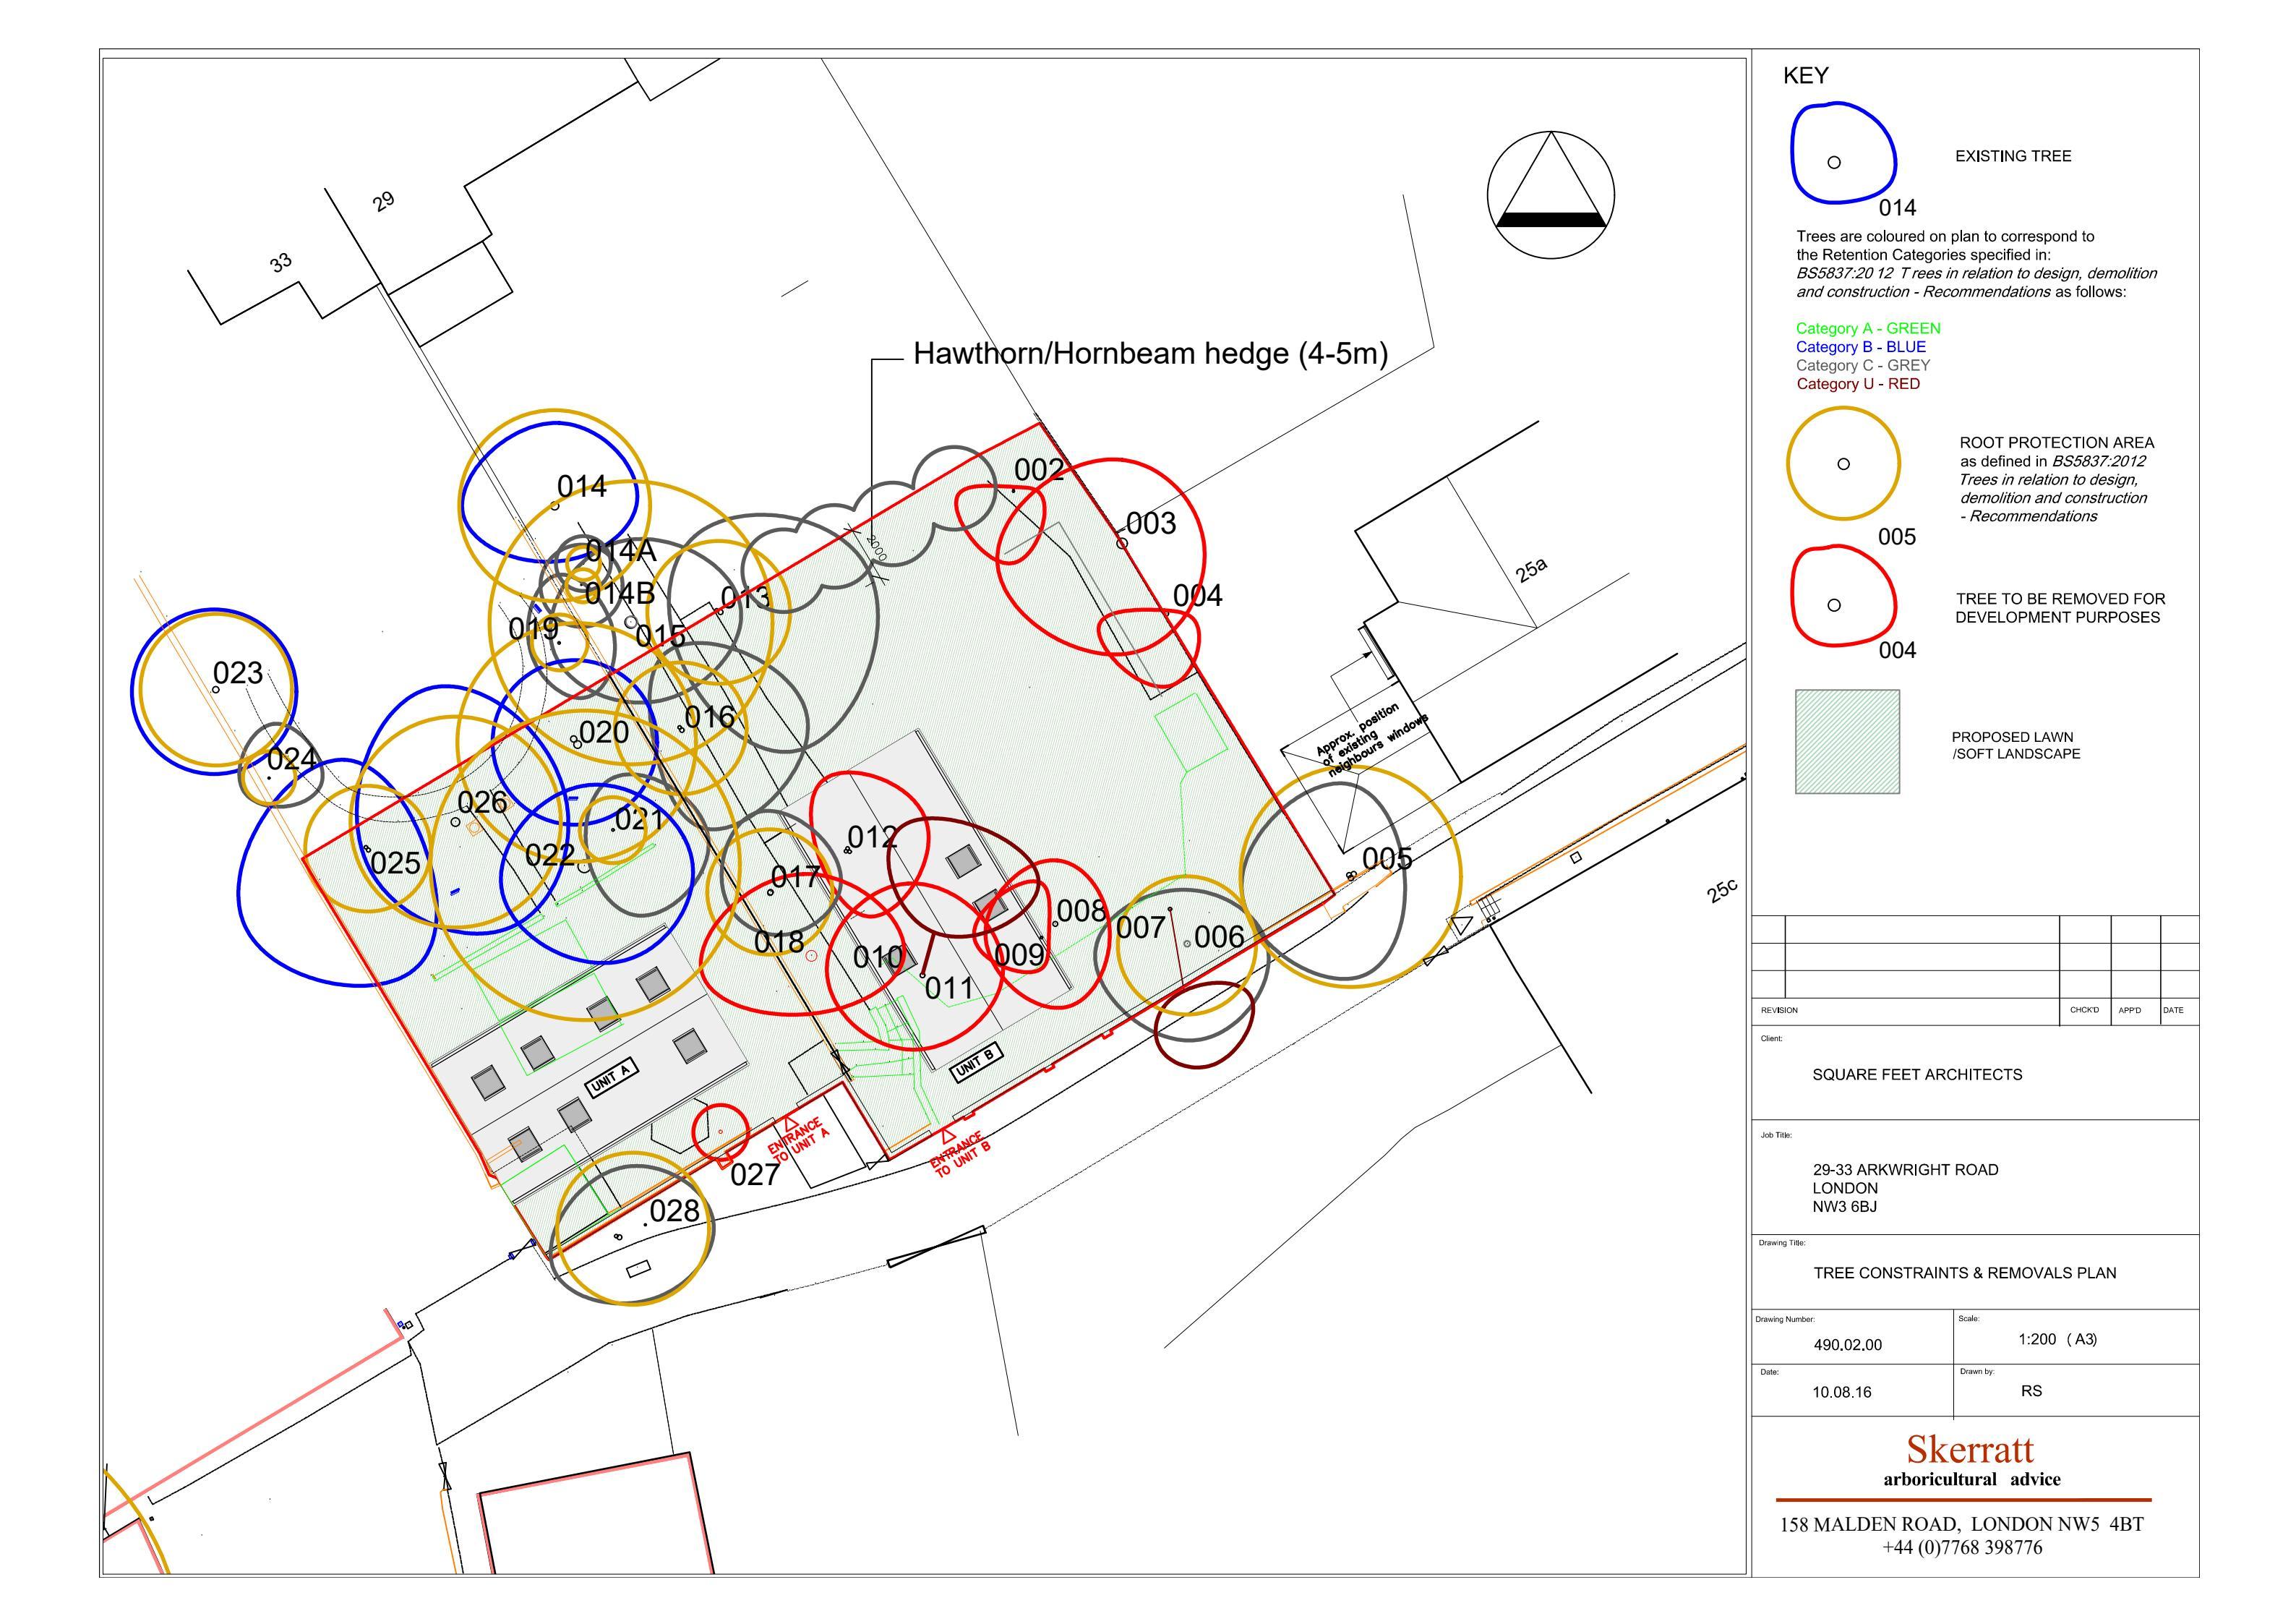
- 3.1.1 The **Tree constraints and removals plan** in **Appendix a** shows the recommended Root Protection Area (RPA) for each tree, arranged symmetrically around the main stem and highlights the primary potential area of conflict between proposed development and retention of existing trees, namely conflicting demands for space at and below ground level.
- 3.1.2 There are no significant, quantifiable existing barriers within the site to the lateral spread of roots.

- 3.3.5 **Table 2** overleaf summarises the likely impacts upon retained trees (001 and 005 excluded for the reason discussed above).
- 3.3.6 The footprints of the 2 proposed dwellings overlap the RPAs of Trees 017 (Holly) and 022 (Pear).

- 3.3.7 In both cases the overlaps do not exceed 10% of total RPA and there is open undeveloped ground contiguous with both Root Protection Areas on their off-site sides.

- 3.3.8 It is proposed to construct both dwellings on small-diameter piles with a shallow floor slab positioned wholly above existing ground level, thus avoiding the need for excavation to reduced levels for strip foundations and other sub-structure components.
