## Tree Survey, Arboricultural Impact Assessment Arboricultural Method Statement & Tree Protection Plan In Accordance with BS 5837:2012

Proj. No <b>7007</b>		44 Platts Lane, Hampstead, London, NW3 7NT				
	Clie	nt:	Mr Rupert	Horrocks		
Date of Report: 09/11/2018			Revision:	Original

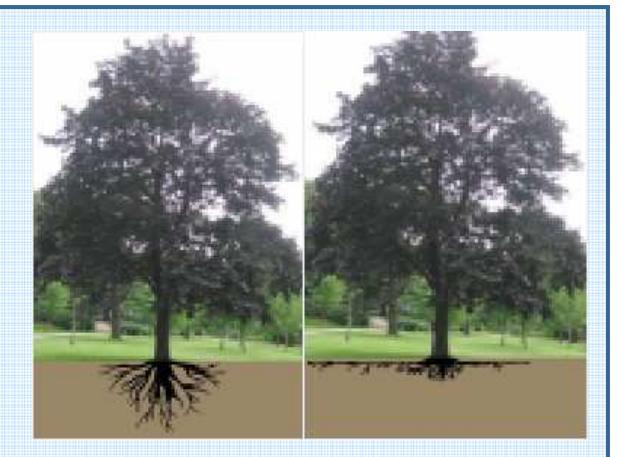
People often wrongly assume that tree roots are thick and grow down into the soil for many metres (Figure A). In reality tree roots:

- Are usually only large near to the trunk and get thinner the deeper and further from the tree they go. At a distance of just 3-4 metres from the trunk most roots are no bigger than a few centimetres in diameter.
- Spread outwards from the trunk, more or less parallel with the soil rather than growing downwards (Figure B).
- Can spread horizontally in any direction for a distance equivalent to at least the tree's height.
- Are usually relatively shallow; 80-90% of a tree's roots are in the Upper metre of soil. Few roots reach depths of more than about 2-3 metres and at this depth they are only a few millimetres in diameter.

Figure A: Incorrect

Figure B: Correct

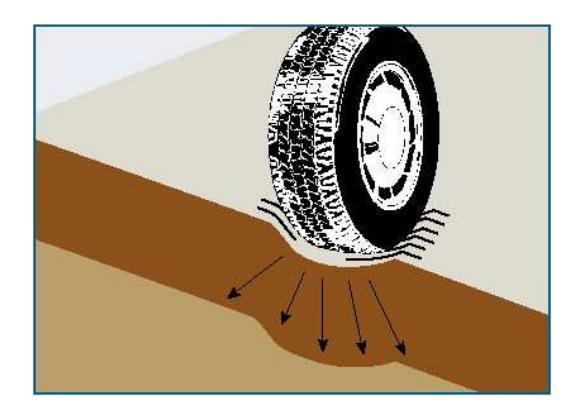
No ground reinforcement: Unreinforced soil becomes compacted and rutted by vehicle loads

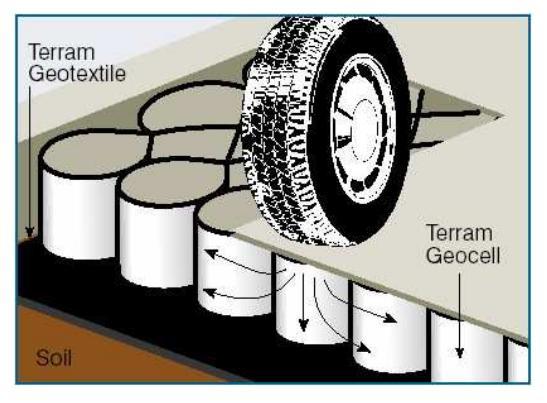
Geocell ground reinforcement: Forces are spread Laterally reducing loads on the underlying soil

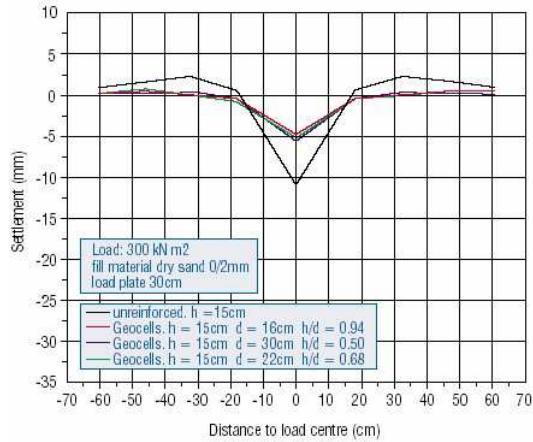
Figure 4. Static loading tests of up to 300kN/m2 revealed only minimal deflection (<5mm) of the surface of filled Geocell

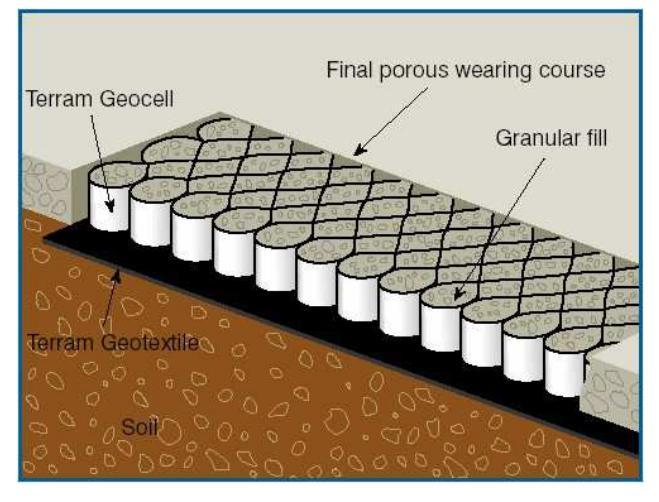
Figure 6. Components of an above-ground load bearing platform suitable for vehicles

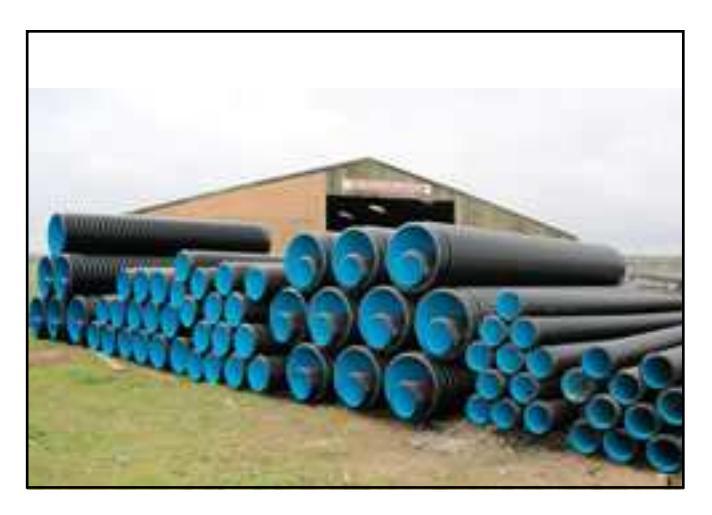
INSIDE: Flexible, cushioning protection of fibre/felt carpet padding

• Protects the bark against injuries from inside the pipe

FASTENER: Strap-on construction made of Tree Chain Lock Ties and Lock/Bolt

○ Fastens the BarkSavers<sup>™</sup> firmly to the tree

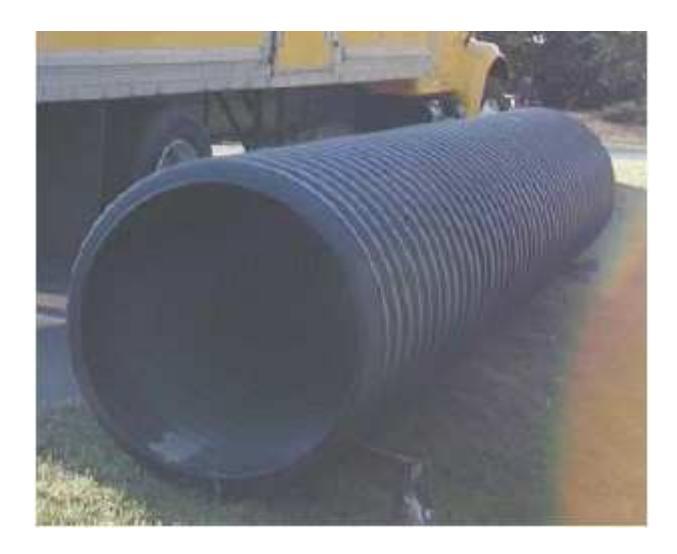
Whole Pipe

Cut drainage pipe with a saws all, a circular saw or with a hack saw
 a. Each section of pipe will be cut twice to form 2 halves
