19/30896-2 November 2019

### 8A FAWLEY ROAD,

#### LONDON, NW6 1SH

#### **BASEMENT IMPACT ASSESSMENT**

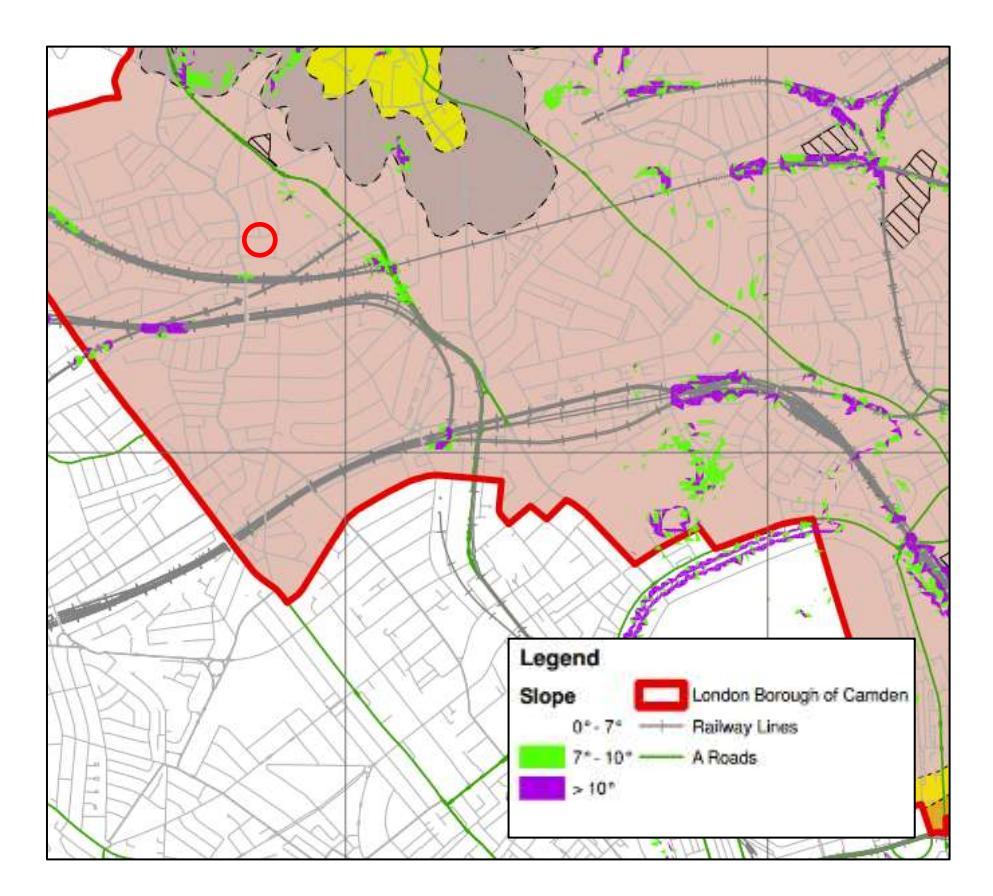
The site its relatively flat with no noticeable slope. The slope angle is less than 7 degrees. Also with reference to the Camden Geological, Hydrogeological and Hydrological Study, (Figure 2 below), the neighbouring properties also have slopes less than 7 degrees.

Figure 2. Exact from Figure 16 of the Camden CPG4 showing slope angles within the borough

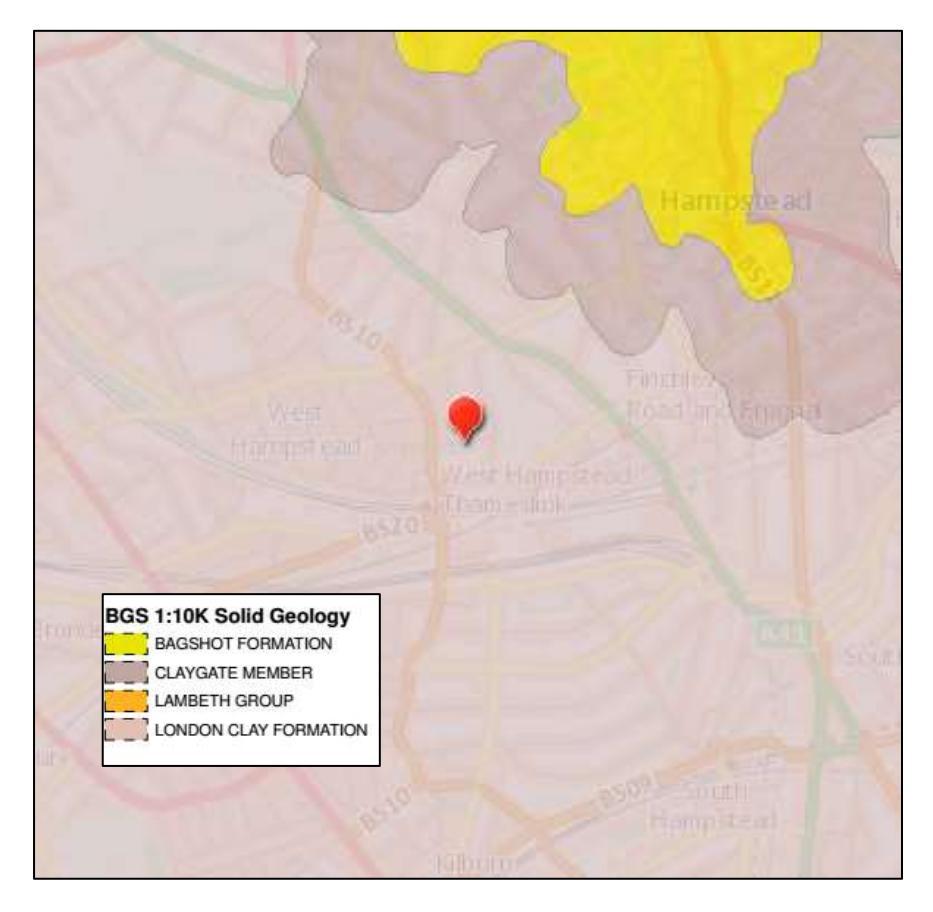
The 1:50000 Geological Survey of Great Britain (England and Wales) covering the area is detailed in Figure 3 below and indicates the site to be underlain by the London Clay Formation. Deposits of the overlying Claygate Member are indicated to approximately 500m to the north-east of the site.

Figure 3. Geology of the Site (Ref. BGS Geoindex)

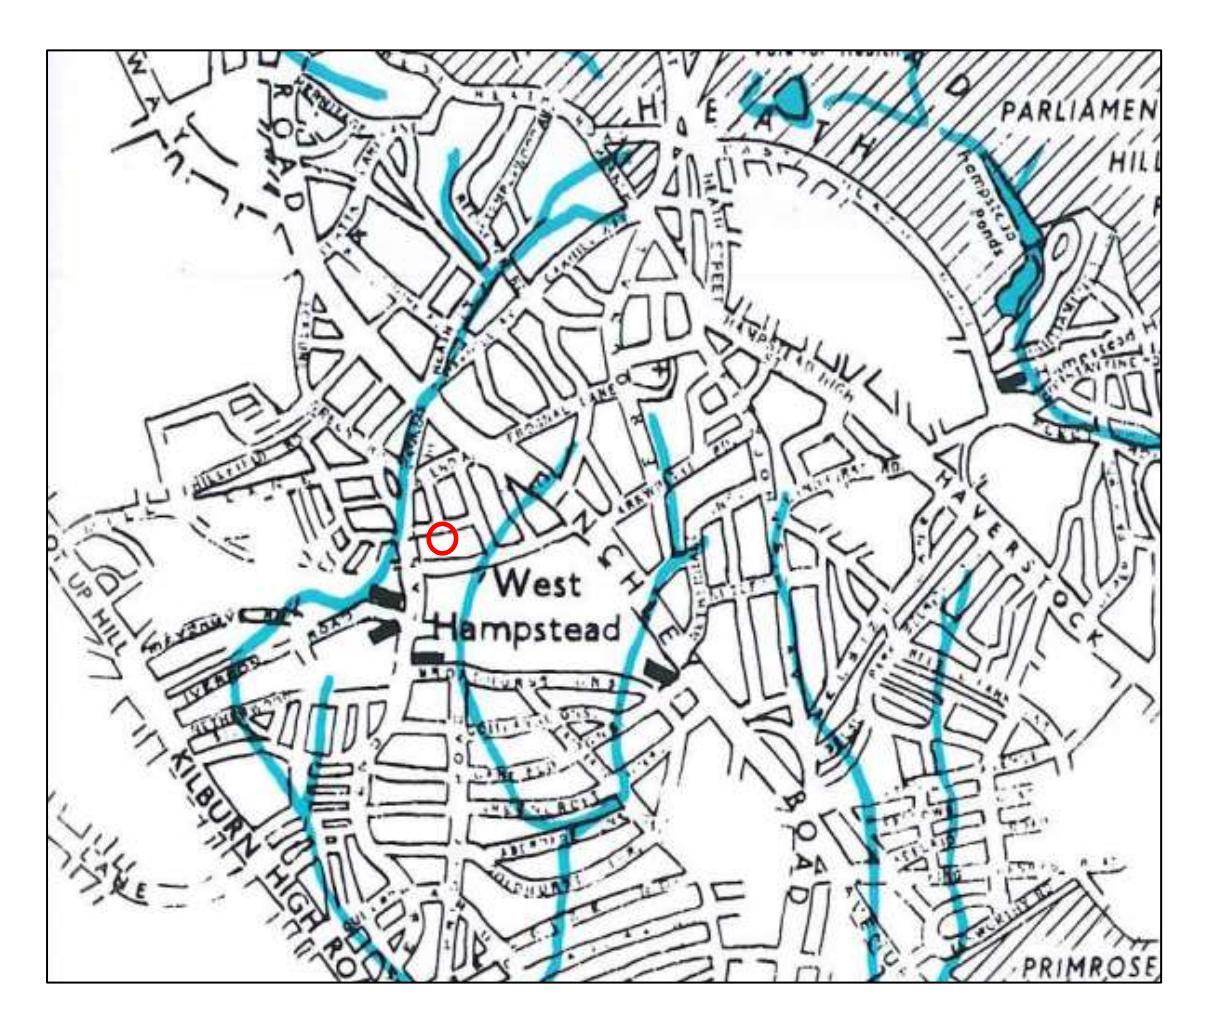
With reference to Camden Geological, Hydrogeological and Hydrological Study (1999), Talling (2011) and Barton (1992) springs that sourced tributaries of the 'lost rivers' River Westbourne were located approximately 120m east and 105m west of the site respectively (Figure 4).

Figure 4. Location of site (circled) relative to the 'Lost Rivers' of London (Source: Barton, 1992)

| Item | Description | Response | Comment |
|---|---|---|--|
| | 5. Is the lowest point of the proposed excavation (allowing for any drainage and foundation space under the basement floor) close to, or lower than, the mean water level in any local pond or spring line. | No | Envirocheck indicates that there are no surface water features within 1 kilometre of the site. According to publications regarding Lost Rivers of London (Barton, 1992) and (Talling, 2011) and Stanford (1868) the site is not within 100m of a 'Lost River' with the closest being a tributary to the River Westbourne 105m west (Figure 4). |

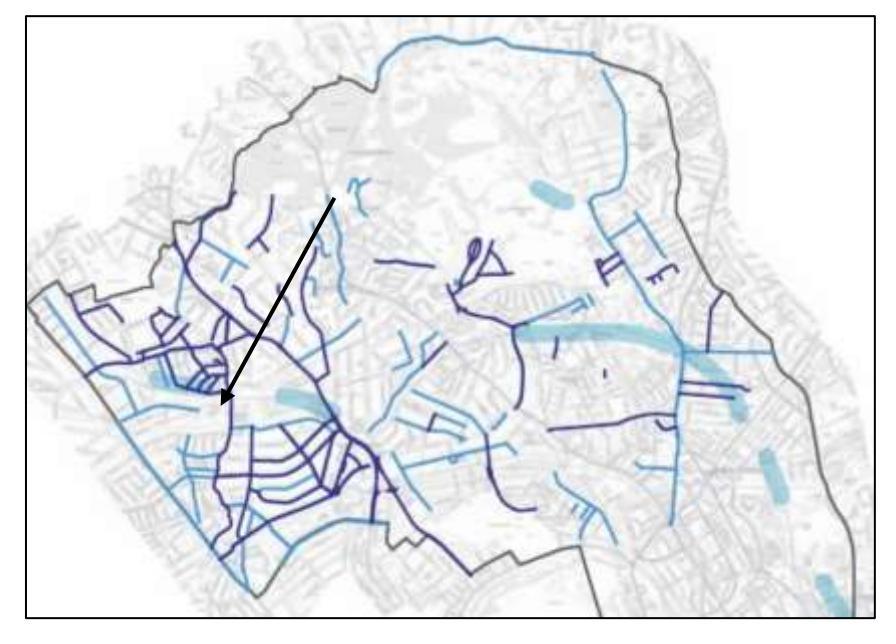
Figure 5 shows that Fawley Road didn't flood during either the 1975 or 2002 flood events.

Figure 5. Exact from Figure 15 of the Camden CPG4 showing roads which flooded in 1975 (light blue), in 2002 (dark blue) and 'areas with potential to be at risk from surface water flooding' (wide light blue bands)

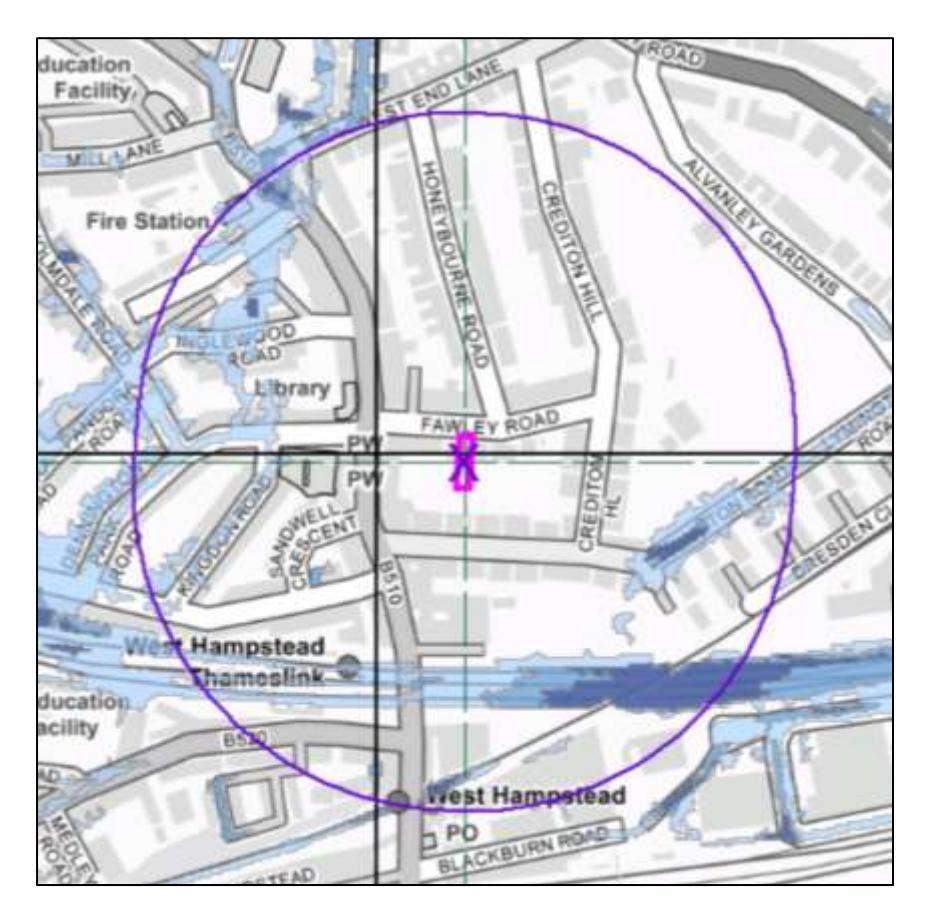
Further modelling of surface water flooding has been undertaken by the Environment Agency and was published on its website in January 2014; an extract from their model is presented in Figure 6. Whilst this map identifies four levels of risk (high, medium, low and very low) it is understood that it is based at least in part on depths of flooding. This modelling shows a 'Very Low' risk of flooding (the lowest category for the national background level of risk) for No.8a and the surrounding area.

Figure 6. Extract from the Environment Agency's 'Risk of Flooding from Surface Water'. Ordnance Survey Crown copyright 2015. All rights reserved.

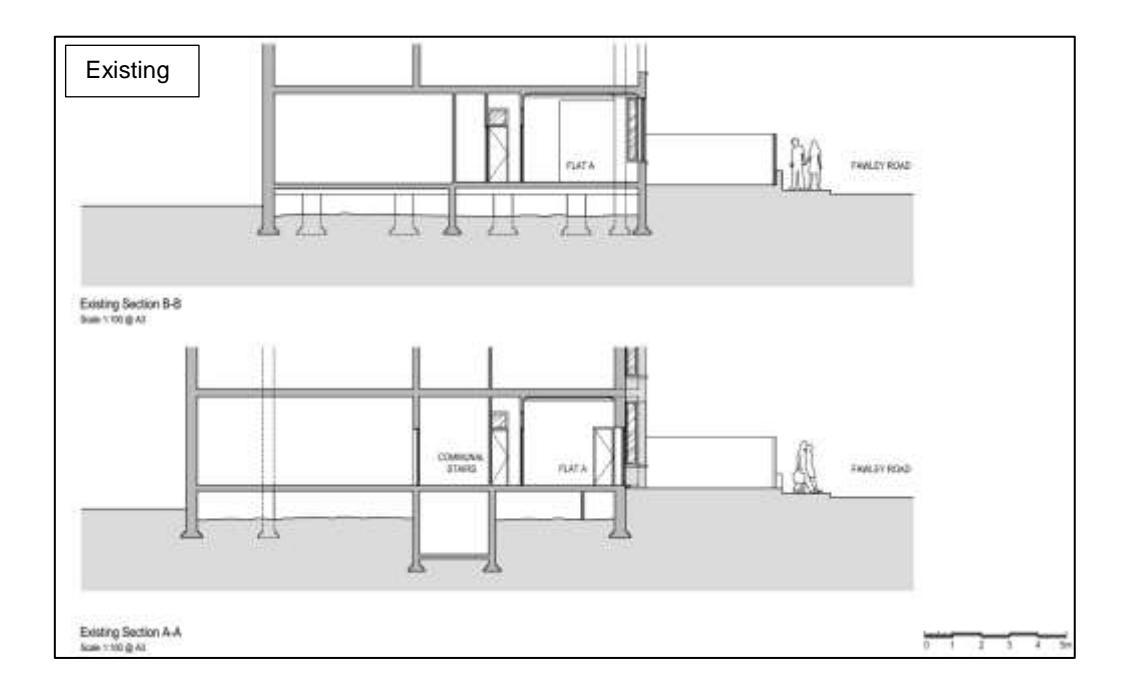
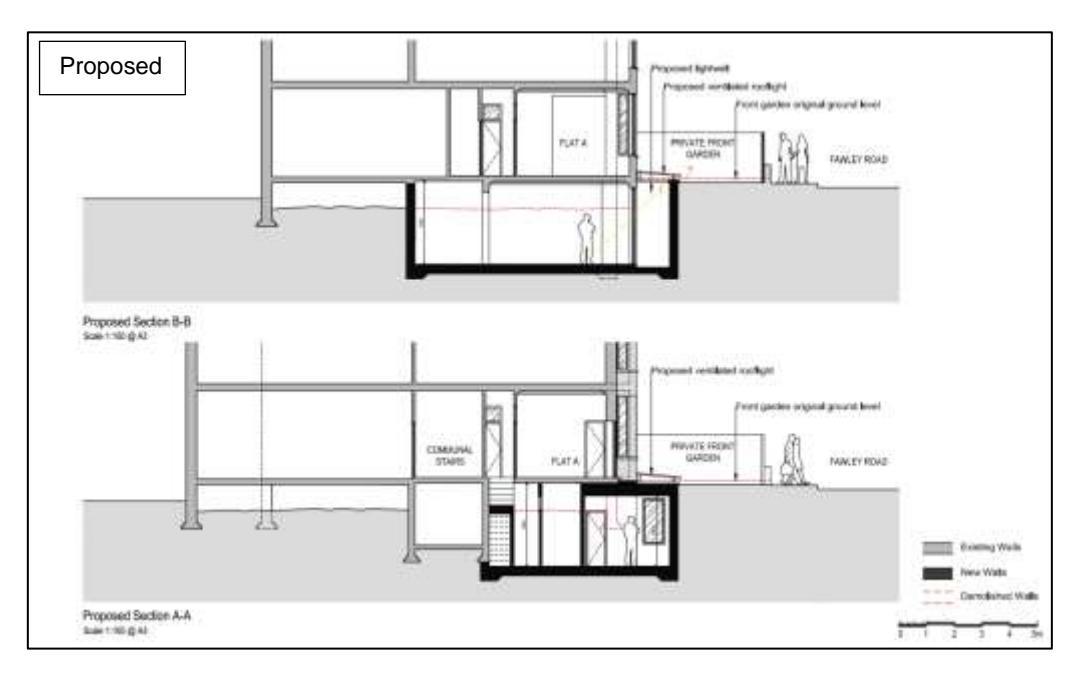
It is proposed to construct a single storey basement beneath the front half of the existing property with a front light well. It is understood that the proposed basement of approximately 3.5m below ground level.

Sections showing the proposed developments are detailed in Figure 7 below.

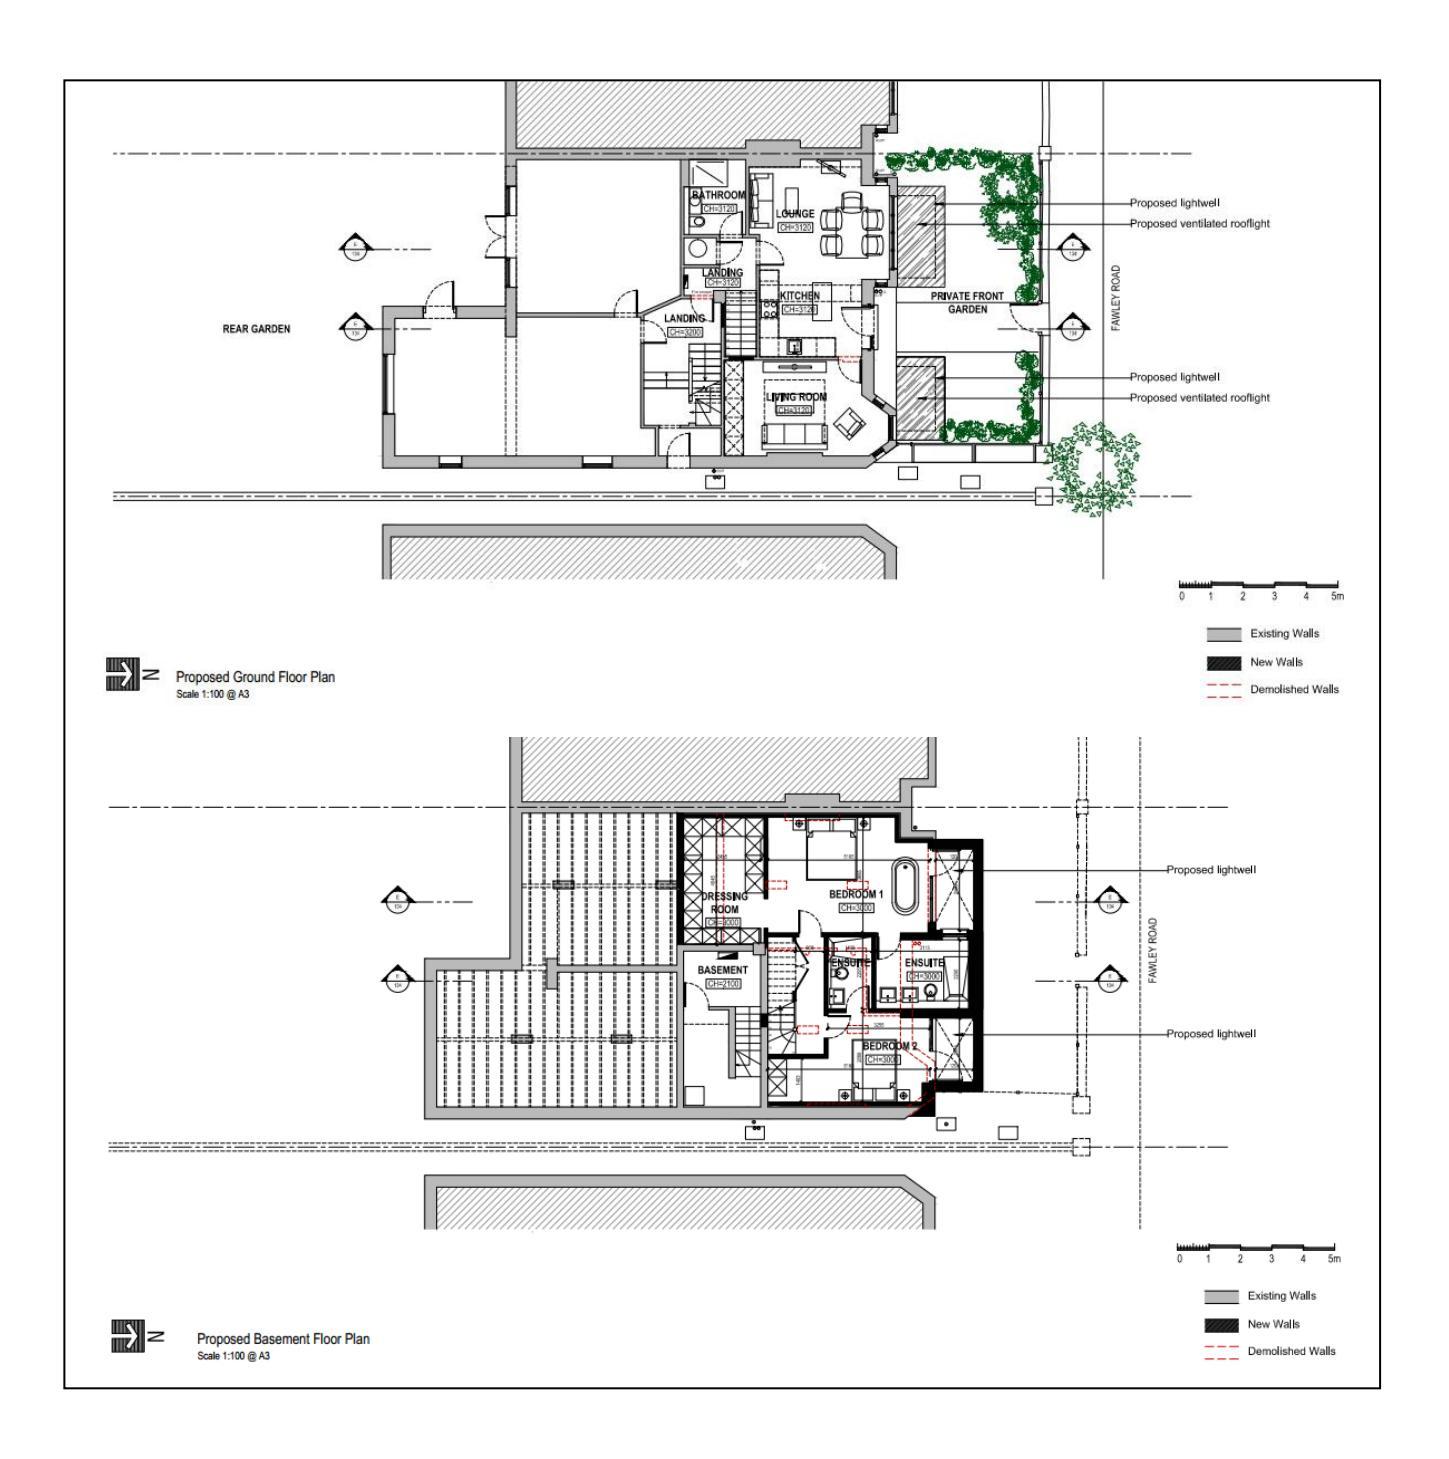
| Δ | Site A | Site Analytical Services Ltd. | | | | | | | | |
|---|---|---|---|---|---|--|--|--|--|--|
| SAS | LOCATION: | 8a Fawley Road, London, I | VW6 1SH | | FIG: 2 | | | | | |

| Δ | Site A | Site Analytical Services Ltd. | | | | | | | | |
|---|---|---|---|---|---|--|--|--|--|--|
| * | TITLE: | Proposed Site Plan | DATE: | Nov' 2019 | SCALE: NTS | | | | | |

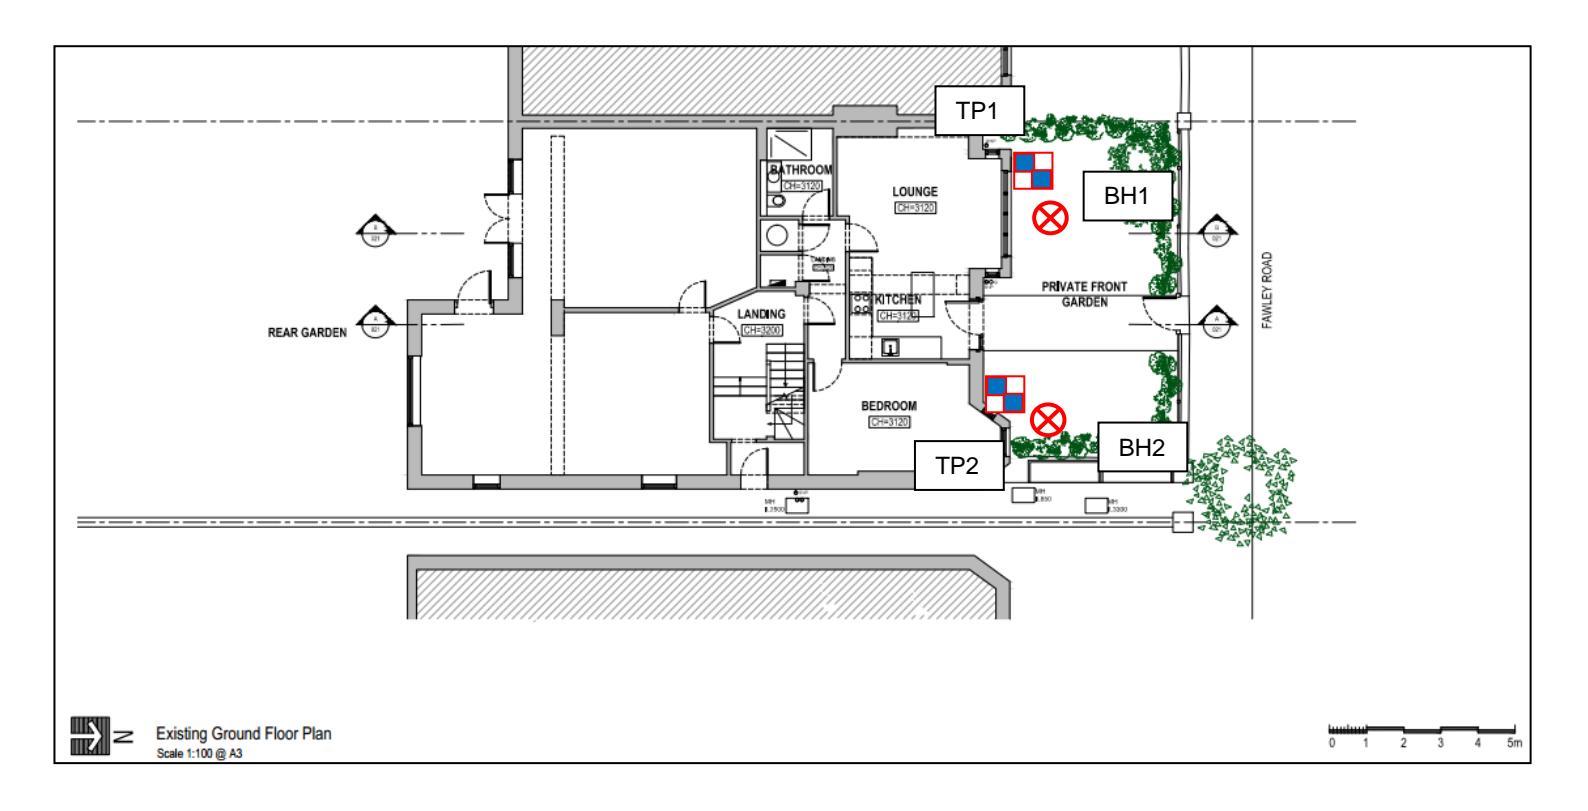
| ٨ | Site A | nalytical Sei | vices | Ltd. | REF: 19/30896-1 |
|---|---|---|---|---|---|
| sAs | LOCATION: | 8a Fawley Road, London, | NW6 1SH | | FIG: 1 |

| ٨ | Site A | nalytical Sei | vices | Ltd. | REF: 19/30896-1 |
|---|---|---|---|---|---|
| * | TITLE: | Site Sketch Plan | DATE: | Nov' 2019 | SCALE: NTS |
