# DESK STUDY, GROUND INVESTIGATION, BASEMENT IMPACT ASSESSMENT & GROUND MOVEMENT ASSESSMENT REPORT

35 TEMPLEWOOD AVENUE LONDON NW3 7UY

Report Title: Geotechnical Desk Study, Ground Investigation, Basement Impact Assessment & Ground Movement Assessment for 35 Templewood Avenue, London, NW3 7UY

Job No: P1019J1129

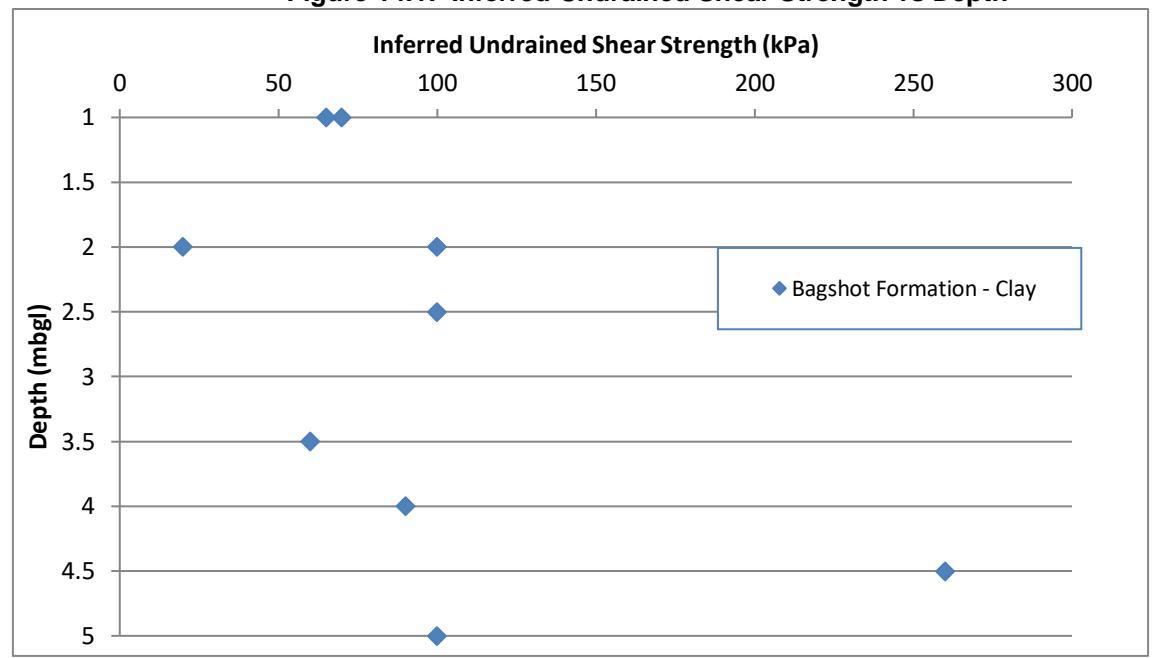
Figure 14.1: Inferred Undrained Shear Strength vs Depth

- 14.3.2 The f<sub>1</sub> constant is dependent on the plasticity of the material. For the Bagshot Formation -Clay the plasticity index has been shown to average 25% and therefore a value of 5 has been adopted.
- 14.3.3 The graph below shows the shear strength profile of the Bagshot Formation Clay encountered at the site, based on the SPT to shear strength correlation described above.

14.3.4 An SPT 'N' value of 22 was reported for the layer of Bagshot Formation - Sand at 3.50mbgl. This is slightly higher than the values recorded in the clay at around the same depth.

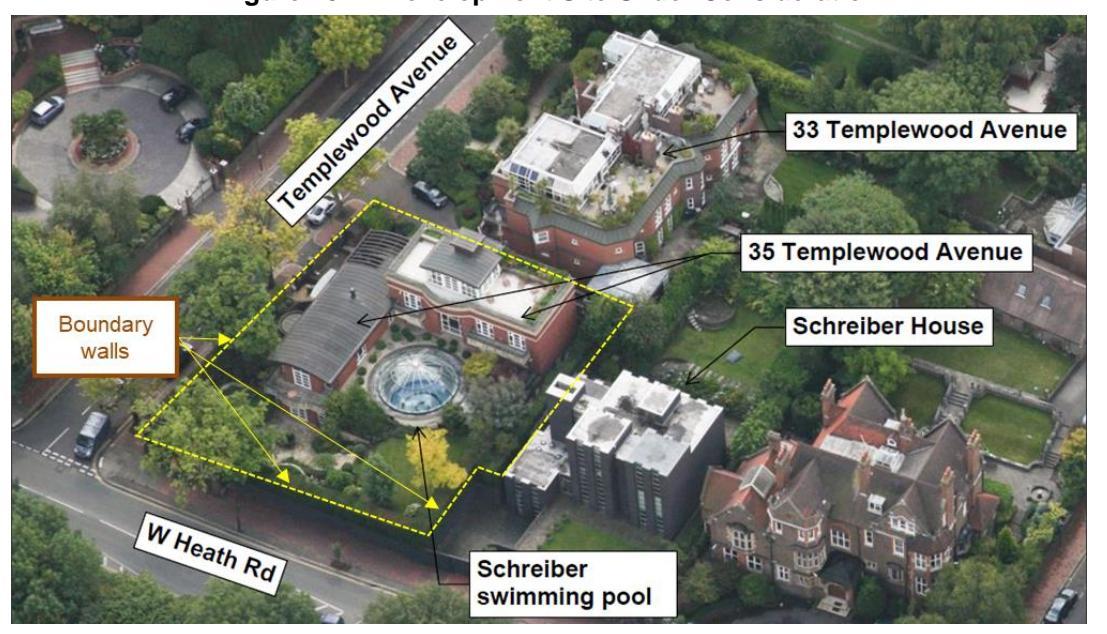
Figure 16.1: Development Site Under Consideration

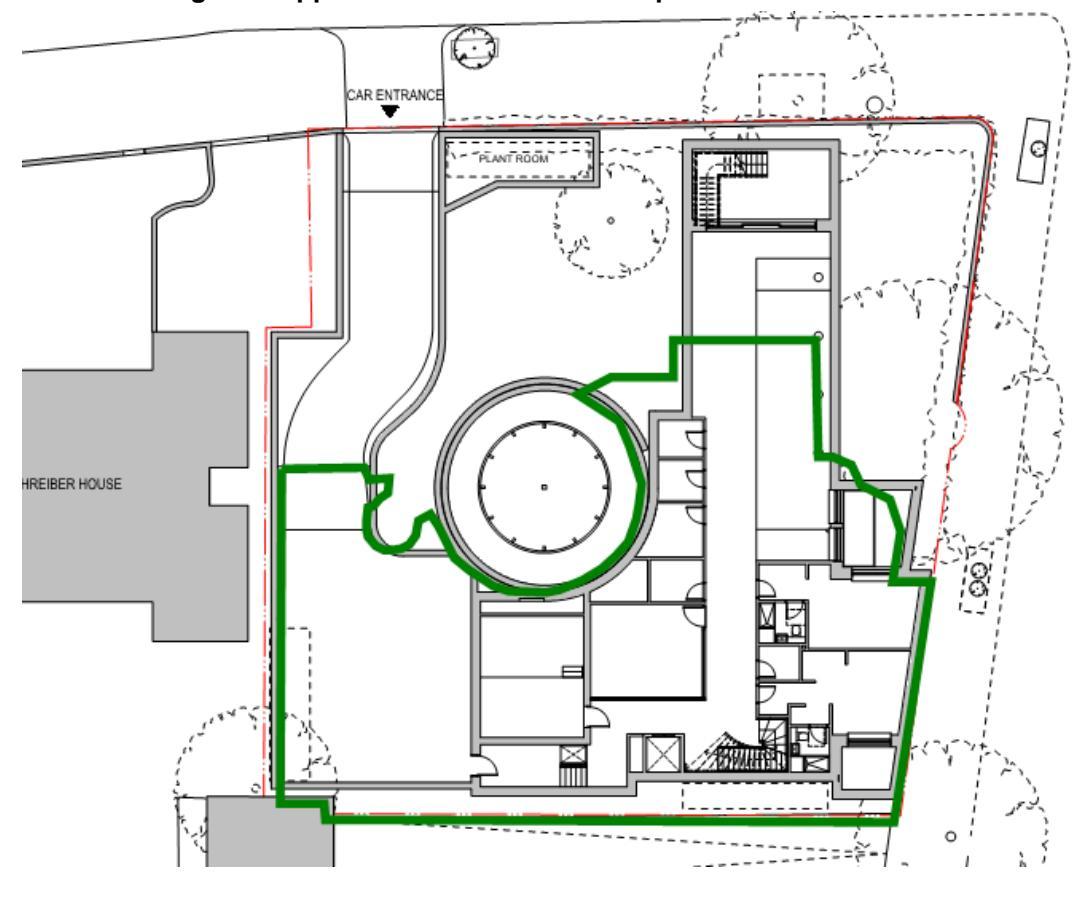
Figure 16.2: Proposed lower ground floor plan. Approximate outline of existing ground floor marked in green. Approximate Basement 2 footprint indicated with dashed lines.

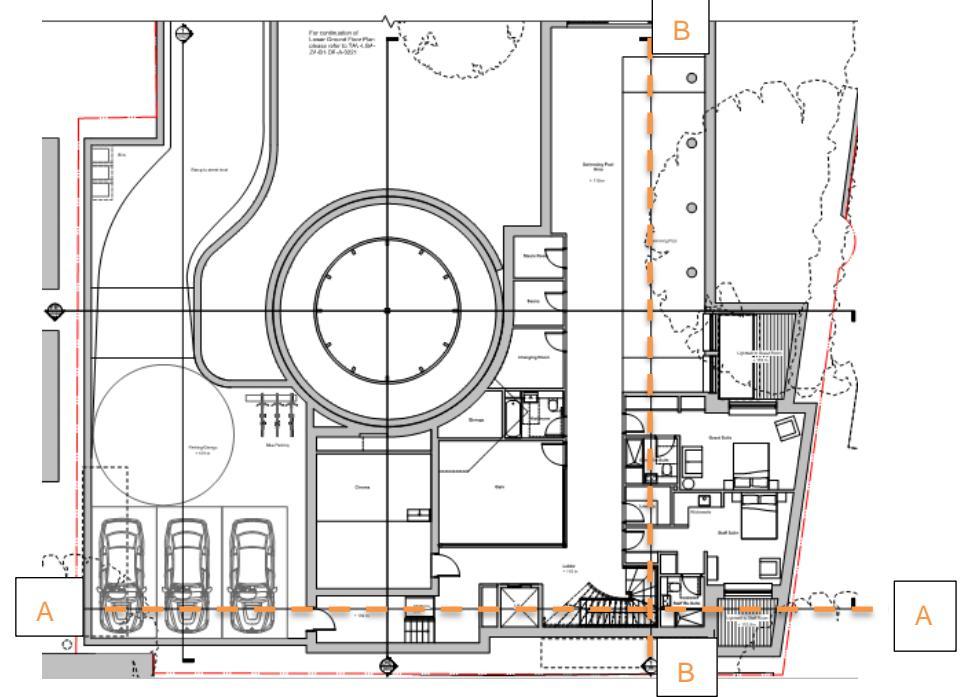
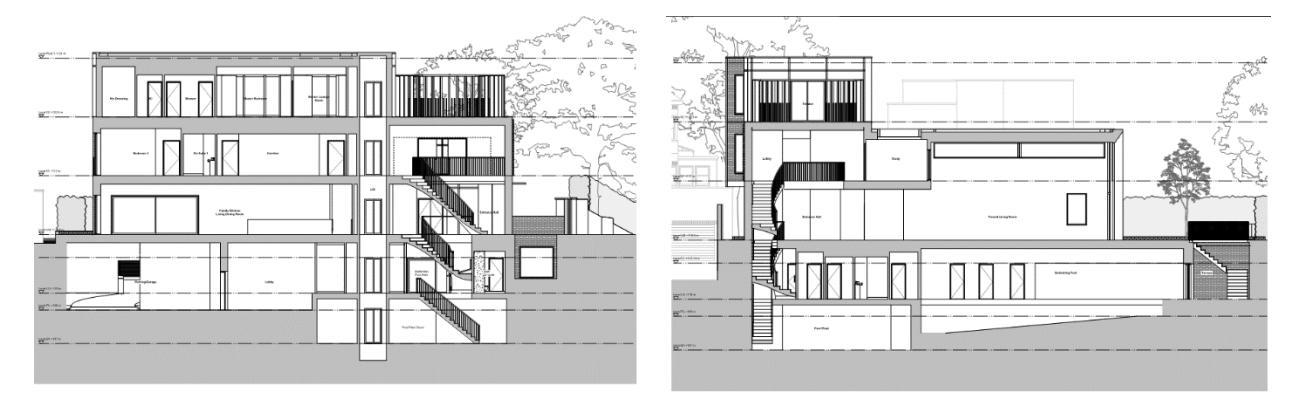
# Figure 16.3: Plan view of the proposed ground floor and key cross sections.

(a) Proposed scheme ground level plan

(b) Proposed section A-A

(c) Proposed Section B-B

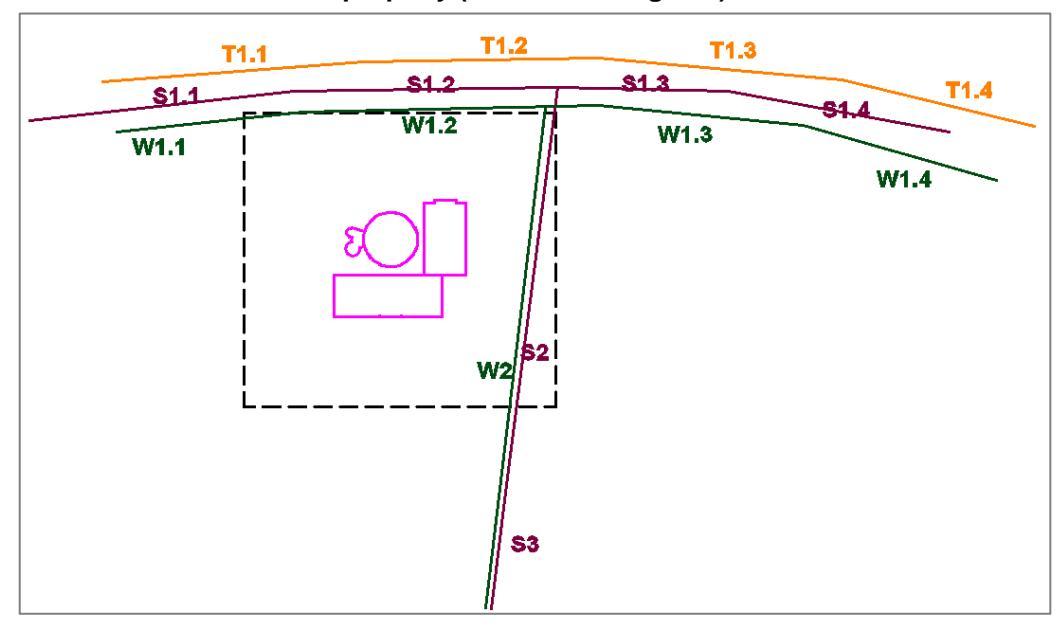
# Figure 16.4: Location of the TW assets with respect to the existing 35 Templewood Avenue property (outlined in magenta)

16.3.1 Thames Water (TW) assets are present adjacent to the Site. The assets comprise a number of sewers and water mains. Details relating to these utilities are summarised in Figure 16.4 and Table 16.1. Their relative locations are based on the currently available survey information and the Thames Water Asset Search Location Map.

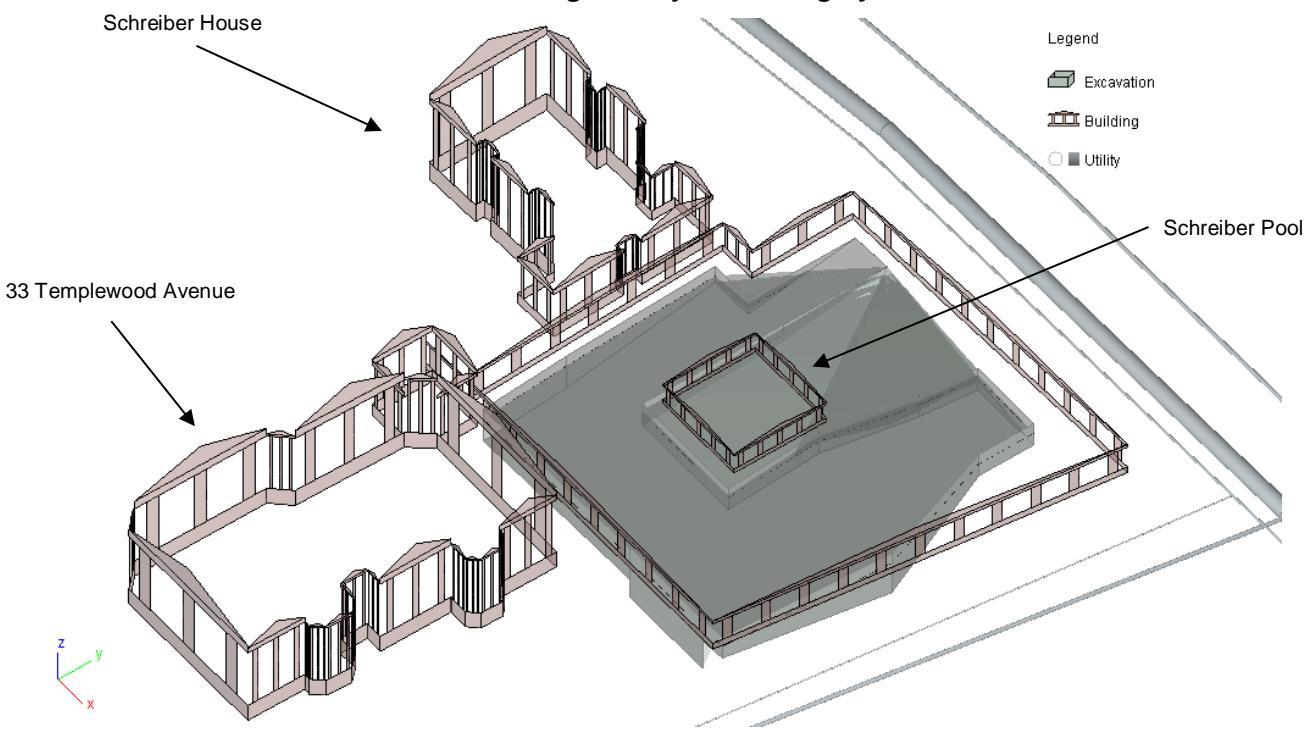
# Figure 16.6: Indicative plot of the three-dimensional analytical model produced using the Oasys software suite (soil and Thames Water assets removed for clarity of presentation). Simplified excavation geometry shown in grey.

- 16.4.4 A series of three-dimensional models of the proposed scheme have been developed in both software packages outlined previously and have been combined by means of superposition to represent the various ground displacement fields summarised above.
- 16.4.5 An indicative plot of the analytical model is presented below in Figure 16.6. The model includes a number of conservative simplifications relating to the geometry of the proposed scheme and topography/geomorphology. These have been adopted in an effort to overcome the limitations of the software used for the purposes of this assessment, which represents current industry best practice means and methods.

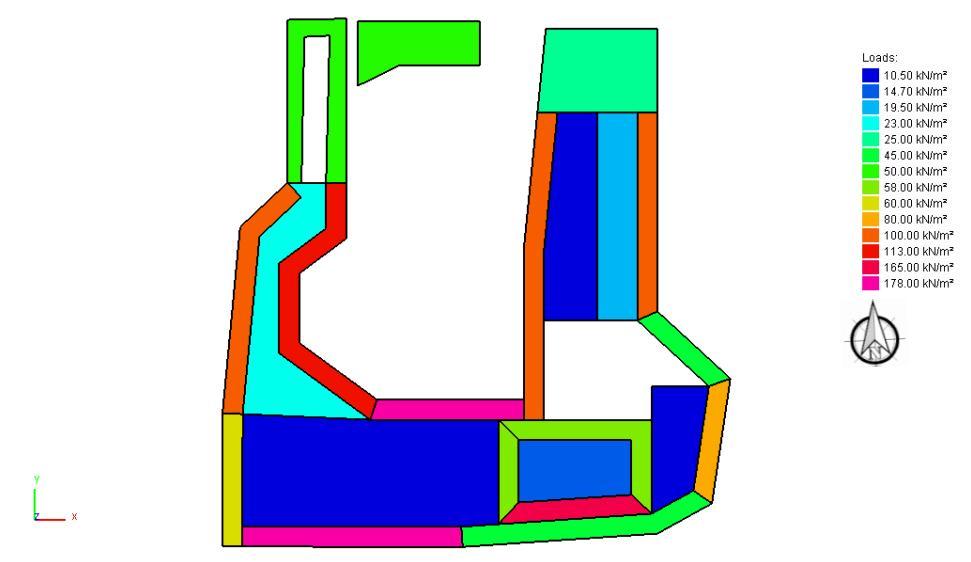
Figure 16.7: Idealised long-term loading regime modelled in Pdisp

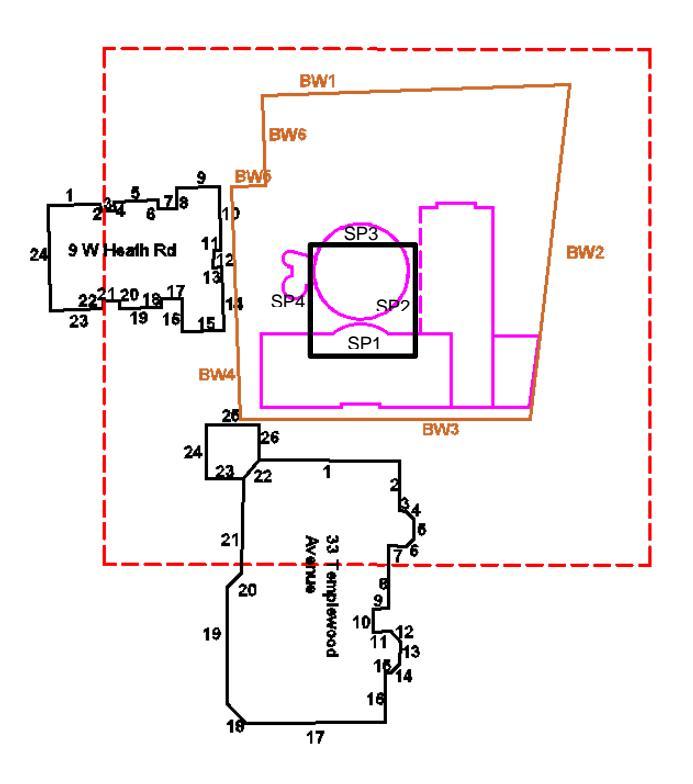
Figure 16.8: Nomenclature for building façades/masonry wall elements/Shreiber pool (black), existing 35 Templewood Avenue property (magenta), boundary walls (brown) and excavation zone of influence (dashed red).

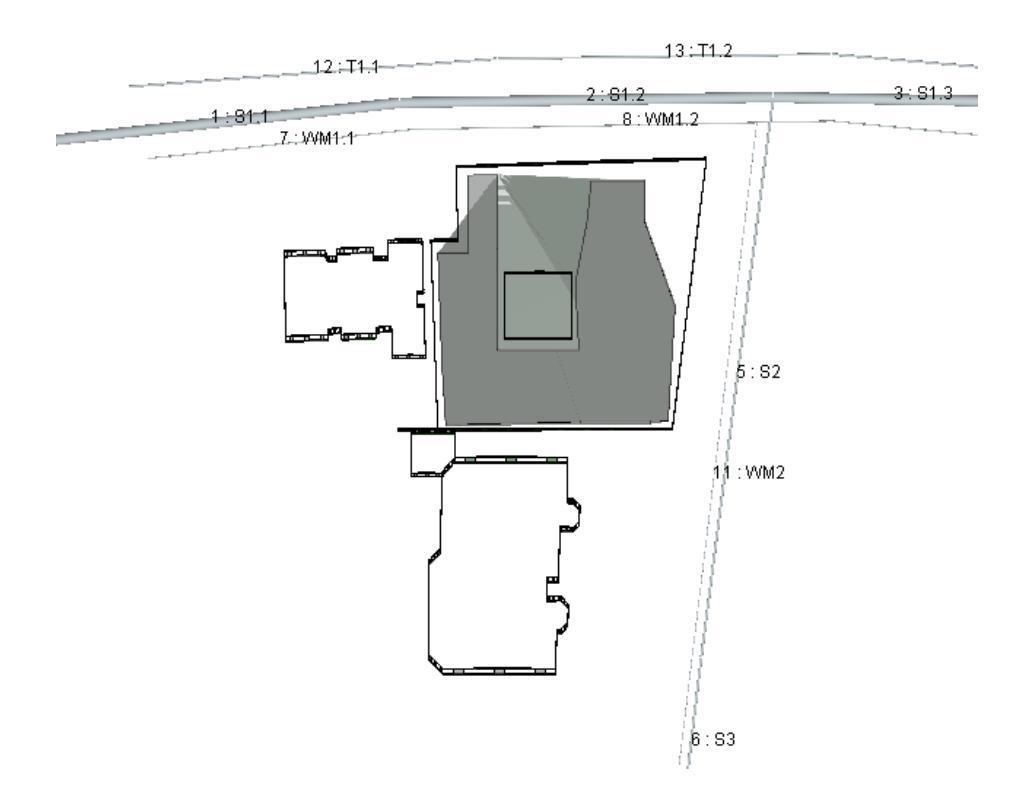
### Figure 16.9: Xdisp model indicating the proposed excavation works and the TW assets analysed

16.6.7 The potential impact induced on the adjacent Thames Water assets has been evaluated on the basis of the calculated ground movement field. The same methodology has been followed for the Thames Water assets (Method 1 and Method 2), using XDISP to conduct the utility damage assessment. Figure 16.9 shows the Xdisp model geometry, which considers a simplified excavation area as previously discussed in Figure 16.6.

- 16.6.8 Details of the material and size of each asset were input in accordance with Table 16.1 for XDISP to calculate curvature, compressive and tensile strains due to the assessed movements. All utilities were assumed to be near surface assets.

- 16.6.9 A maximum allowable tensile strain of 500με has been used for masonry sewer (S1). For the assumed concrete sewer (S2 & S3), an allowable limit of 3mm has been used for pull-out checks, 2° for rotation checks and 40με and 400με for tensile and compressive strain checks, respectively.

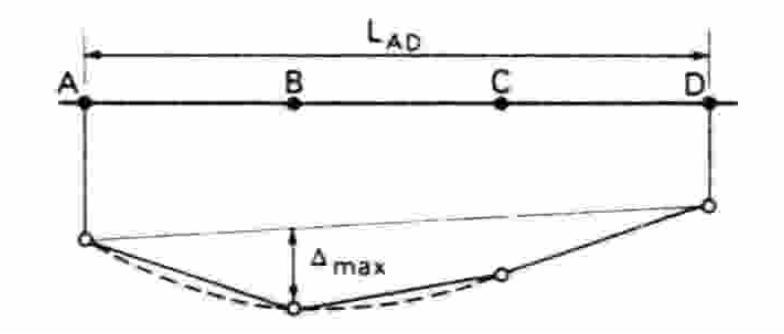
Figure 16.10: Definition of relative deflection  $\Delta$  and deflection ratio  $\Delta$ /L.

Burland (1997) damage classification method, as presented and summarised in Table 16.3 & Figure 16.10.

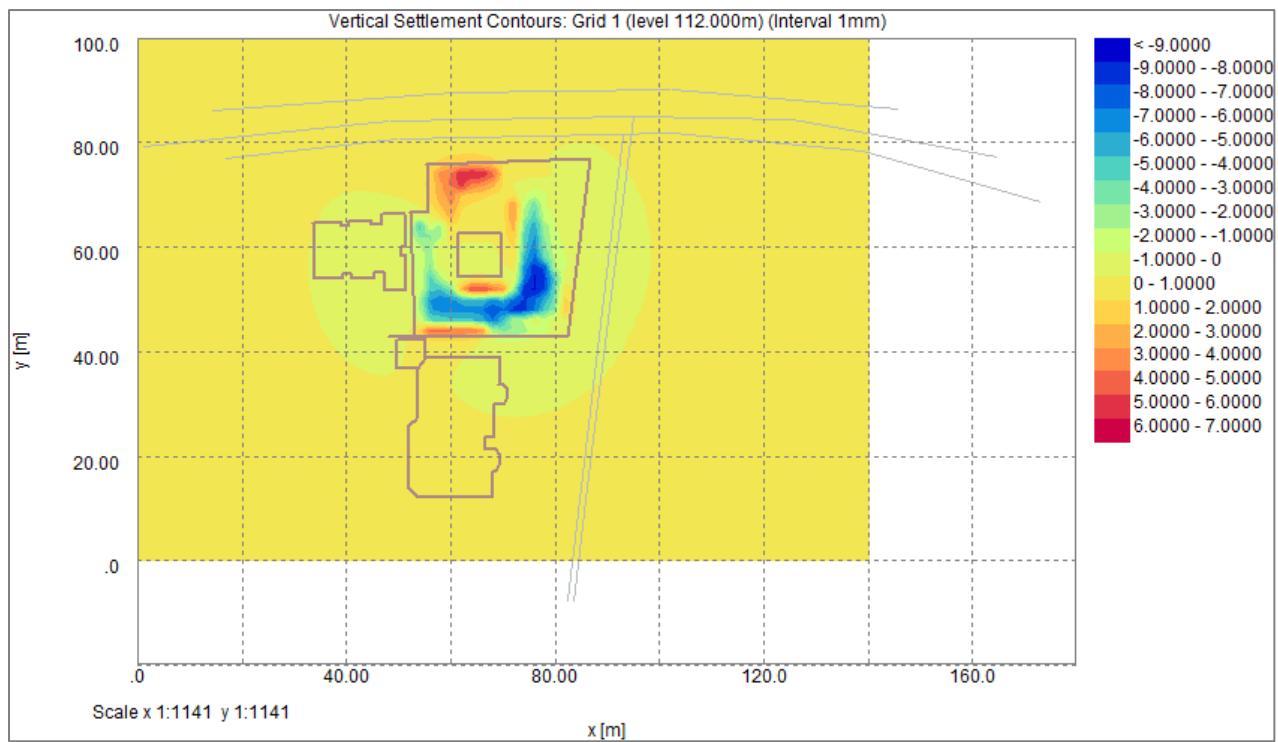
Figure 16.12: Vertical Movement – Method 1 Long-term

Note: In the contour plots, a positive (+) sign in vertical movement indicates settlement and a negative (-) sign indicates heave.

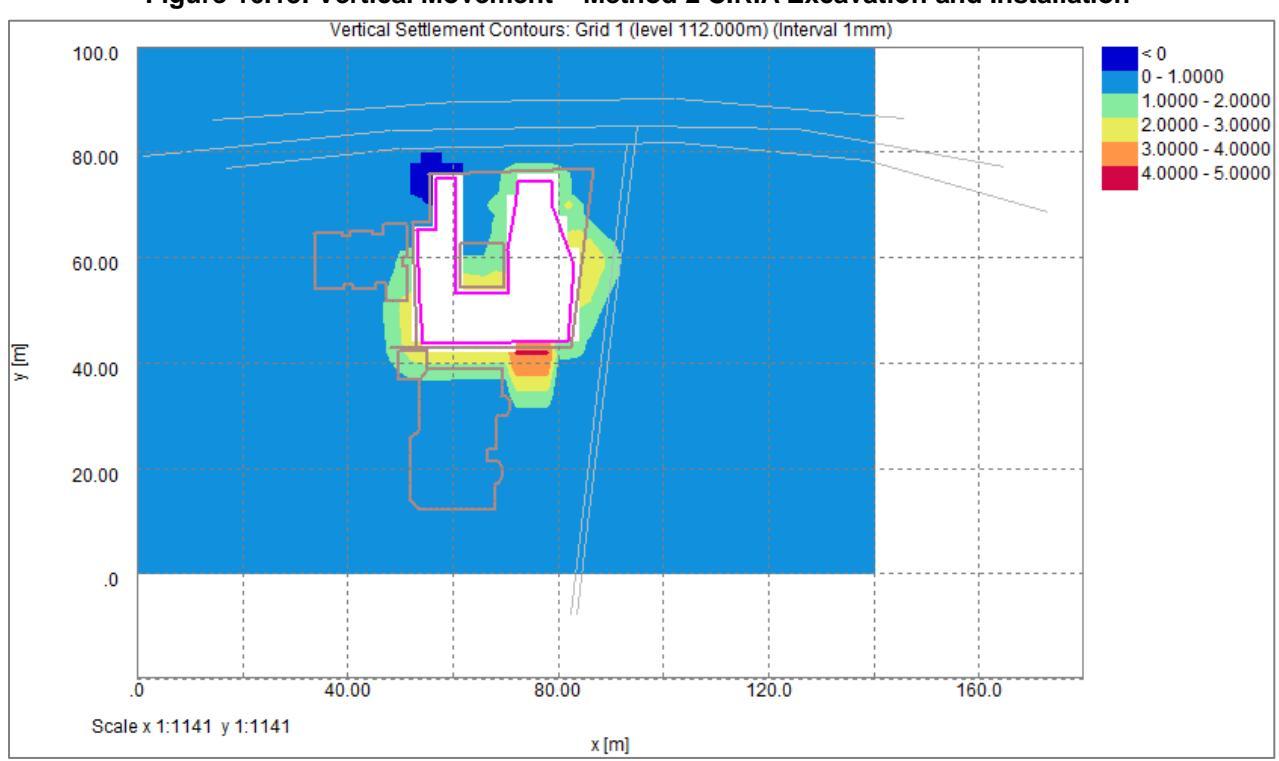
## Figure 16.13: Vertical Movement – Method 2 CIRIA Excavation and Installation

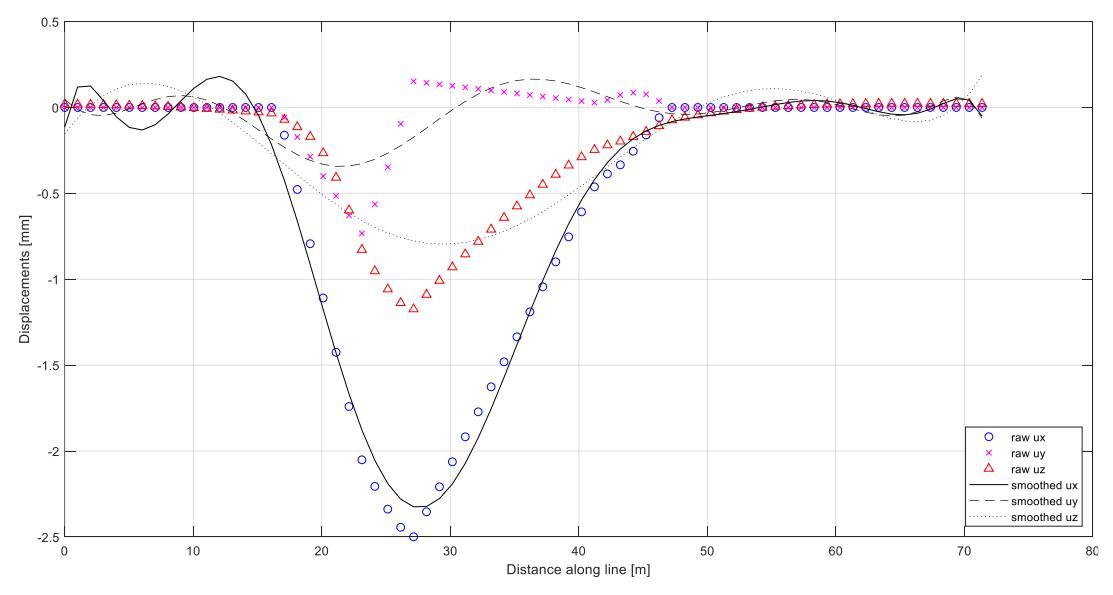
# Figure 16.15: Raw and smoothed deflection profiles of Sewer S2 – Method 2 CIRIA Excavation and Installation

16.8.3 In light of the above, a smoothing exercise has been undertaken to evaluate more realistic deflections. This was undertaken by adjusting polynomial curves to the raw deflection data shown in Figure 16.15. The resulting smoothed deflection profiles were imported in XDISP and the strains were re-calculated. The strain plots resulting by the raw and smoothed deflection profiles are depicted in Figure 16.16 and Figure 16.17, respectively.

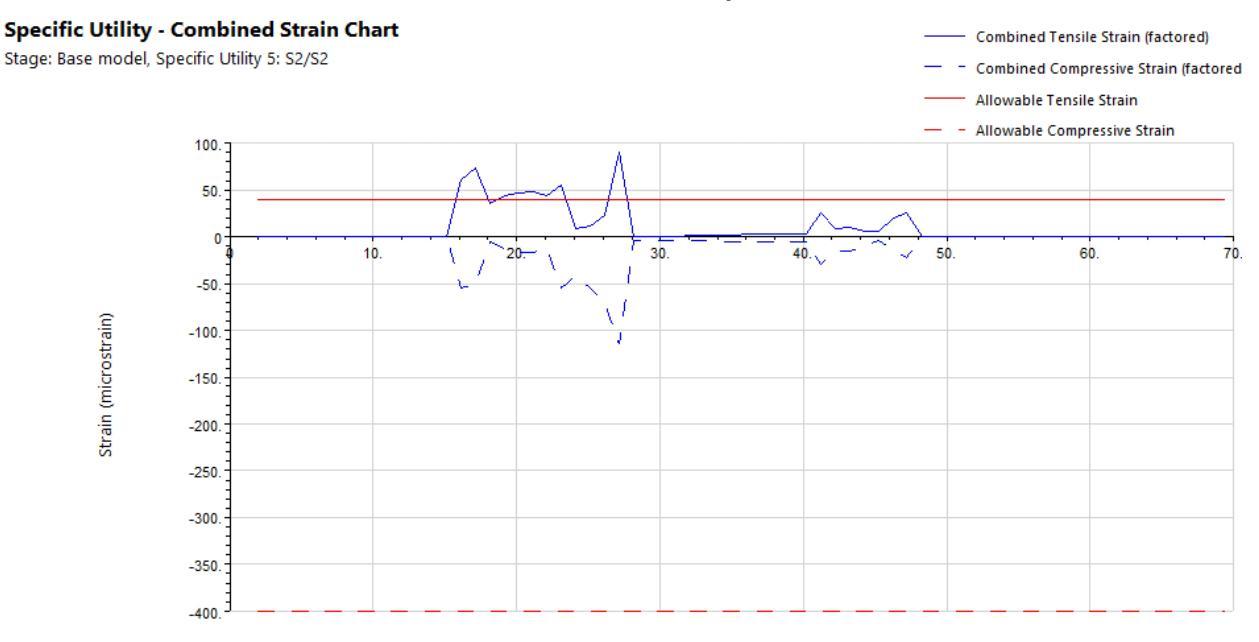
# Figure 16.16: Combined strain profile of Sewer S2 – Method 2 CIRIA Excavation and Installation - based on raw deflection profile

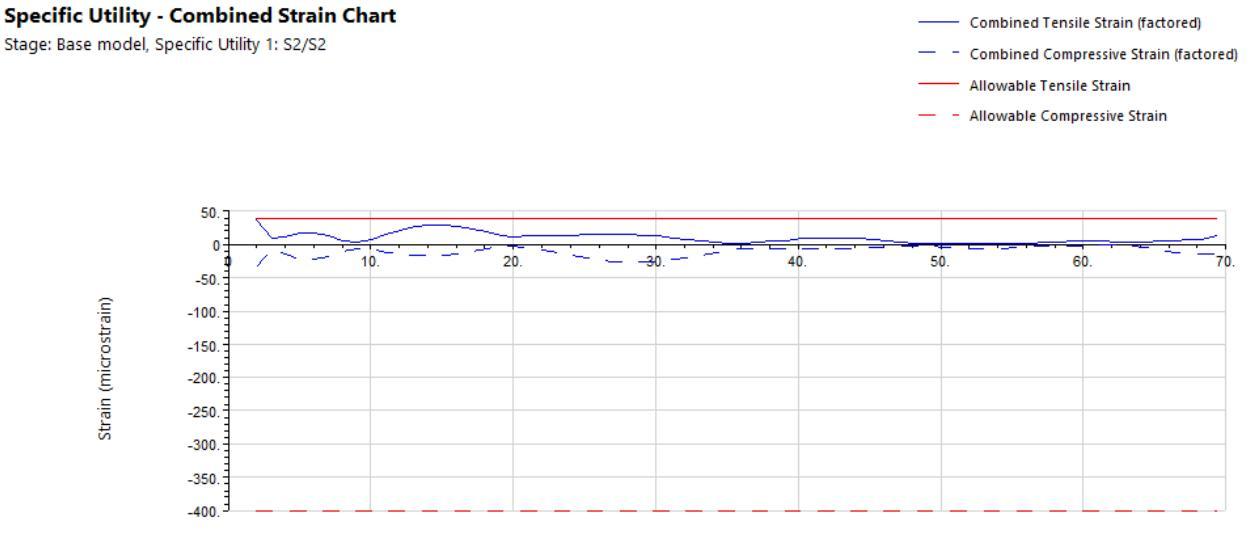
# Figure 16.17: Combined strain profile of Sewer S2 – Method 2 CIRIA Excavation and Installation - based on smoothed deflection profile

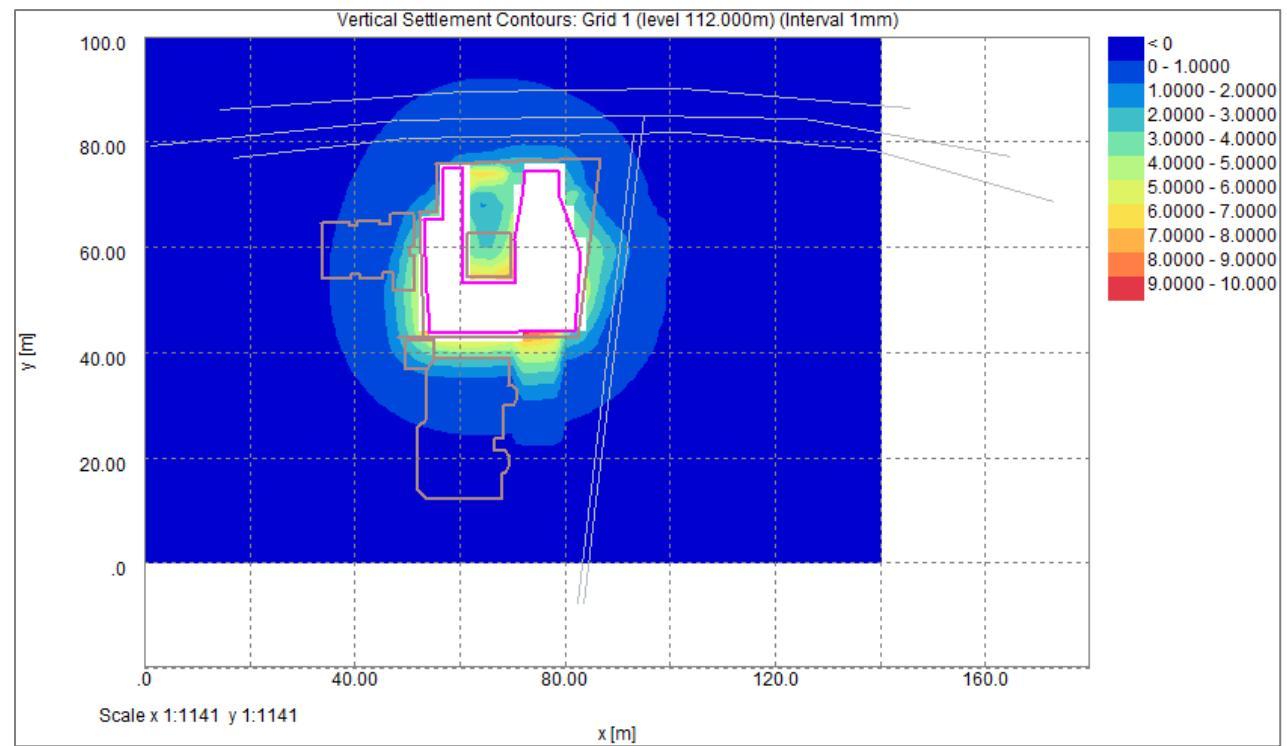
Figure 16.18: Vertical Movement – Method 2 – CIRIA curves + Long-term loading

16.8.4 The horizontal movements at this stage are the same as the previous stage (Figure 16.14) since the movements of the PDISP long-term movements are only vertical movements (settlement). The figure below shows the cumulative vertical movements of XDISP using CIRIA curves and the PDISP Long-term loading.

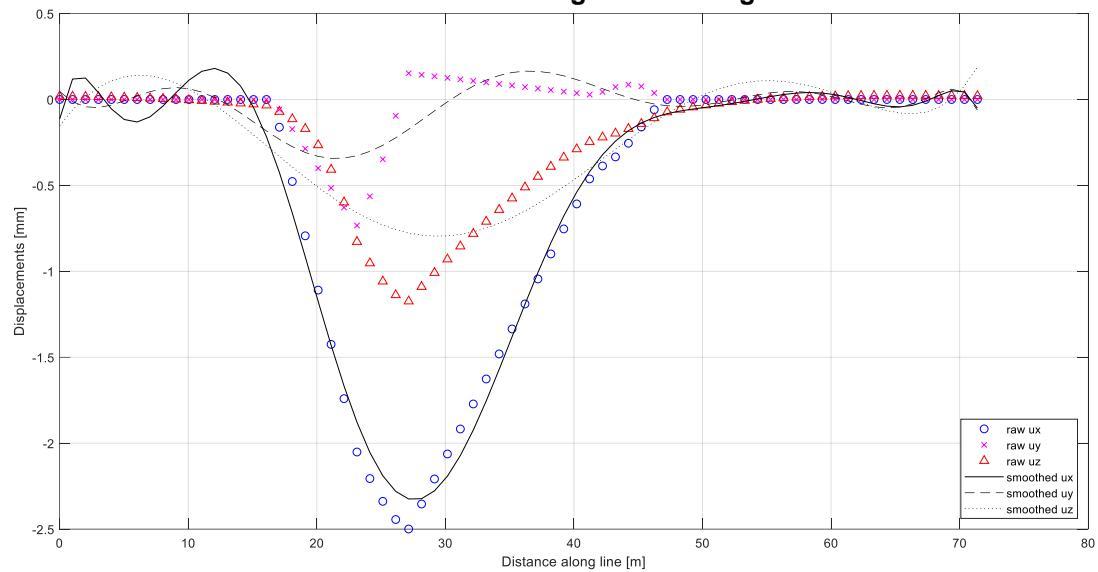
Figure 16.19: Raw and smoothed deflection profiles of Sewer S2 – Method 2 CIRIA Excavation and Installation + Long-term loading

deflection profiles are shown Figure 16.19. The combined strains of Sewer S2 resulting from both raw and smoothed deflection profiles are presented in Figure 16.20 and Figure 16.21.

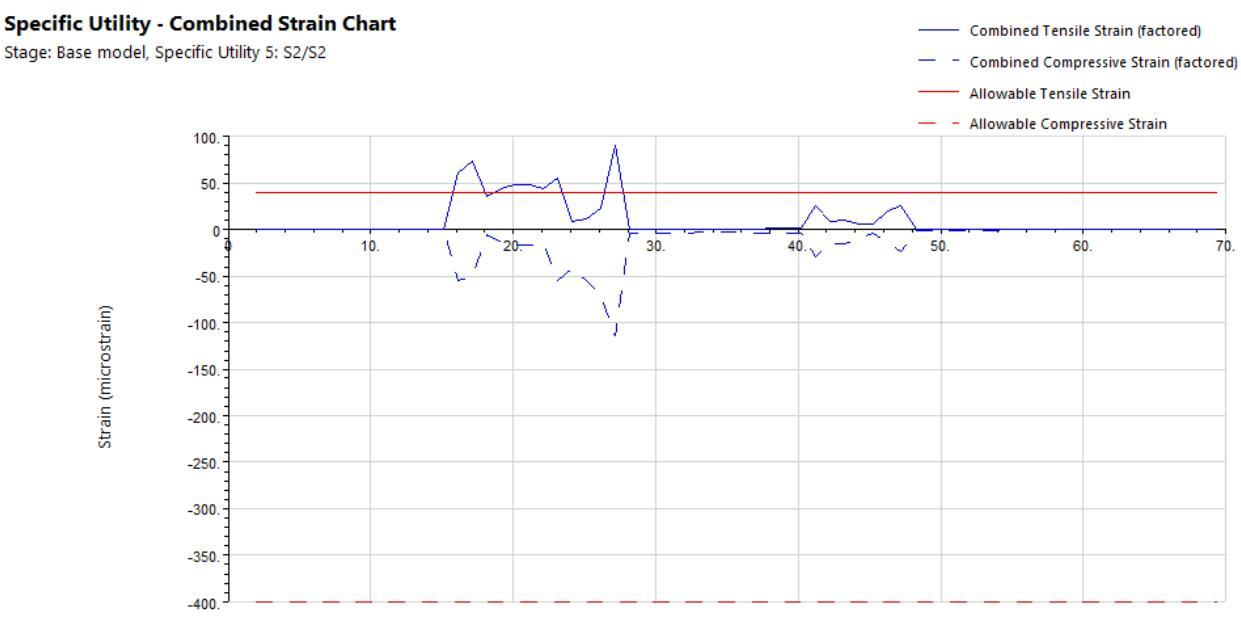
Figure 16.20: Combined strain profile of Sewer S2 – Method 2 CIRIA Excavation and Installation + Long-term Loading - based on raw deflection profile

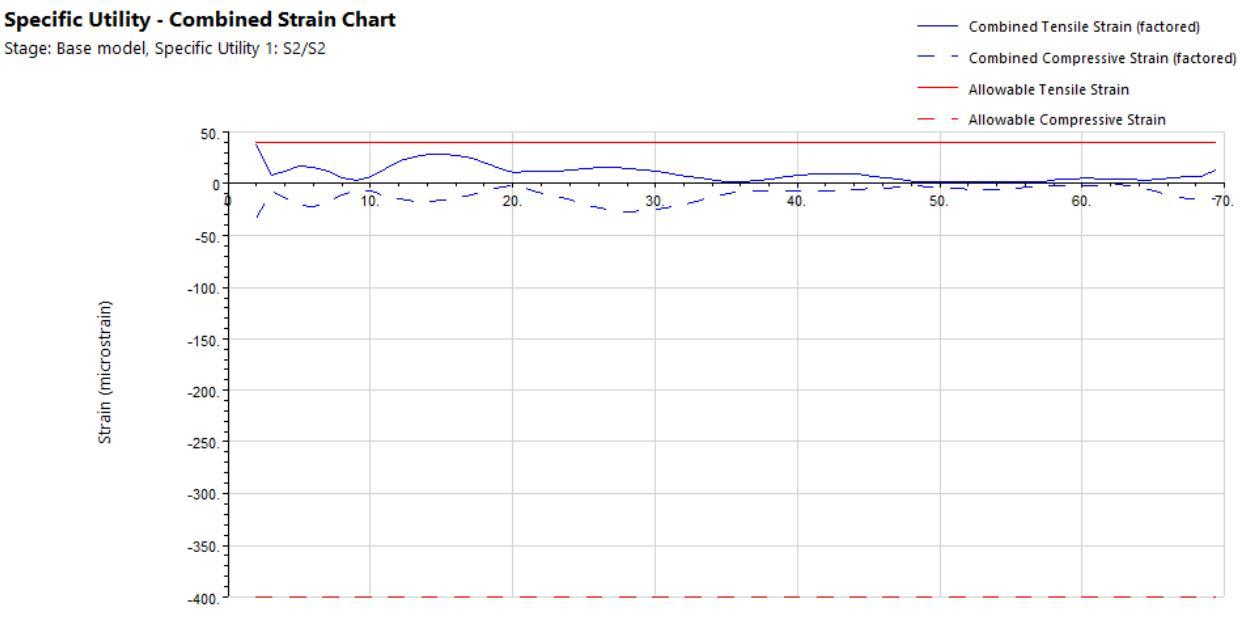
# Figure 16.21: Movement profile of Sewer S2 – Method 2 – CIRIA curves + Long-term loading – based on smoothed deflection profile
