DR WILLIAMS'S LIBRARY - 14-15 Gordon Square, London DESIGN & ACCESS STATEMENT | SEPTEMBER 2021 8555-CPM- ZZ-ZZ-RP-A-10003_P04

This report has been commissioned by the Trustee's of Dr Williams's Library. The document describes proposals for the refurbishment and re-ordering of University Hall, now known as Dr Williams's Library. The Library occupies number 14-15 Gordon Square, and is regarded as the pre-eminent library for the study of English Protestant Dissent. For further information on the listed asset as well as the Library and its legacy, refer to the Statement of Significance.

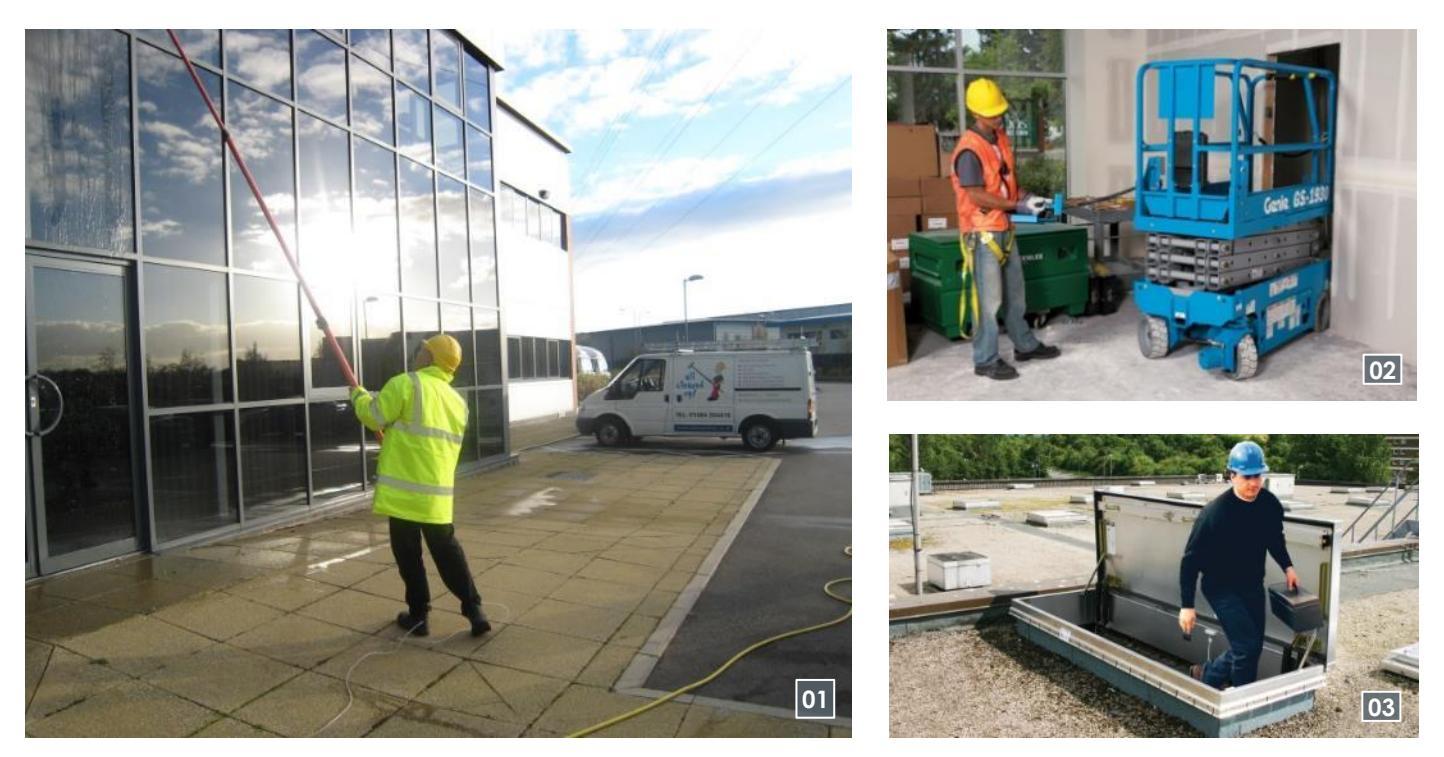
No new plant is to be placed on the existing building roof. Access to gutters for maintenance to the front and rear elevation has been made better by allowing for new access roof lights and increasing numbers. A new man safe system is to be allowed for.

External window cleaning to the existing building is currently via roped access, this strategy will remain as is, as the proposals make this no worse. To the rear of the building new areas of hardstanding will be allowed for within the landscape design to accommodate appropriate maintenance activities. Such as cleaning windows via long pole-handled brushes, which are suitable for use up to 20m.

MAINTENANCE STRATEGY: 01 Long Reach Pole 02 Vertical Access Platform 03 Roof Access Hatch

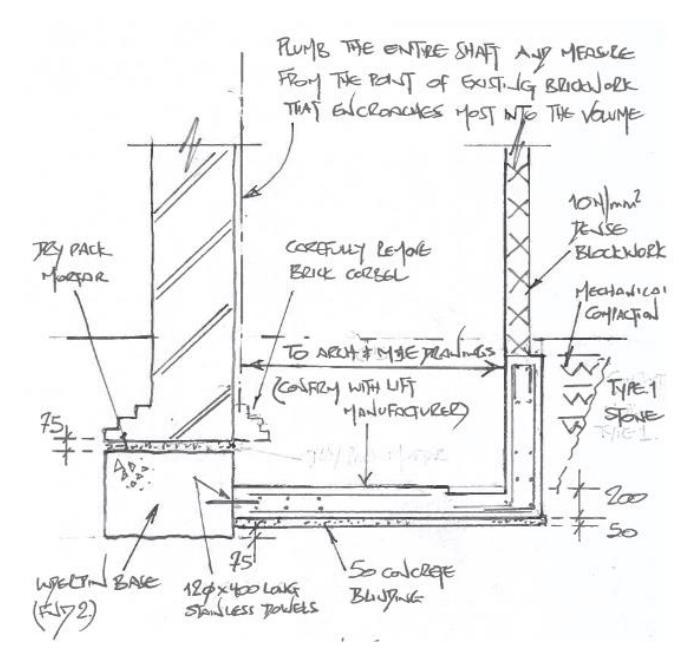
Figure 1

The new shaft will require timber joists to be cut back at all levels and re-framed with a timber trimmer around the shaft opening. Two of the shaft walls will be the existing masonry and two would be constructed in new blockwork. Tolerance will need to be allowed for any lack of verticality. Construction of the lift pit will require careful local underpinning of the existing walls (*see Figure 1*), to a depth of about 1.7m below floor level; the lift requires an overrun at the top, the opening for which will be formed by cutting-back the ceiling joists in similar manner to the floors (*see Figure 2*)

A new lift shaft is proposed for the building. The existing shaft will be retained. The location of the new shaft to the north of the core will mirror the location to the south.

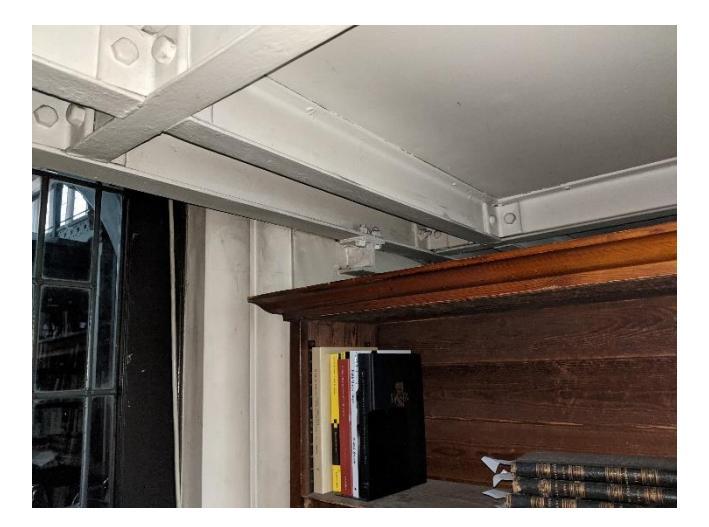
Photo 1

The iron library gallery rising from Level 4 in the front of the building, together with the open spiral stairs, are a later insertion. Whilst of interest, they also mask some of the masonry features of the original envelope (see Photo 1)

In particular, the heads of the stone arched doors and dividing screen at Level 4 are hidden. It is proposed to remove the centre section of the lower level of this two-level gallery by very carefully and neatly cutting the two parallel wrought iron beams as they span across the largest arch head. The cast iron columns and integral cast seating plates would not be affected. The system remains stable without further work. The removed section for railing will be used to return the balustrade in.

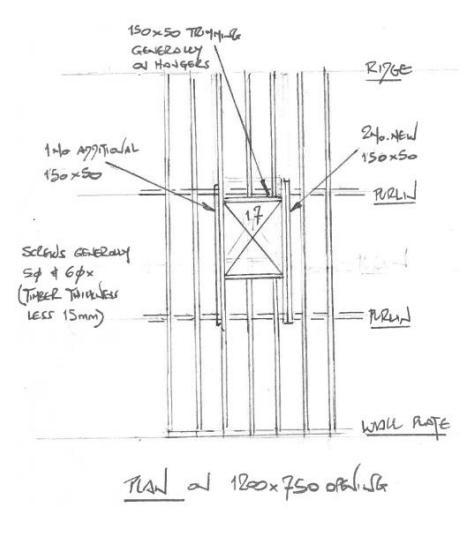
Figure 6

The proposed new openings require conventional timber strengthening to existing rafters with new timbers and local trimming to single rafters where openings are required. Locations will avoid purlins and primary structure, and coordinate with the tile locations to minimise unnecessary disturbance. (see Figure 6)

The areas of infill will require the careful dismantling of redundant ventilation dormers and placement of 100x50 rafter infills to the voids created.

To facilitate external access to the roof for maintenance purposes, it is intended that two new access openings will be provided through the roof. The existing dormers will not require any unaltered rafters to be cut, the existing trimming out will be increased to suit the new structural opening of access rooflights. The roof is a traditional pitched timber cut roof, containing tiles on battens fixed to rafters. The rafters are supported on purlins spanning between load bearing walls, and also propped along their span to binders at 7th floor ceiling level.

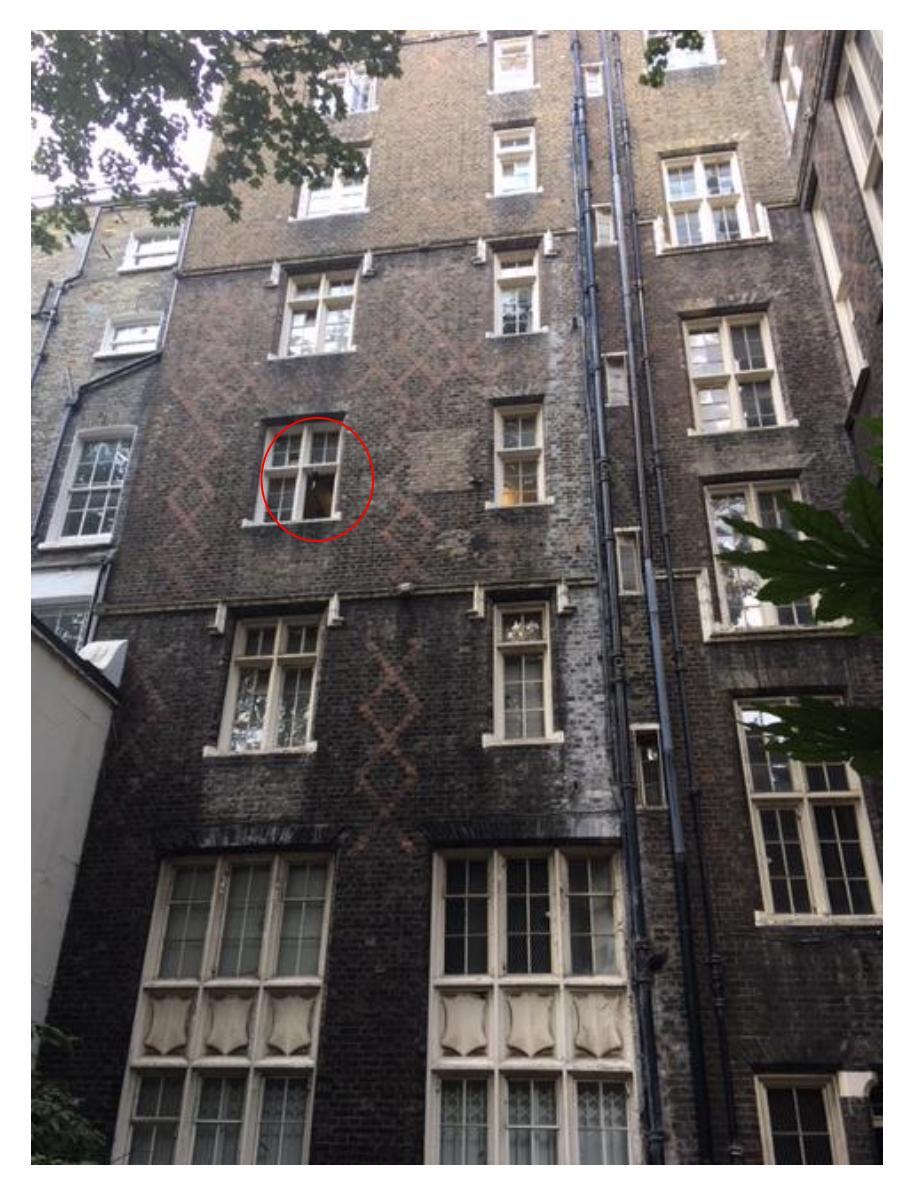
This location was chosen to be reasonably representative of the background noise levels at the nearest noise sensitive receptors.

Figure 2 Photograph of the logger location

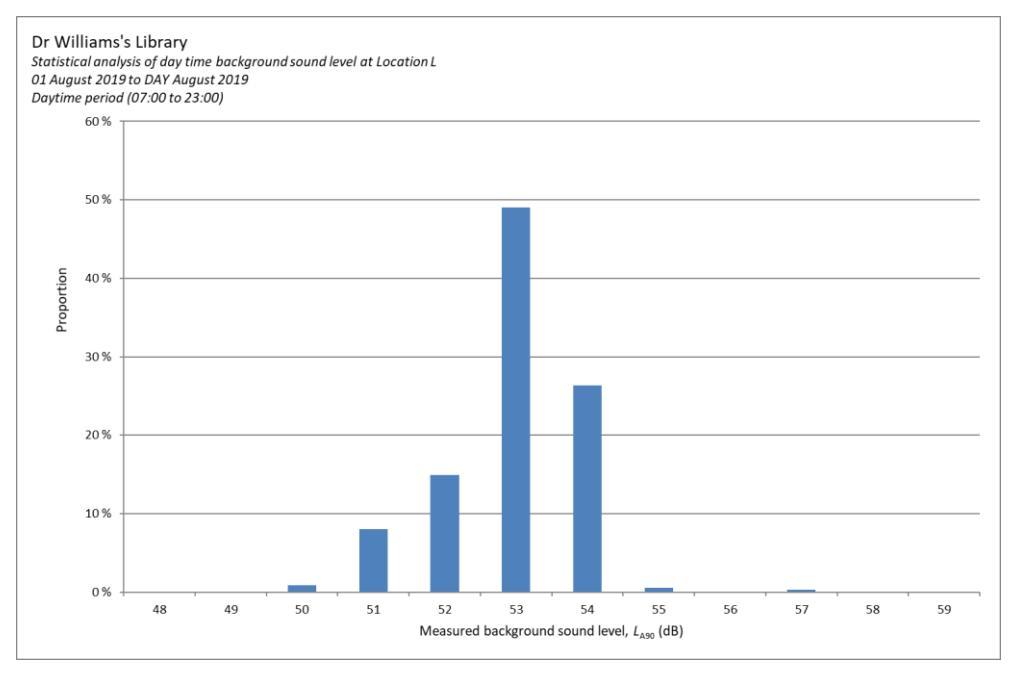
Figure 3 Statistical analysis showing measured background noise levels at location L (07:00-23:00)

From this analysis the representative background sound levels measured during the survey were $L_{A90,15min}$ 53 dB during the daytime and $L_{A90,15min}$ 51 dB at night.

Daytime and night time statistical analysis of representative values for the site are given in Figure 3 and Figure 4.

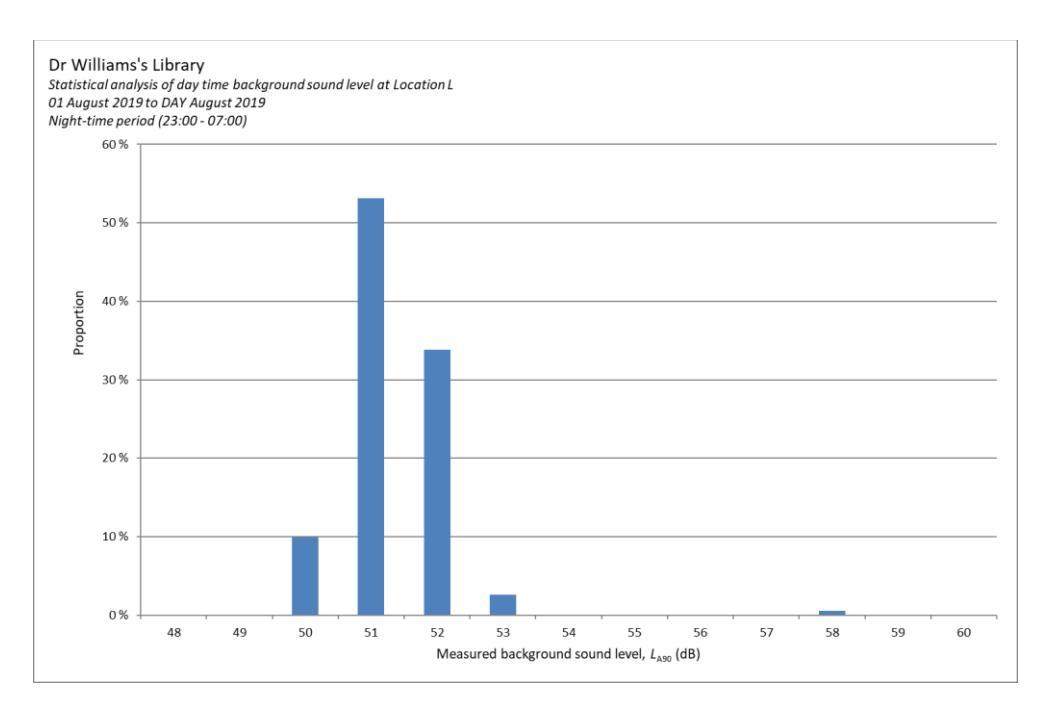
Figure 4 Statistical analysis showing measured background noise levels at location L (23:00-07:00)
