# **Inclinometer Report**

23<sup>RD</sup> AUGUST 2021 - WEEK 29, REPORT 023

Project Name – Camden Street Project Number – 35357 Client – Murphy Group

## Document Register – MGS35357-OP-RP-02-023

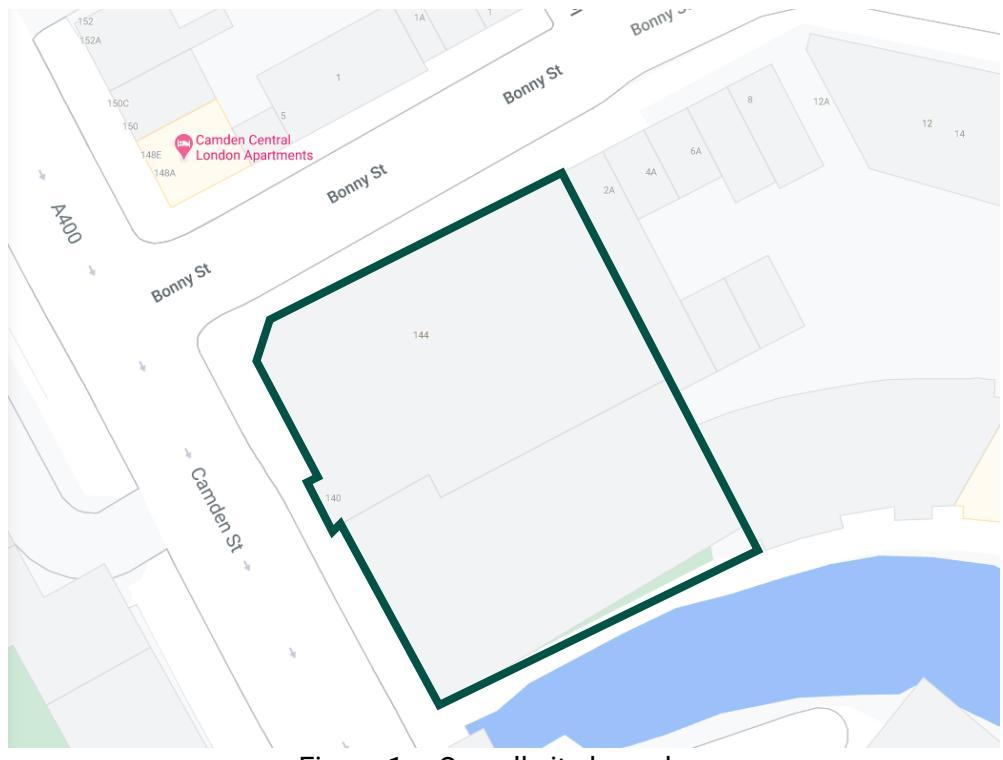
Figure 1 – Overall site boundary

The works will be carried out as per the client's specification and requirements. A layout diagram can be seen below (Figure 1) detailing the proposed area of work.

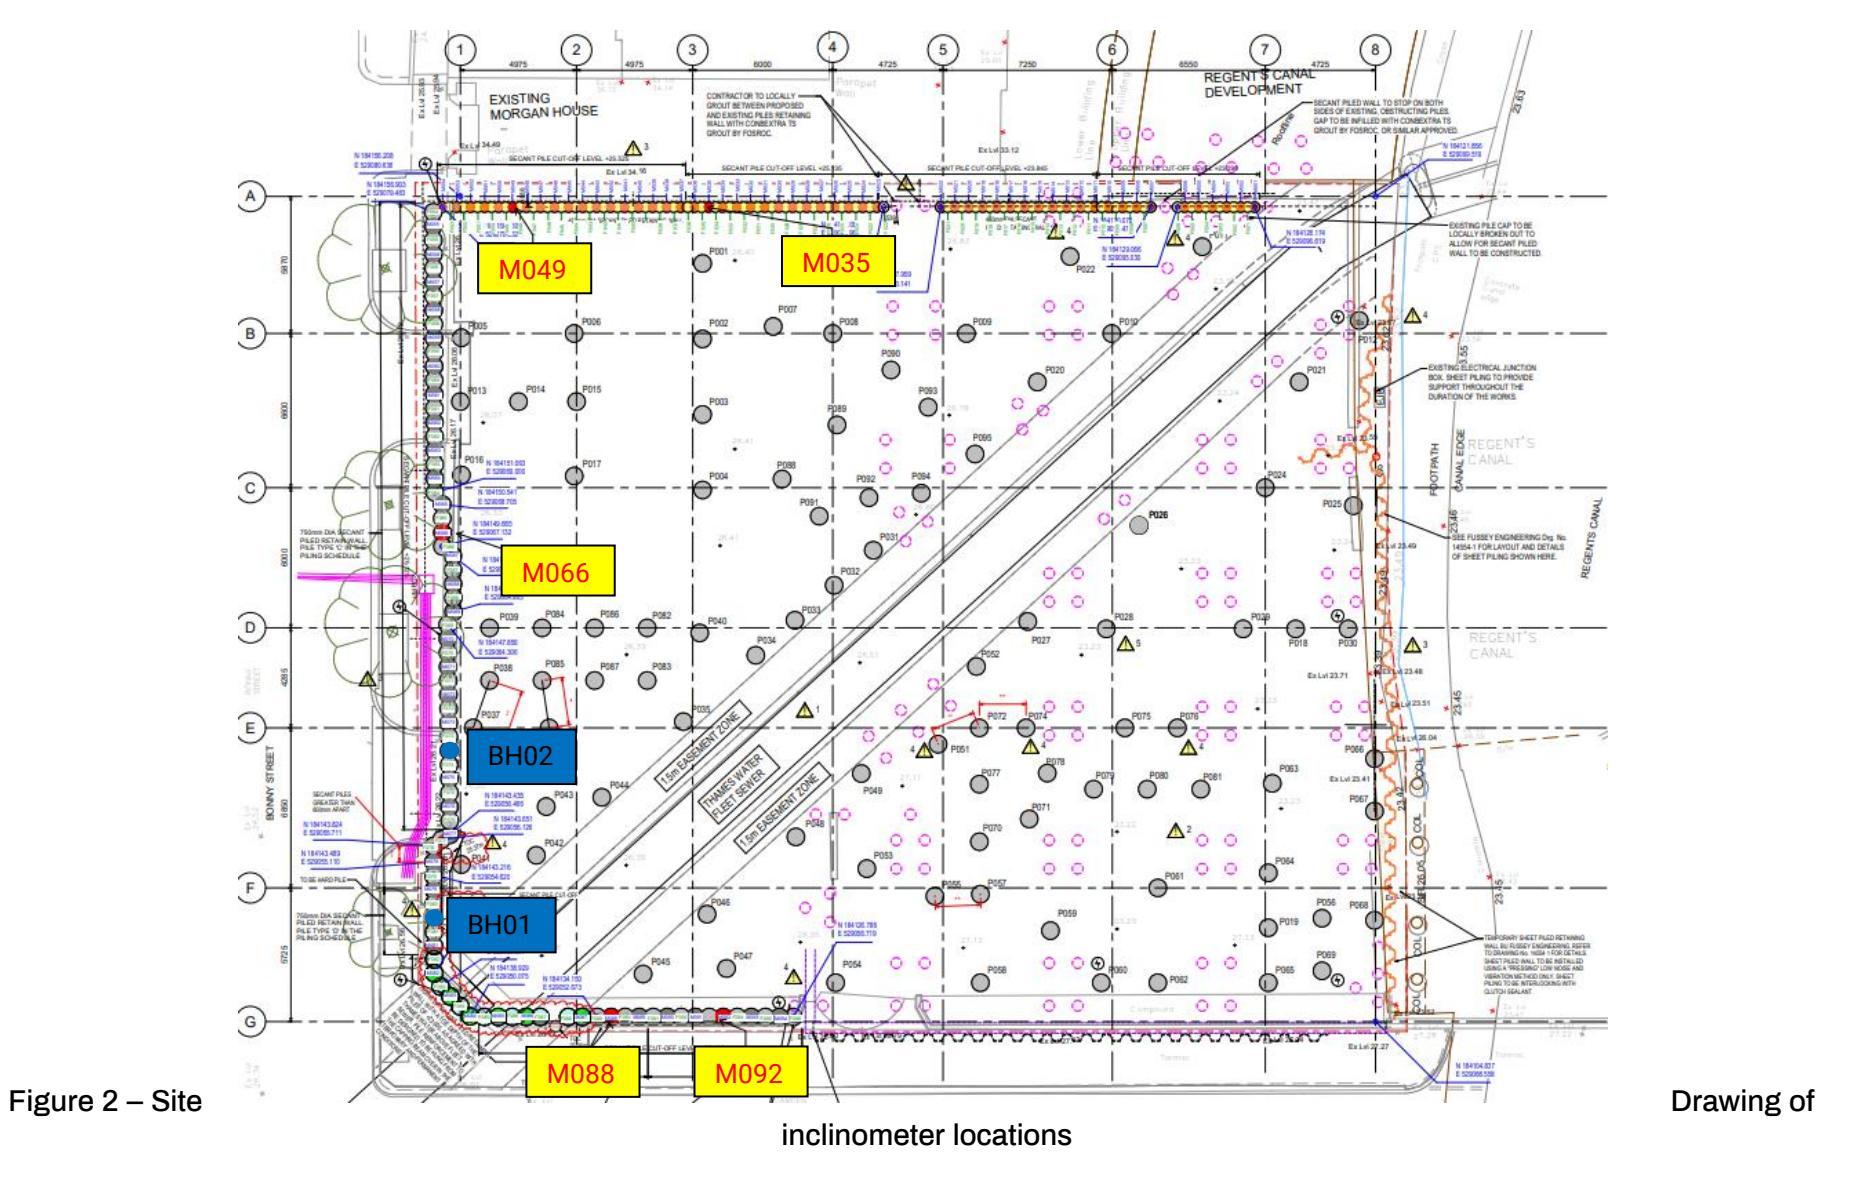
### 2. Monitoring Network Layout and Installation overview

The following report details the weekly observed inclinometer readings, with the five pre-determined areas located within 140-146 Camden Street, the locations of which can be seen in (Figure 2) site diagram drawing on page 5.

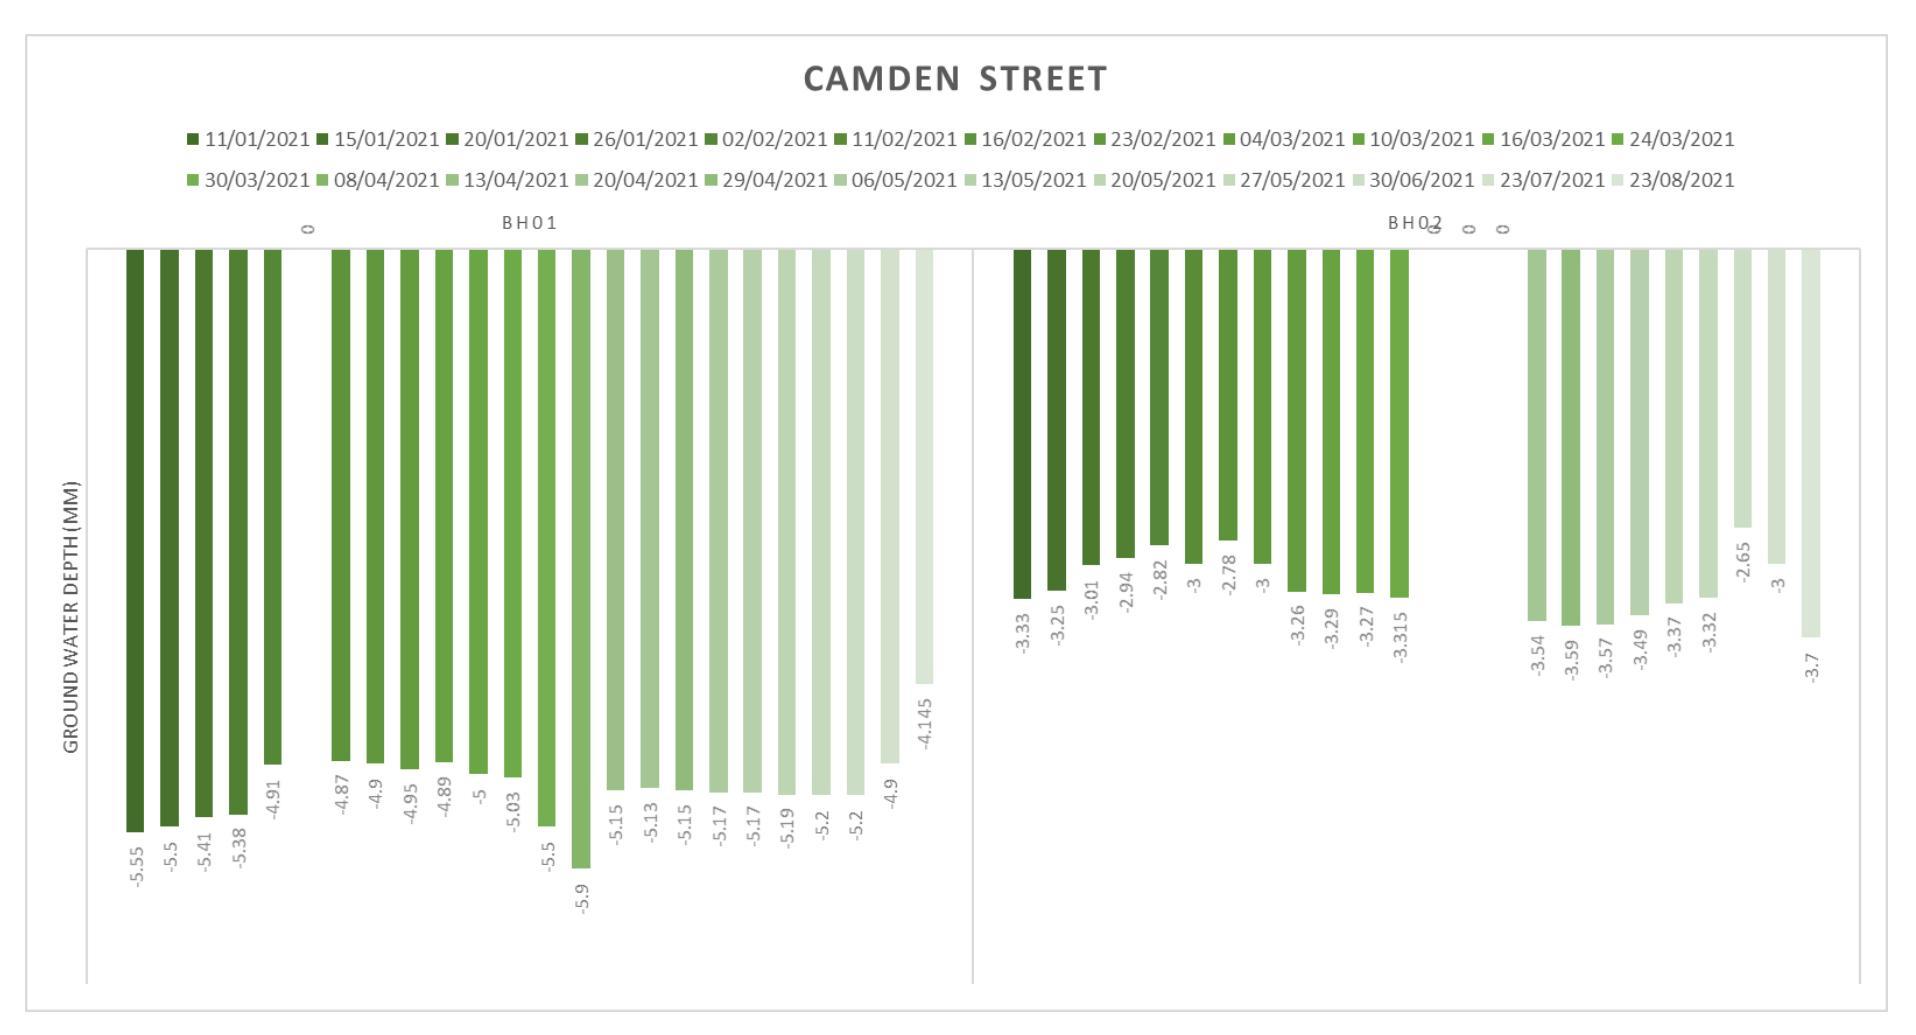
Figure 04 - Graphical Representation of Piezometer boreholes

## 4. Graph Representation – Piezometer boreholes
