### 19-37 Highgate Road \_ Construction Programme

# 19 - 37 Highgate Road London NW5 1JY

### **Asbestos Survey For**

### **Dust Management Plan**

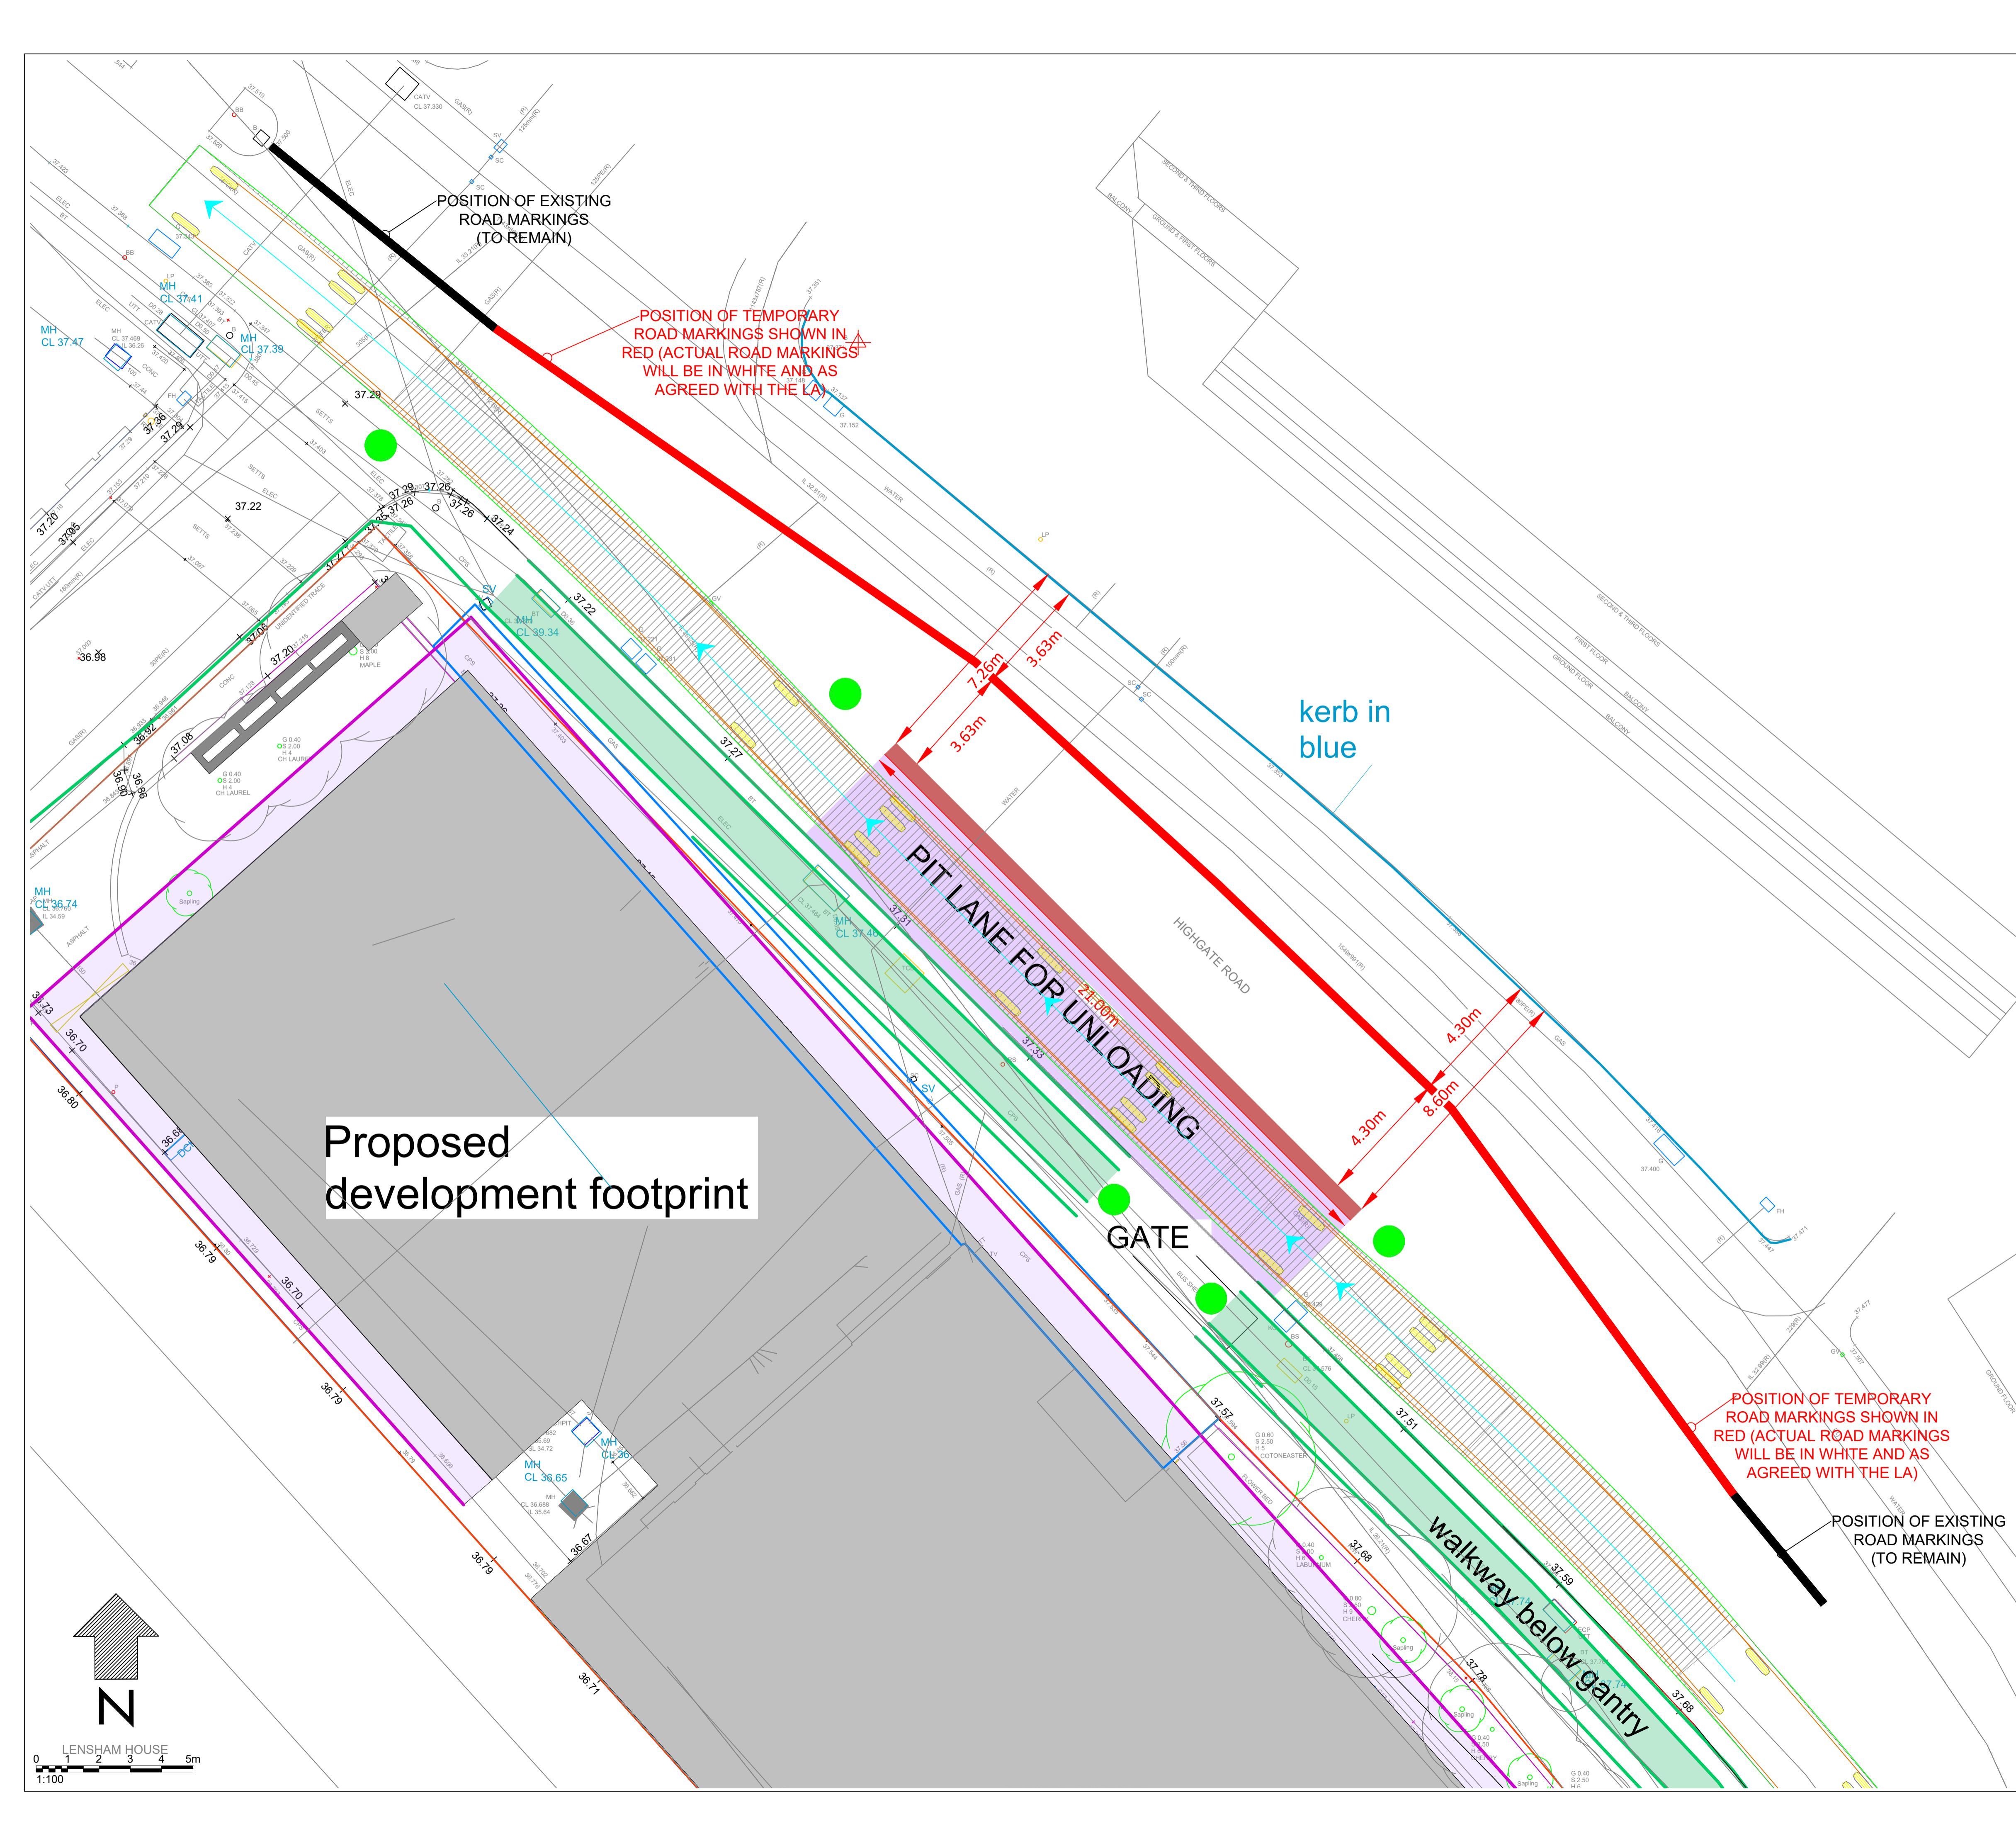
REV: DETAILS:
	V7         RIGID FLATBED DELIVERY VEHICLE: ACCESS AND EGRESS (CONSTRUCTION WORKS) 08.07.22
	VEHICLE DETAILS:
	VEHICLE: RIGID FLATBED LEGNTH: 10.00m WIDTH: 2.50m NB: VEHICLE PROFILE IS FOR ILLUSTRATIVE PURPOSES ONLY
	FORWARD MOVEMENTS ARE SHOWN IN GREY (design speed for all constrained forward movements - 3mph)
	<b>REVERSE MOVEMENTS ARE SHOWN IN BLUE</b> (design speed for all reverse movements - 2mph)
	TRAFFIC MARSHAL POSITION
	<ul> <li>NOTES:</li> <li>a. Do not scale from this drawing.</li> <li>b. This drawing is to be read and printed in colour.</li> <li>c. This drawing is for illustrative purposes only.</li> <li>d. Road layout and location of street furniture is approximate.</li> <li>e. These Swept Path Analysis drawings are indicative only, it remains the Principal Contractor/Freight Operators responsibility to ensure that vehicles are able to undertake the proposed manoeuvres.</li> </ul>

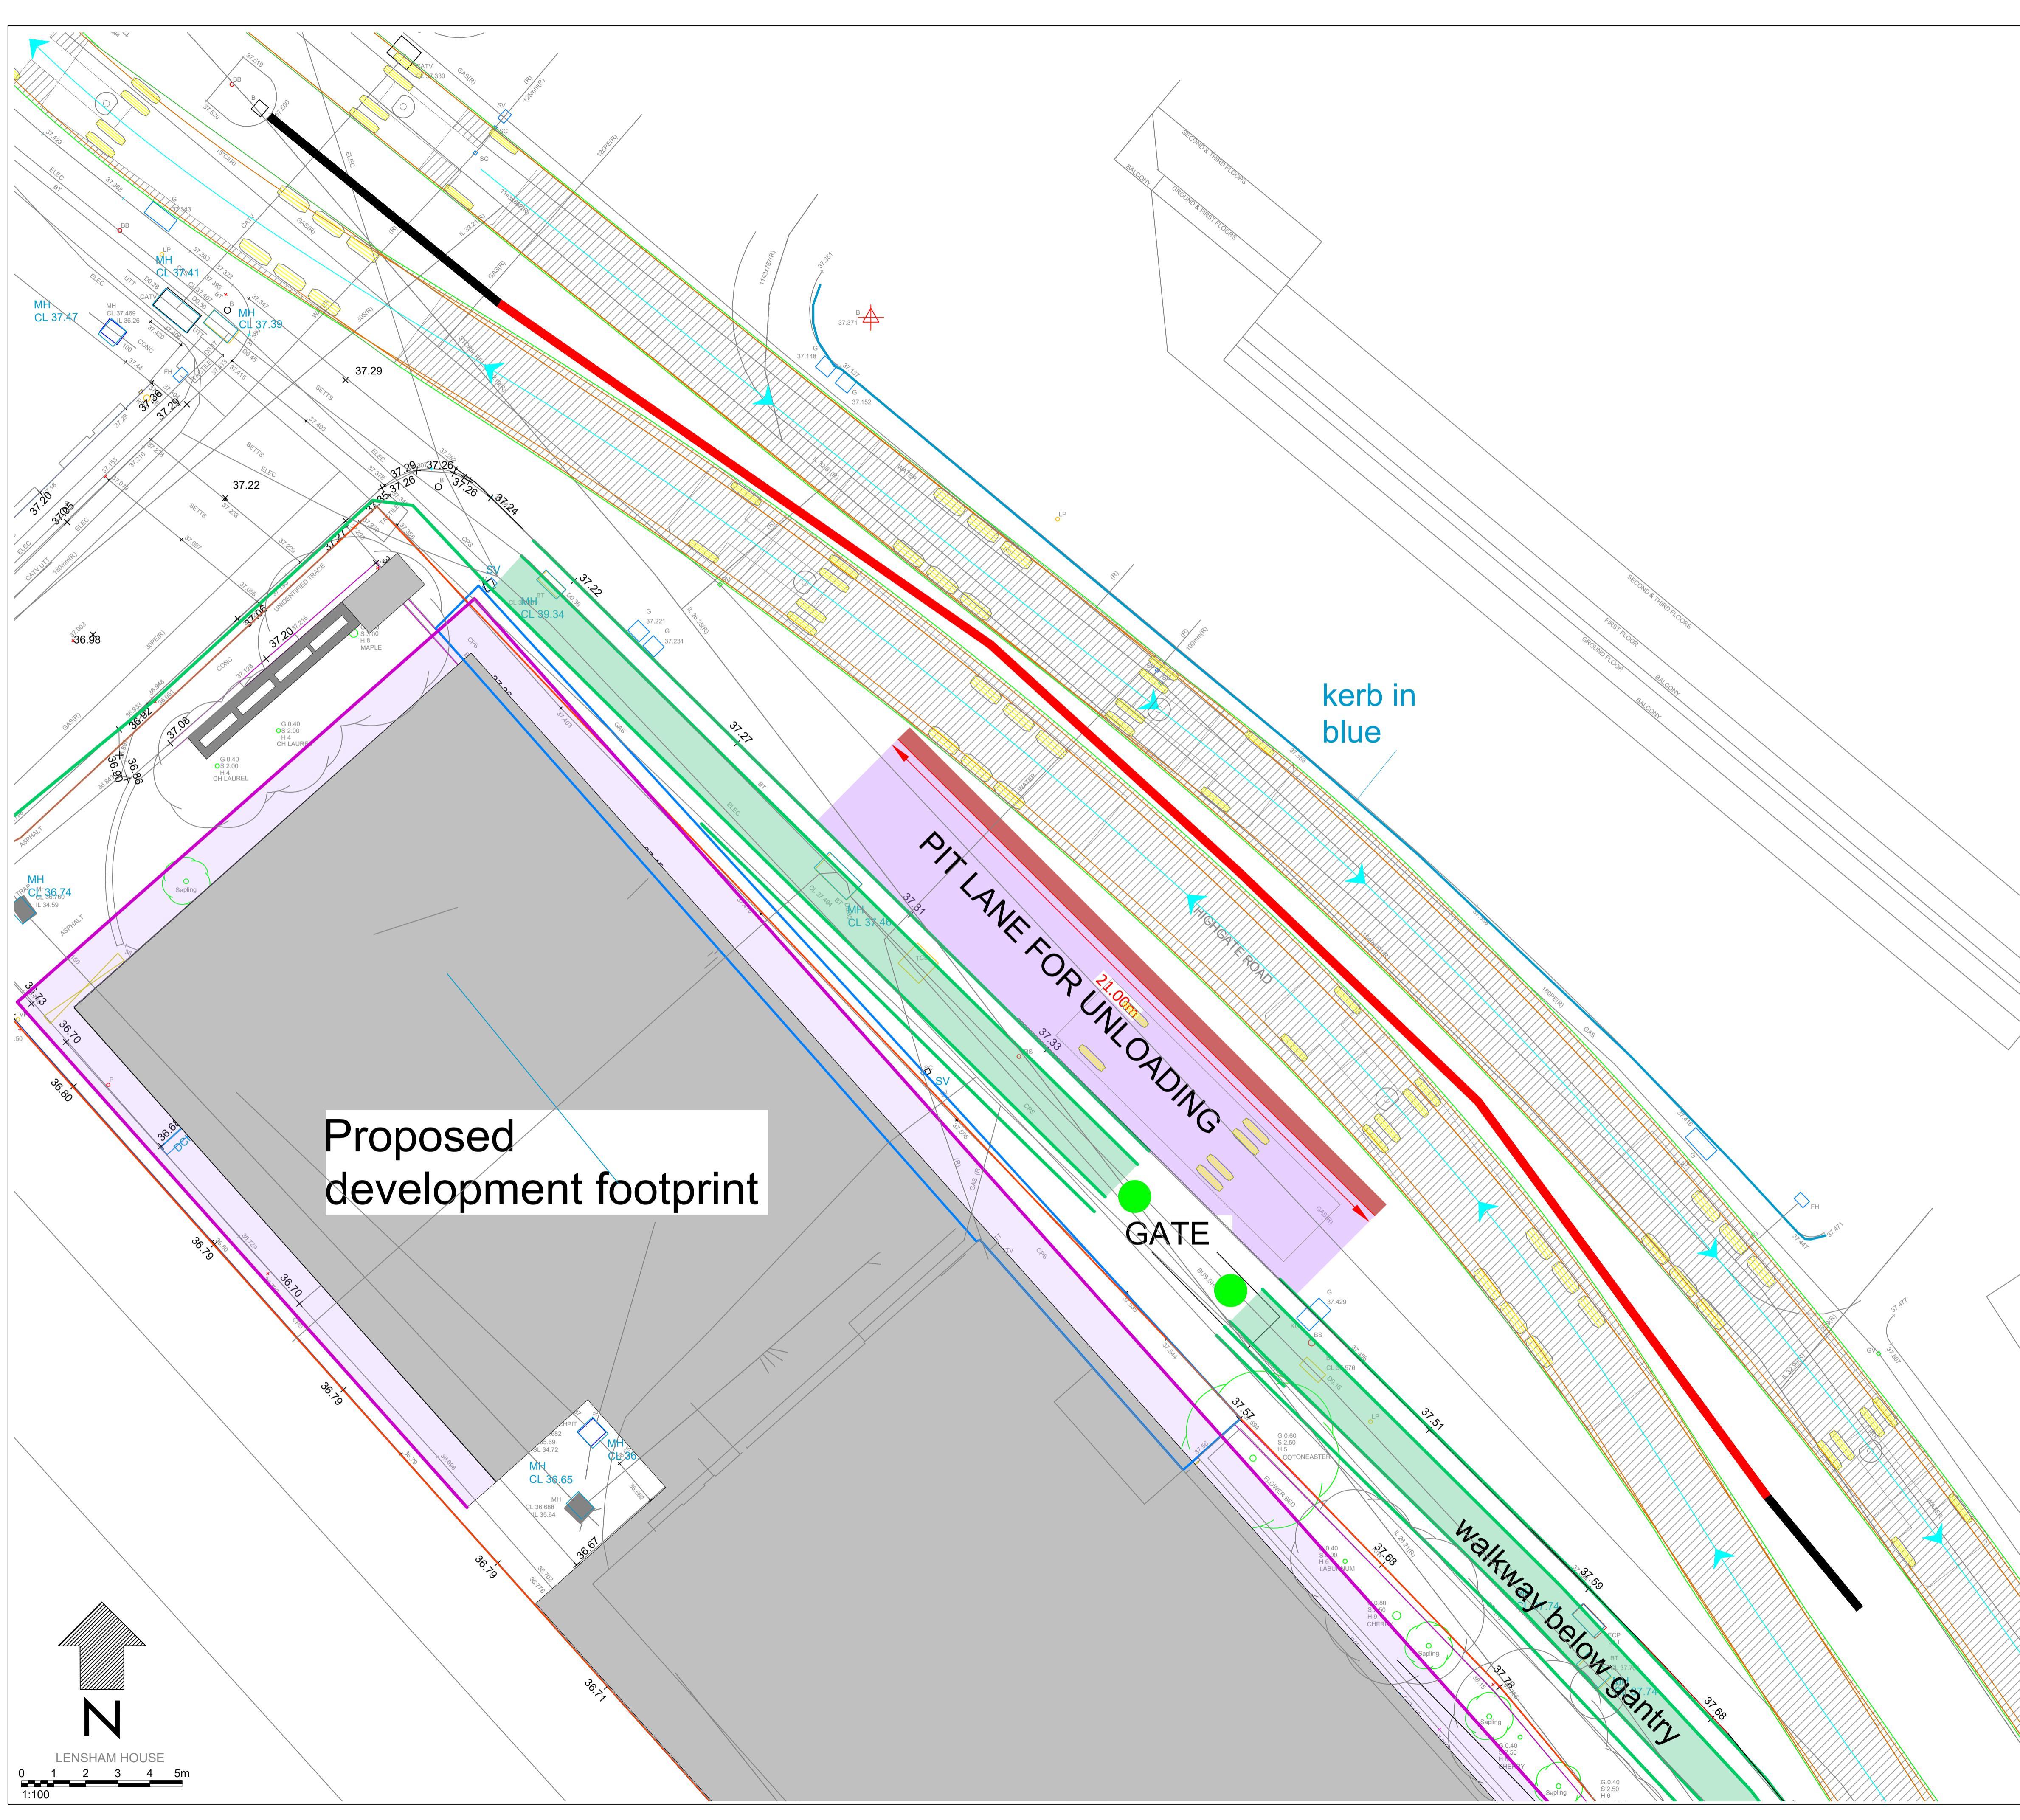
REV:     DETAILS:       V7     ARCTIC PAST SITE (CONSTRUCTION WORKS)       08.07.22
	1.36 3.80 1.80 1.80 1.61 7.80 0.68 0000 1.36
	ARTIC       meters         Tractor Width       : 2.55       Lock to Lock Time       : 6.0         Trailer Width       : 2.55       Steering Angle       : 34.3         Tractor Track       : 2.47       Articulating Angle       : 75.0         Trailer Track       : 2.45
	FORWARD MOVEMENTS ARE SHOWN IN GREY (design speed for all constrained forward movements - 3mph)
	REVERSE MOVEMENTS ARE SHOWN IN BLUE
	(design speed for all reverse movements - 2mph)
	KEY:
	TRAFFIC MARSHAL POSITION
	<ul> <li>NOTES:</li> <li>a. Do not scale from this drawing.</li> <li>b. This drawing is to be read and printed in colour.</li> <li>c. This drawing is for illustrative purposes only.</li> <li>d. Road layout and location of street furniture is approximate.</li> <li>e. These Swept Path Analysis drawings are indicative only, it remains the Principal Contractor/Freight Operators responsibility to ensure that vehicles are able to undertake the proposed manoeuvres.</li> </ul>

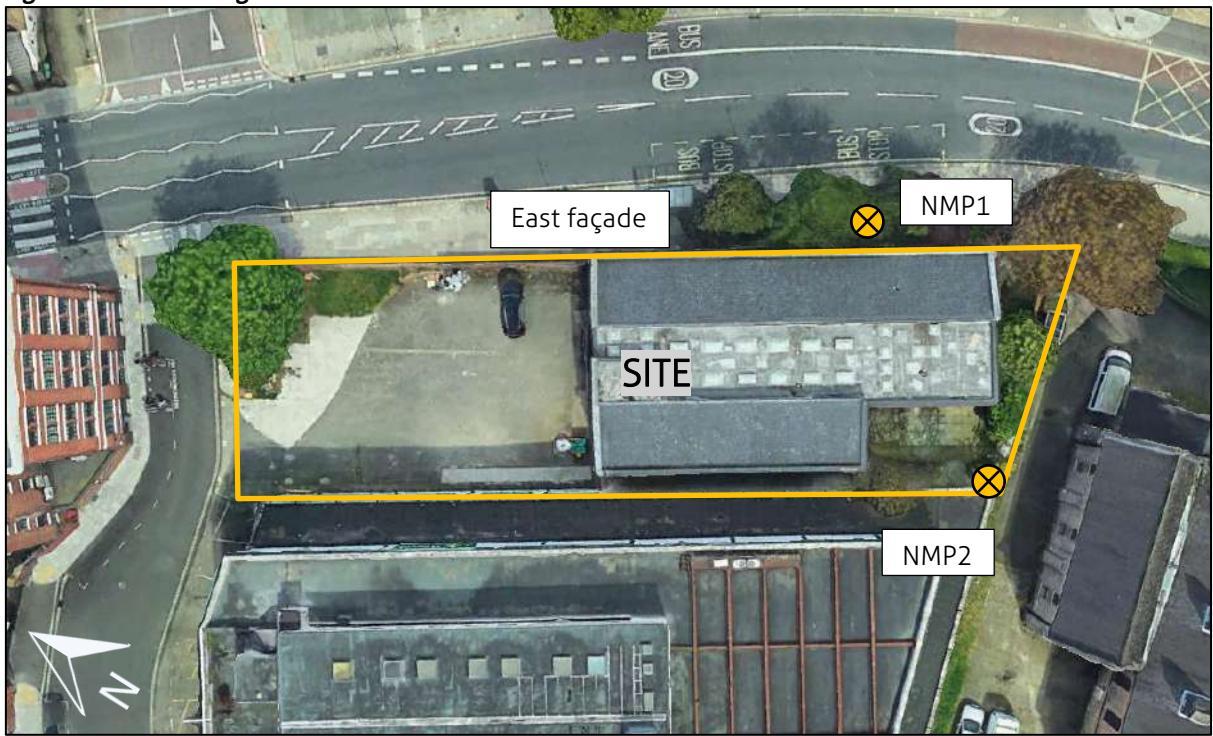
#### Figure 4.1: Monitoring Locations

Monitoring locations are presented in Figure 4.1 below, results of the survey are presented in Table 4.1.

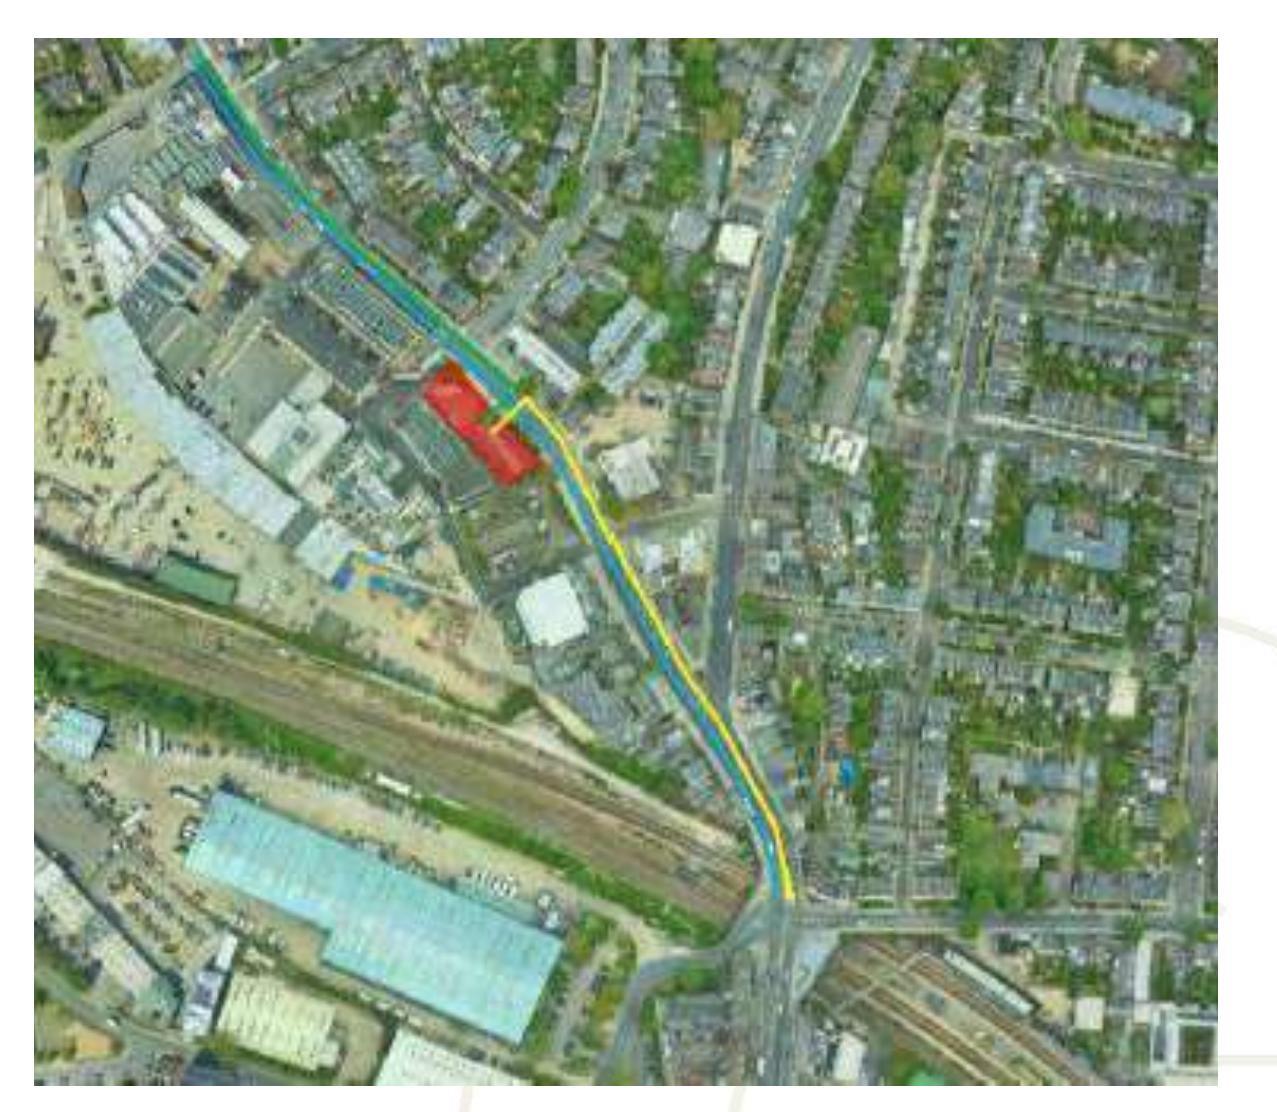
#### Site Egress: Yellow Arrow

- 3. Exit site in a forward gear and turn right onto Highgate Road (B518)
- 4. Continue away from site on Highgate Road (B518) in a south easterly direction

On entering and exiting site suitably qualified and experienced banksmen will oversee all vehicle manoeuvres to ensure that:

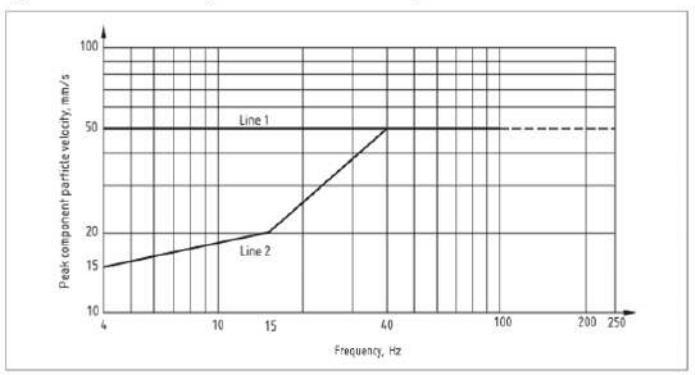
Figure B.1 Transient vibration guide values for cosmetic damage

Line (see Figure B.1)	Type of building	Peak component particle velocity in frequency range of predominant pulse		
		4 Hz to 15 Hz	15 Hz and above	
1	Reinforced or framed structures	50 mm/s at 4 Hz and	50 mm/s at 4 Hz and	
	Industrial and heavy commercial buildings	above	above	
2	Unreinforced or light framed structures	15 mm/s at 4 Hz increasing to 20 mm/s	20 mm/s at 15 Hz increasing to 50 mm/s	
Residential or light commercial at 15 Hz buildings	at 15 Hz	at 40 Hz and above		
NOTE 1 Value	s referred to are at the base of the build	ding.

The standard states that minor damage is possible at vibration levels which are greater than twice those given in Table B.2, and major damage at values greater than 4 times the tabulated values.

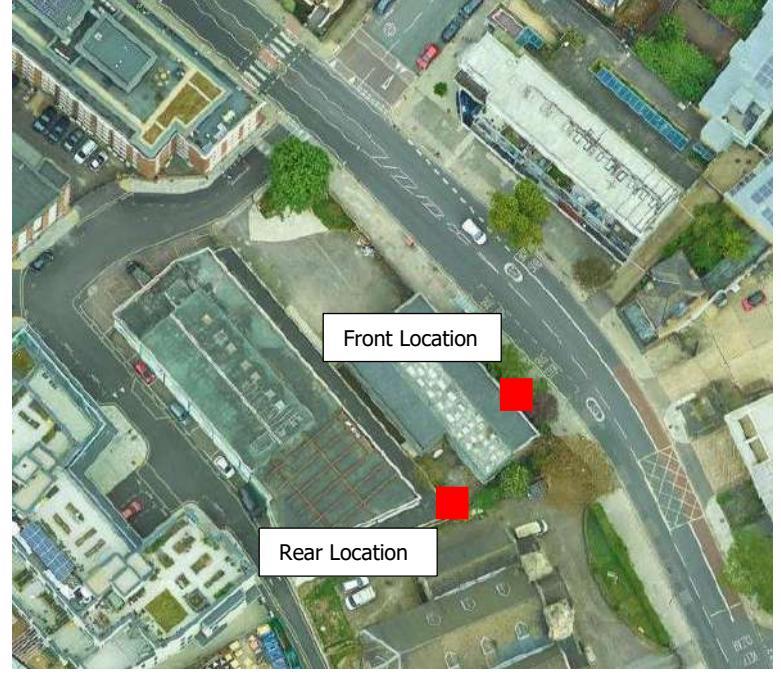
Figure 2: Noise Survey Locations

Measurements were undertaken at two locations representative of the front and rear of the site. The equipment located at the front was installed 2m above ground at 1.5m from the existing façade, and the equipment at the back was located 4m above ground in free-field conditions. These are shown in the figure below.

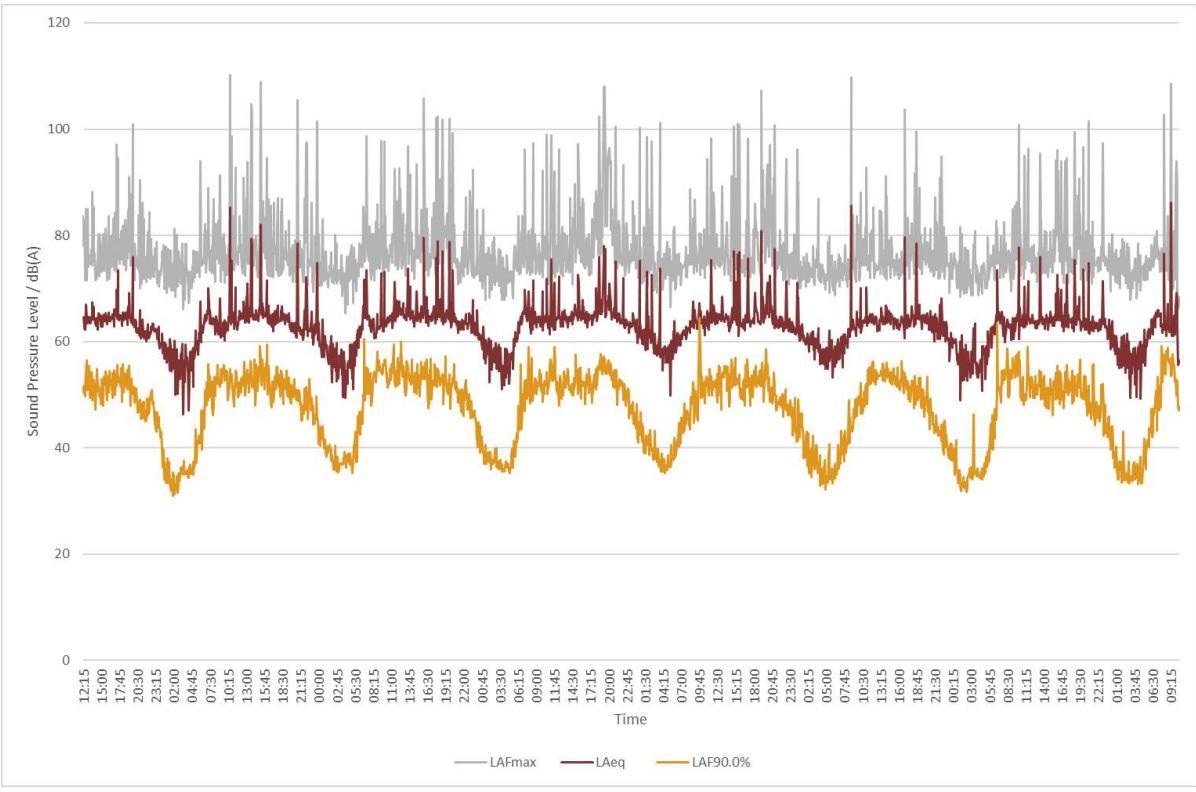
Chart 1: Measured noise levels at Front Location

The measurement results of such survey are as follows:
