BS 5837:2012 Tree Survey & Impact Assessment For Proposed Extension

Address: St Mary's Church, Primrose Hill

Date 24th September 2021

Tree Survey & Arboricultural Impact Assessment St Mary the Virgin Parish Church, Primrose Hill

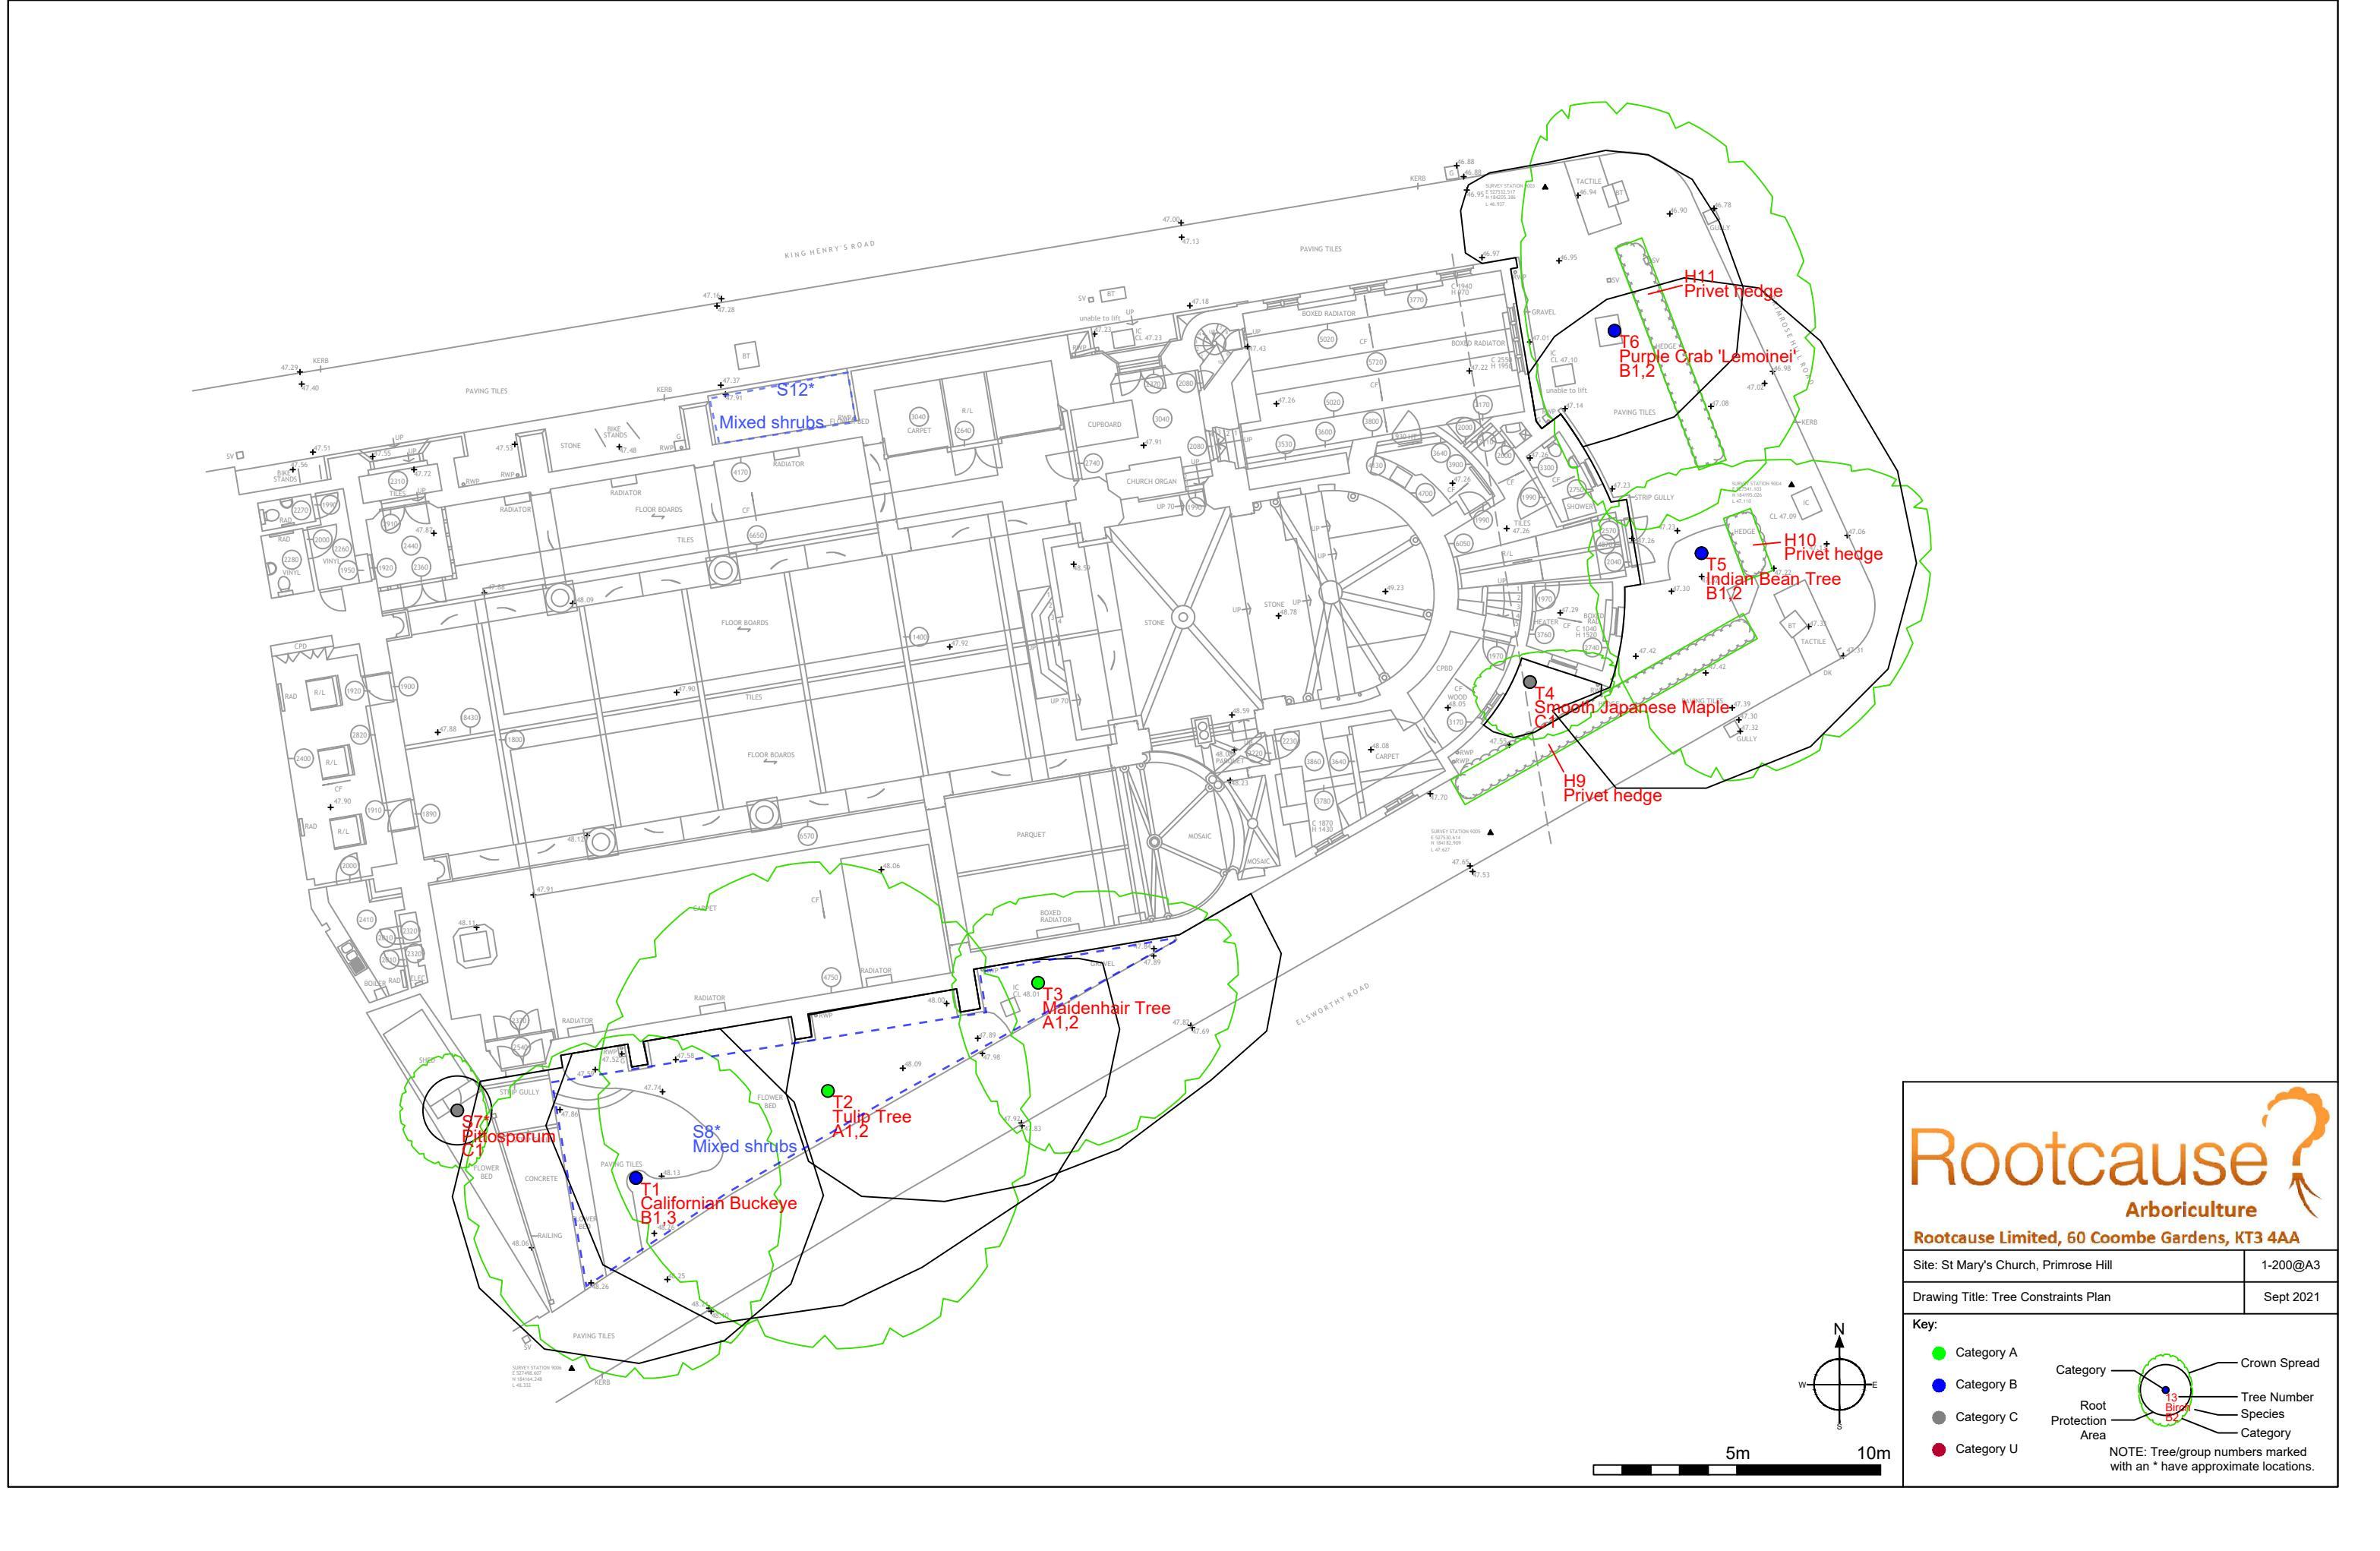
9. Appendix 3 Existing Site Plan with Tree Constraints

- 5.1 I have adjusted the shape of the RPAs of the trees to match the existing building shape. Some roots of T5 and possible T6 could be growing beneath the existing low impact foundation for the existing extension.
- 5.2 The existing foundation for the curved vestibule consisted of a 200mm reinforced concrete slab on 400mm deep ground beam above piled foundations. The proposed vestibule extension uses the same foundation, but it is extended in some places with a 250mm concrete reinforced floor slab with screw piles to support the edge of the cantilevered slab. See Foundation Ground Floor Plan 4455-01 25.05.21.

6.3 The retained trees will need to be protected from construction damage. The existing hard surface will need to be retained to protect the roots. Additional ground protection may be required during foundation works when the ground is exposed. The tree stems will need to be protected with boxed structures and there will be limited space for storage and construction work within the site.

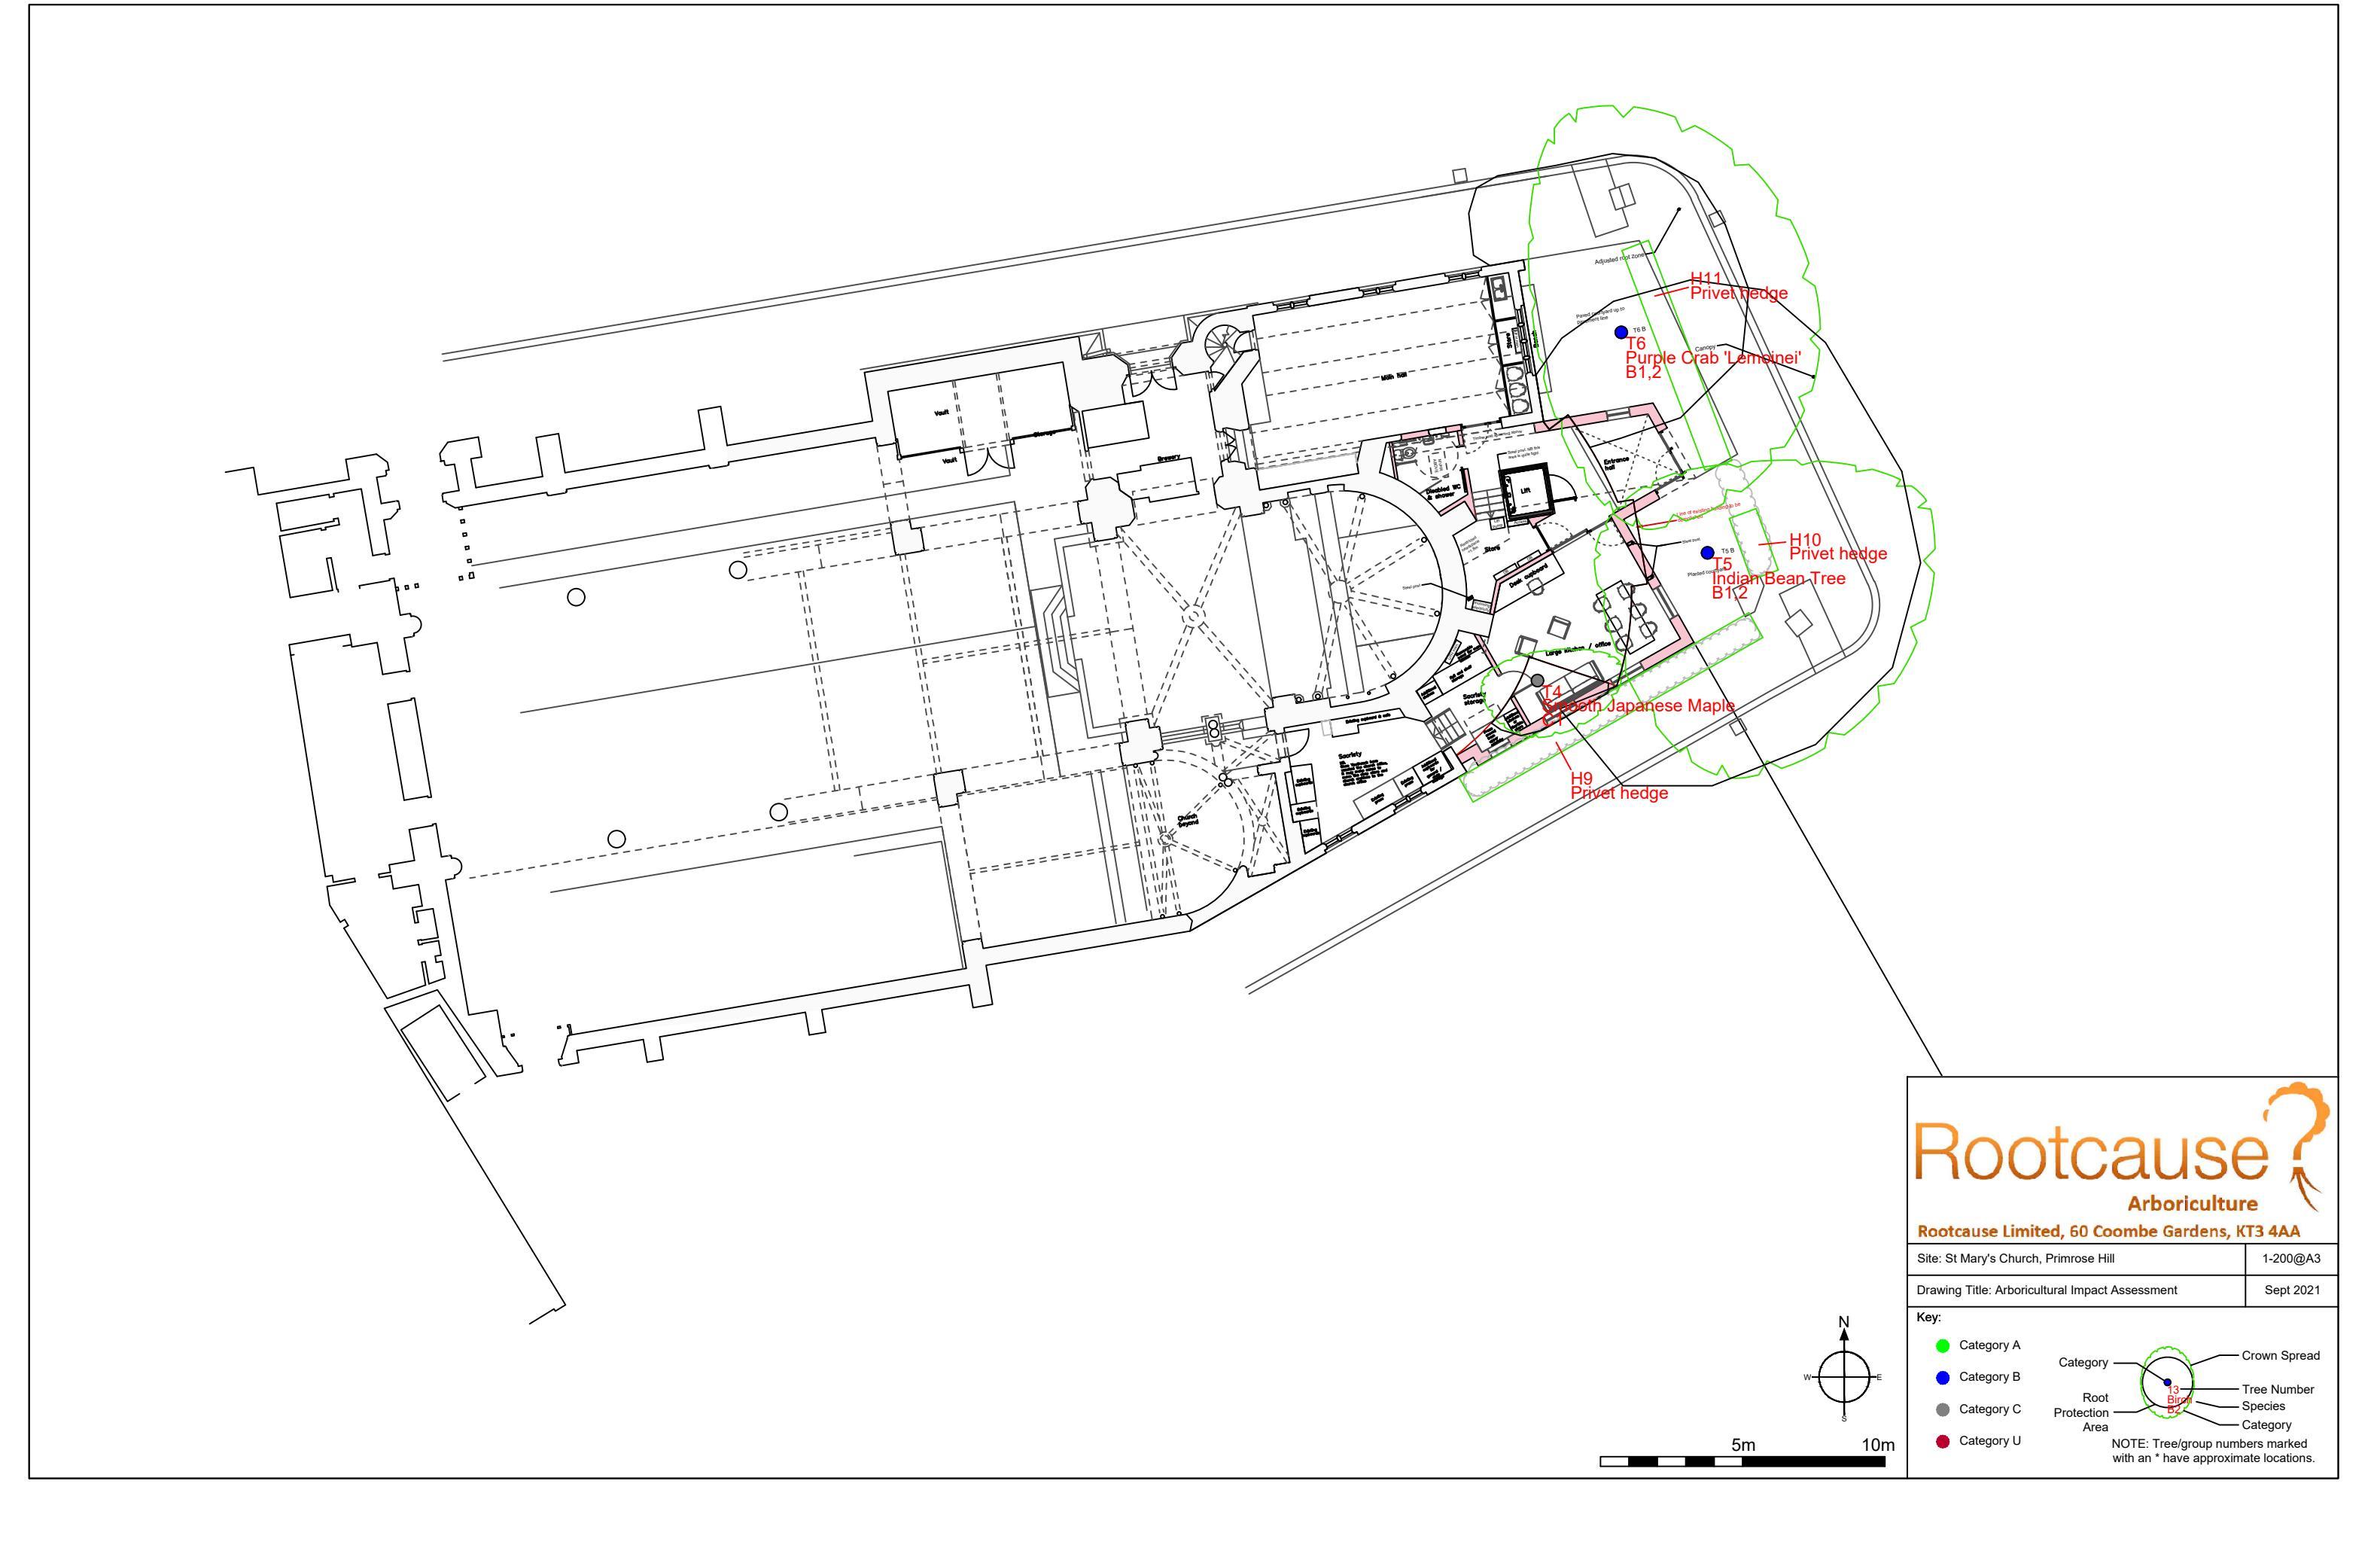
10. Appendix 4 Proposed Extension and Tree Constraints

- 5.4 The small Japanese Maple (T4) and the Privet hedge (H9) cannot be retained as they are growing within the footprint of the extension. The hedge (H9) appears to be growing outside of the site, but it is rooted within the site and the stems are aligned along the boundary.

- 5.5 The proposed extension will affect 14.5m² (9%) of the adjusted root protection area (RPA) of the Indian Bean Tree (T5) and the crown will be pruned to accommodate the building (and where it overhangs the road to clear traffic). The crown overlaps the proposed 2 story extension by 2.4 m and the road by 2.4 south and 3m east. The 2-storey extension is between 5 and 7.7m high adjacent T5 as it is a pitched roof. It is normal to provide at least 2m working space for a new building but the tree is approximately 2m from the front elevation so the building's front elevation should be constructed with minimal working space to preserve as much of the branch structure as possible.

- 5.6 The proposed extension will affect 3m² (4%) of the RPA of the Apple (T6). The extension affects the southwest corner of the crown which will be pruned. The building should be constructed with minimal working space so that as much crown is retained as possible.

- 6.1 The amount of rooting space on the Catalpa T5 is small and because of the limited depth it is tolerable. The crown pruning for the building is more substantial. The crown can regrow, but Catalpa has a domed spreading crown and so there will be conflicts (as there currently are) with the building and the road. It would be preferable to remove the tree and plant a species with a fastigiate (upright) growth habit, but the tree can be retained and shaped into a taller narrower tree by pruning, albeit less effective.
- 6.2 The loss of rooting space on the Apple T6 is minimal and tolerable. The pruning required to accommodate the extension will affect the building side of the tree, but it will regrow new foliage.
