Report prepared for: Thorsten Lindner c/o Globe Lawn Tennis club

For the Site of: Globe Lawn Tennis Club 190A Haverstock Hill London NW3 2AL

Preliminary Roost Assessment (PRA)

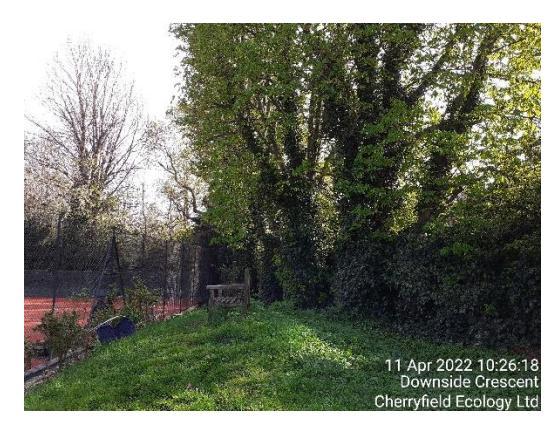
Figure 2: Example of tree line to rear of site (by T2)

The northeast of the site is bordered by a line of trees, comprised of three horse chestnut *Aesculus hippocastanum*, two poplar *populus sp*. and one cherry laurel *Prunus laurocerasus*. These trees provide negligible potential for roosting bats due to a lack of holes, crevices and other suitable roosting features. English Ivy *Hedera helix* climbs the base of the trees low to the ground so is unlikely to mask any suitable roosting features. No other possible roosting habitats are found on site.

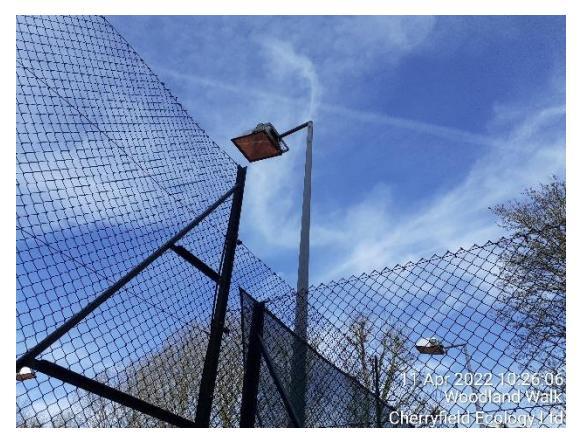
Figure 3: Example of existing floodlight by T2

The site is well lit from existing floodlights installed in neighbouring tennis courts, which are approx. 30 years old and provide a large amount of light spill. Some flood light columns also have a small backlight installed below the floodlight. Additionally, street lights line the street to the east of the site and security lights are found on the residential buildings to the south and east of the site.

It is recommended that the existing floodlighting be upgraded to minimise the light spill that is currently on site, in line with the BCT lighting guidelines as above.

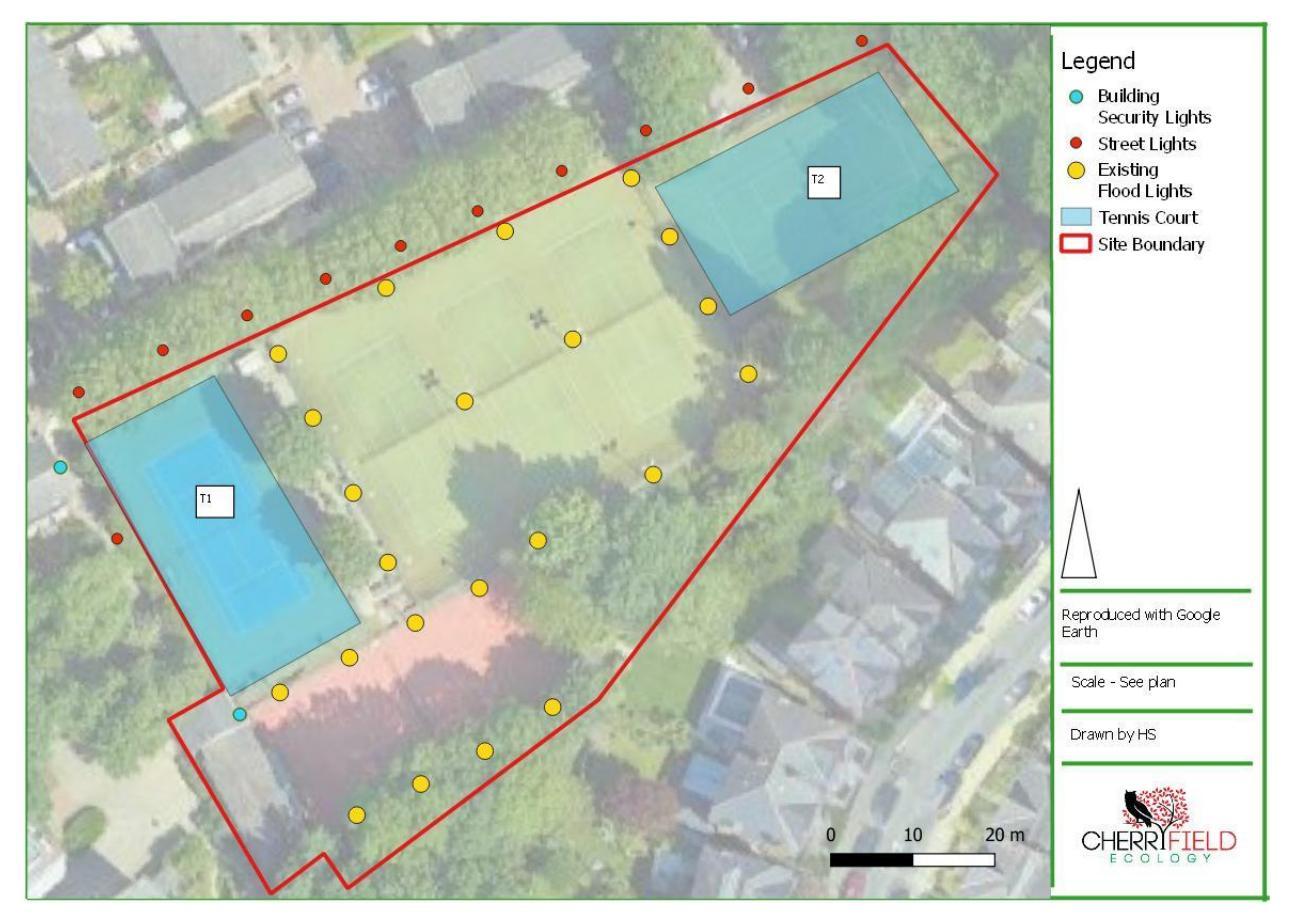
Figure 7: Site Plan

The client, Thorsten Lindner c/o Globe Lawn Tennis Club (hereafter referred to 'the club'), has commissioned Cherryfield Ecology to undertake a PRA for the site of Globe Lawn Tennis Club 190A Haverstock Hill London NW3 2AL. Planning permission is being sought to install floodlights on two tennis courts (T1&2- see site map, figure 7) within the club.

This section details the structures reference and description (see Figure 7 for Site Plan).
