SOUTH HAMPSTEAD JUNIOR SCHOOL, LONDON

ARBORICULTURAL IMPACT ASSESSMENT

Report No: RT-MME-154145-02

Date: June 2021

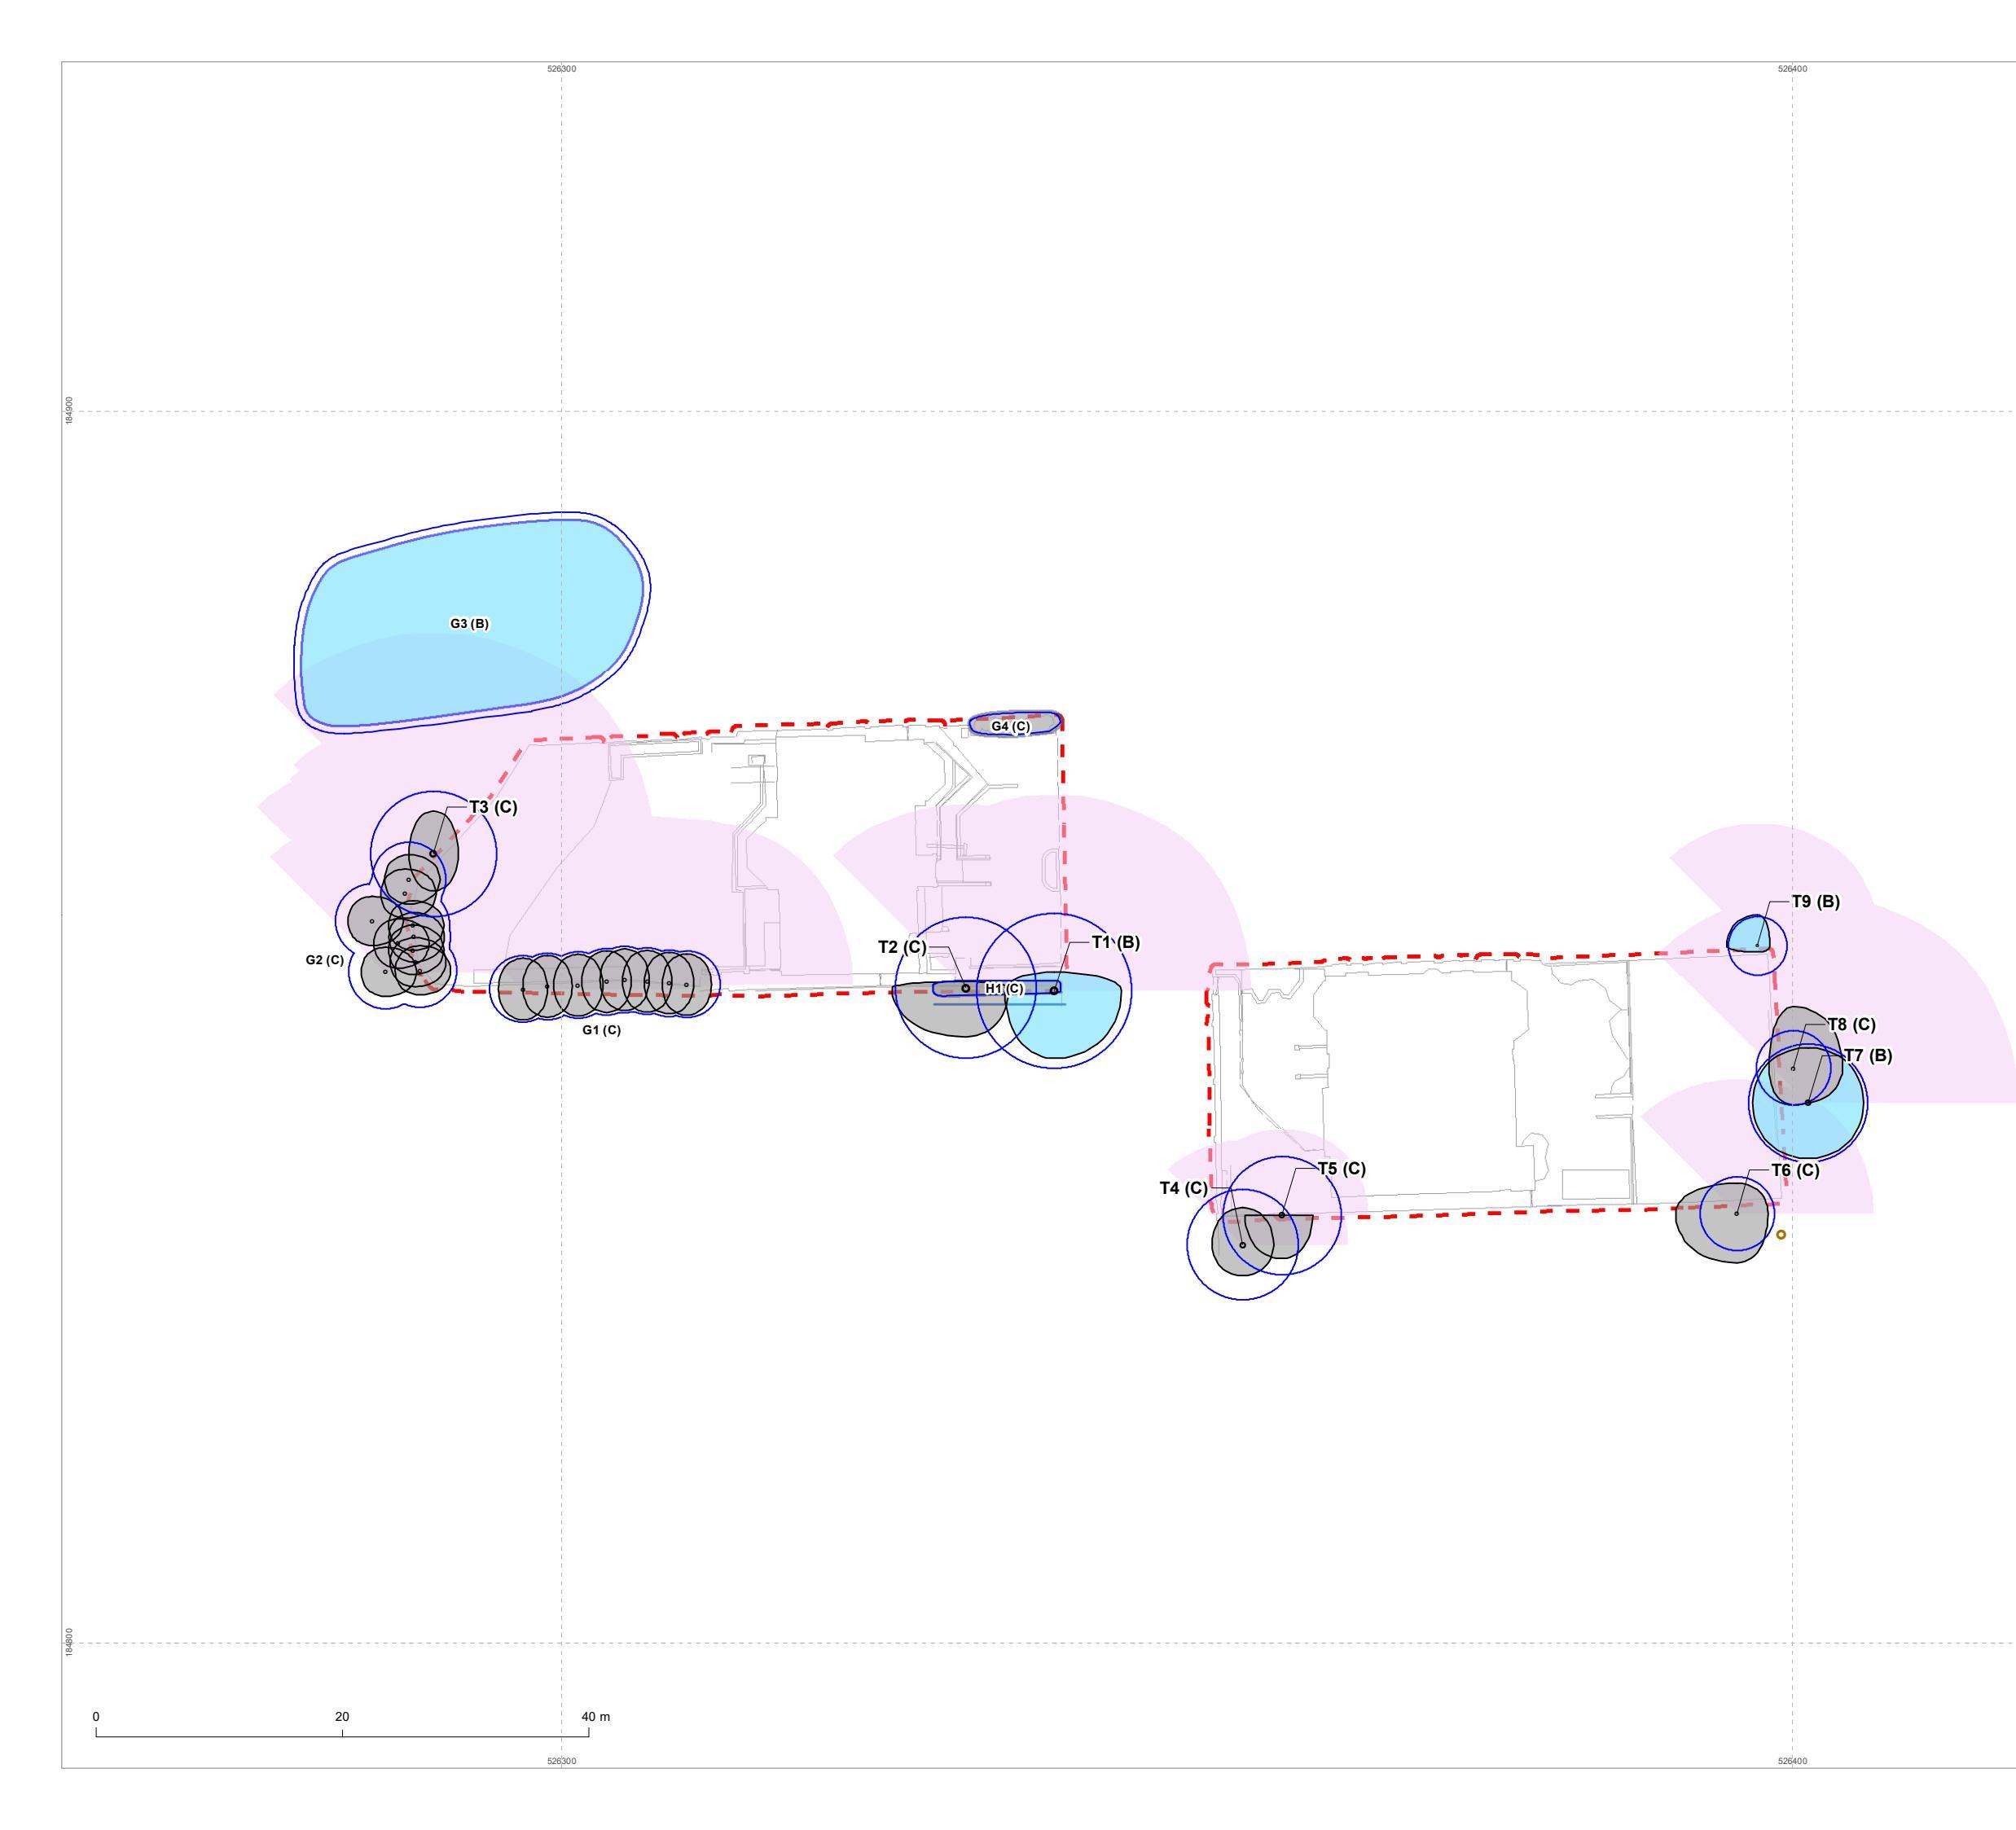
Drawing Number C154145-01-01 - Tree Survey Plan

The location of the trees surveyed can be found on Middlemarch Environmental Ltd Drawing Number C`54145-01-01, attached to this report.

The location of the trees can be found on the Tree Survey Plan (C154145-01-01) and a schedule of the trees (Appendix A) attached to this report.

C154	145-01-01
	Legend	
	• Tree location	and stem diameter
	• Tree stump	
	Root Protecti	on Area
	Category B	py extent
	Category C	
	Indicative tree	e shadow
	Site boundar	y
	T - Tree H - Hedgerow G - Tree group	
	Note: tree locations are	approximate, based
	on combined field obser	ations and aerial imagery
	The original of this dra a monochrome cop	wing was produced in colour - y should not be relied upon
	NOTES All dimensions to be verified use figured dimensions only. Project Arboriculturalist. Draw Preliminary Arboricultural / Drawing has been produced informaton in dwg format, i where appropriate. A monoc decked and verified on site design, tree operations or co Further survey work would b depths. Trees are living organism condition of all trees illust by the Project Arboricultu 12 months after the SOME TREES MAY BE CONSTRAINTS. IT IS TH WORKS SHOULD BE UI LLUSTRATED HEREIN WI RELEVANT AUTHORISATIOI AS PER THE APPROVED CONSERT. This drawing is the property and is issued on the conditi disclosed to any unauthorisis without writhen consent of Middlemarch Environmental L1	on site. Do not scale this drawing, All discrepancies to be clarified with ving to be read in conjunction with Assessment and Tree Schedule. In colour and is based on digital aerial images and/or GPS location throme copy should not be relied individual trees or species included woodland or hedgerow should be prior to any decisions for foundation nstruction activity being undertaken. e required for calculating foundation s that change over time, the rated herein, are to be checked rated herein, are to be checked of this survey. SUBJECT TO STATUTORY EREFORE ADVISED THAT NO VDERTAKEN TO ANY TREES THOUT FIRST OBTAINING THE N TO DO SO UNLESS AGREED PLANS THROUGH PLANNING of Middlemarch Environmental Ltd on it is not reproduced, retained or ad person, either wholly or in part if Middlemarch Environmental Ltd. d accept no liability for third party use.

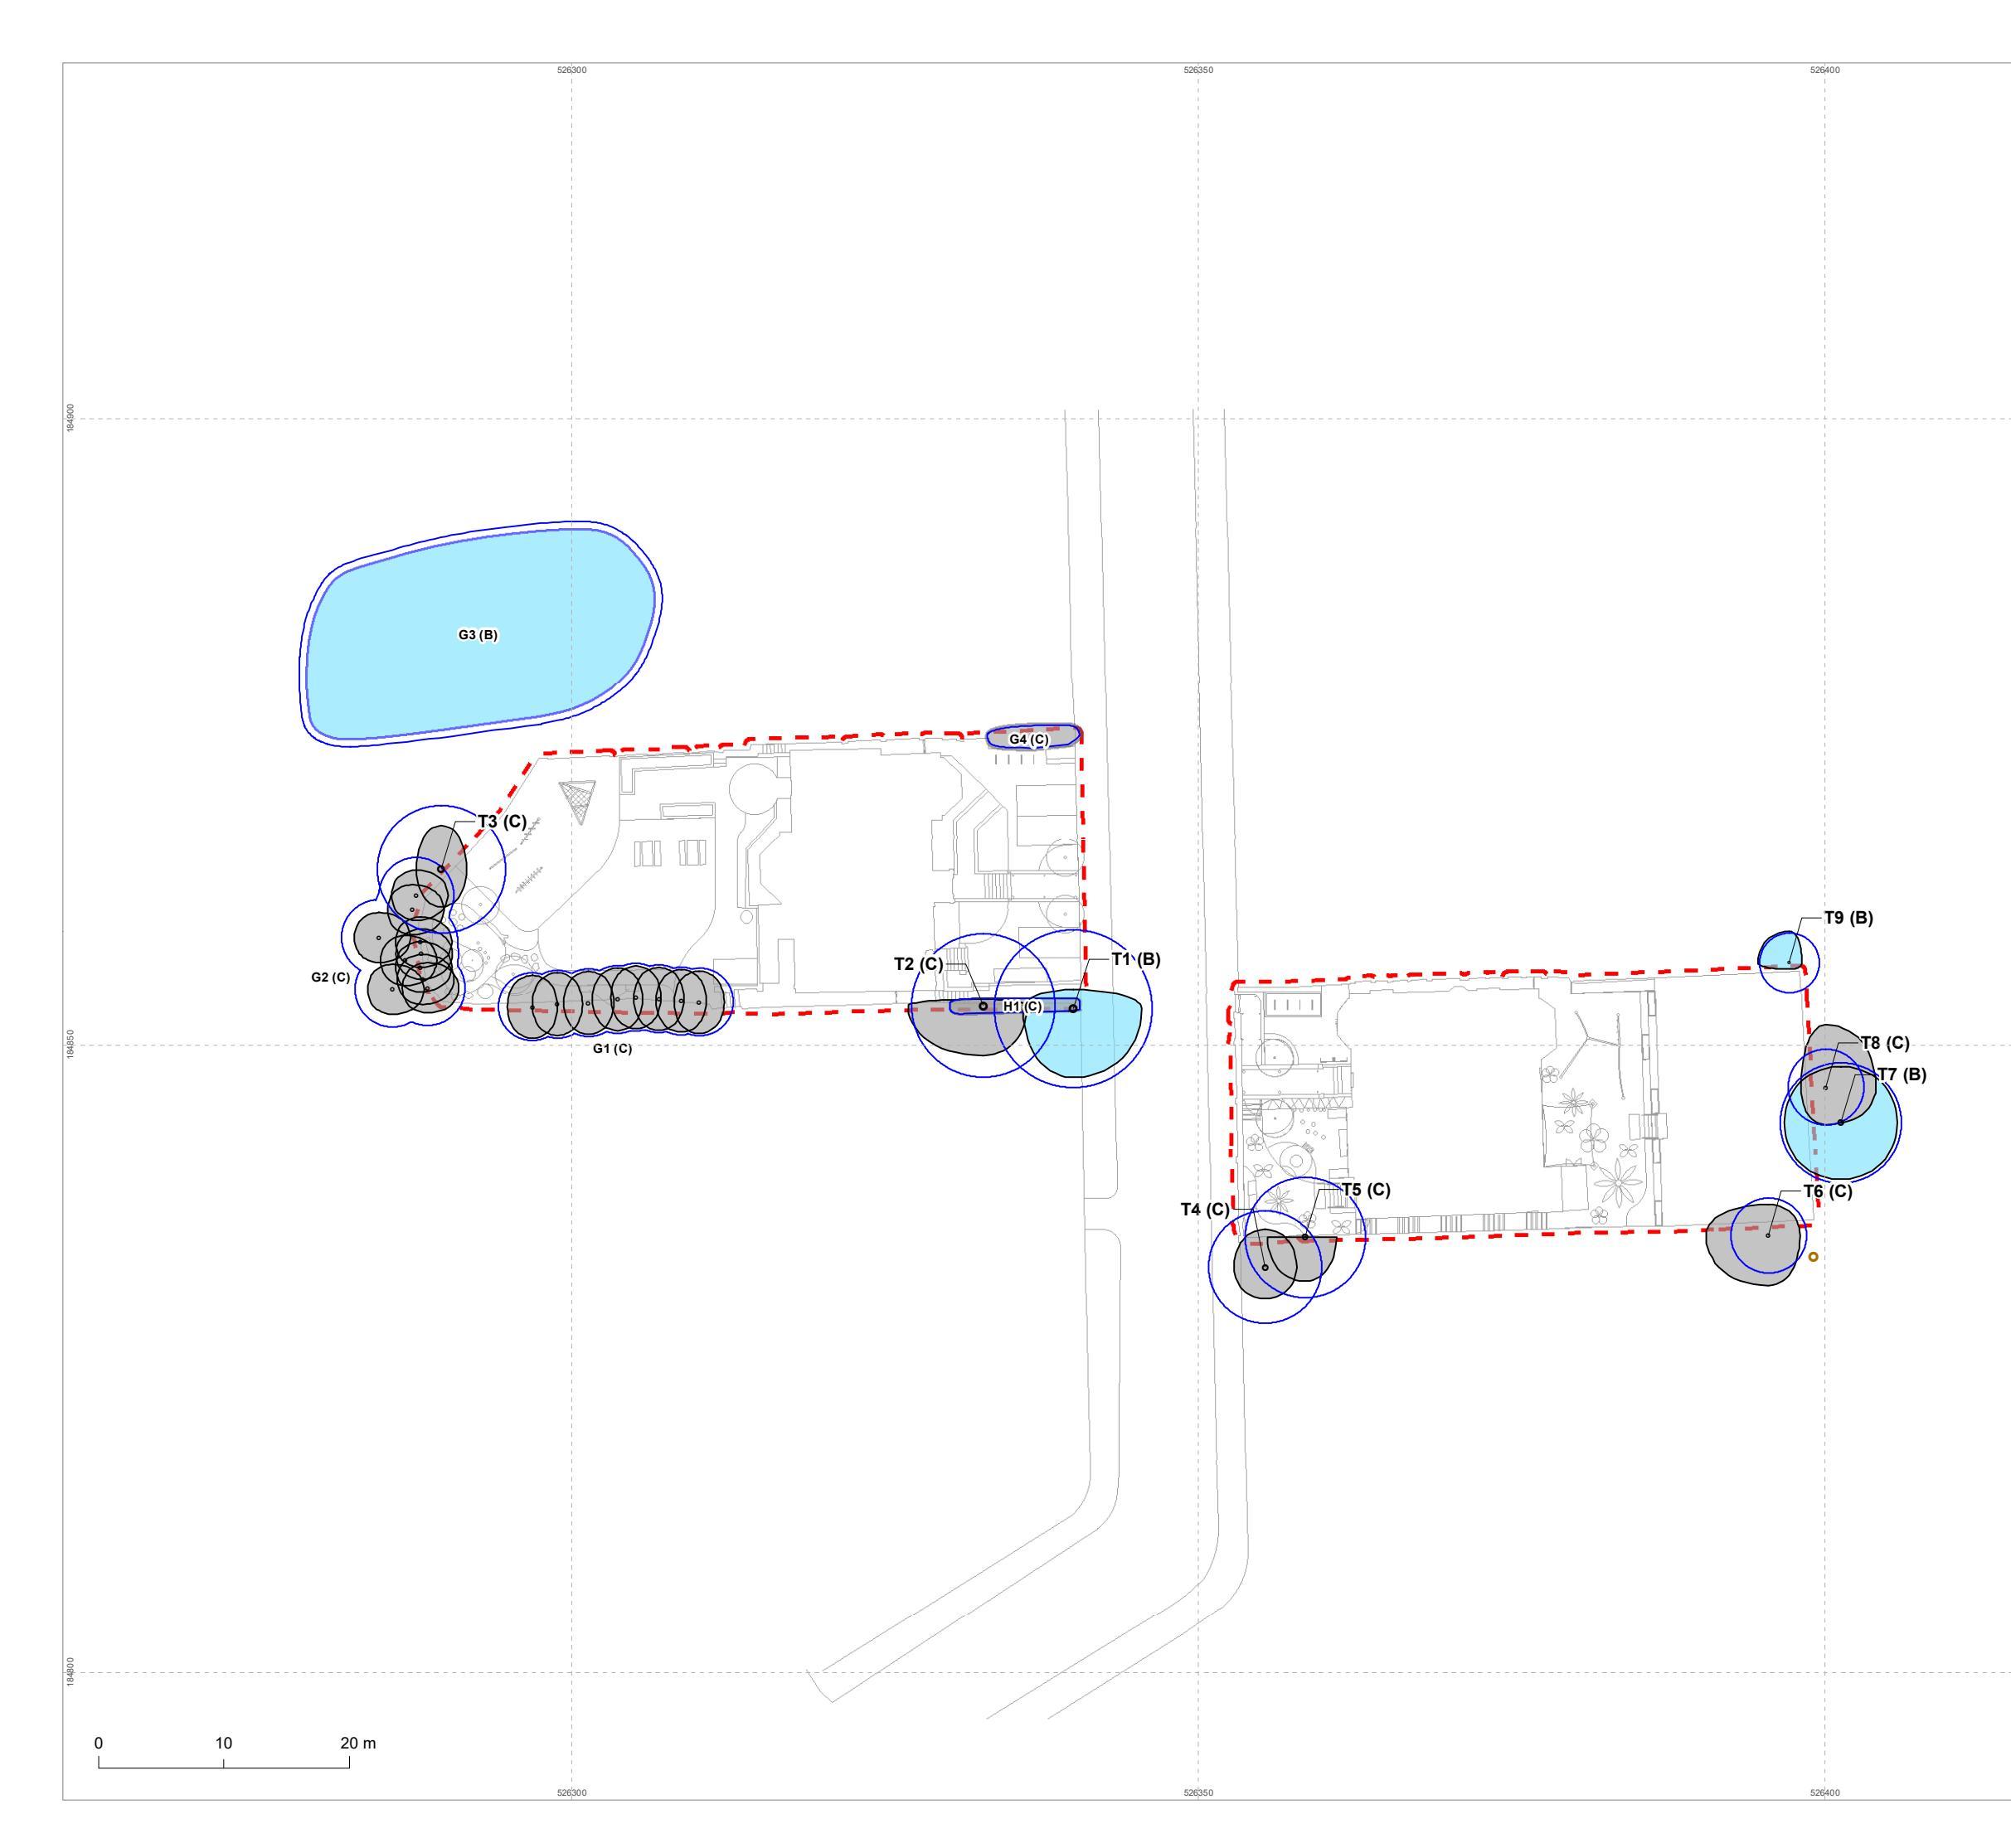
Drawing Number C154145-02-01 - Tree Retention Plan

The proposed development will not require the removal of any existing trees or groups within or adjacent to the site.

C154145-02-01 Legend • Tree location and stem diameter Tree stump Category B Category C ----- Current canopy - tree to be retained - Root Protection Area Site boundary T - Tree H - Hedgerow G - Tree group Note: tree locations are approximate, based on combined field observations and aerial imagery The original of this drawing was produced in colour a monochrome copy should not be relied upon NOTES All dimensions to be verified on site. Do not scale this drawing, use figured dimensions only. All discrepancies to be clarified with Project Arboriculturalist. Drawing to be read in conjunction with Preliminary Arboricultural Assessment and Tree Schedule. Drawing has been produced in colour and is based on digital informaton in .dwg format, aerial images and/or GPS location where appropriate. A monochrome copy should not be relied upon. The exact position of individual trees or species included as part of a tree group, woodland or hedgerow should be checked and verified on site prior to any decisions for foundation design, tree operations or construction activity being undertaken. Further survey work would be required for calculating foundation depths. Further survey work would be required for calculating foundation depths. Trees are living organisms that change over time, the condition of all trees illustrated herein, are to be checked by the Project Arboriculturalist should works commence 12 months after the date of this survey. SOME TREES MAY BE SUBJECT TO STATUTORY CONSTRAINTS. IT IS THEREFORE ADVISED THAT NO WORKS SHOULD BE UNDERTAKEN TO ANY TREES ILLUSTRATED HEREIN WITHOUT FIRST OBTAINING THE RELEVANT AUTHORISATION TO DO SO UNLESS AGREED AS PER THE APPROVED PLANS THROUGH PLANNING CONSENT. This drawing is the property of Middlemarch Environmental Ltd CONSENT. This drawing is the property of Middlemarch Environmental Ltd and is issued on the condition it is not reproduced, retained or disclosed to any unauthorised person, either wholly or in part without written consent of Middlemarch Environmental Ltd. Middlemarch Environmental Ltd accept no liability for third party use. South Hampstead Junior School, London Tree Retention Plan GDST (The Girls' Day School Trust) C154145-02-01 00 ale @ A3 1:500 June 2021 BJ RP A MIDDLEMARCH /*_ ENVIRONMENTAL Triumph House, Birmingham Road, Allesley, Coventry CV5 9AZ T:01676 525880 F:01676 521400 E:admin@middlemarch-environmental.com This map is reproduced from the Ordnance Survey material with the permission of uro of The Controller of Her Majesty's Stationary Office. ® Crown copyright. Unauthorized Crown copyright and may lead to prosecution of civil proceedings Licence Number: 100040519
