# **VERIFICATION REPORT**

138-140 HIGHGATE ROAD, HIGHGATE, LONDON NW5 1PB

Report Title:	Verification Report for 138-140 Highgate Road, Highgate, London NW5 1PB										
Report Status:	Final v1.0										
Job No:	P1323J1303/TE										
Date:	01/12/2022										
Quality Contro	I: Revisions		1								
Version	Date	Issued By	Comment								
	Prepared by	: JOMAS ASSOC	IATES LTD For: SPA	ACE FREE LTD							
Prepa	ared by	<mark>Rev</mark>	<mark>iewed by</mark>	Approved by							
Dominic Hutcl	chins BEng(Hons) Tom Elbourne BSc (Hons), FGS Tom Elbourne BSc (Hons),										
Eng	gineer Geo-environmental Engineer Geo-environmental Engineer										
The Tillen Tillen

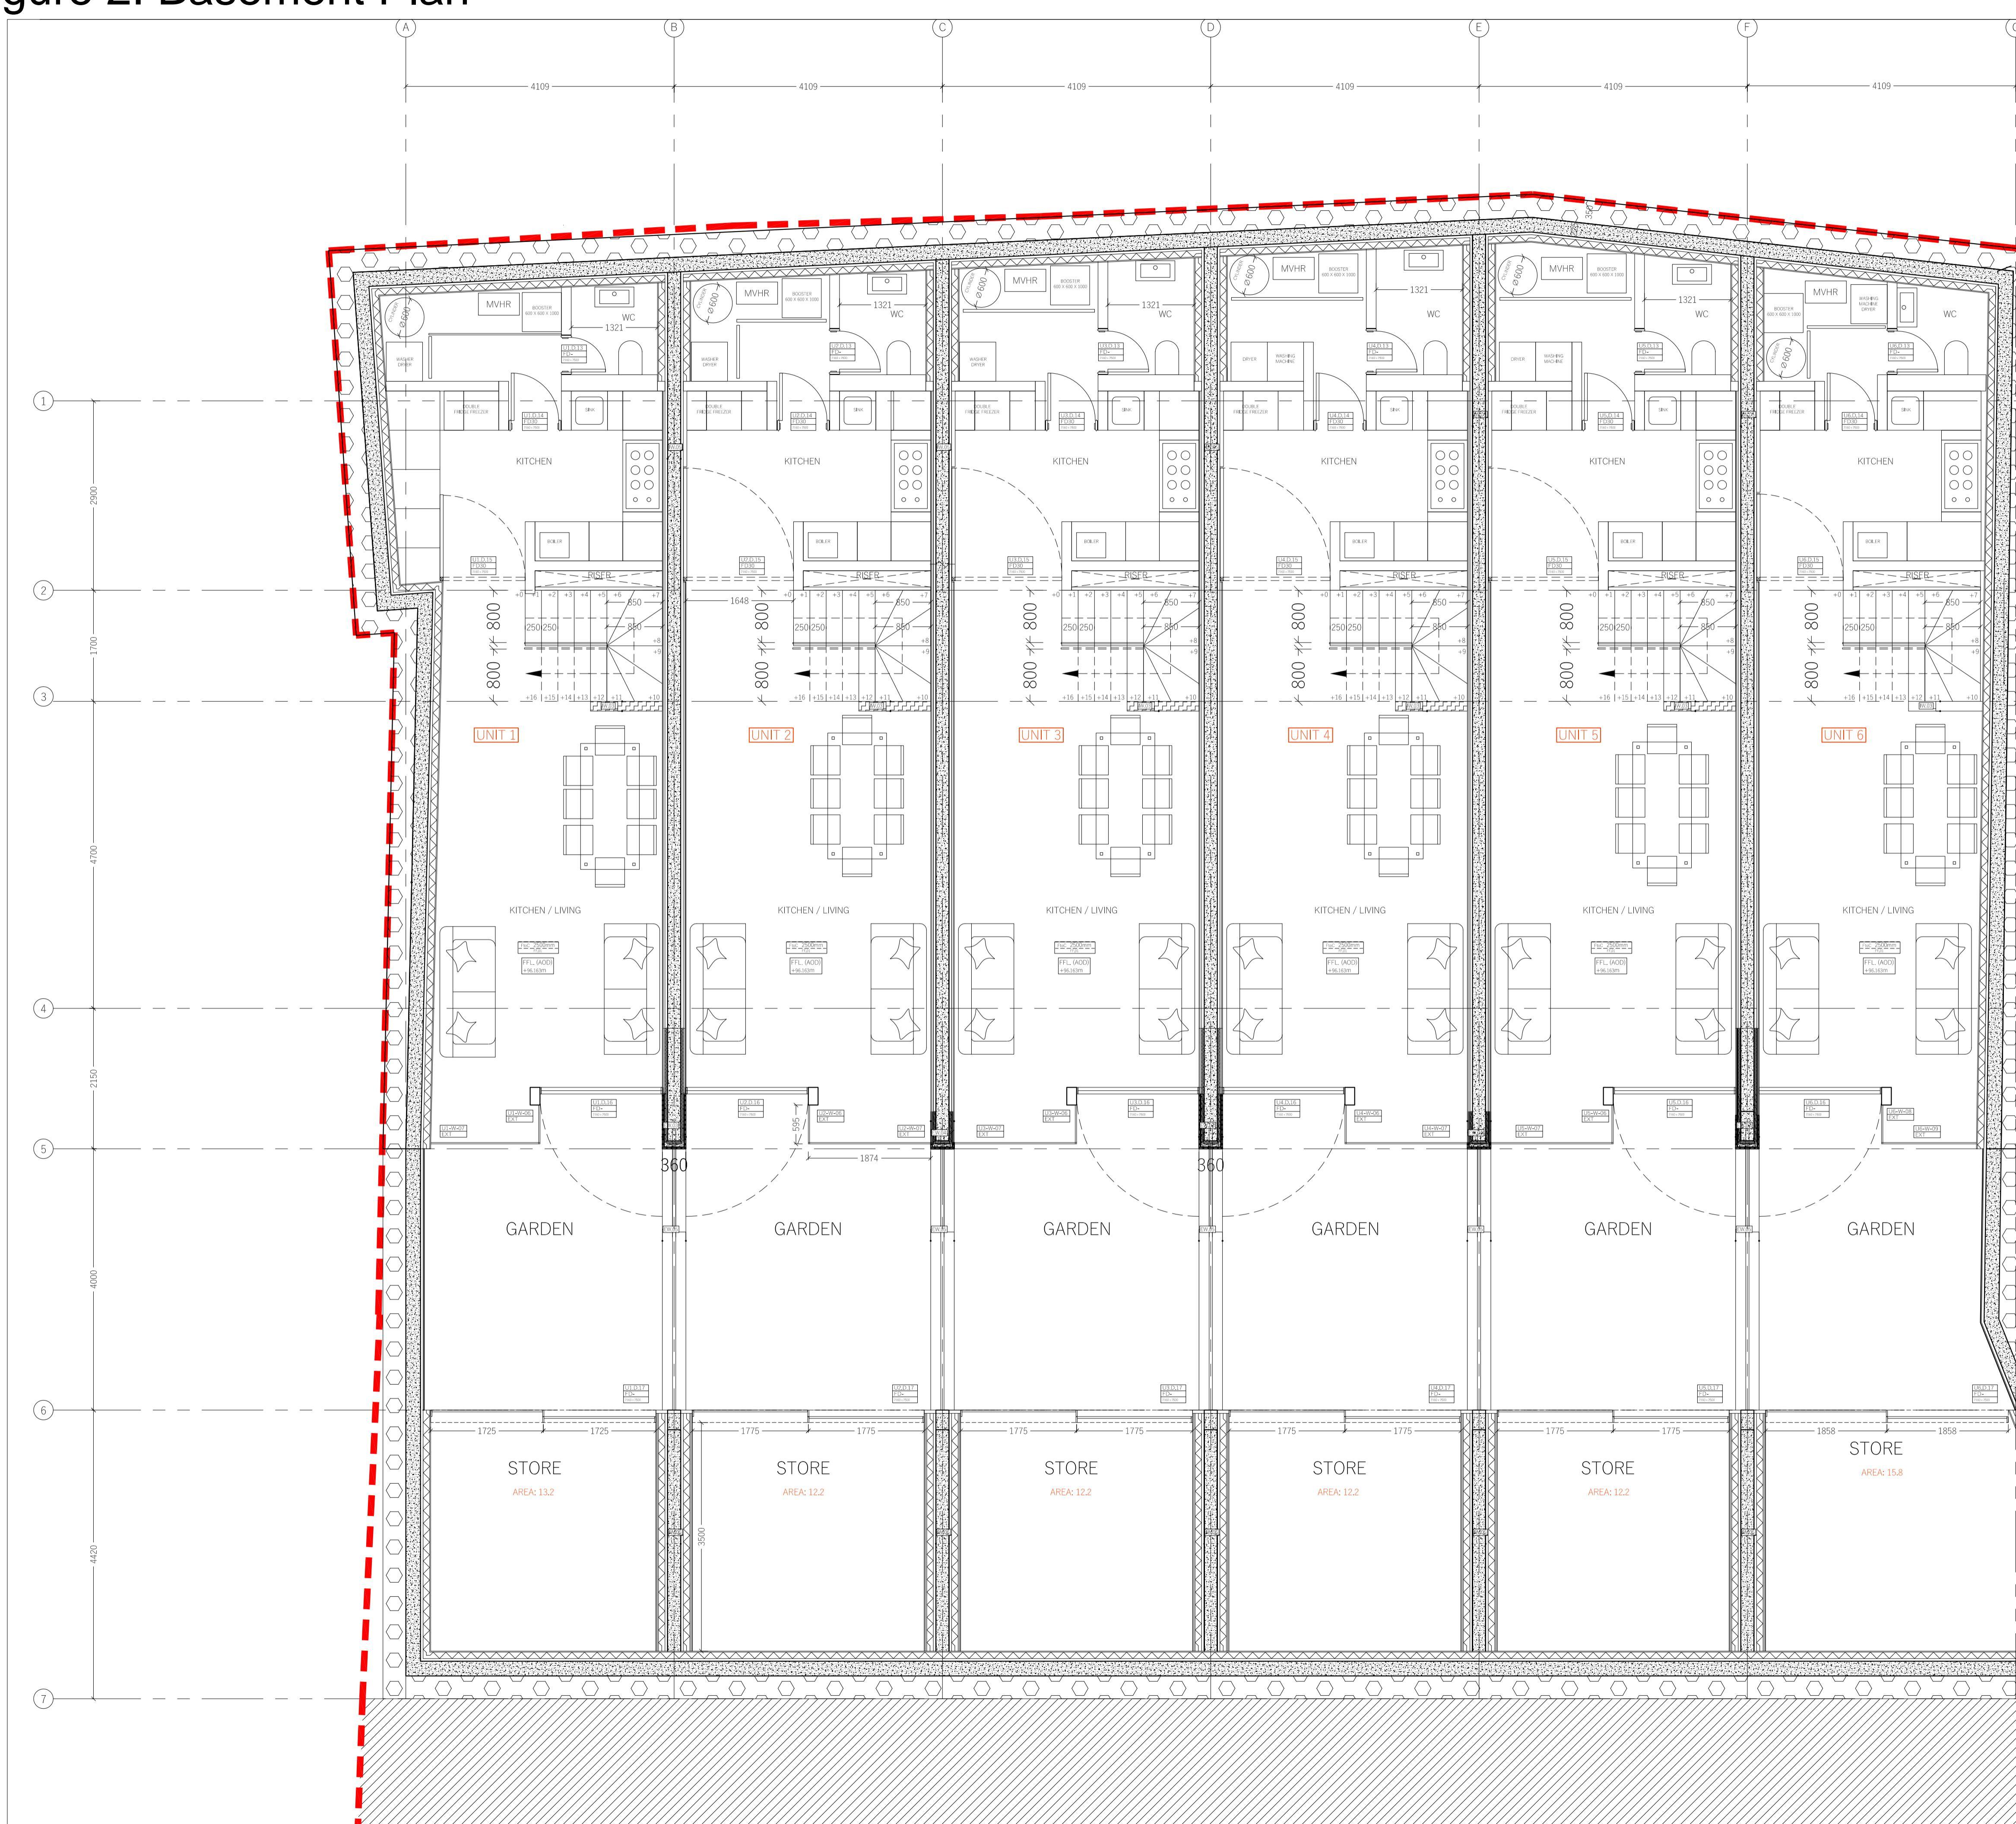
# Figure 2: Basement Plan

- 1.1.2 A site location plan is provided as Figure 1.
- 1.1.3 The site has undergone redevelopment comprising the demolition of the existing structures associated with former fuel station and workshop use and construction of a new three-storey residential development. The development includes a lower ground floor (north-east is entirely below ground level and south-west is at ground level due to site topography) and a full single-storey basement below. An area of communal soft landscaping is present facing Highgate Road. Private landscaping has been provided above the proposed basement slab. Basement and ground floor plans are presented as Figures 2-5.
