HERITAGE / DESIGN AND ACCESS STATEMENT

FULL PLANNING IN A CONSERVATION AREA

THE TOWERS, 39 DARTMOTUH PARK AVENUE, CAMDEN, NW5 1JP

2nd March 2023 – V. P2

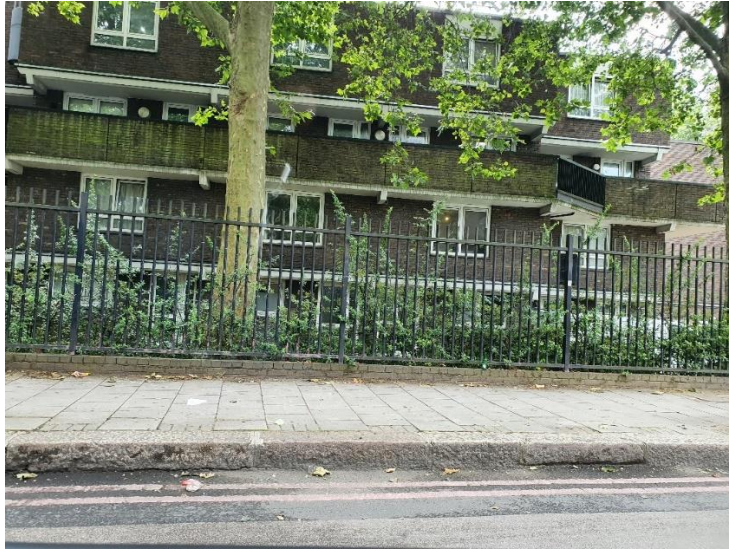
As part of the exercise, Potter Raper have found a similar example within Camden, which the photo below identifies. This design provide a high level of security and access control, without having an significant impact on viewing the building from the street due to the gaps between railing bars.

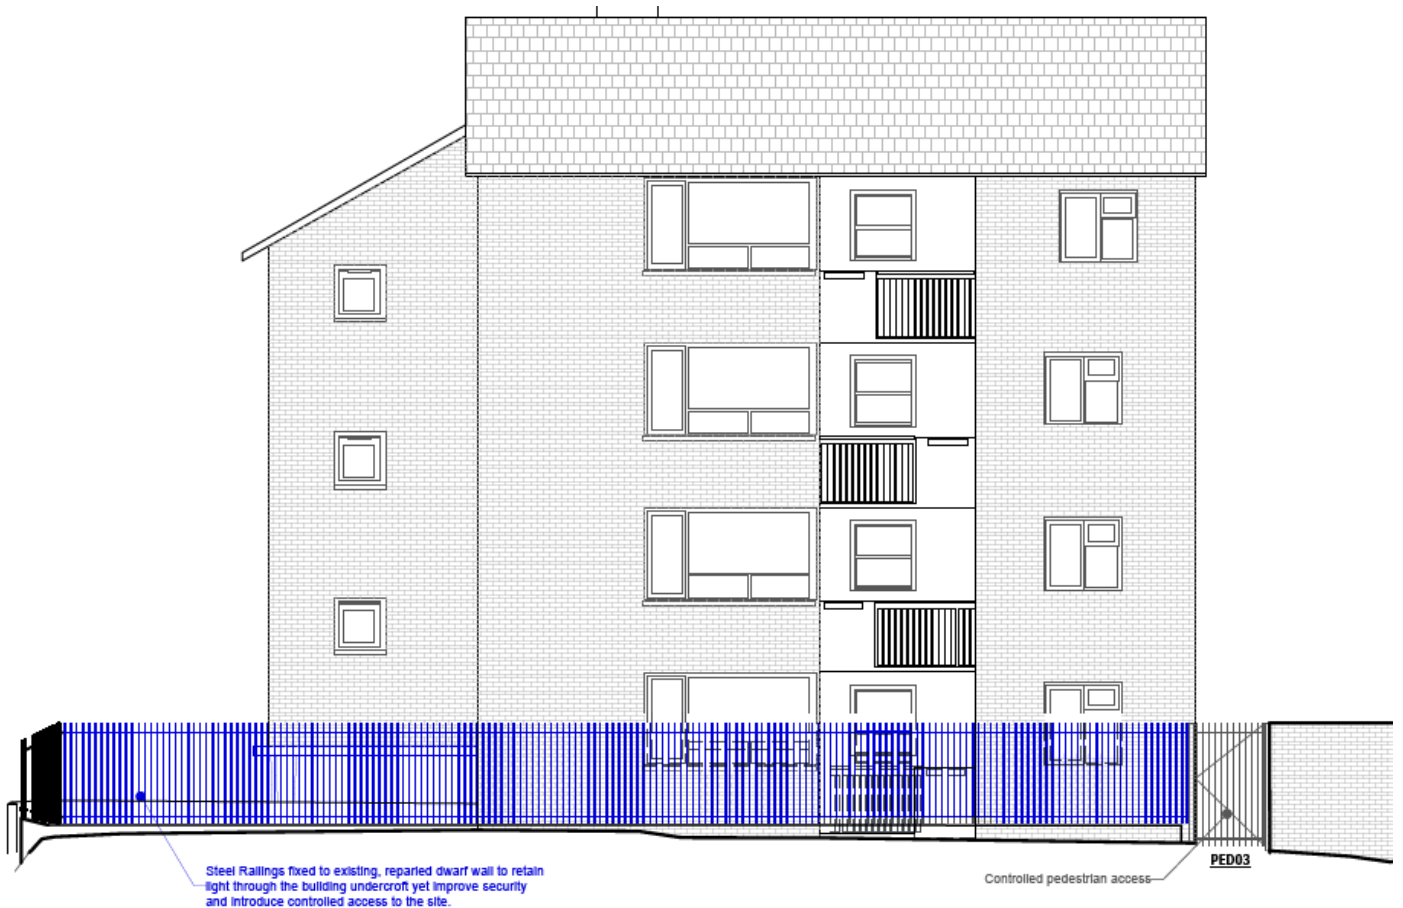
Further to this, the topography of the site means that the 1.8m high railings have a reduced impact on the view of the building itself. On Dartmouth Park Hill, where the railing will be at the highest topography, the significant undercroft feature that the local planning authority are keen to preserve is not visible. The view from this street is simply of the 'rear' elevations of 4 of the eastern units. There is already a low level fence in place here which is a grated design and less sympathetic in style as the proposals. The 1.8m high option will also match the height of the brick wall located to the north eastern boundary of the site, along the Dartmouth Park Hill Street Scene.

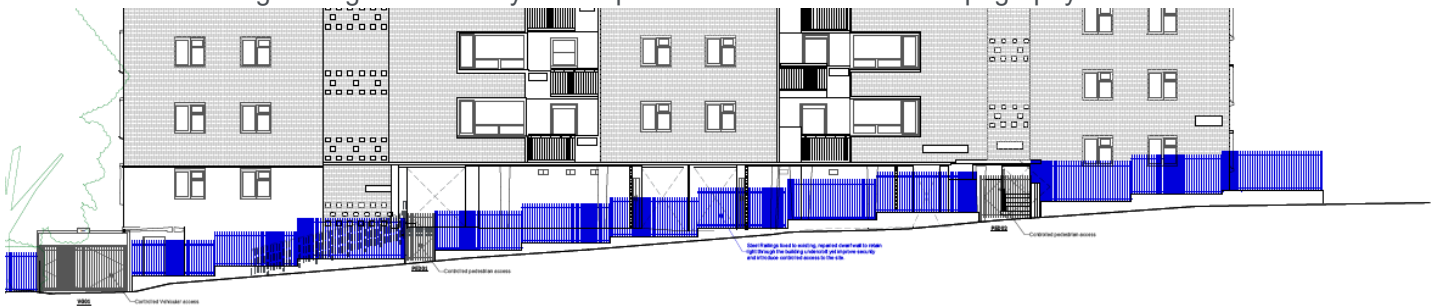
Along the Dartmouth Park Avenue street scene, the topography falls, reducing the impact the boundary treatment has on the ground floor of the block because the ground floor is at a consistent height. The most affected area is therefore the entrance to the eastern stair core. This area has limited visibility as it is through to the rear, as there is a much narrower corridor of light. In terms of light from the rear, the railings will have little material impact due to the gaps between bars as well as being located away from the building, on the boundary. The architectural importance of the building is subsequently largely maintained whilst helping to solve to ASB issues experienced by residents. By the midpoint of the undercroft where most of the light comes through from the rear, the topography at the boundary is much lower, meaning that the proposed boundary treatment has a lesser effect on the view of the building. By the end of the block the railings and gates has very little impact at all due to the lower topography.
