31 Highgate High Street, London, N6 5JT
Design, Access & Heritage Statement - Rev 03

New rooflight to roof to rear outrigger, restoration works
to main facade.

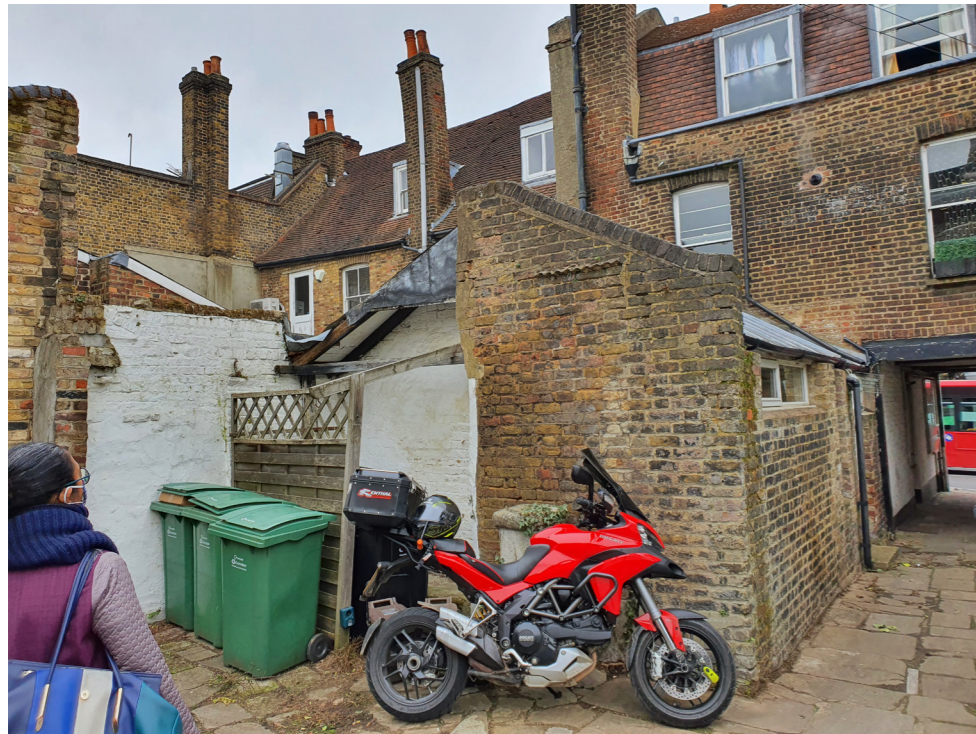
Rear single storey annexe to original building

This rear wing has been modified extensively over the years with the addition of glazed bricks and a glazed roof that is now in a state that needs attention.

The back extension's brickwork is in bad shape and has undergone significant changes. Given the shape of the back elevation of the house and the presence of two apertures that are presumed to have been a window and a doorway, it appears that the outbuilding is a later addition. This implies that there was once an external elevation here.

The back outbuilding's footprint, form, scale, and massing will all remain unchanged. Poorly done interventions have harmed the outbuilding externally. The suggestions will restore the structure to a decent condition, preserving the existing brickwork walls and repairing them with similar materials.

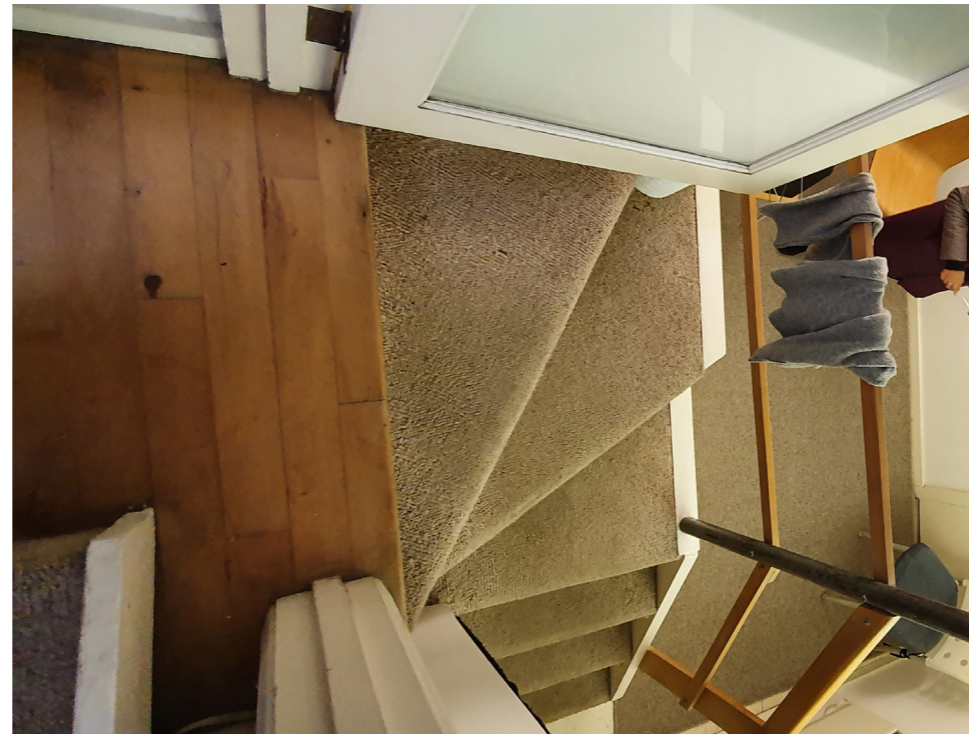
Current staircase down to basement level

The original rear opening at ground floor is also to be utilised as the ongoing access down to the basement level. The glass block infill that has been added to the archway will be removed, and the original opening will be restored in its entirety: this will allow for better headroom down the stair into the basement which is currently awkward.

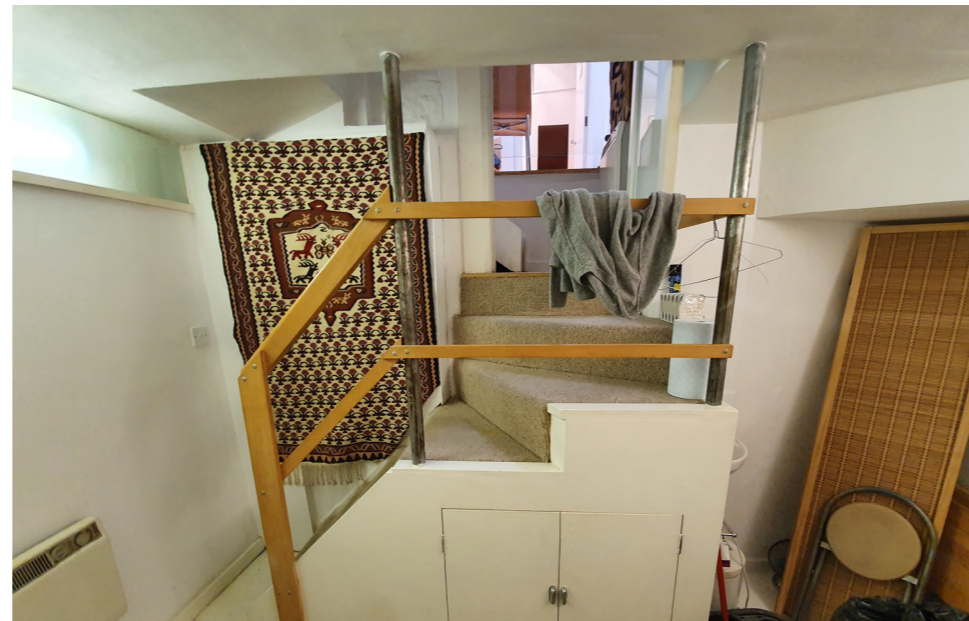
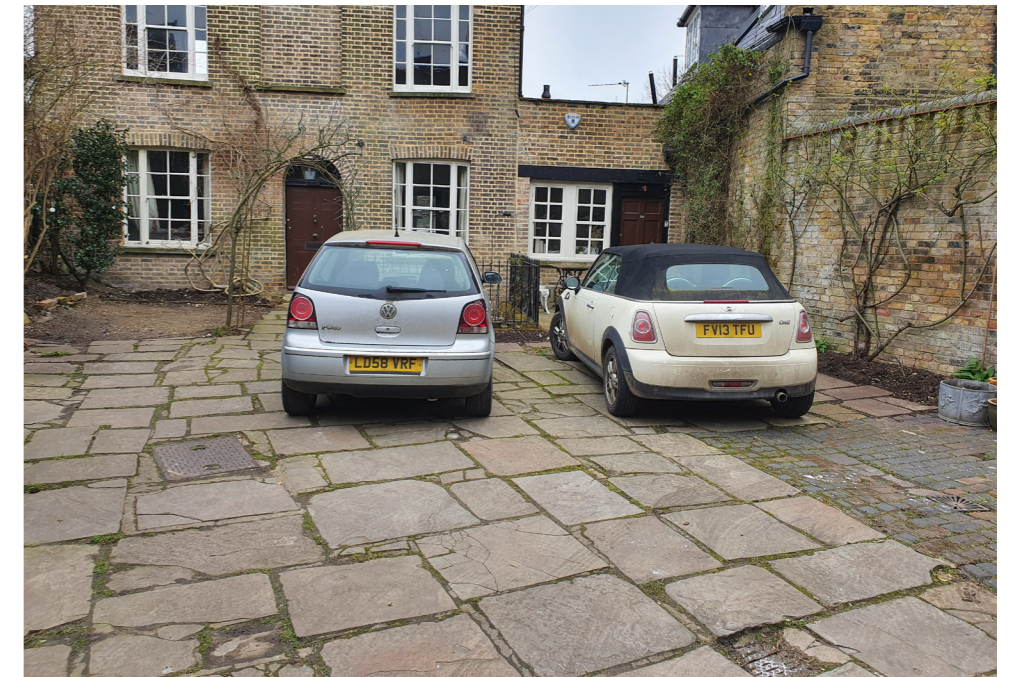
Rear courtyard with residential unit beyond

The unit benefits from a basement which has currently been split internally with the front portion designated as ancillary to the retail unit and the rear portion accessed via a secondary staircase from the office. The stairwell to this appears to have been formed from an original rear opening to the building. Albeit this staircase down is awkward in terms of access.

- Create a replacement freestanding staircase down to the basement.
- Instate a shower room to support the legal requirements of an office.
- Create a storage area.
- Remove existing plasterboard and instate new timber frame with DPM to back face, to treat damp to walls internally.

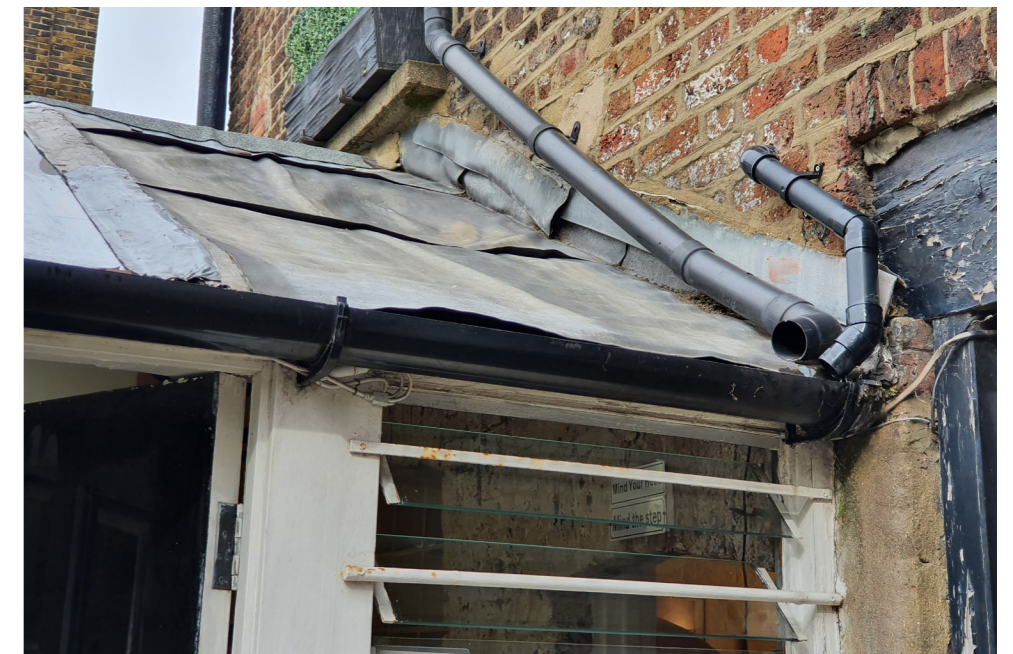
Ad-hoc nature of existing roof to annexe

The roof over this rear wing has come into a state of disrepair and a number of adhoc repairs have already been undertaken. This opportunity is being taken to renew the roof and restore some of the original detailing in terms of guttering and architectural articulation for this area, including the introduction of a parapet and cast iron rainwater hopper for the discharge of rainwater from the roof.

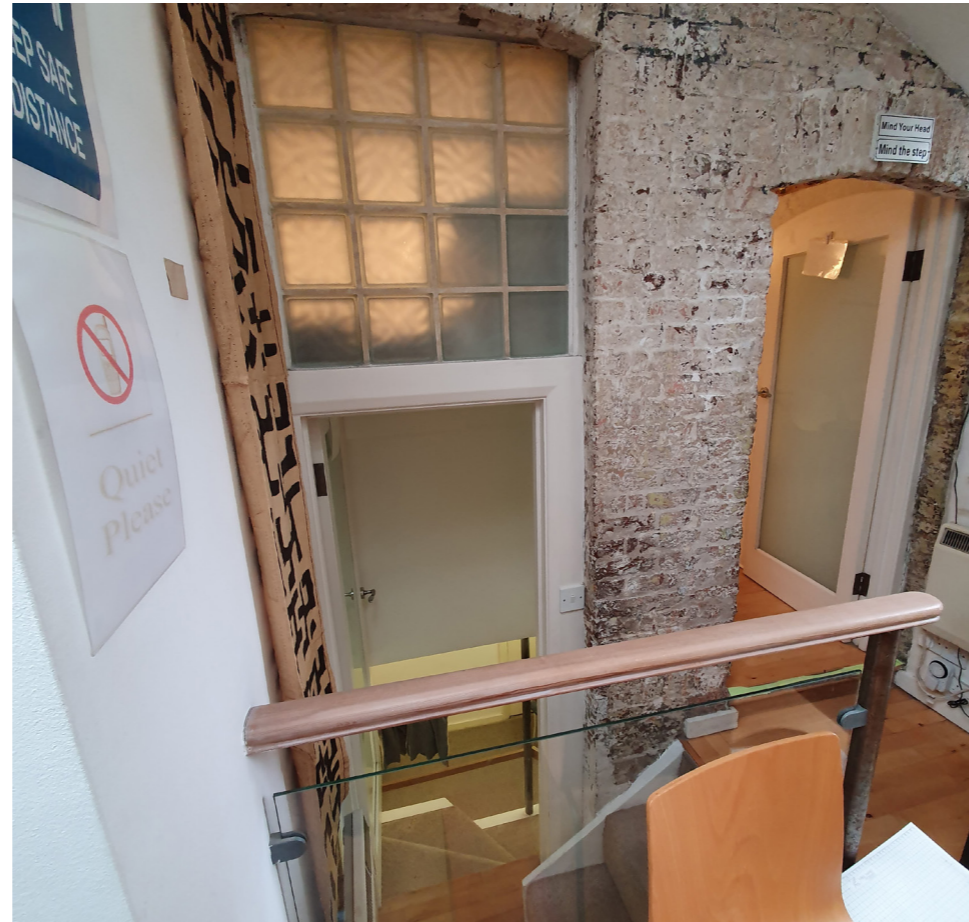
Existing opening which takes staircase down to the basement level

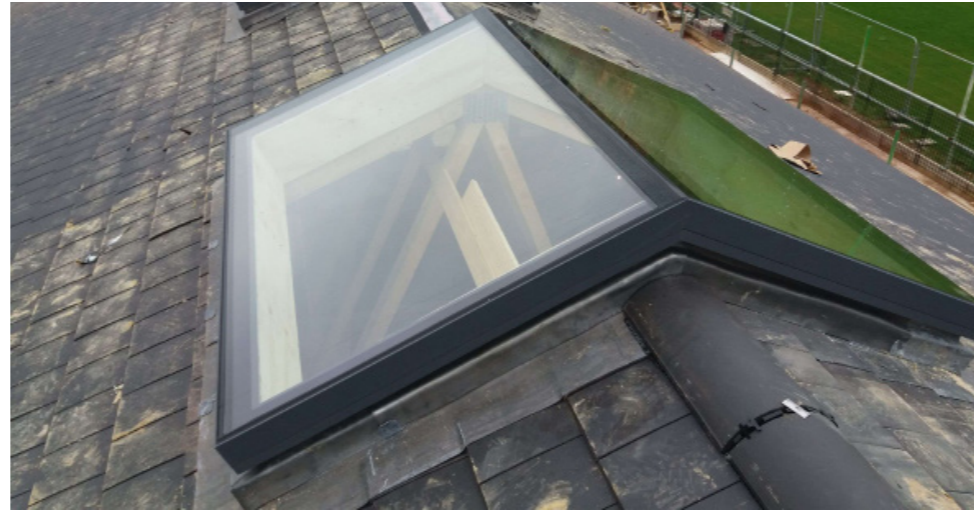
Sliding rooflights (for illustrative purposes)

At ground floor, the proposal allows for a sliding rooflight in the office space to maximise ventilation and natural light. Historic records show that this was originally built in two sections and the proposed structure reflects this.

To the roof of the rear annexe, this will be re-tiled in slate to match the original roof with some additional double glazed sliding over rooflights in a conservation area style.
