10 Bloomsbury Way, London WC1A 2SL +44 (0)20 3871 2951 www.theheritagepractice.com info@theheritagepractice.com Heritage Appraisal No. 91a Belsize Lane, London, NW3 5AU January 20223

1 Introduction

1.1 The following Heritage Appraisal has been prepared in support of applications for planning permission and listed building consent for the extension and alteration of no. 91a Belsize Lane, London, NW3 5AU. No. 91a comprises the ground and lower ground floors of no. 91 that was converted into two, twostorey maisonettes in the 1970s. The following appraisal should be read in conjunction with the drawings and Design and Access Statement prepared by Chris Dyson Architects.

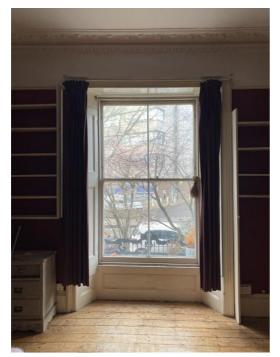
Figure 9: Front room bay with original window and associated details.

a bay to the street housing an original window with shutters, lining and architrave. There are good skirting and cornice details and an original fire surround with grate. The door and architrave to the entrance hall is original and of a good quality.

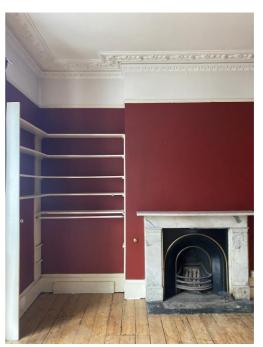
Figure 10: Cornice and fire surround detail, front room.

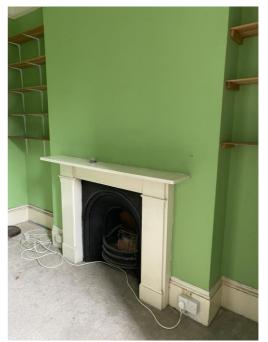
Figure 14: Original fireplace to rear room and original skirting.

3.14 With the exception of the 1930s fire surround, this room retains its historic form and character (figures 22-25). The panelling to the shutters is more modest than at ground floor level, reflecting the floor hierarchy and the more modest character of the lower ground floor. This is also reflected in the lack of cornices and modest skirting (modern).

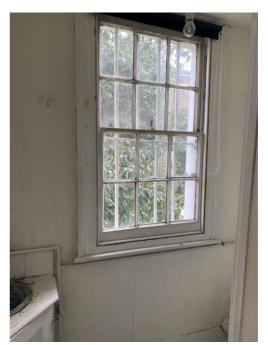
Figure 16: Original window to rear bathroom.

3.10 The rear closet wing retains a similar level of historic fabric and fittings. The ground to lower ground floor stair is original, as is the door that encloses this stair (figures 15-18). The door to the rear bathroom is also original.

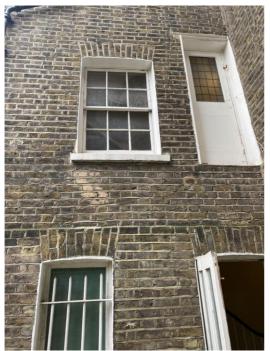
Figure 18: Historic ground floor door adjacent to original window opening.

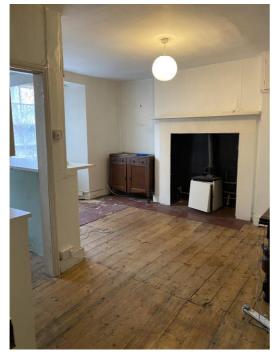
Figure 19: Front room, lower ground floor.

3.13 The front room has a small kitchen added in the south-west corner but is otherwise complete in terms of its original volume (figure 19). There is a good sized chimney breast opening to the front room with original timber surround. The opening is indicative of a historic kitchen use. There is an area of painted flagstone around the window which is an interesting survival. The flagstones appear to be in a poor condition. The door to the front room is original.

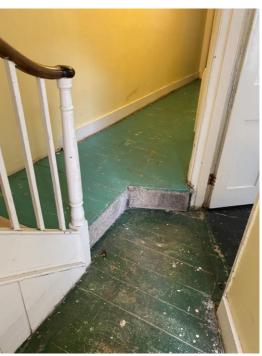
Figure 20: Platform in lower ground floor hallway.

3.12 The lower ground floor comprises front and rear rooms with a bathroom in the rear closet wing as noted above. A long corridor extends the length of the flat from the stairs towards the front of the building. The floor level has been raised in this location, apparently to deal with a change in levels across the flat. However, this platform has affected the stair and is generally atypical in this context (figure 20).

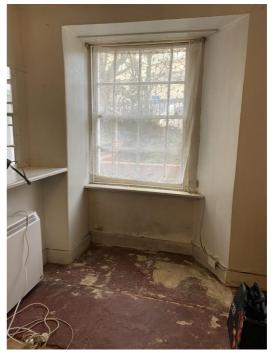
Figure 21: Front window at LGF with flagstone below.

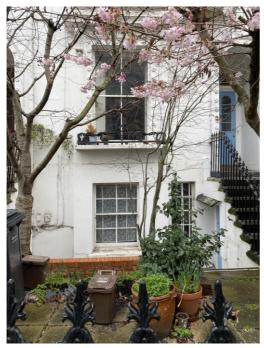
Figure 29: Front elevation with poor retaining wall treatment.

and historic window alterations and the retaining wall affect that architectural expression.

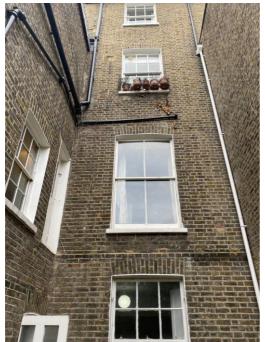
Figure 30: rear elevation.
