Planning

London NW3 4DU

Rear Elevations

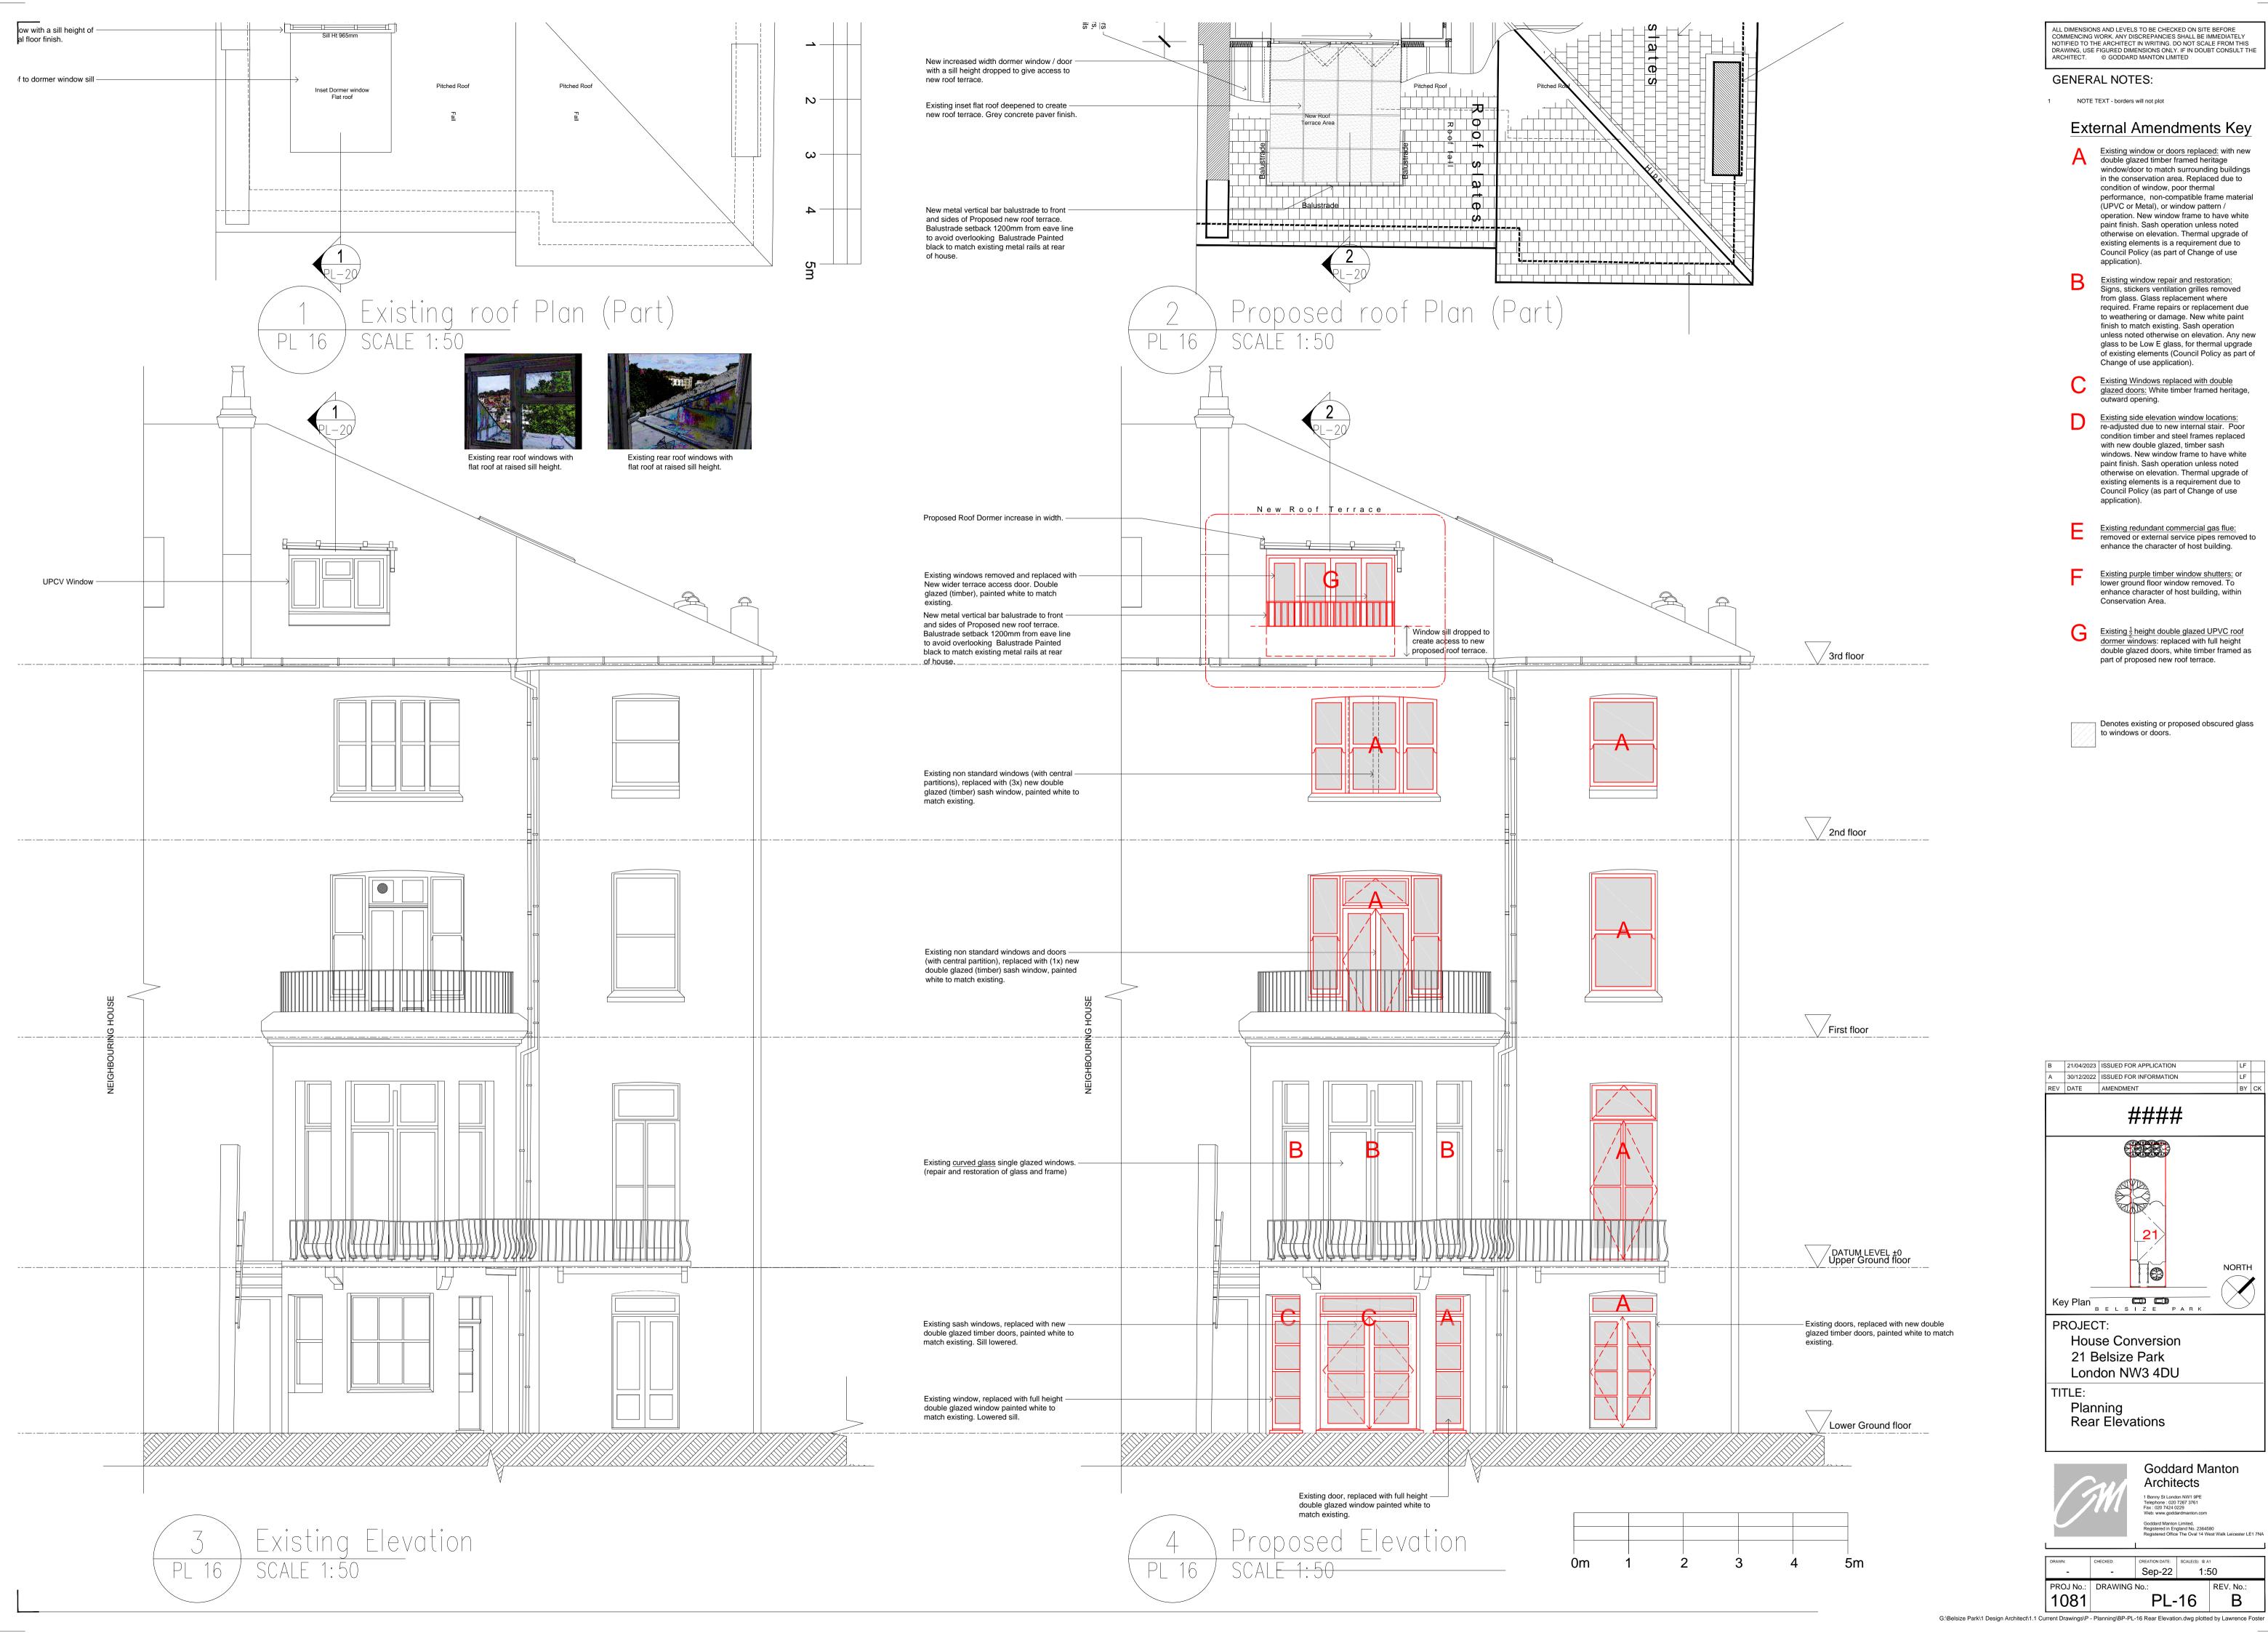
Sep-22 1:50 PL-16

Existing window or doors replaced: with new double glazed timber framed heritage window/door to match surrounding buildings in the conservation area. Replaced due to condition of window, poor thermal performance, non-compatible frame material (UPVC or Metal), or window pattern / operation. New window frame to have white paint finish. Sash operation unless noted otherwise on elevation. Thermal upgrade of existing elements is a requirement due to Council Policy (as part of Change of use application).

Existing window repair and restoration:
Signs, stickers ventilation grilles removed from glass. Glass replacement where required. Frame repairs or replacement due to weathering or damage. New white paint finish to match existing. Sash operation unless noted otherwise on elevation. Any new glass to be Low E glass, for thermal upgrade of existing elements (Council Policy as part of Change of use application).

Existing Windows replaced with double glazed doors: White timber framed heritage, outward opening.

Existing side elevation window locations: re-adjusted due to new internal stair. Poor condition timber and steel frames replaced with new double glazed, timber sash windows. New window frame to have white paint finish. Sash operation unless noted otherwise on elevation. Thermal upgrade of existing elements is a requirement due to Council Policy (as part of Change of use

Existing redundant commercial gas flue: removed or external service pipes removed to enhance the character of host building.

Existing purple timber window shutters: or lower ground floor window removed. To enhance character of host building, within Conservation Area.

$\frac{\text{Existing }\frac{1}{2} \text{ height double glazed UPVC roof}}{\text{dormer windows}} : \text{replaced with full height}$ double glazed doors, white timber framed as part of proposed new roof terrace.

Denotes existing or proposed obscured glass to windows or doors.
