BS 5837 Arboricultural Report

Impact Assessment & Method Statement

**Wallace House
Fitzroy Park
London
N6 6HT**

**Dated
3rd April 2023**

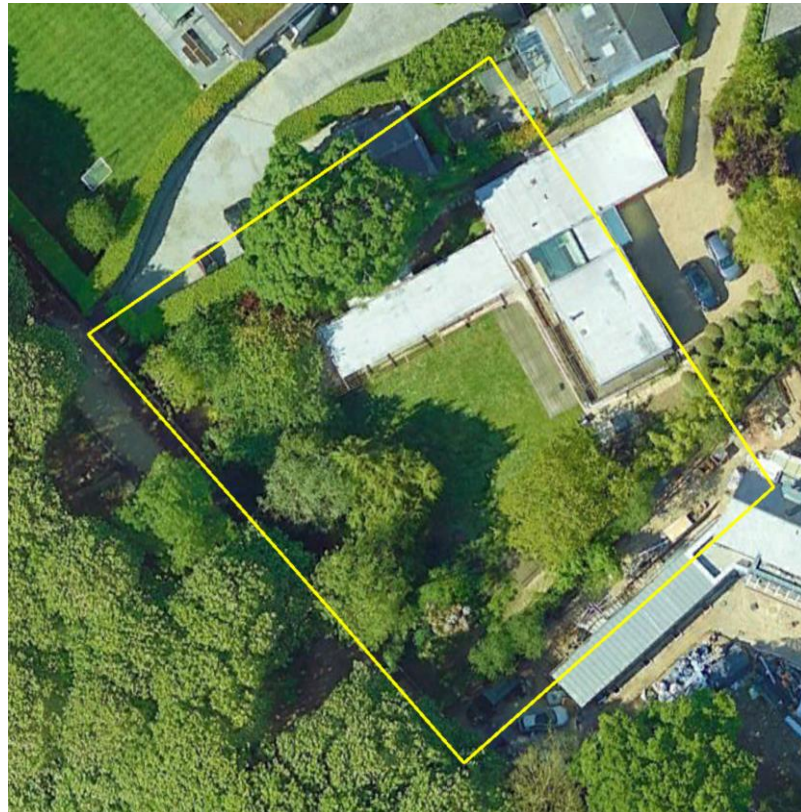
Figure 1 Extent of the survey (image is not current).

2.1.3. The survey area encompasses the rear garden of a detached property (the 'site') along with trees beyond the site boundary, which could potentially be affected by any development of the site.

2.1.2. Our survey covered the area indicated in Figure 1.
