Arboricultural Impact Assessment Method Statement & Tree Protection Plan (to BS:5837 2012)

15 Crediton Hill, London

Prepared for Mr & Mrs Warren

Ref: TH 3771

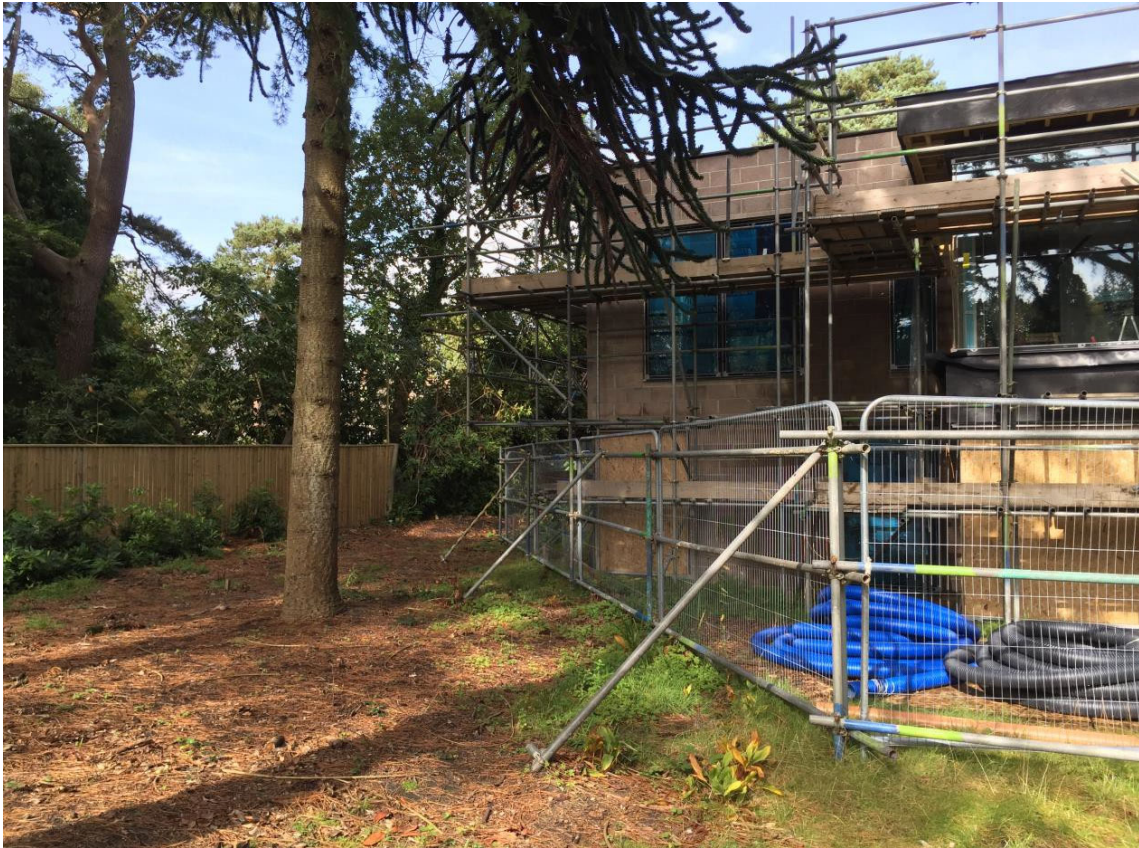
Photo 1: A worked example of the default specification for protective barrier (BS 837:2012)

The framework support (shown in Figure 2 and photo 1) is the usual method of support for 'Heras' fencing. Some variations are possible if site conditions are appropriate; i.e. support by wooden posts (75mm x 75mm x 2.75m) dug or concreted into the ground (dry mix concrete contained within a plastic bag), or if there is no pressure for access, a lighter form of netting on stakes.

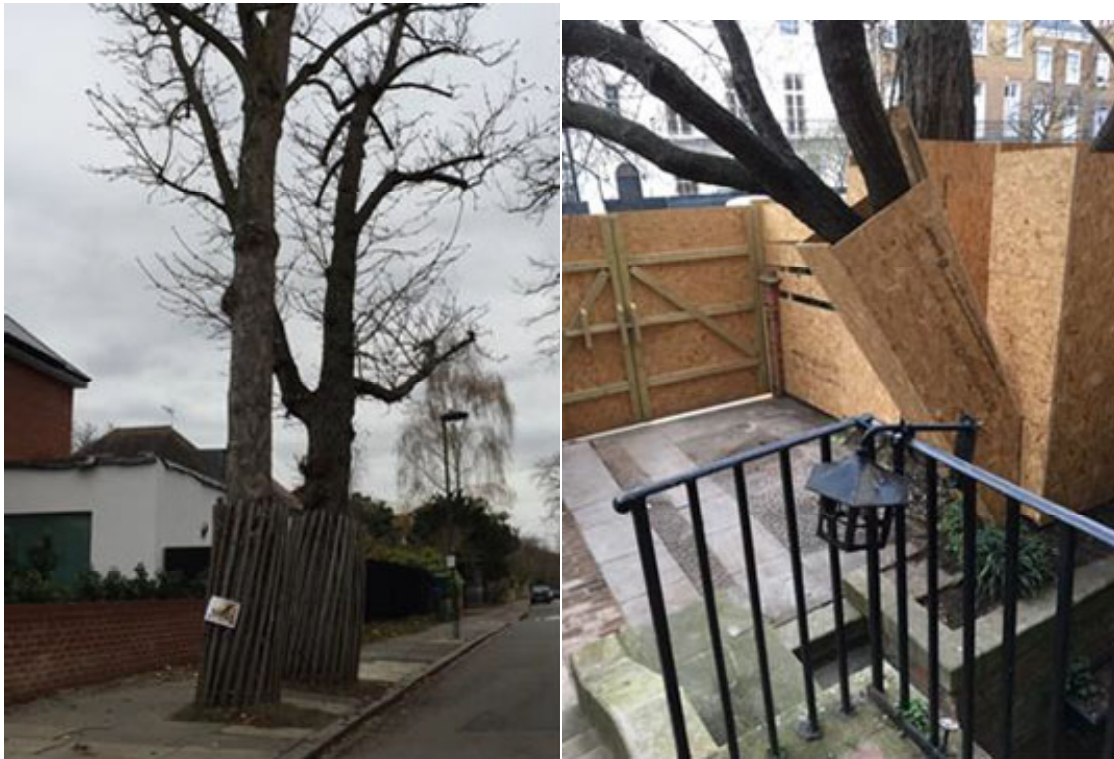
Photo 2: Trees protected by hessian & chestnut pale fencing / limbs protected by wooden boxing

Where specified in the AMS, the tree(s) stem/s shall be boxed off with wooden ply boards or wrapped in hessian and chestnut pale fencing / trunk protection (see example below). This will help avoid any direct damage to tree stems from passing machinery (see photo 2).
