Project
 1 Templewood Avenue

Title
 South East Elevation
 Existing with demolition

Drawing Number	Revision
1705_PL_07_120	P01

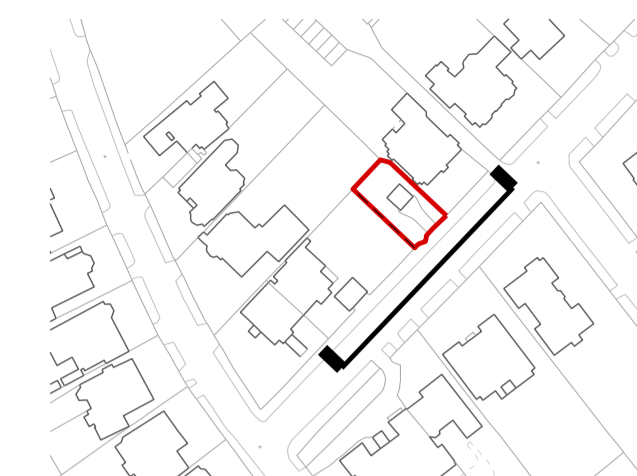
Overgrown, dead and poor quality trees impacted by the works removed in accordance with the Arboricultural report and Tree Survey - refer to Elemental AIA and Seed Landscapes removal drawing

Existing entrance brickwork removed sufficiently to allow for tooting of new brickwork to match existing

Existing garages and surrounding retaining walls demolished

Existing concrete driveway demolished
