© Copyright Rock Townsend Architects LLP

MF5 Ceiling Section

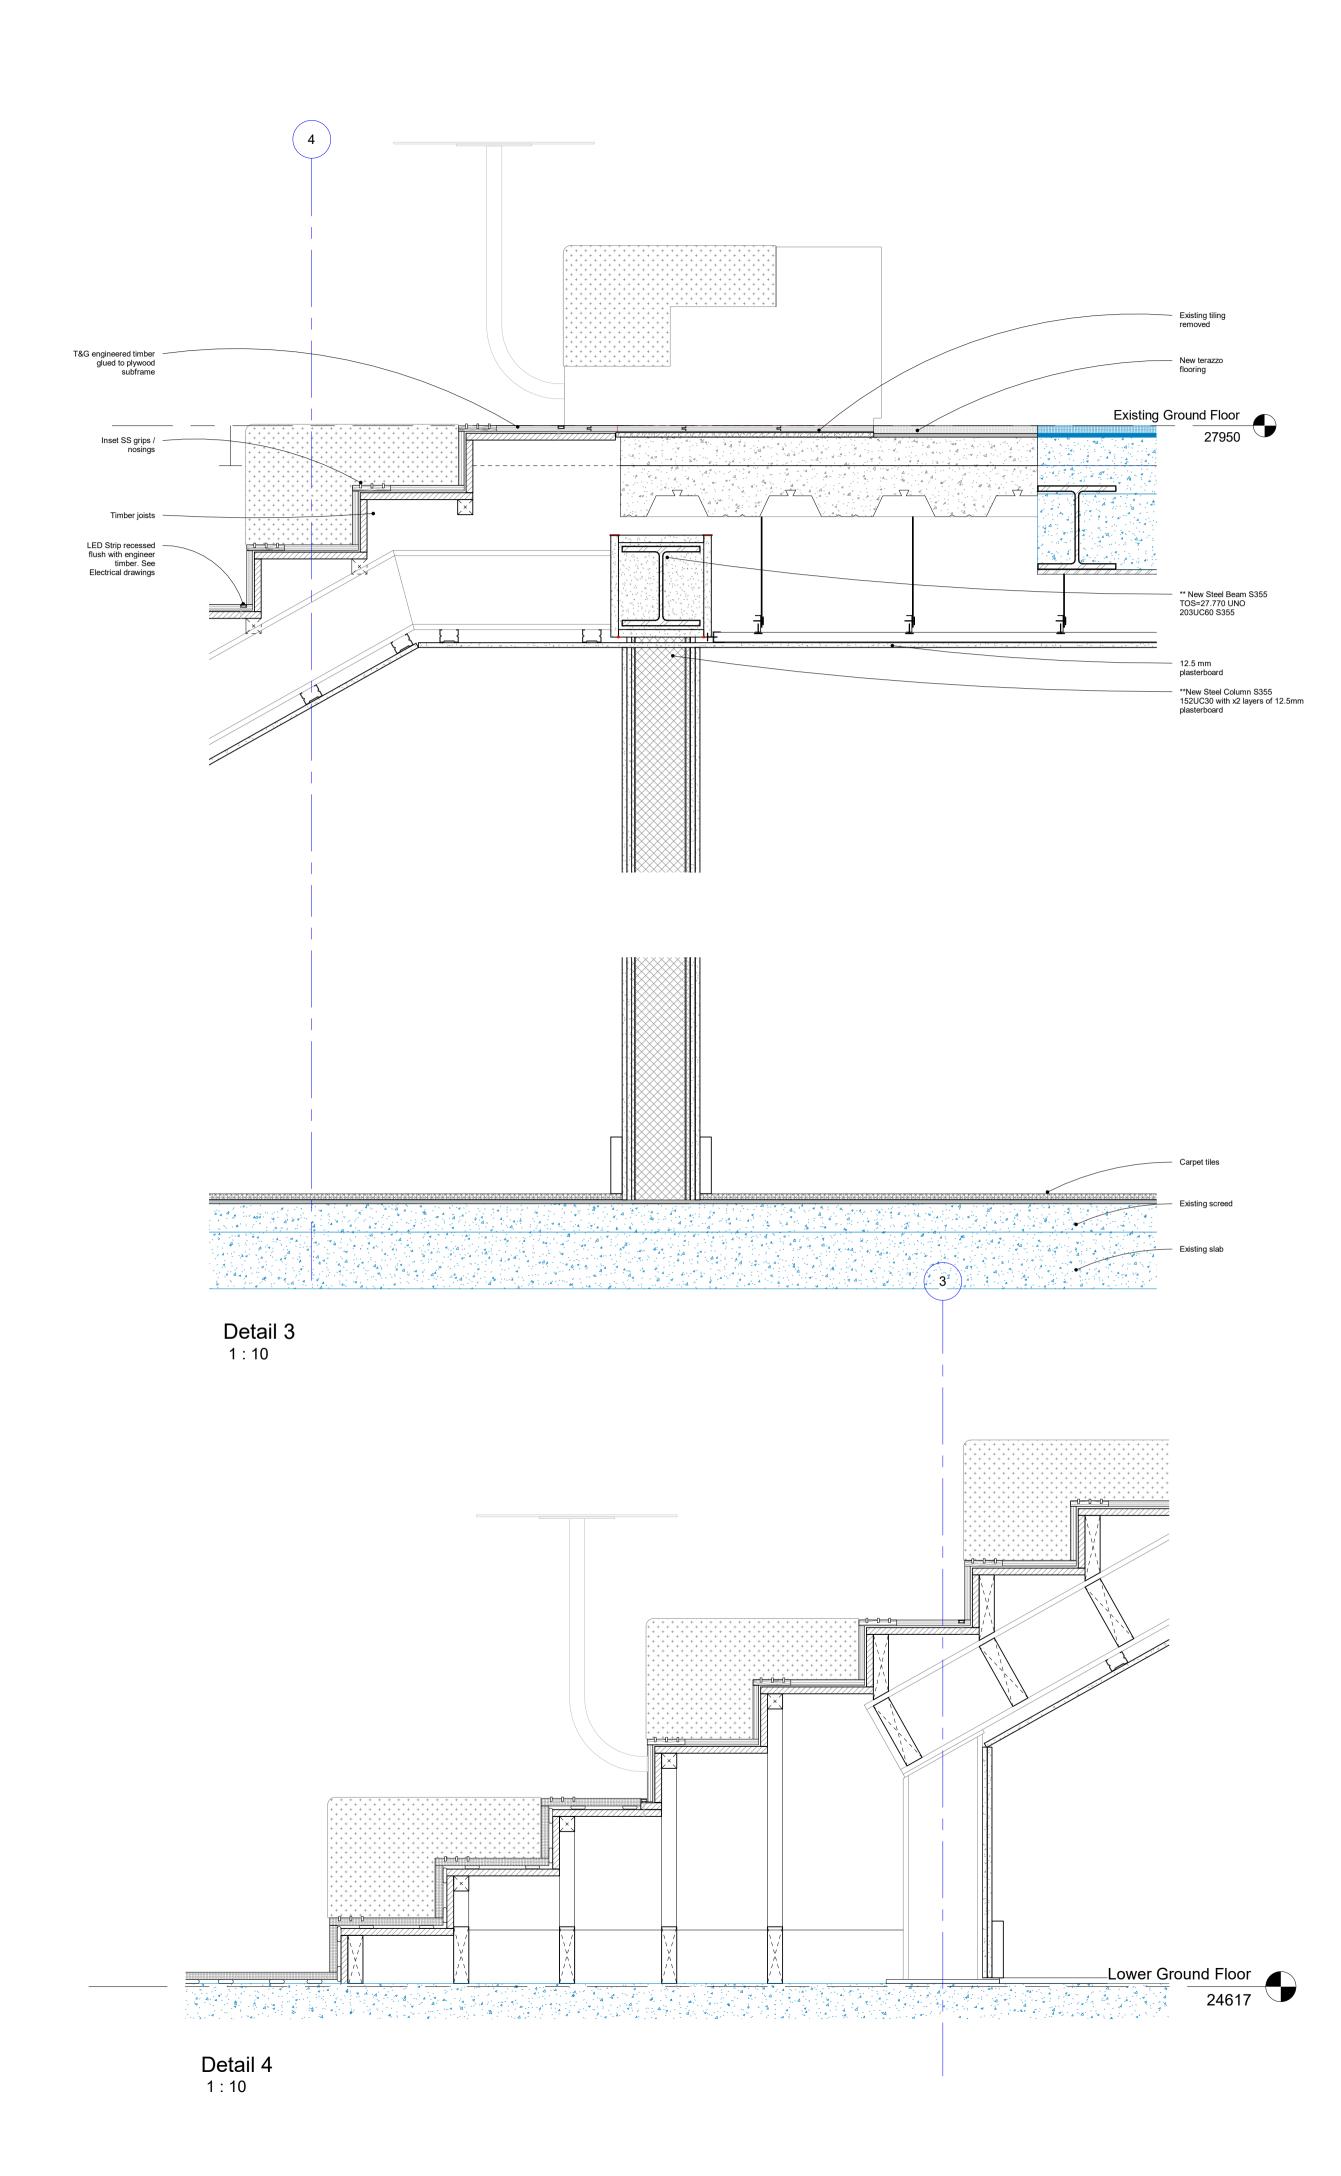
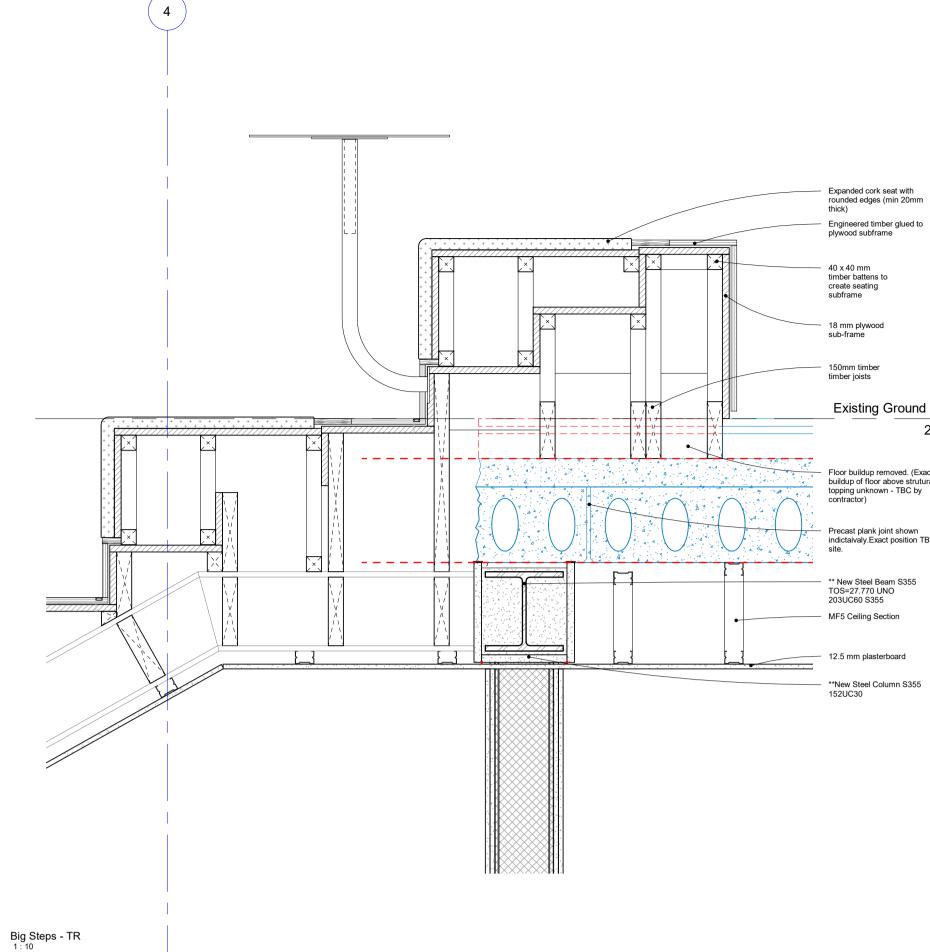
Engineered timber glued to plywood subframe

timber battens to create seating subframe

18 mm plywood

sub-frame

150mm timber timber joists

Existing Ground Floor 27950

Floor buildup removed. (Exact buildup of floor above strutural topping unknown - TBC by contractor)

Precast plank joint shown indictaivaly.Exact position TBC on site.

** New Steel Beam S355 TOS=27.770 UNO 203UC60 S355

**New Steel Column S355 152UC30
