—The British Museum
Great Russell St, London WC1B 3DG

PROJECT:
BM Water Ingress Roof Works

DRAWING:
South Elevation - Proposed

STATUS:	DATE:	DRAWN:	CHECKED:
Planning	26/05/2023	JD	AD
SCALE:	DRAWING NO.:	REVISION:	
1:50 @ ISO A1	111-Nex-00-XX-DR-A-251	P1

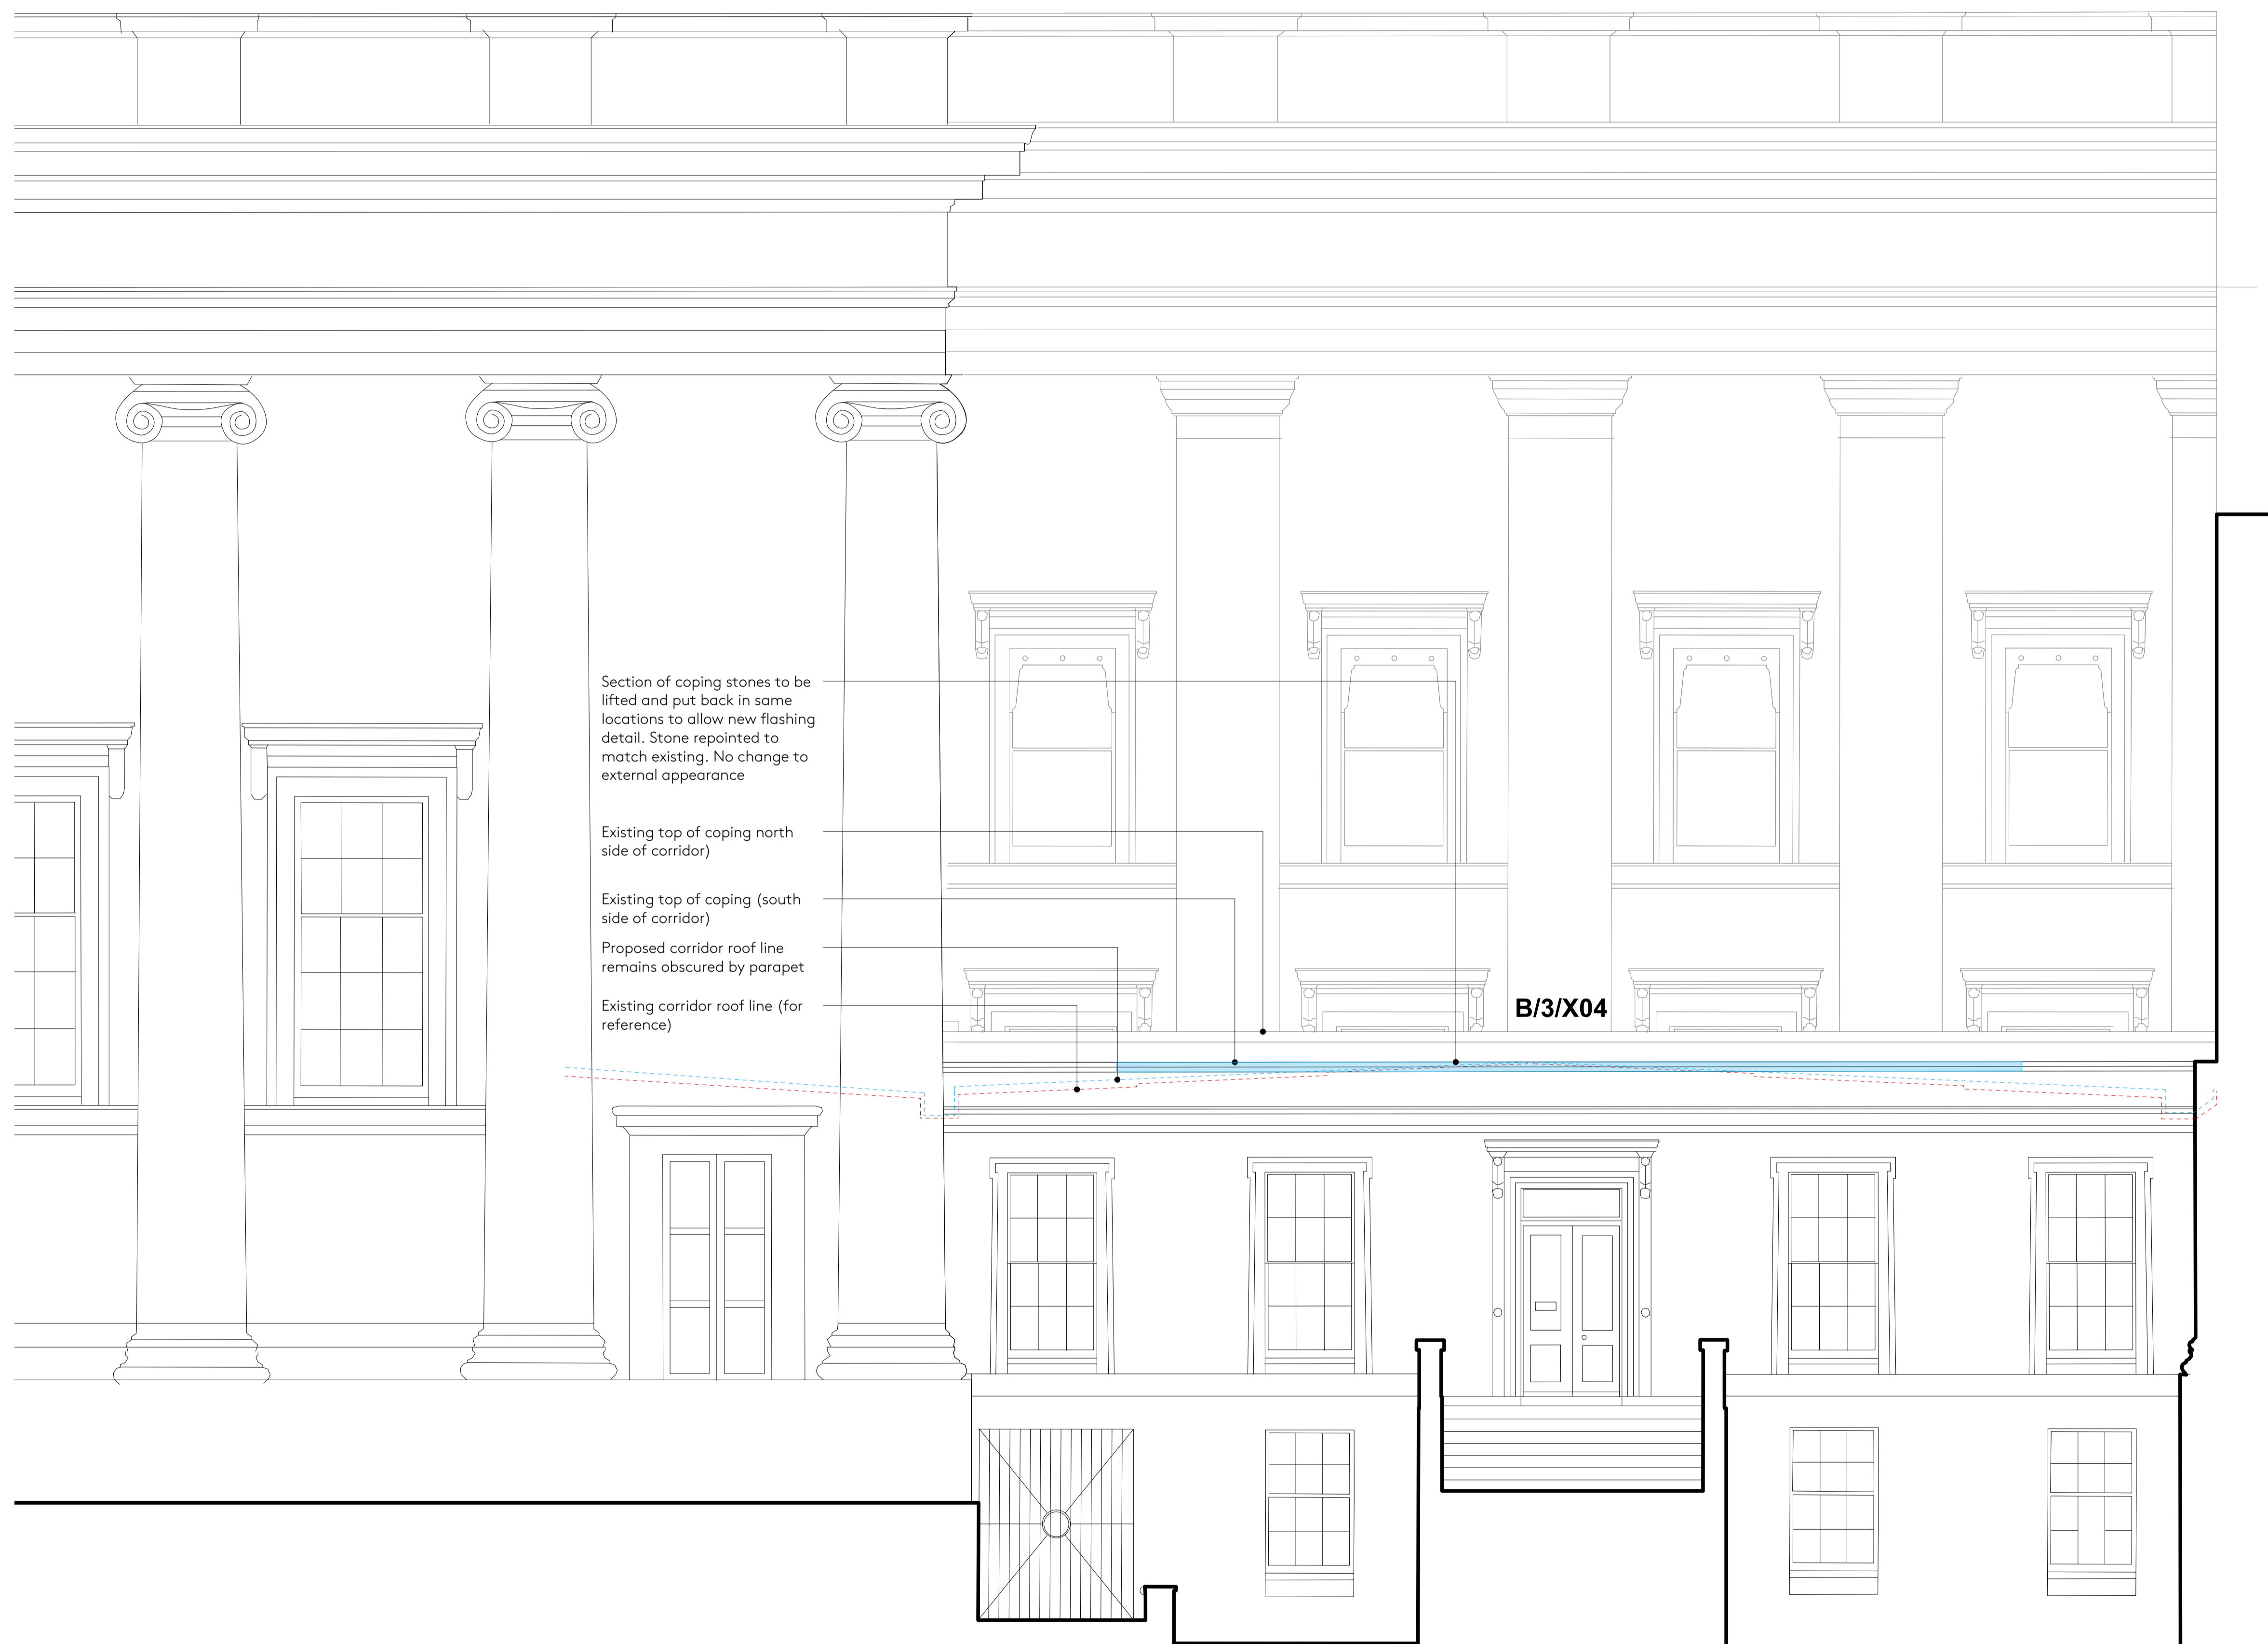
Section of coping stones to be lifted and put back in same locations to allow new flashing detail. Stone repointed to match existing. No change to external appearance

Existing top of coping north side of corridor)

Existing top of coping (south side of corridor)

Proposed corridor roof line remains obscured by parapet

Existing corridor roof line (for reference)

- Existing corridor roof line (obscured by parapet)
- Proposed corridor roof line (remains obscured by parapet)
- Coping stones lifted and put back in same location, per note
