Croft Structural Engineers  
Clock Shop Mews  
Rear of 60 Saxon Road  
London SE25 5EH

# Basement Impact Assessment

35 Greville Road  
London  
NW6 5JB

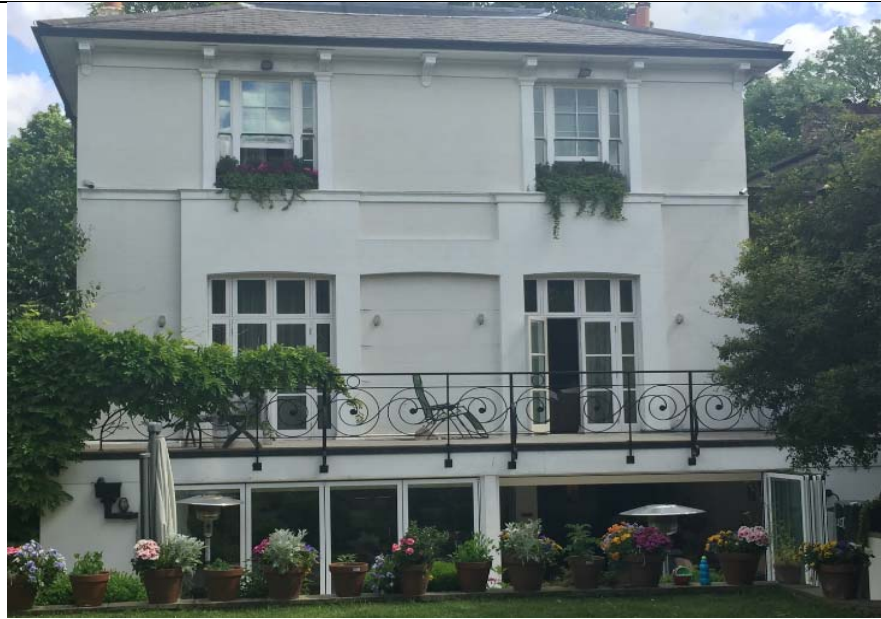
*Figure 1: Side elevation, viewed from South-west*

The existing property is a detached house. The main entrance of the property is accessed from Mortimer Crescent, which branches off Greville Road. The building has three stories and a loft storage space area. Load bearing masonry walls transfer the weight of the building and the imposed loads to the foundations. The existing Lower Ground floor level is approximately 1.6 metres below ground level.

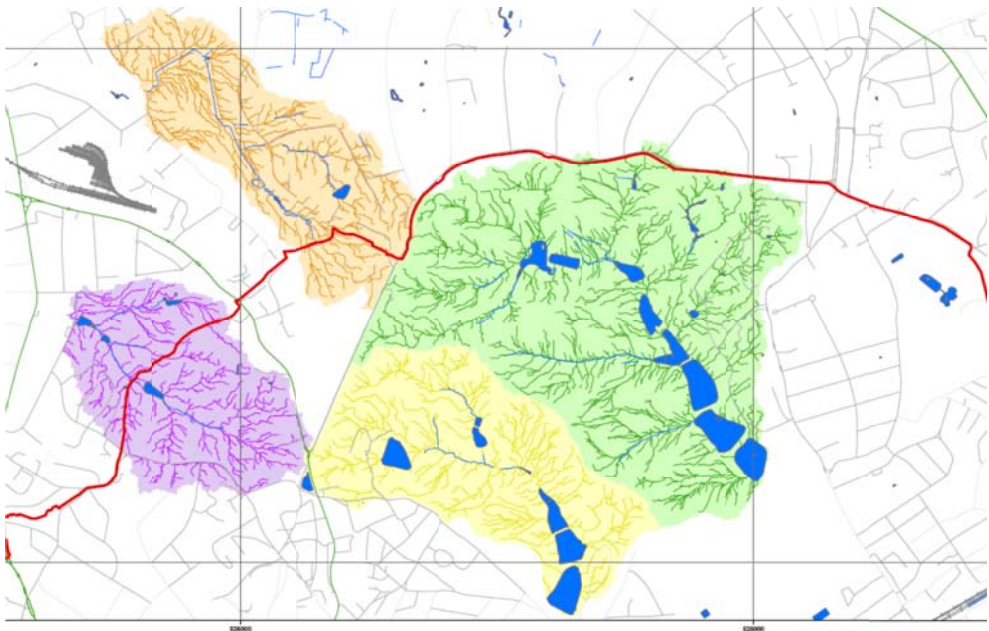
<p><i>Figure 4: Extract from Figure 14 of the GSD (site lies to the south of the shaded areas)</i></p> <p><b>No.</b> The site lies outside the areas denoted by Figure 14 of the GSD (extract shown above)</p>
	<p><b>Question 2. As part of the proposed site drainage, will surface water flows (e.g. volume of rainfall and peak run-off) be materially changed from the existing route?</b></p> <p><b>No</b> – The surface water that flows from the proposed development will be</p>

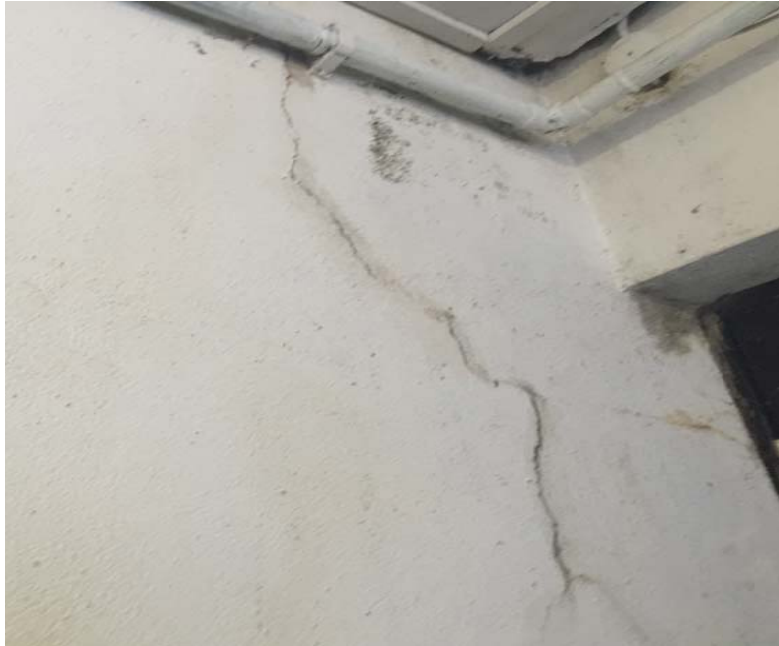
<p><i>Figure 10: Cracking on garage walls</i></p> <p>These cracks are believed to be non-structural. Further investigation should be carried out at detailed design stage to determine the extent of these cracks.</p>
Geology	<p>The site is on made ground (approximately 600mm deep) overlying London Clay. The existing Lower Ground floor extends into the London Clay.</p> <p>Refer to the Ground Investigation report Land Stability assessment for more details of the ground conditions.</p>

lightwell.
Building Defects	<p>A visual inspection was undertaken of the existing building, with particular attention given to any suspected associated movement. The defects noted were:</p> <ul style="list-style-type: none"> <li>• Fine cracking was noted above ground floor door lintel</li> <li>• Fine to moderate cracking was noted on the garage walls</li> </ul>
