## PLANNING

<sup>≝</sup> GA Ele West	vation - E	Existing		
<sup>®</sup> 742-MICA-GC-ZZ-DR-A-19032				<sup></sup> PL1
OH CHECKED		scale 31:100	<sup>III</sup> A3	U4.08.23

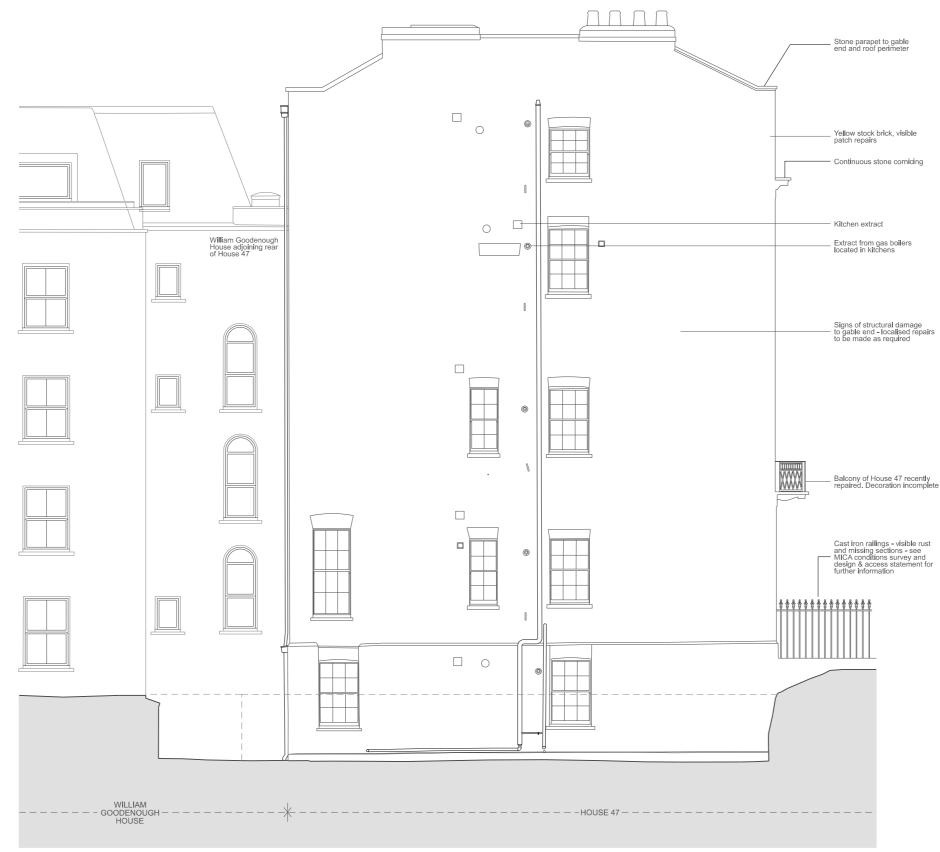
Yellow stock brick, visible patch repairs

Continuous stone cornicing

Signs of structural damage to gable end - localised repairs to be made as required

Cast iron railings - visible rust and missing sections - see MICA conditions survey and design & access statement for further information
